## **NATIONAL TRANSPORTATION SAFETY BOARD**

### **ENGINE EXAMINATION**

**WPR17FA117**

Location: Ventura, California  
Date: December 1, 2017  
Aircraft: Cessna 180  
N3683C, Serial #: 31182  
NTSB IIC: Albert Nixon

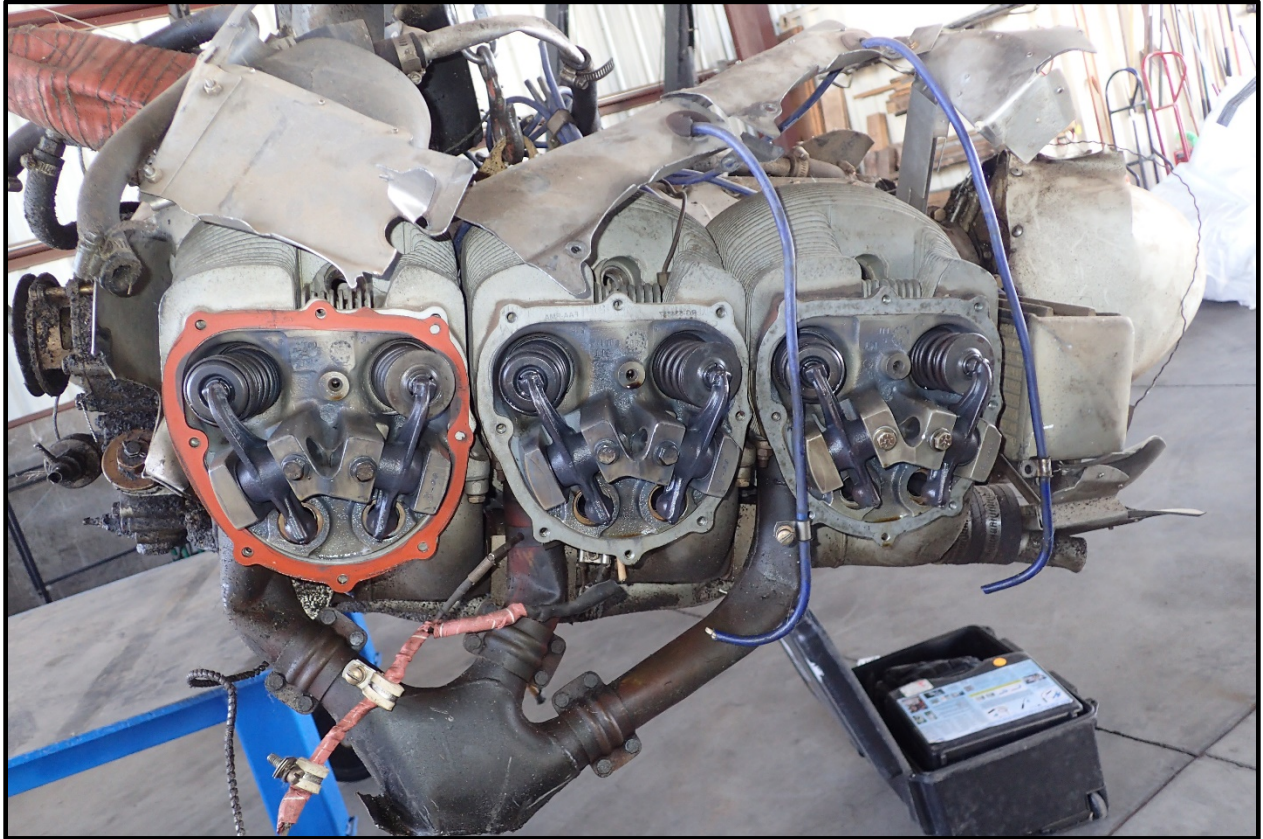
anomalies. A borescope inspection of the right-side cylinders revealed evidence of normal operational conditions.

Figure 1: View of right-side of the engine.

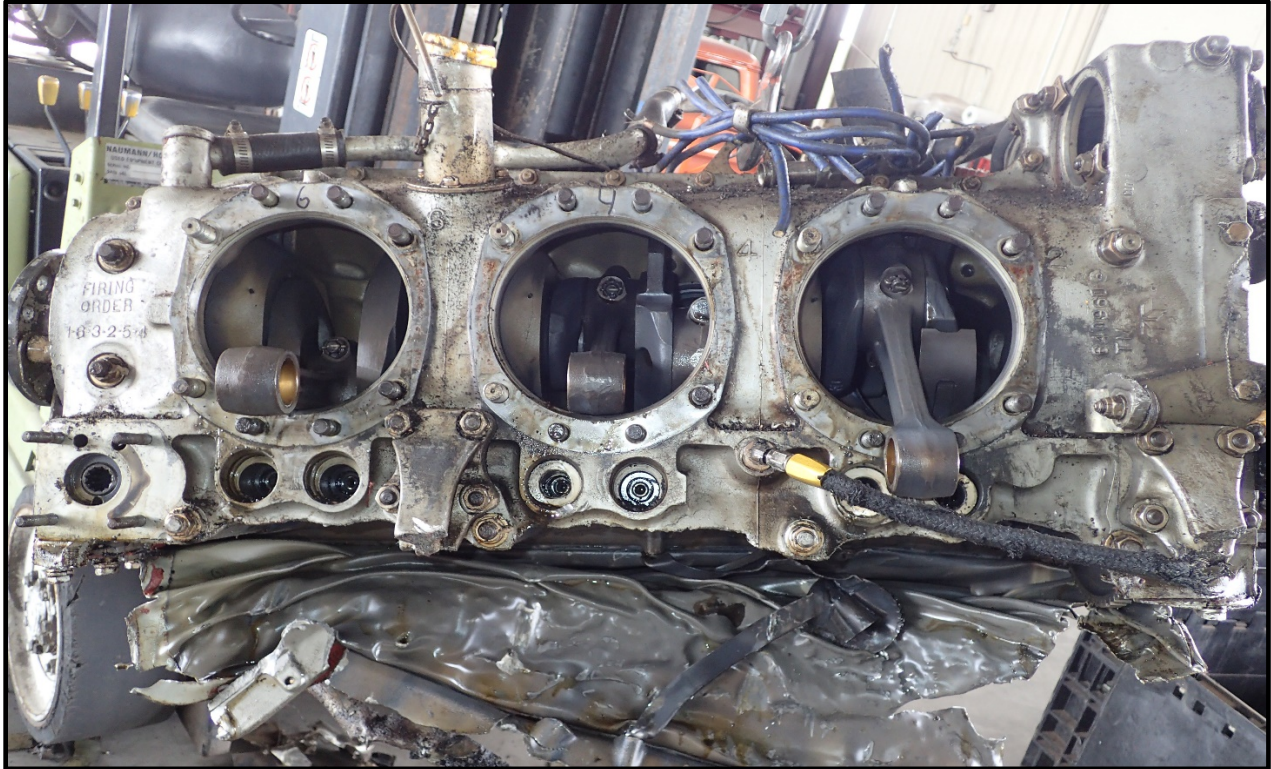
During the engine disassembly examination, the right-side of the cylinder overhead areas were unremarkable. The left-side valves sustained impact damage and exhibited normal operating signatures. Several rocker arms on the left-side sustained impact damage and were either partially or totally separated. The left-side cylinders sustained impact damage and were removed. Subsequently, the crankshaft was able to be rotated by utilizing a hand tool on the accessory section and rotational continuity was established throughout the engine and valve train. The internal crankcase components were visible through the left-side cylinder bays revealing no

Figure 2: View of the left-side of the engine with the cylinders removed.
