## **NATIONAL TRANSPORTATION SAFETY BOARD**

# **WRECKAGE EXAMINATION SUMMARY**

**WPR17LA118**

| Aircraft: | N66117; Cessna 150M |

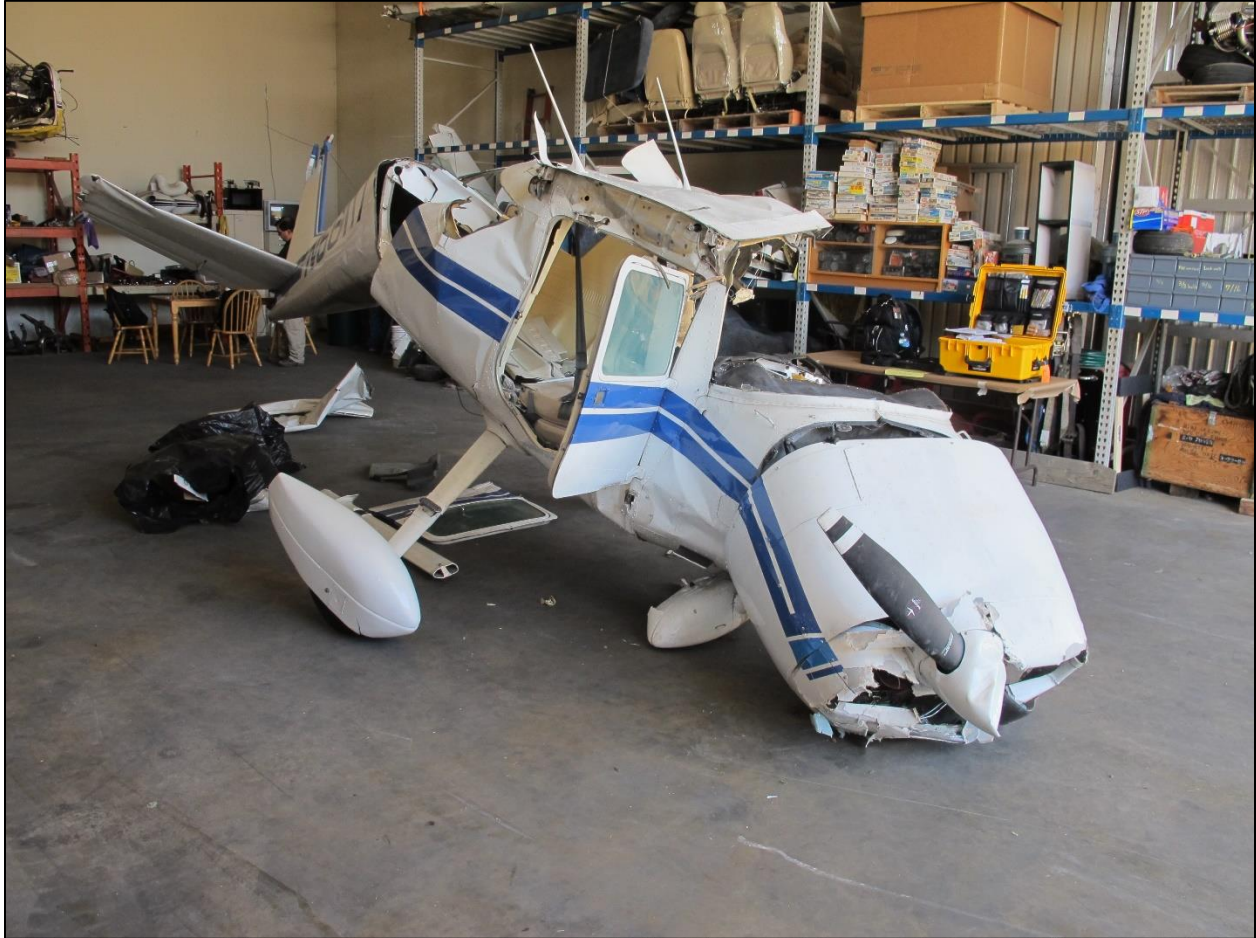
**Figure 1-Main Wreckage**

Examination of the recovered wreckage was conducted on June 13, 2017 at the facilities of South West Aircraft Transportation and Recovery, in Chino, California, by the National Transportation Safety Board (NTSB) investigator-in-charge (IIC), Federal Aviation Administration (FAA), Textron Aviation and Continental Motors Group. The examination revealed no evidence of any preimpact mechanical malfunctions or failures that would have precluded normal operation.

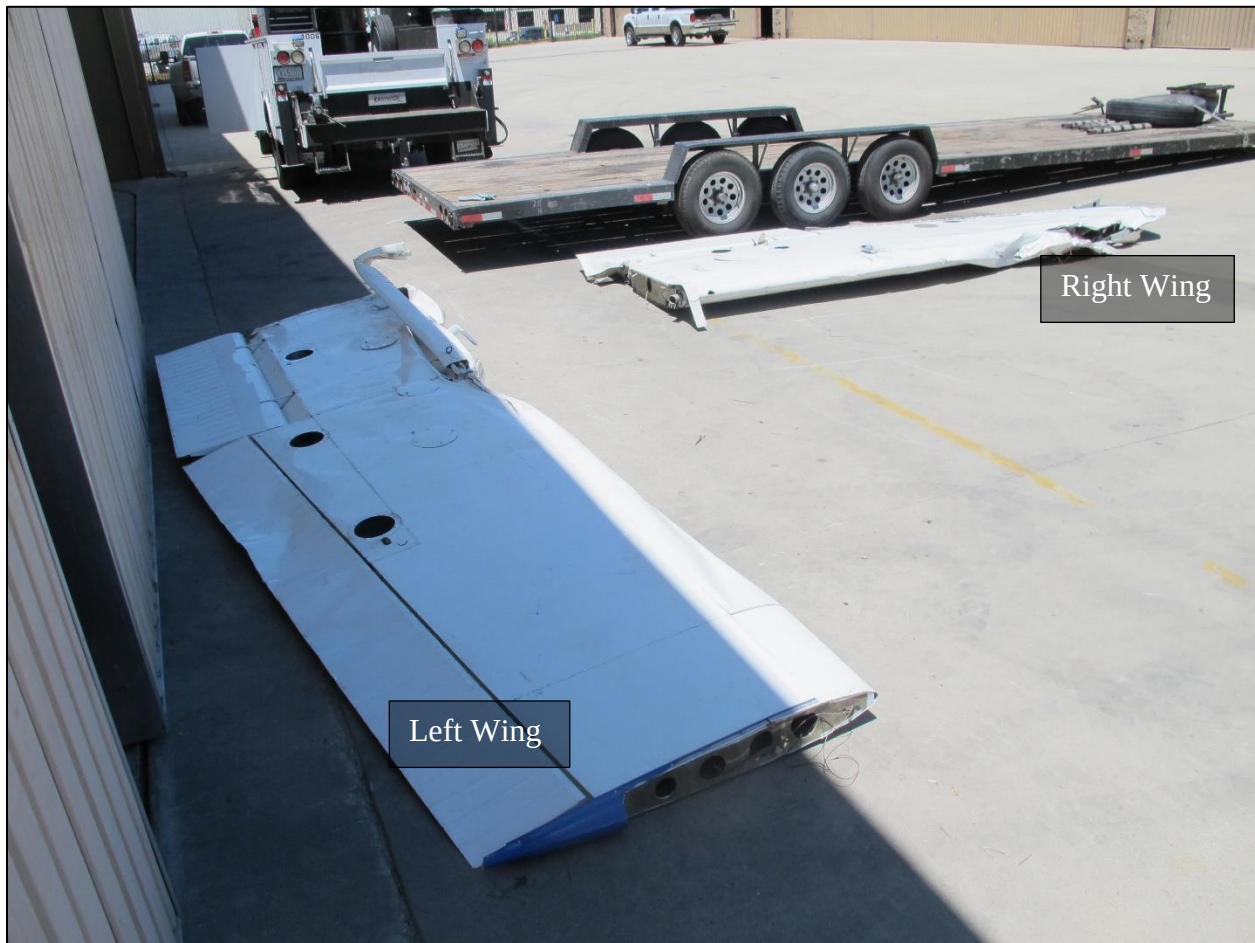
**Figure 2. Wreckage Layout, Left Wing**

The left wing had impact damage consistent with tree strikes to the leading edge from the midsection to the wing root. The wing separated from the fuselage at the wing spar by impact forces, and the control cables remained attached. The wing strut had impact damage consistent with a tree strike near the fuselage attachment. The fuel tank was found empty prior to the recovery efforts and the fuel tank cap was secured and was undamaged. Cable control continuity was established from the cut cables at the wing root to the control surfaces.

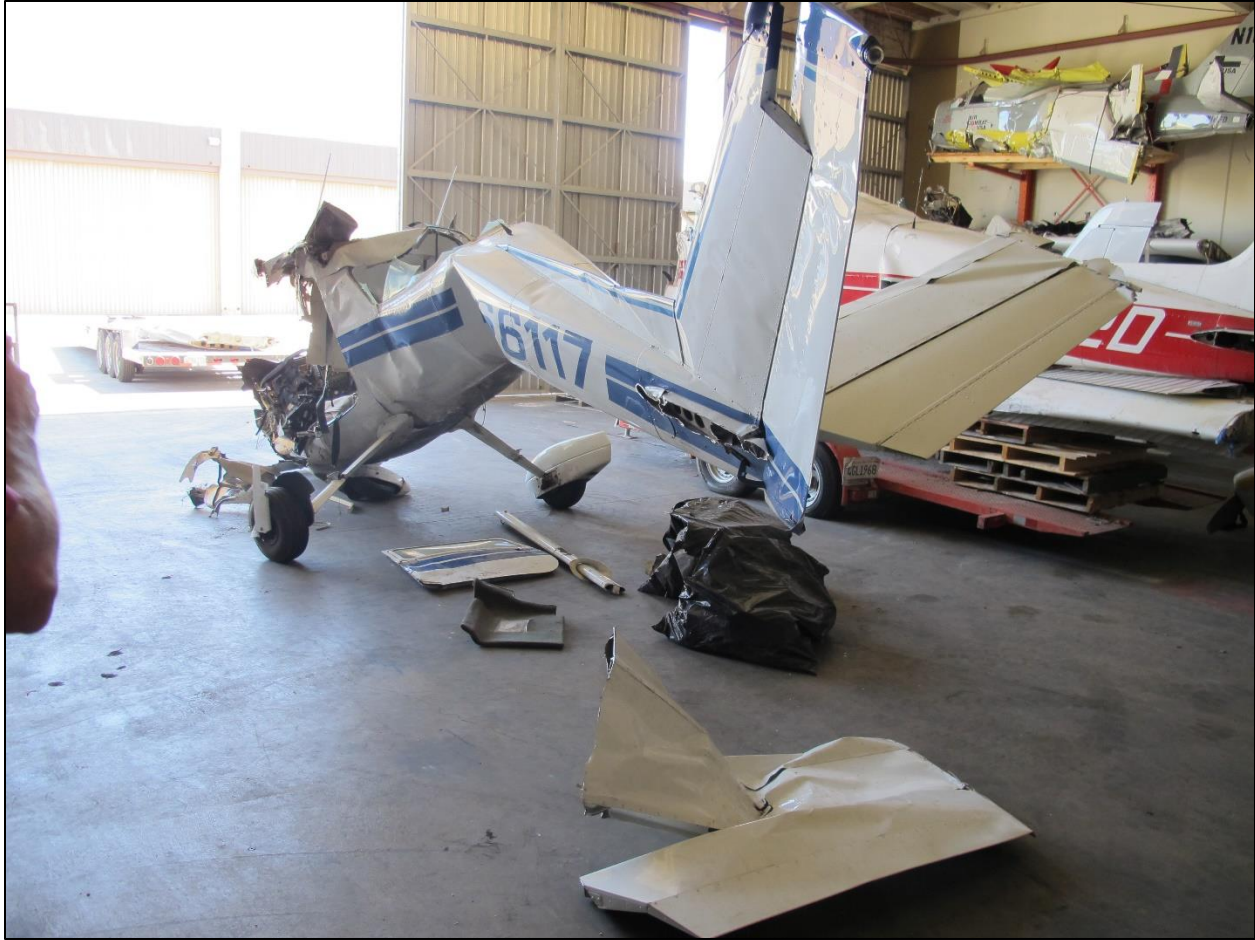
**Figure 3-Empennage**

The left elevator was removed during the wreckage recovery. Both horizontal stabilizers and elevators revealed impact damage. The rudder and vertical stabilizer were buckled. Cable control continuity was established from the flight control surfaces to the cabin controls.

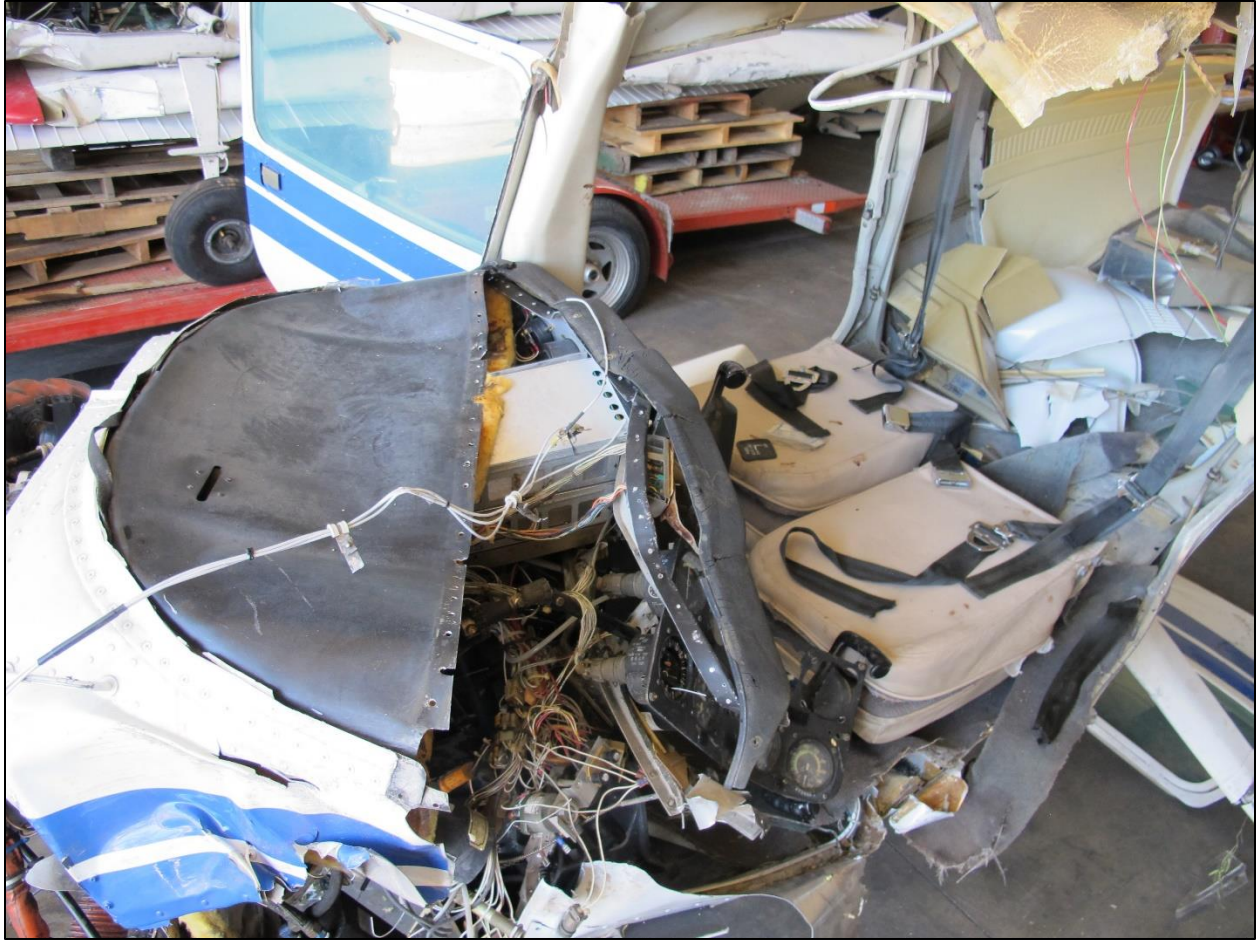
**Figure 4-Cabin Area**

The aft fuselage had impact damage and was buckled. The forward fuselage was torn open exposing the forward left side of the instrument panel. The left forward window post separated from the fuselage.

The seats remained attached to the floor rails and the seat belts remained attached to their mounts. The left seat belts were unbuckled. The left seats belt webbing was cut by first responders and the shoulder harness remained attached to the latch bushing. The right seat belts were unbuckled. The right seat belt webbing was undamaged and the shoulder harness was not attached to the latch bushing.

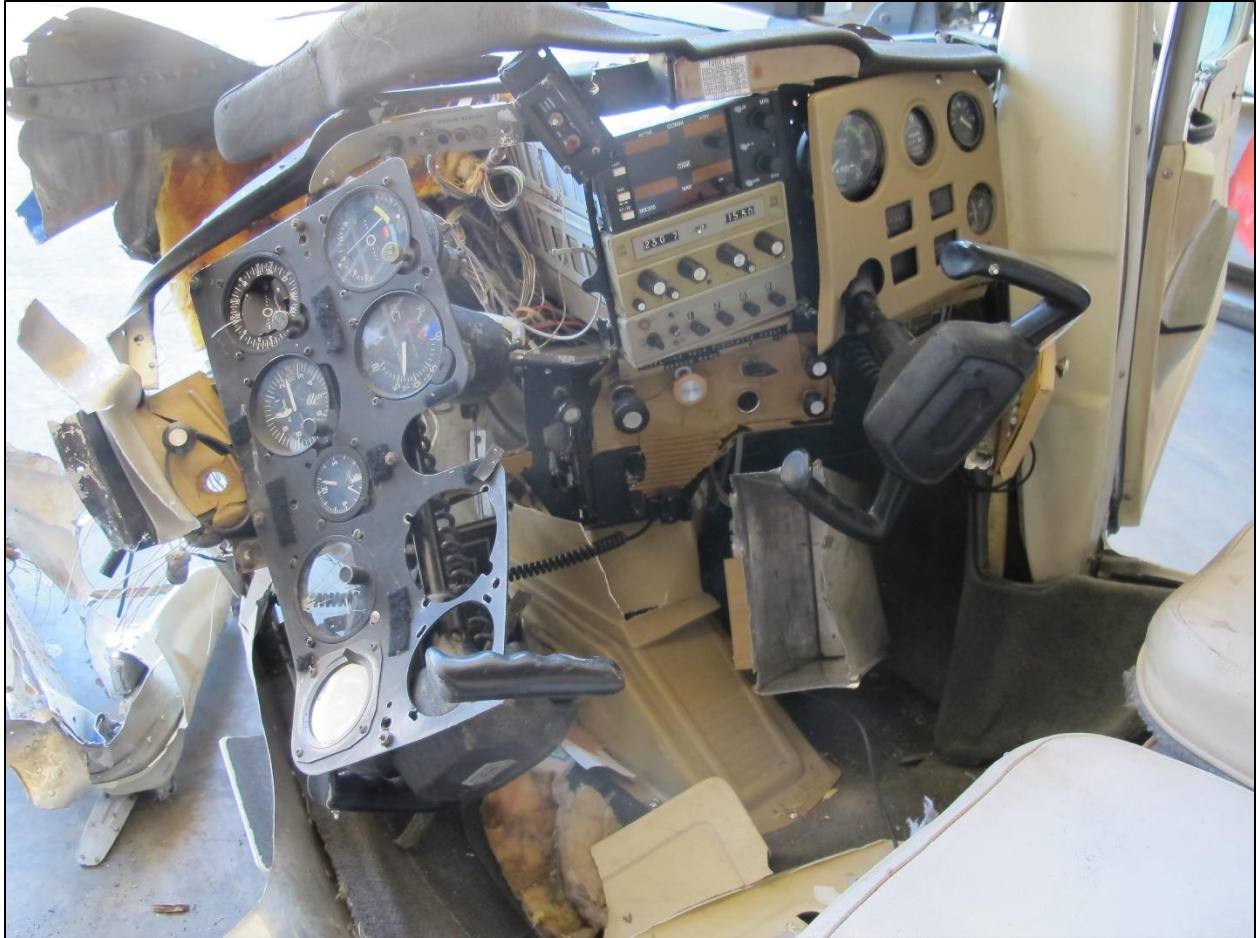
**Figure 5-Instrument Panel**

The left control yoke, left forward cabin structure and left side instrument panel had impact damage. The right control yoke was bent downward and to the right.

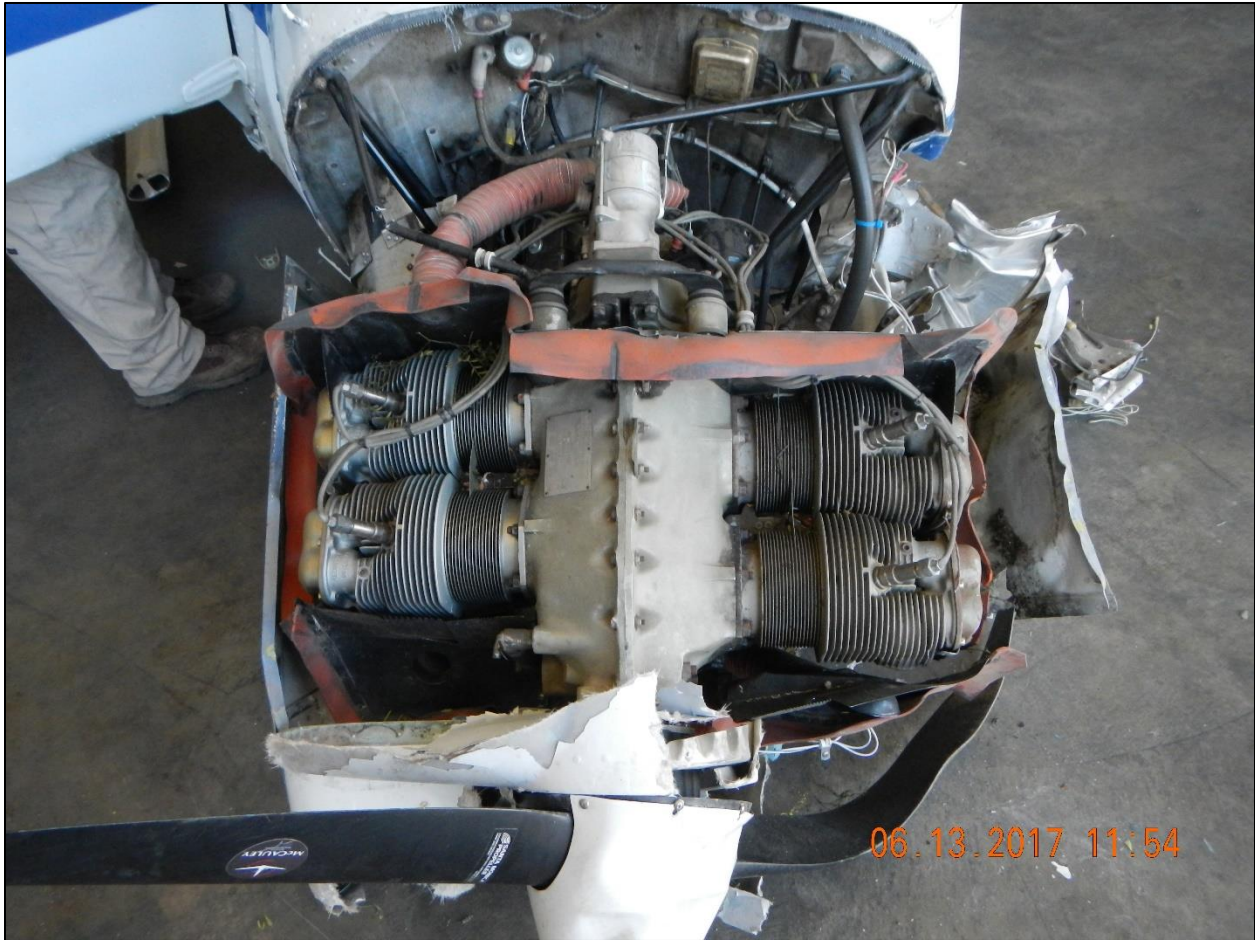
**Figure 6-Engine**

The engine was undamaged and remained attached to the mounting assembly. Cable control continuity was attained from the cockpit controls to the engine components with exception to the carburetor heat control due to impact damage. The upper spark plugs and valve covers were removed and cylinder compression, gear and valve train continuity was established. The lower spark plugs were removed and all spark plug electrodes had (Worn out-Normal) wear conditions when compared to a Champion AV-27 chart. The electrode areas had a light amount of dark combustion deposits. The magnetos were not removed from the engine and spark was produced at each ignition lead when the crankshaft was rotated by hand. The vacuum pump was removed from the engine and disassembled. The drive coupler, rotor and blades were undamaged. The vacuum pump rotor housing had chatter marks on the interior surface. The air induction assembly and the carburetor was removed from the engine. The carburetor accelerator pump was actuated by hand and fuel flowed freely from the nozzle. The carburetor was disassembled and fuel was found in the bowl. Water detection paste was used in the remaining fuel and was negative for contaminants. The carburetor revealed no mechanical anomalies.

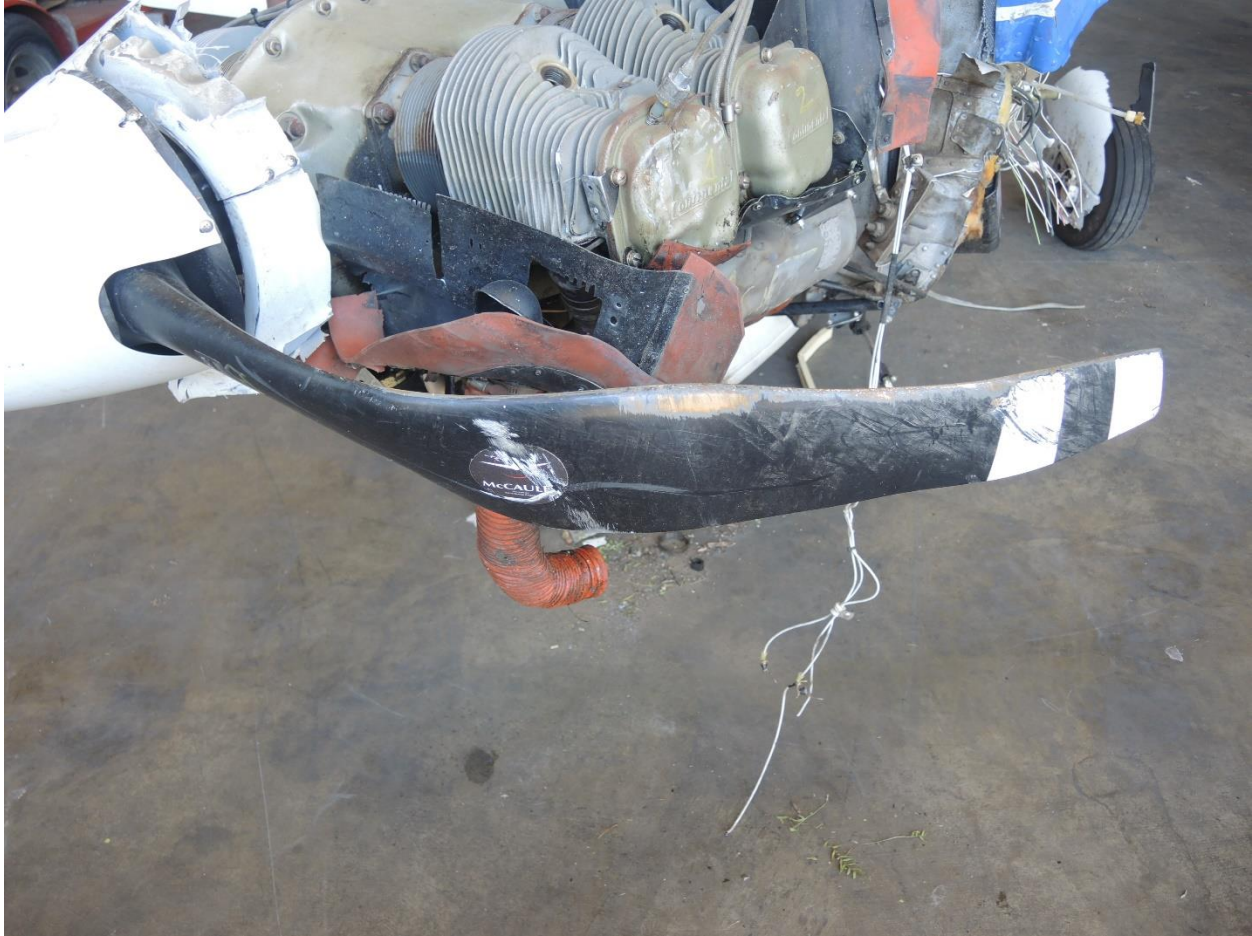
**Figure 7-Blade 2**

The propeller assembly remained attached to the engine crankshaft flange and had impact damage to the number 2 blade. The blade surface had multidirectional scratching and the leading edge had scuffing and polishing. The blade was bent aft near the midsection, consistent with a tree strike, and slight s-type bending to the tip. The number 1 blade had light scratches on the leading edge.

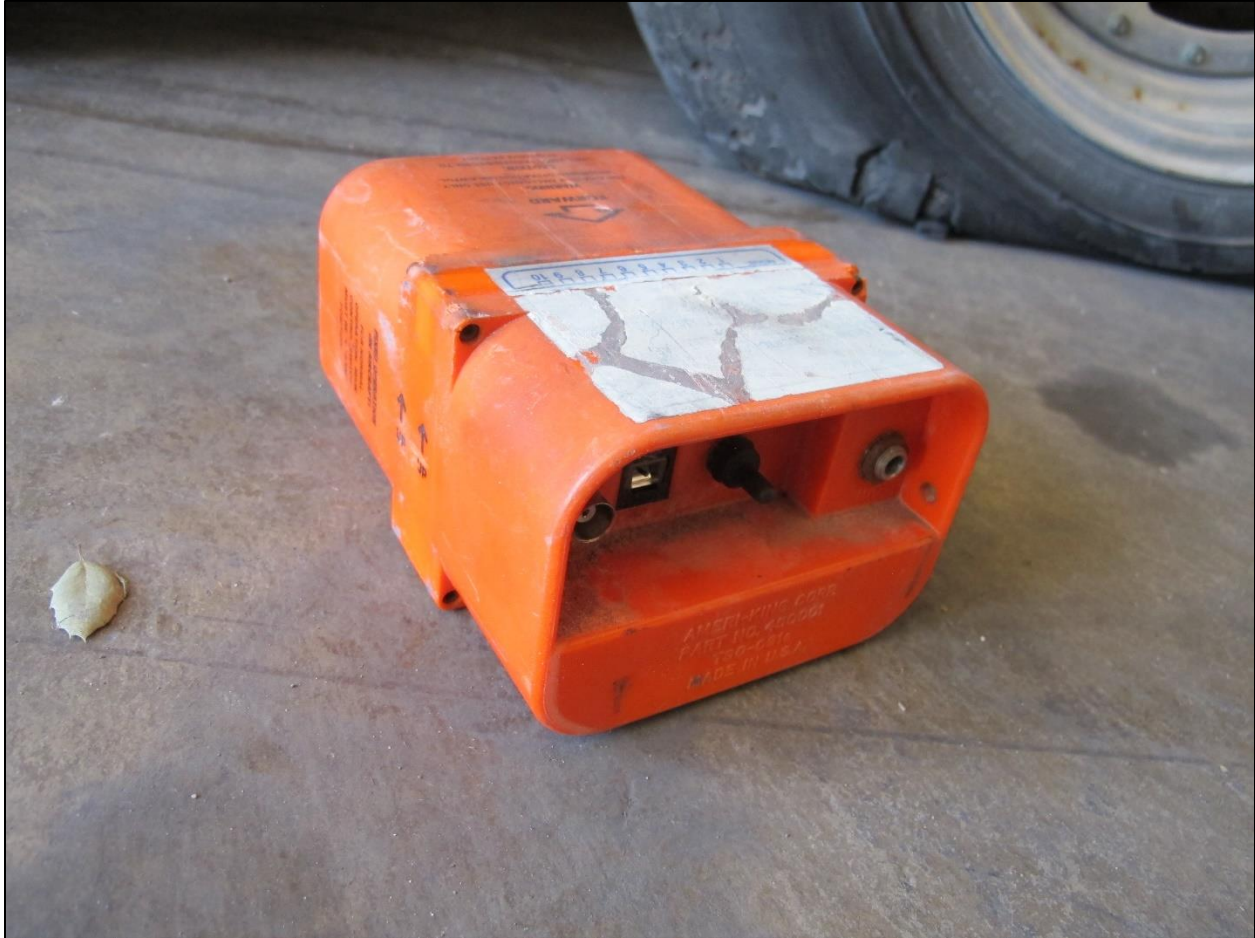
**Figure 9-ELT**

The ELT was found in the armed position by the FAA inspector during the initial accident site examination. During the wreckage recovery, the ELT was removed from its mount and the antenna cable was disconnected from its plug. During the wreckage examination, the ELT switch was turned to the 'ON' position and the transmitting light did not turn on during testing. A radio, tuned to 121.5 MHz did not detect a signal. The unit was opened and no anomalies noted. The D-cell batteries were replaced with new batteries, and the indicating light illuminated when the switch was turned to the 'ON' position. The radio did not detect a signal during the second test. Original batteries were reinstalled in the ELT and the indicator light illuminated when the switch was turned to the 'ON' position. The radio did not detect a signal during the third test. The identification tag was not legible and faded. The ELT was obtained by the NTSB for further testing.
