# Continental Motors

## ENGINE FIELD INSPECTION REPORT

| AIRCRAFT MAKE & MODEL | Cessna 150M |
| FILE NUMBER | 16-628 |

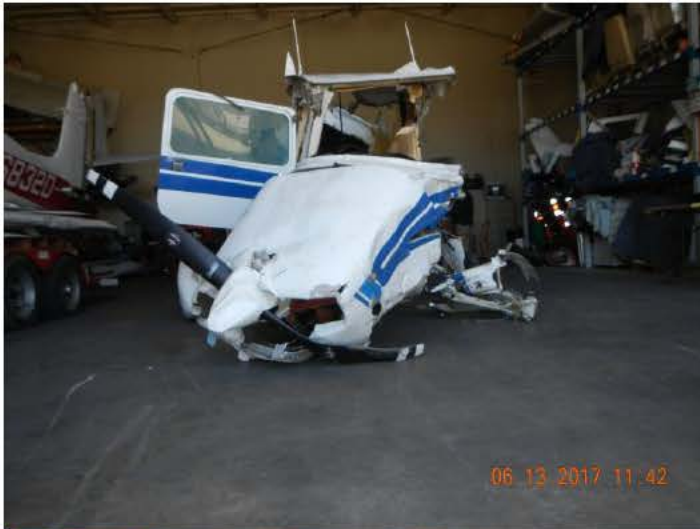
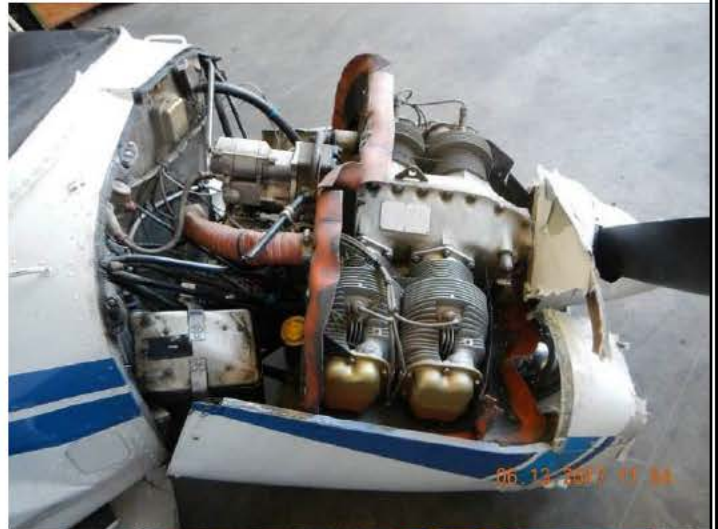
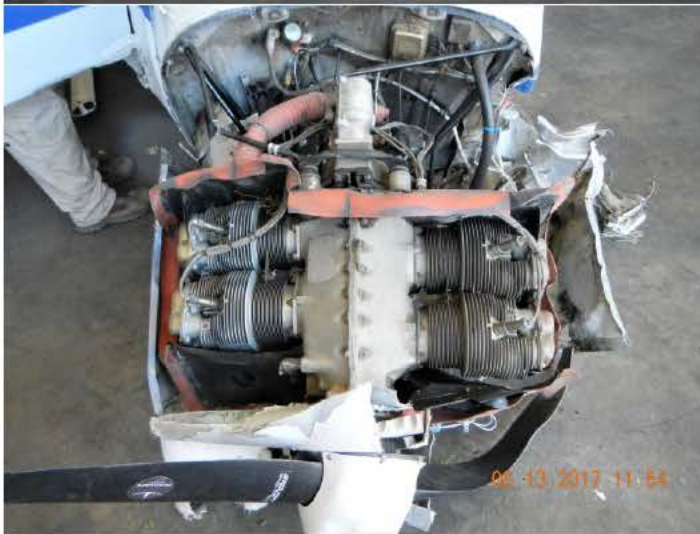
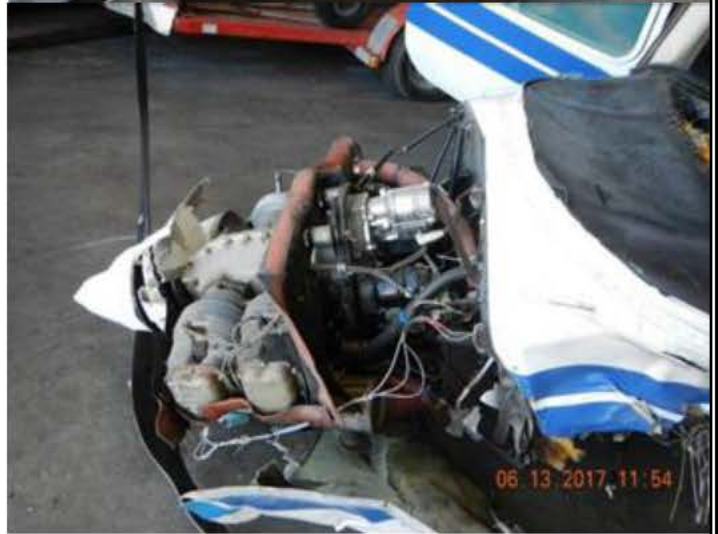
The damaged engine cowlings were removed to facilitate an inspection of the engine. The engine mount was broken and only engine control cables and wiring were securing the engine to the airframe. The engine exhibited only minor impact damage and the propeller remained attached to the crankshaft propeller flange.

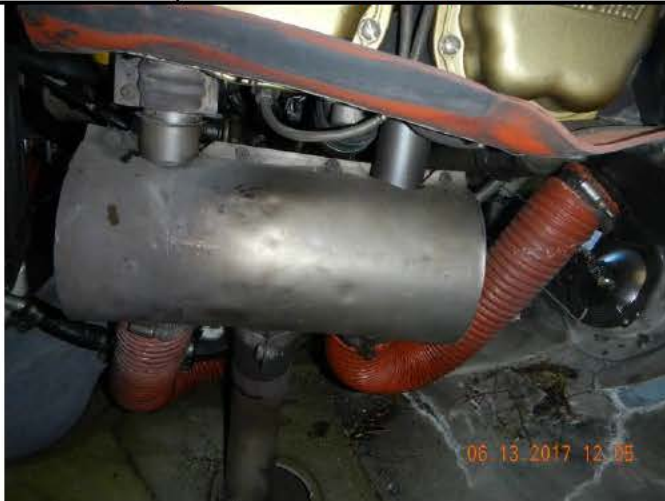
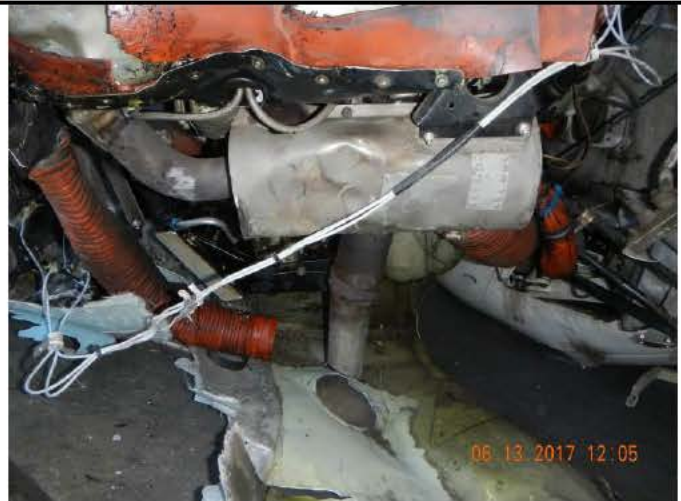
Condition: The right exhaust components were undamaged. The left exhaust muffler received minor impact damage. A lighted borescope inspection of the right and left muffler revealed no internal damage which would cause any exhaust restrictions.

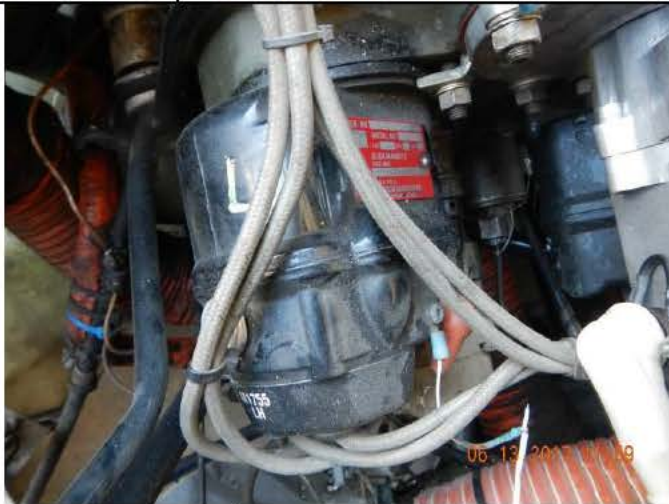
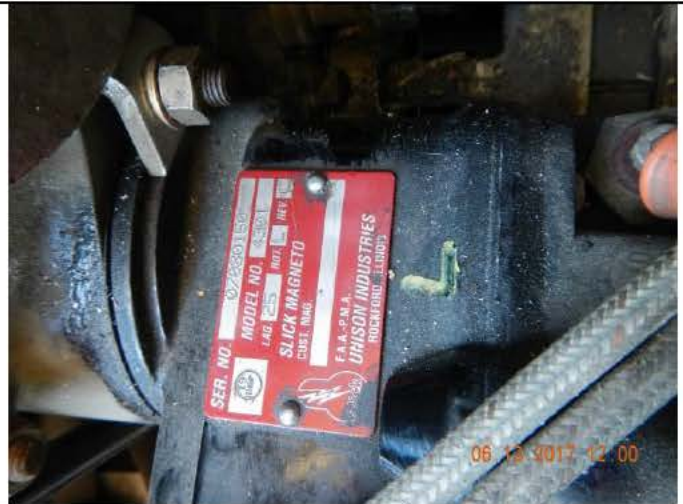
### LEFT MAGNETO

The magneto remained attached and produced spark to ignition leads when the engine was manually rotated

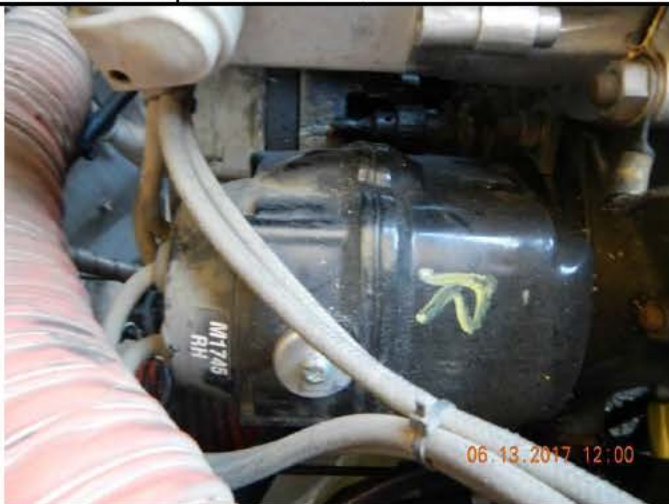
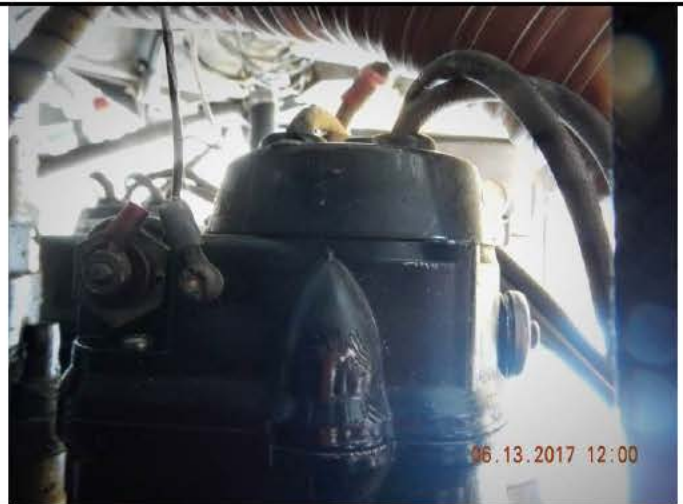
### RIGHT MAGNETO

The magneto remained attached and produced spark to ignition leads when the engine was manually rotated

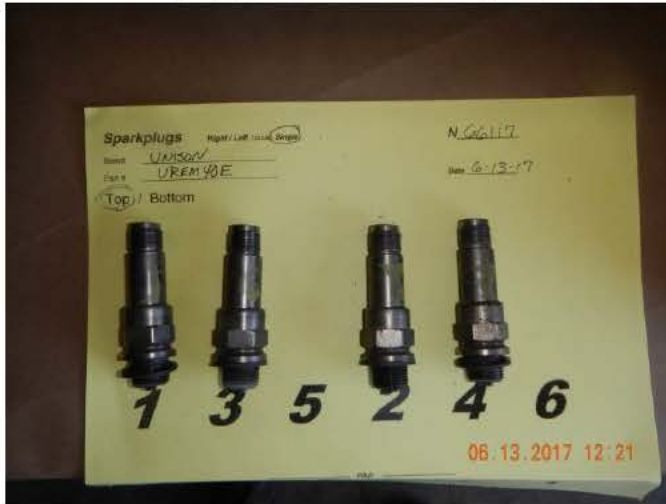
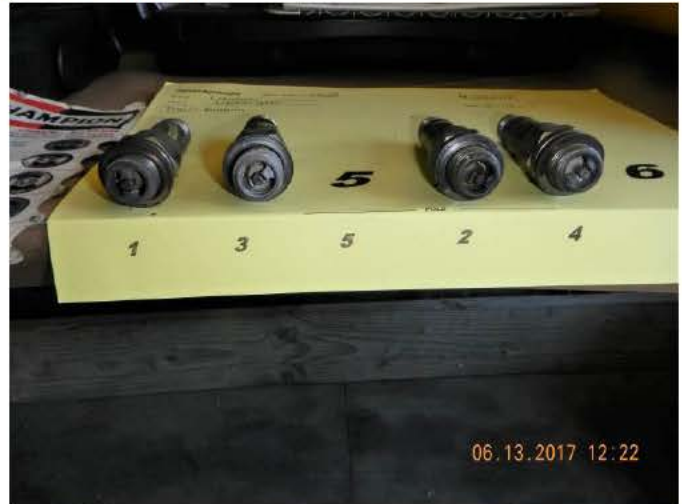
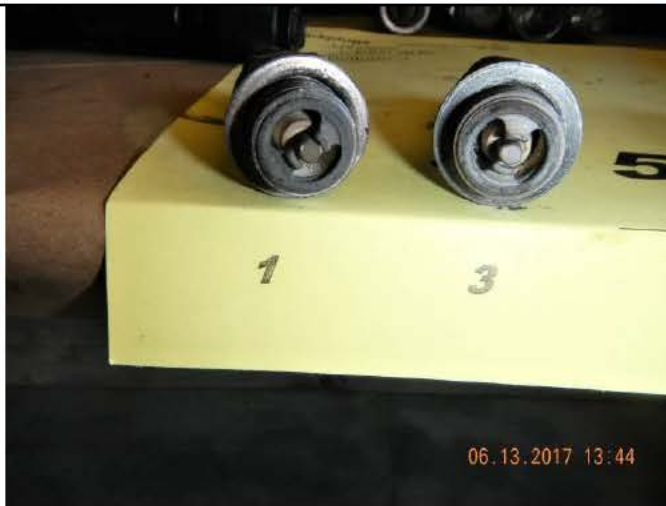
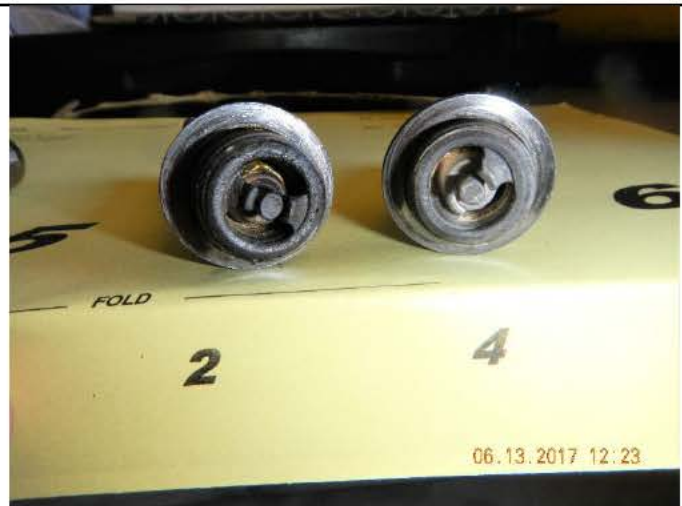
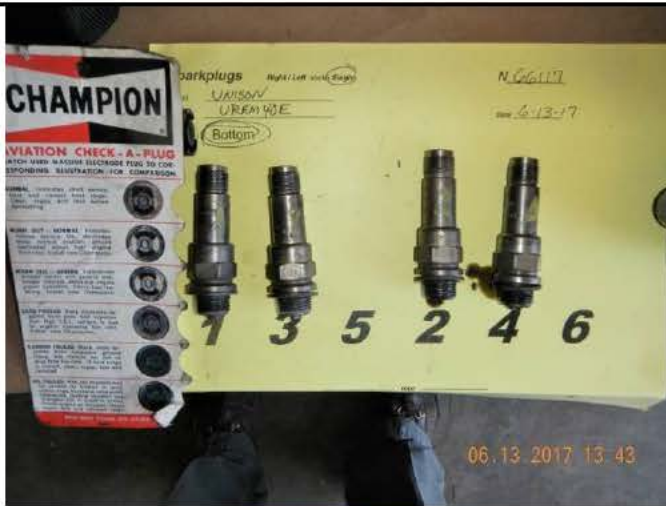
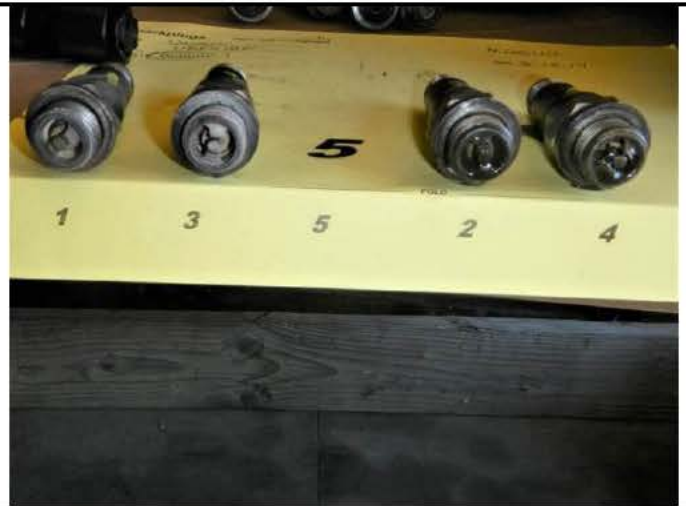
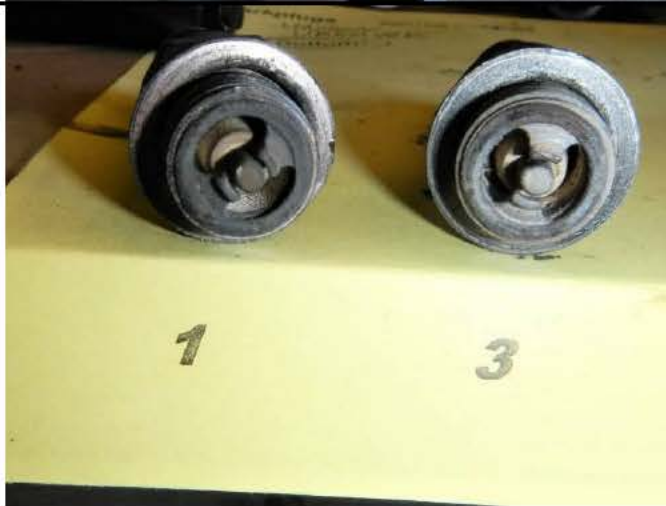
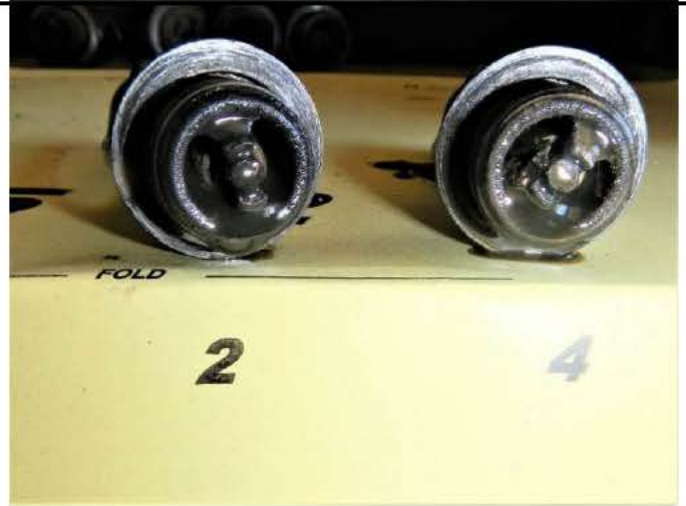
The top sparkplugs were removed and inspected. When compared to a Champion Check-A-Plug chart, the sparkplugs appeared normal in wear and coloration. The bottom sparkplugs were removed and inspected. Sparkplugs from cylinders 2 and 4 were oily in appearance. Bottom sparkplug wear appeared normal.

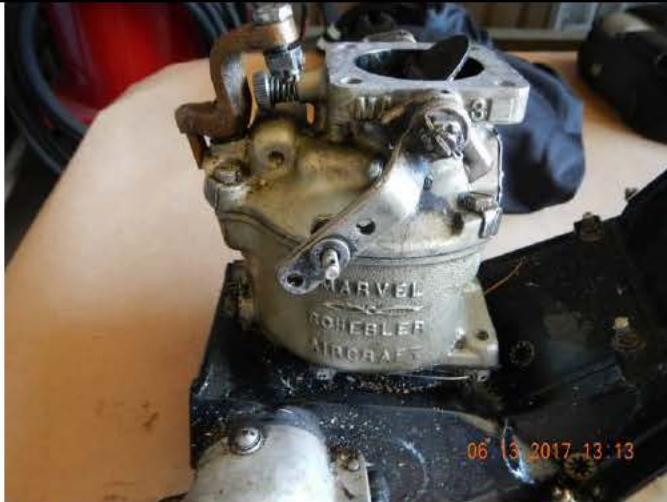
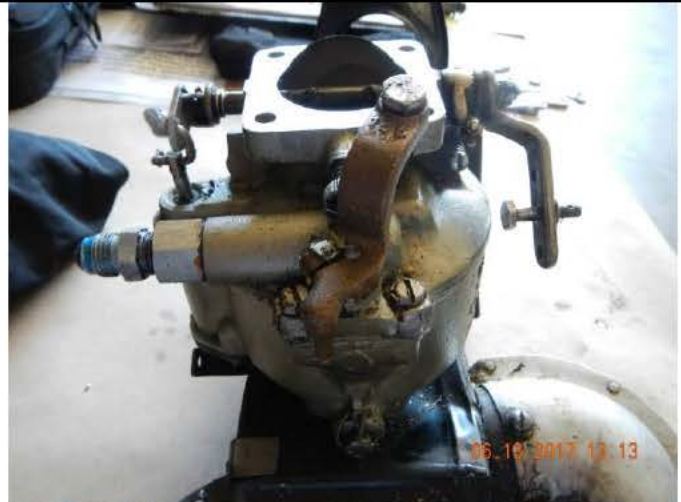
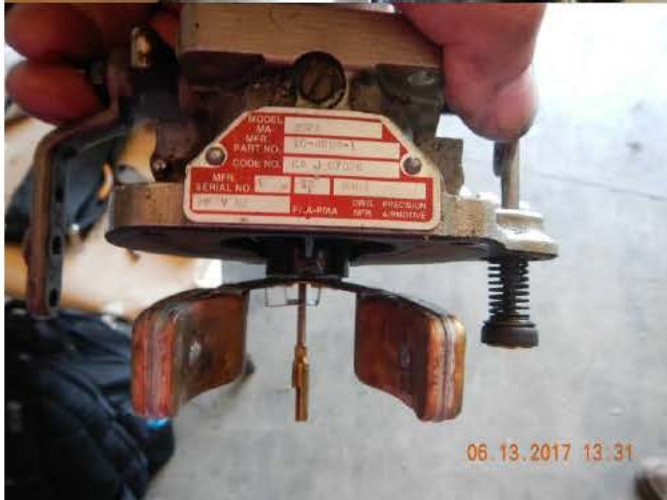
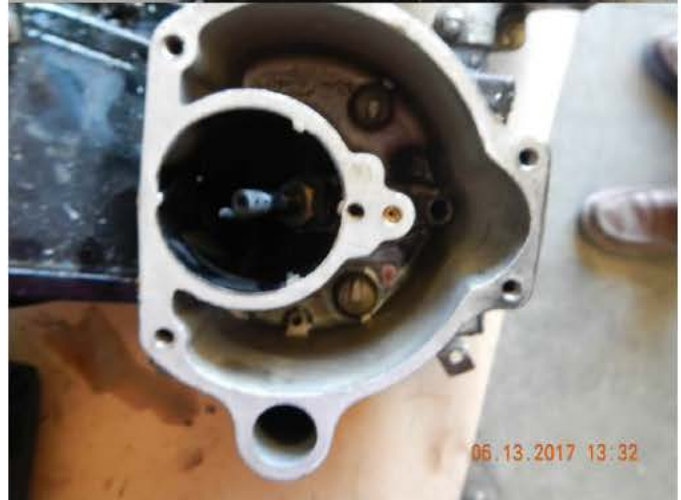
The carburetor was removed and inspected. The accelerator pump was found to be operational. A small amount of blue aviation fuel was present in the carburetor bowl which tested negative for water contamination using water finding paste. The carburetor floats were intact and moved correctly opening and closing the needle valve.

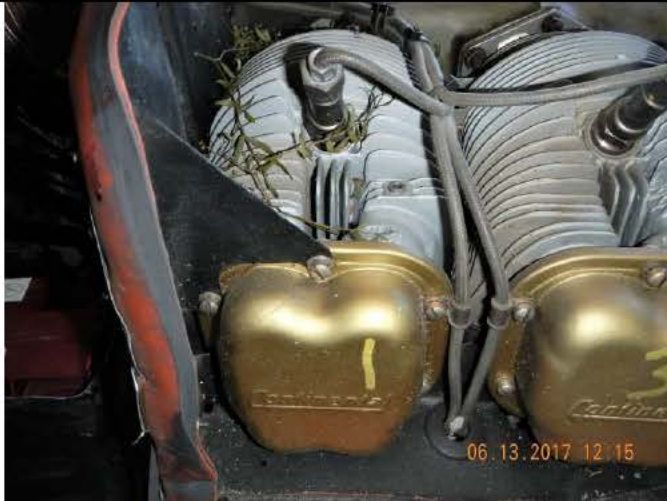
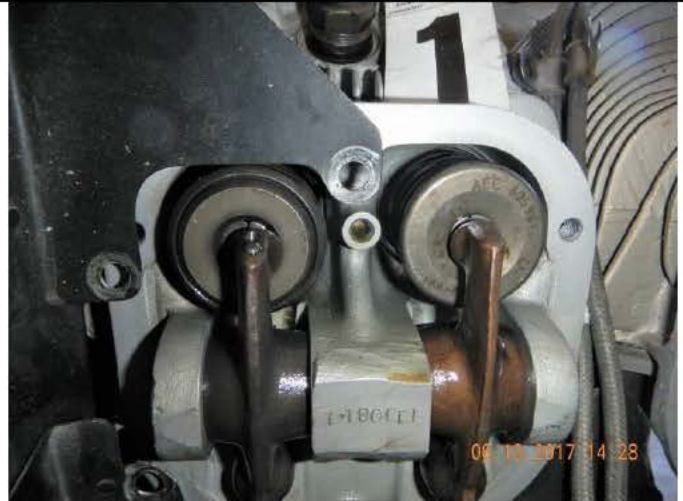
| Condition: | Thumb compression was achieved when the engine was rotated manually. No cooling fin damage was exhibited. | | |

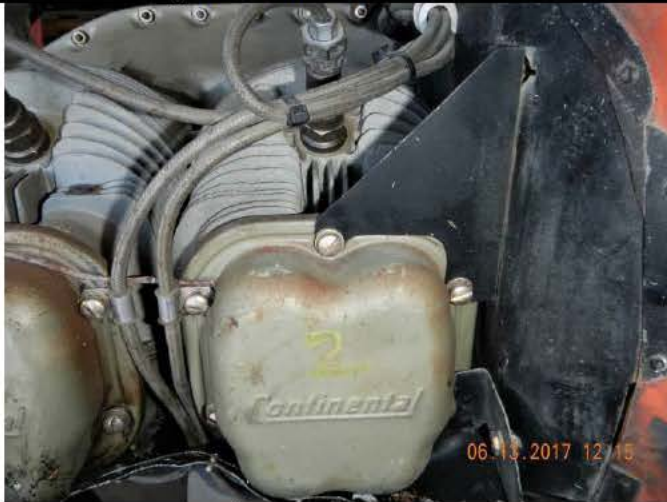
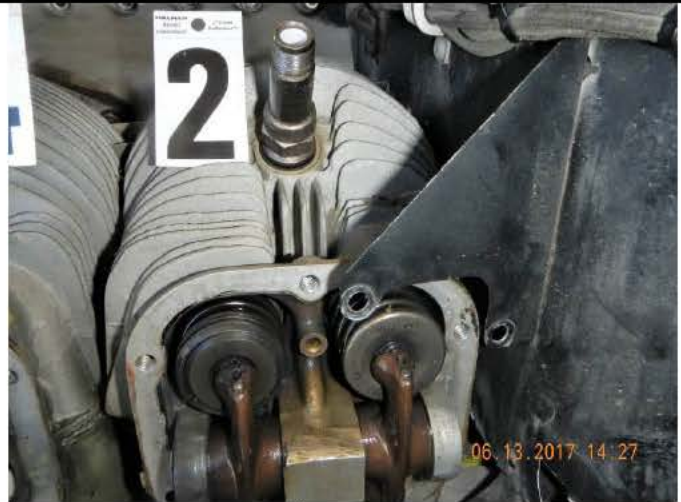
## CYLINDER #2

Thumb compression was achieved when the engine was rotated manually. Thumb compression was achieved when the engine was rotated manually. No cooling fin damage was exhibited.

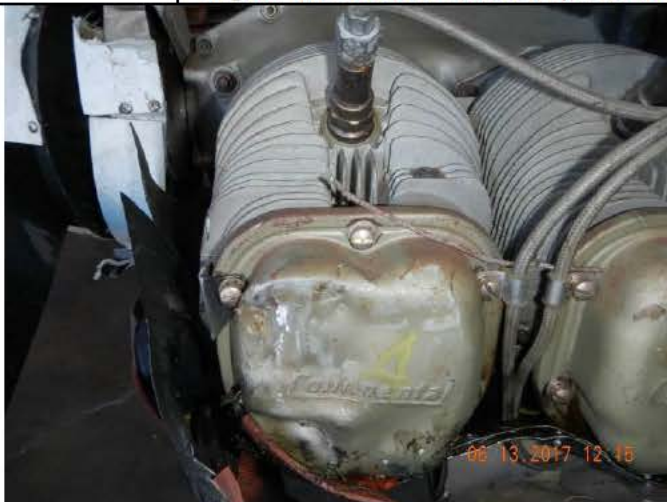
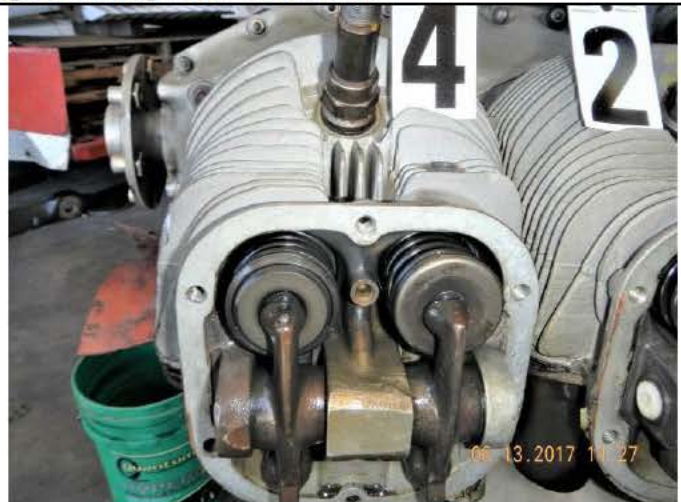
## CYLINDER #4

Thumb compression was achieved when the engine was rotated manually. Minor impact damage was noted on rocker box cover. Thumb compression was achieved when the engine was rotated manually. No cooling fin damage was exhibited.

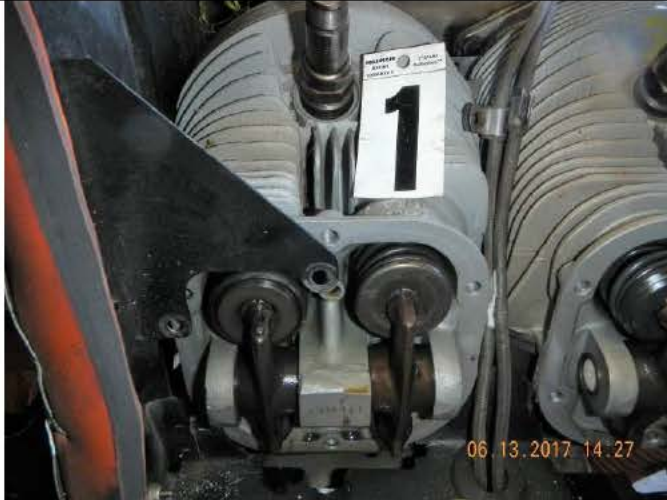
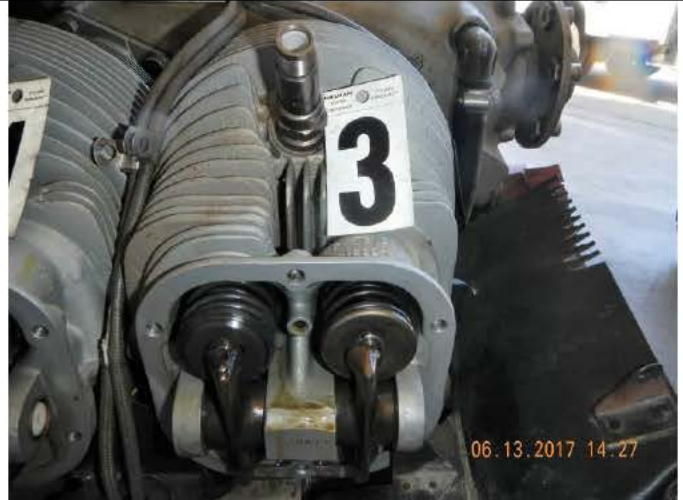
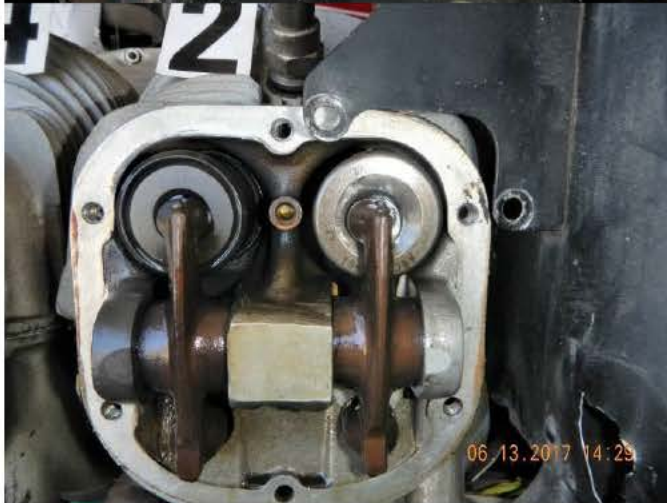
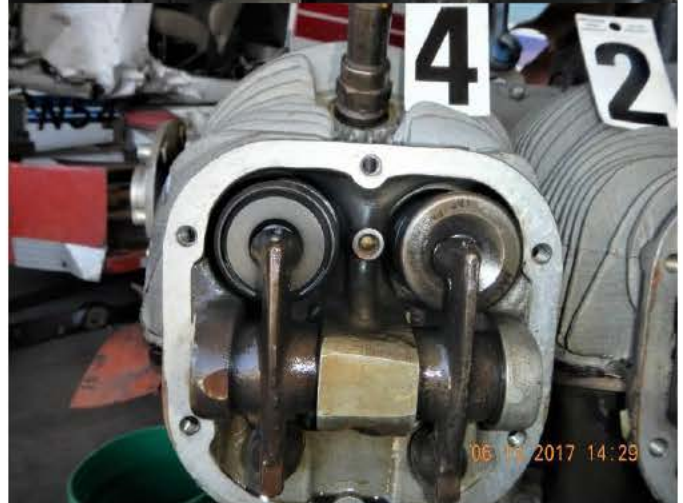
All rocker arms and shafts were intact and operated normally when the engine was manually rotated.

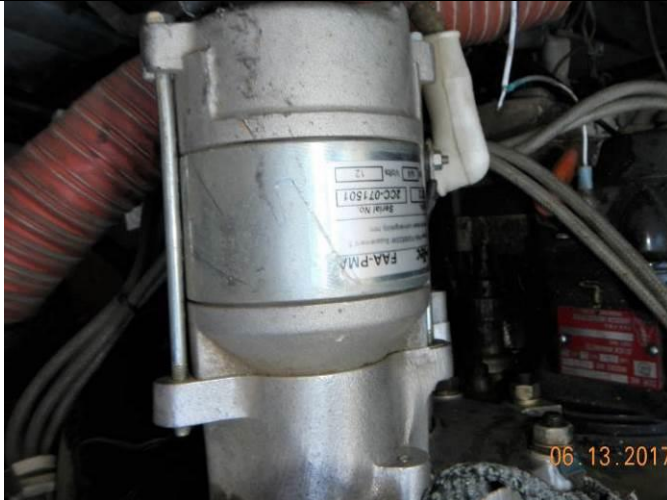
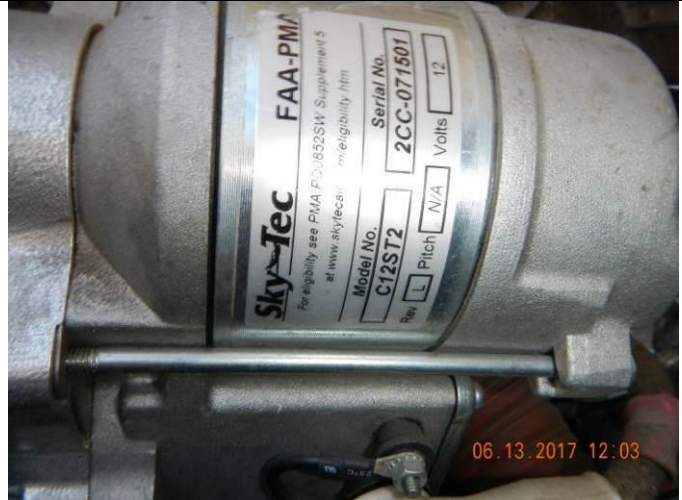
No damage was noted to starter

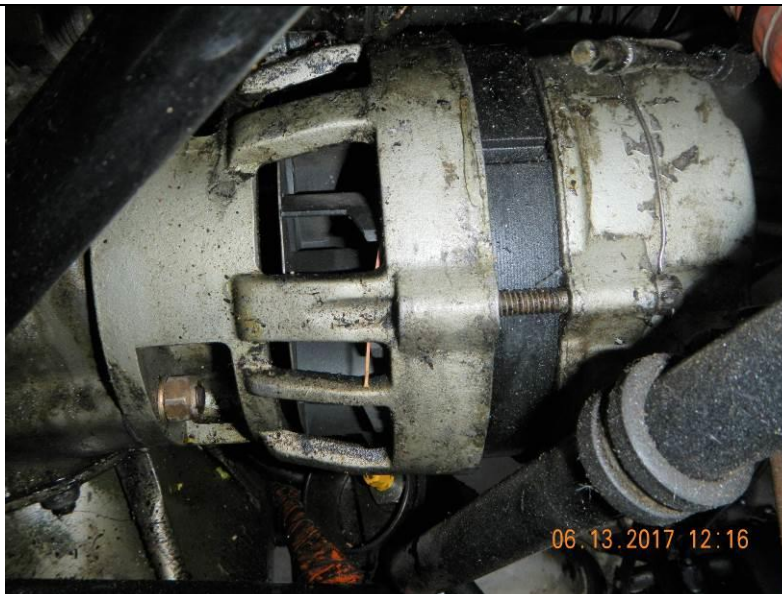
No damage noted.

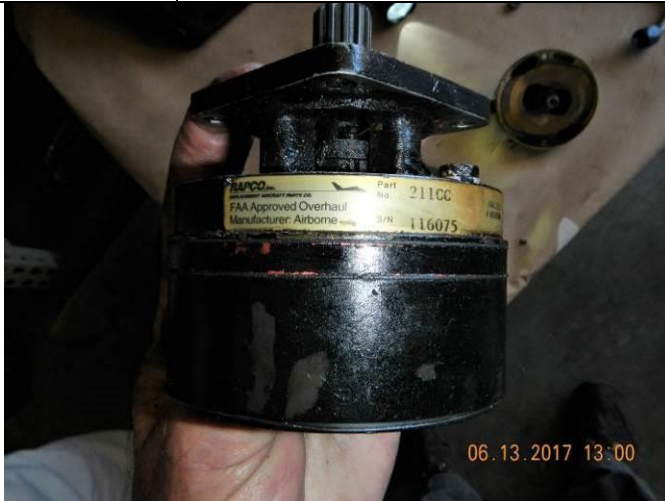
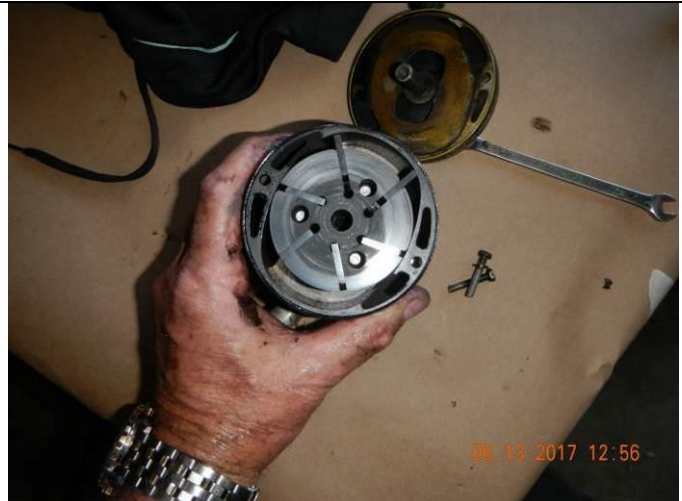
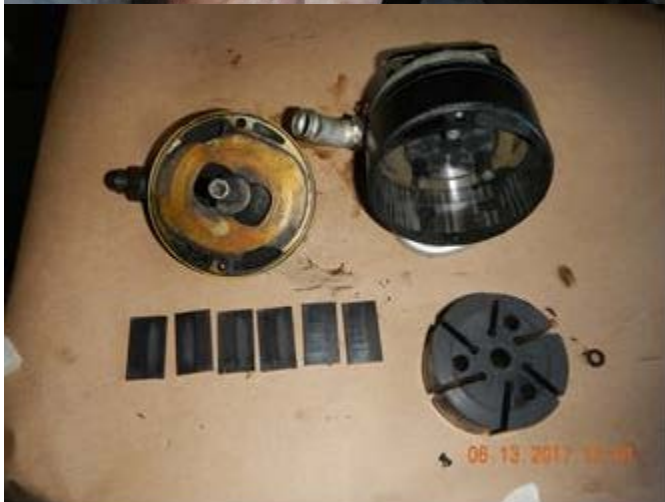
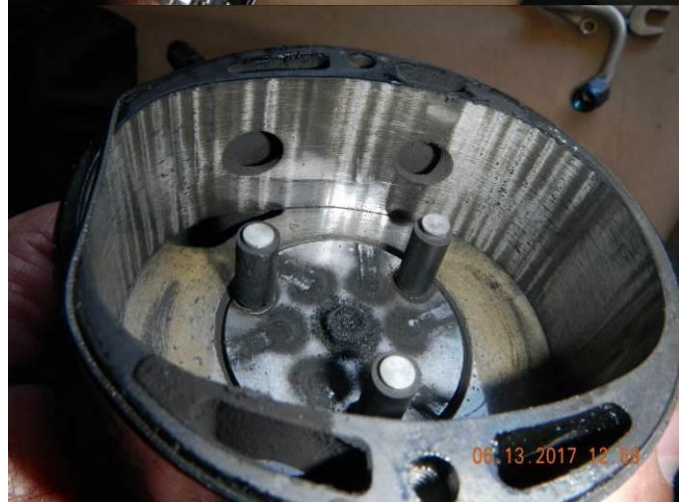
The pump drive was intact and the pump could be manually rotated even though operation was not smooth. The pump was disassembled and inspected. The carbon rotor and vanes were intact. The pump body chamber exhibited scalloped wear- impressions on the chamber surfaces.

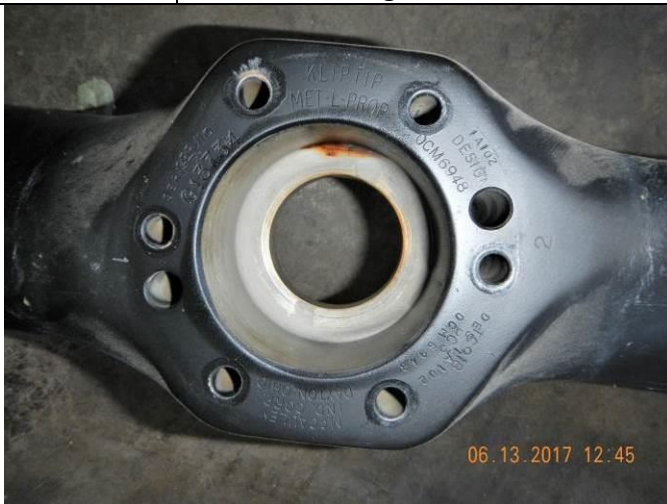
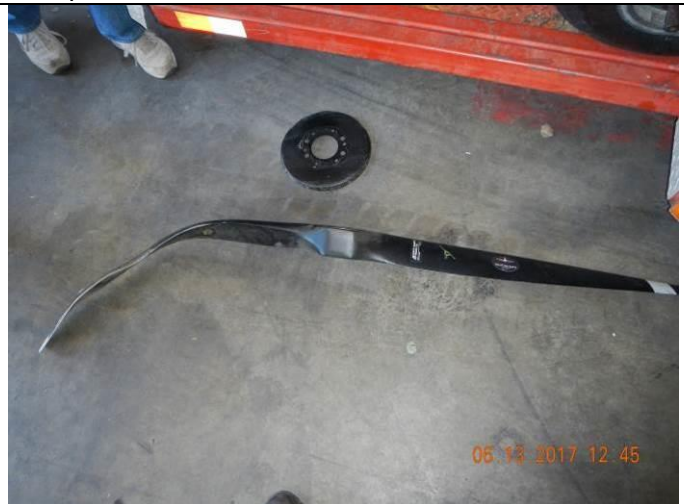
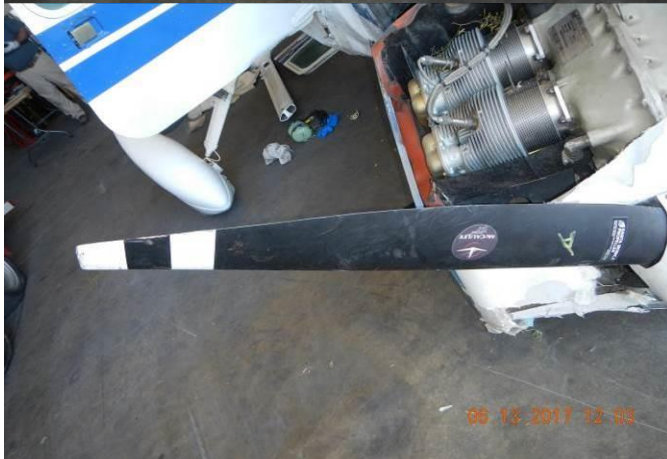
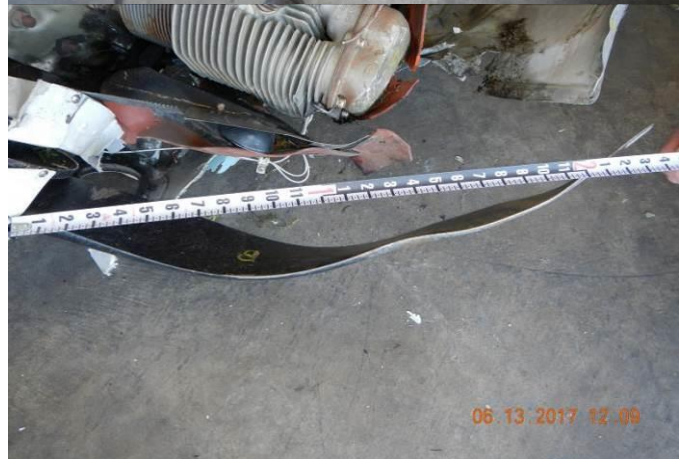
| PROPELLER | Manufacturer: McCauley | P/N: OCM6948 | S/N: C13734 |
|---|---|---|---|
| Condition: | The propeller was a metal, fixed-pitch McCauley two-blade model. The blades were marked with an "A" or "B" for photo identification. Blade A was undamaged. Blade B exhibited a rearward bending pattern beginning approximately 8" outboard of the blade root continuing outward toward the blade tip. | | |
