## **NATIONAL TRANSPORTATION SAFETY BOARD**

# **AIRFRAME AND ENGINE EXAMINATION**

**WPR17FA120**

Location: Moorpark, California  
Date: June 4, 2017  
Aircraft: Piper PA28-180, Registration #: N4871L, Serial #: 28-4226  
NTSB IIC: Elliott Simpson

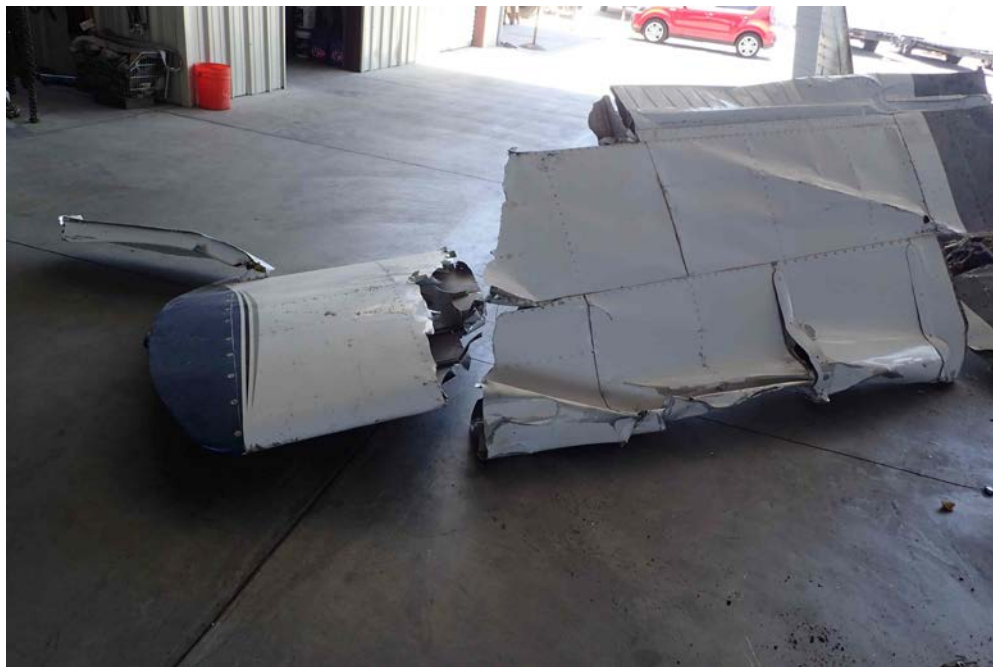
Photo 1 – Right Wing

The right wing remained attached at the root, and had been cut off by the recovery crew. The outboard 4 ft of right wing had separated (Photo 1), bisecting the aileron. The aileron sections remaining attached to the outboard and inboard hinges. The flap remained attached to the aft spar, and the landing gear strut remained attached to the main spar. The wing exhibited leading edge crush damage from the root through to the separation point. The outboard section of the

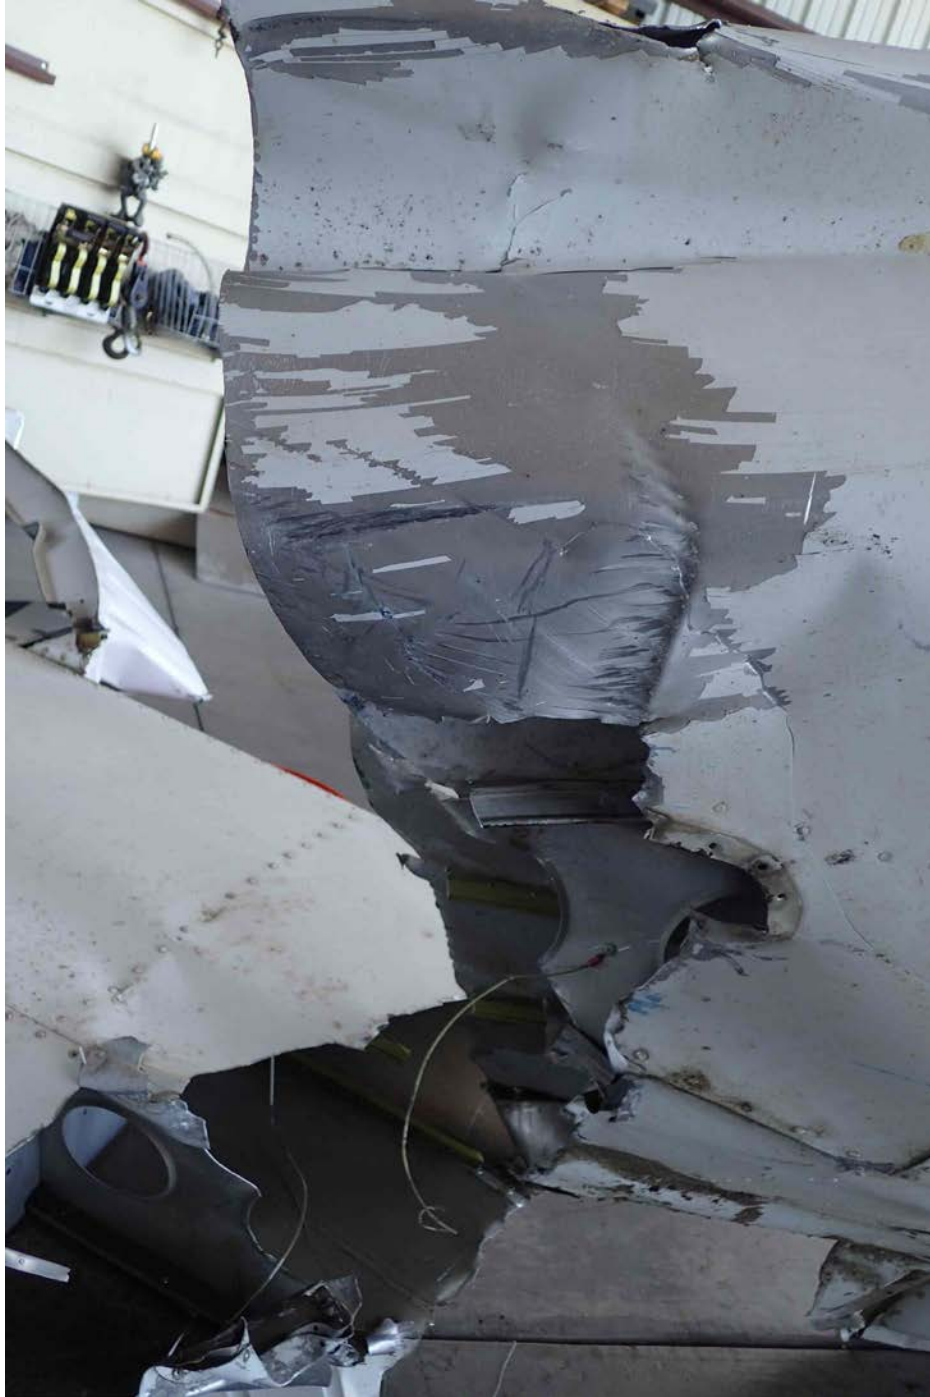
wing did not exhibit leading edge crush damage, and the inboard section exhibited serrations consistent with power line contact at the leading edge (Photo 2).

Photo 2 – Wire Striations on Right Wing

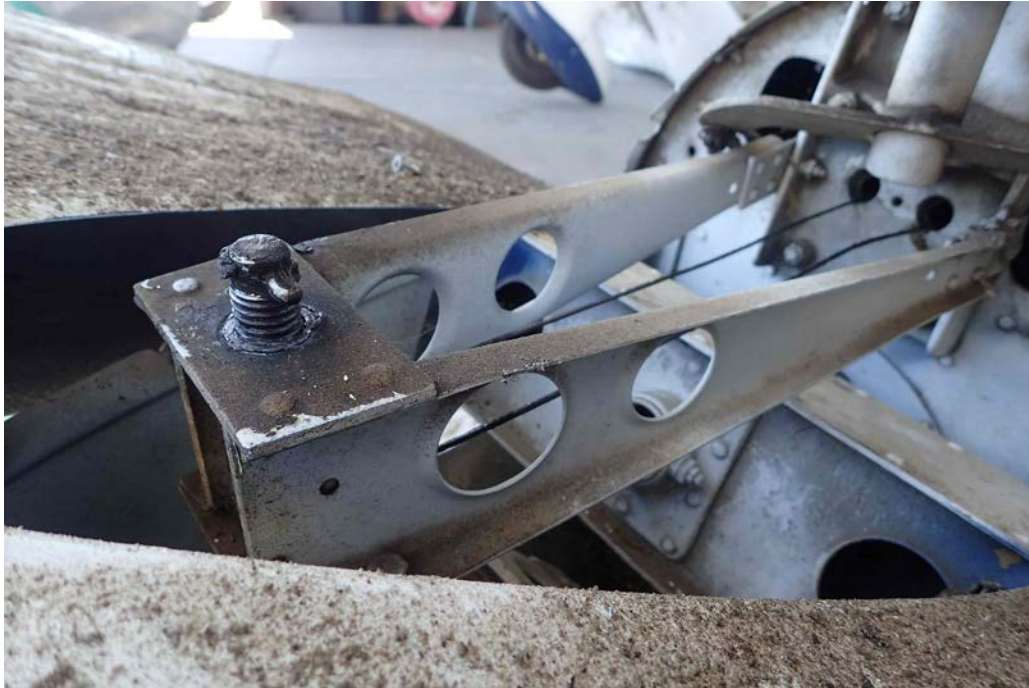
Photo 3 – Stabilator Trim Drum

The empennage was largely intact; the rudder and stabilator cables were continuous to the main cabin, where they had separated at the forward cabin. Move movement of the cables at the separation points responded in corresponding movement of their respective control surfaces. The rudder remained attached to the vertical stabilator by all of its hinges. The stabilator trim drum exhibited 5 exposed threads on the top, consistent with neutral trim position (Photo 3).

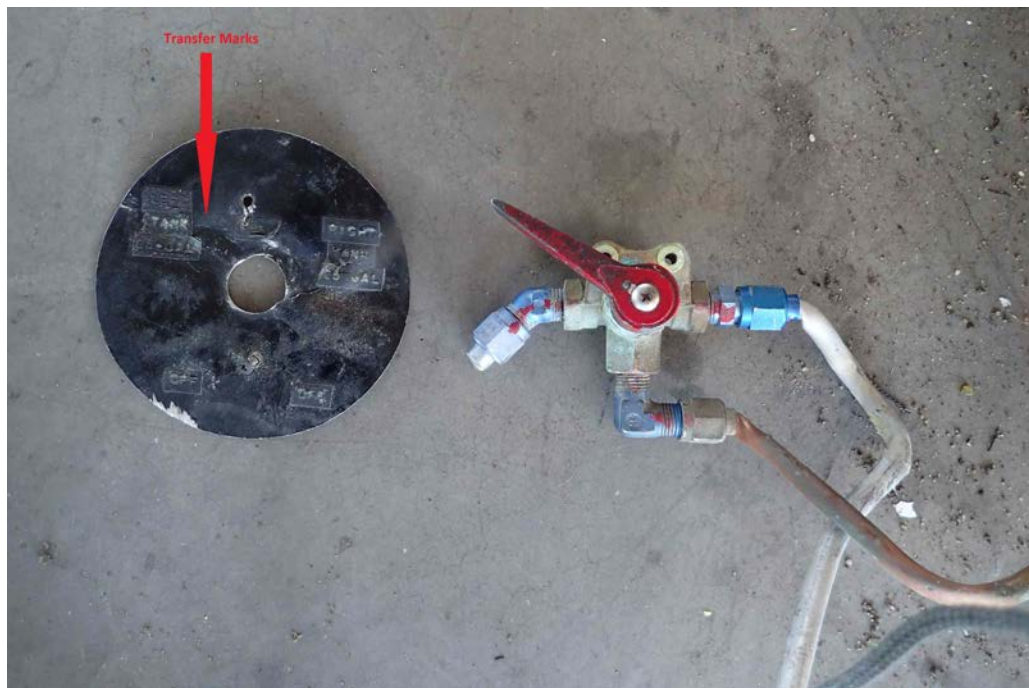
Photo 4 – Fuel Selector Valve and Backing Plate

The fuel selector valve was found in the left tank position; The backing plate exhibited transfer marks from the lever at the left tank position (Photo 4). The valve handle was loose on the fitting due to a worn D-shaped handle receptacle (Photo 5). The handle was stiff to select tanks, and could not be moved to each position without difficulty, although once moved, the detents were felt. All three fuel line b-nut fittings were attached and tight; the right tank fuel line had been severed at the b-nut. The remaining lines were separated about 12 inches from the valve. The valve was clear when blown through at all tank positions. The remaining fuel line sections had been separated both by impact and recovery in several locations, all lines were clear.

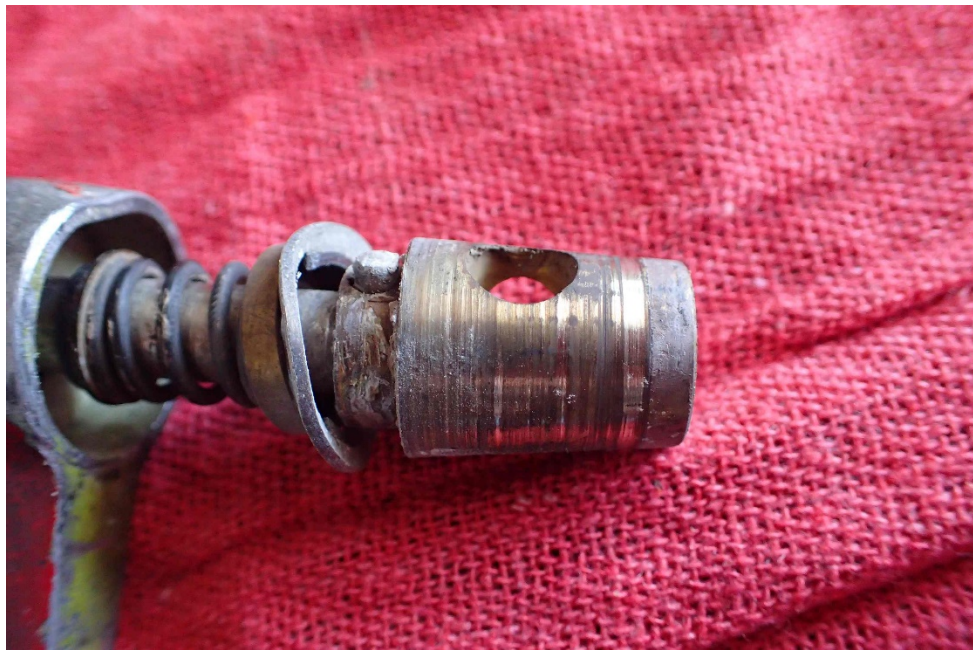
Photo 6 – Fuel Selector Valve

The fuel selector valve was disassembled. The inner valve body and case cavity exhibited radial score marks (Photo 6), and light tan-colored fragments of material broke away from the valve seal upon disassembly (Photo 7). The O-ring at the top of the valve was intact and pliable. Light green discoloration was observed on the outer surface of the valve body.

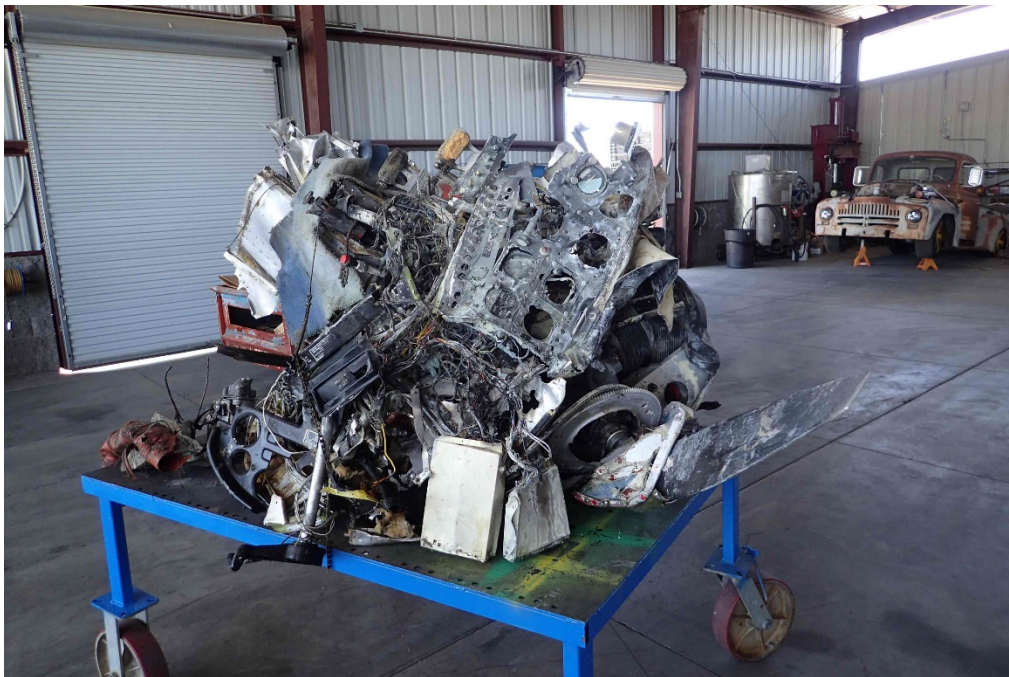
Photo 8 – Engine and Instrument Panel

The engine remained attached to the firewall, and had folded aft and over the top of the instrument panel (Photo 8). The carburetor remained attached to the inlet manifold, which had separated from the engine. The intake box sustained crush damage, and was still attached to the carburetor. The carburetor heat control valve was crushed which precluded any determination of its position prior to impact. The foam filter element was crushed, but remained intact and free of visible obstruction to airflow. The magnetos, vacuum pump, oil filter, and starter motor remained firmly attached to the engine at their respective mounting pads. The alternator sustained impact damage and was still partially attached to its mounting points. The engine driven fuel pump remained attached to its mounting pad; the inlet and outlet fuel lines had broken away from the pump's along with sections of the pumps case.

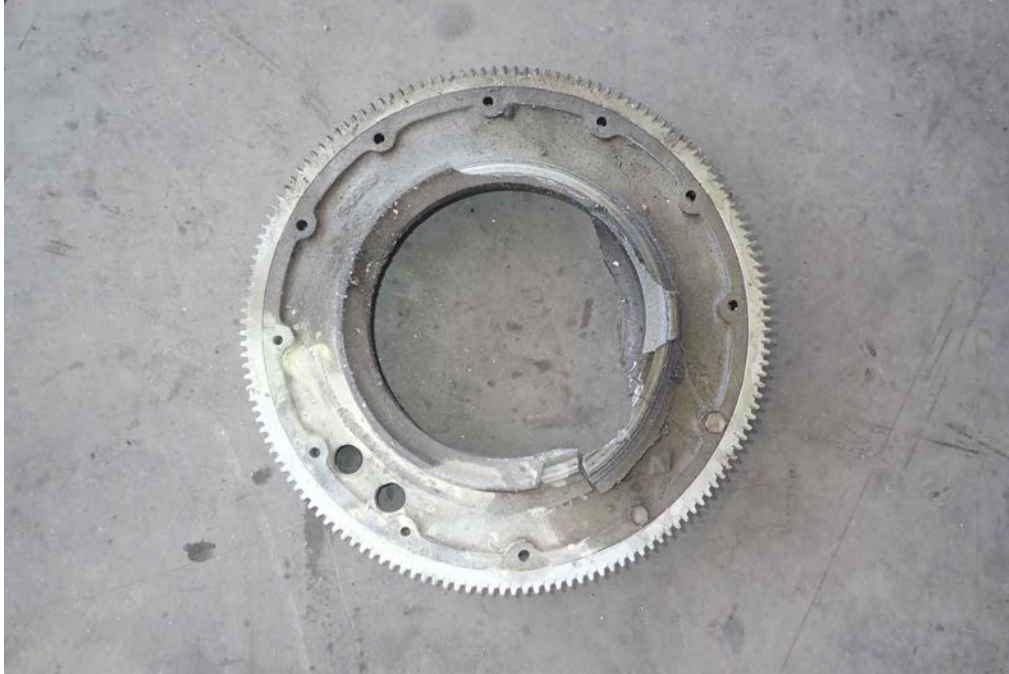
Photo 9 – Flywheel and Starter Ring

The propeller remained attached to the crankshaft flange. The crankshaft flange was partially attached to the crankshaft by two webs. The hub base was attached to the crankshaft. The outer radius of the flywheel along with the ring gear, had completely detached from the hub. The ring gear was undamaged and did not exhibit rotational scoring in the area of starter drive contact (Photo 9).

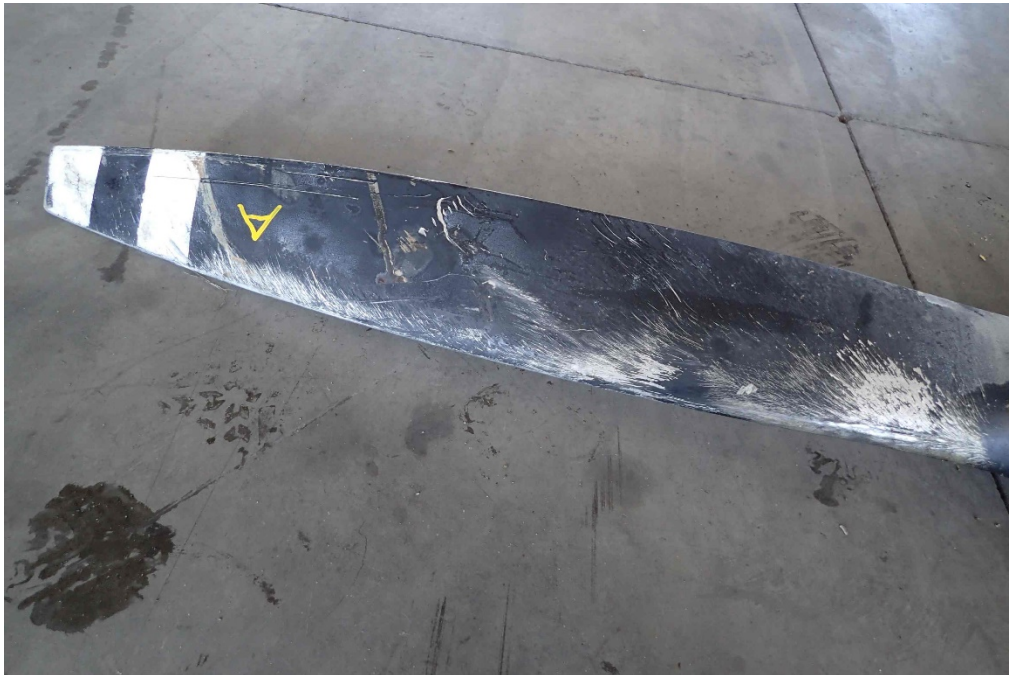
Photo 10 – Propeller Blade

The nose cone base plate had become completely formed around the hub and both blade roots. One of the blades was intact and free of significant damage, and exhibited leading edge polishing with smooth abrasions in the paint radiating about 45° relative to the rotational plane (Photo 10). The second blade was curved about 90° aft along its entire span; the blade exhibited polishing and paint abrasions almost perpendicular to the chord (Photo 11).

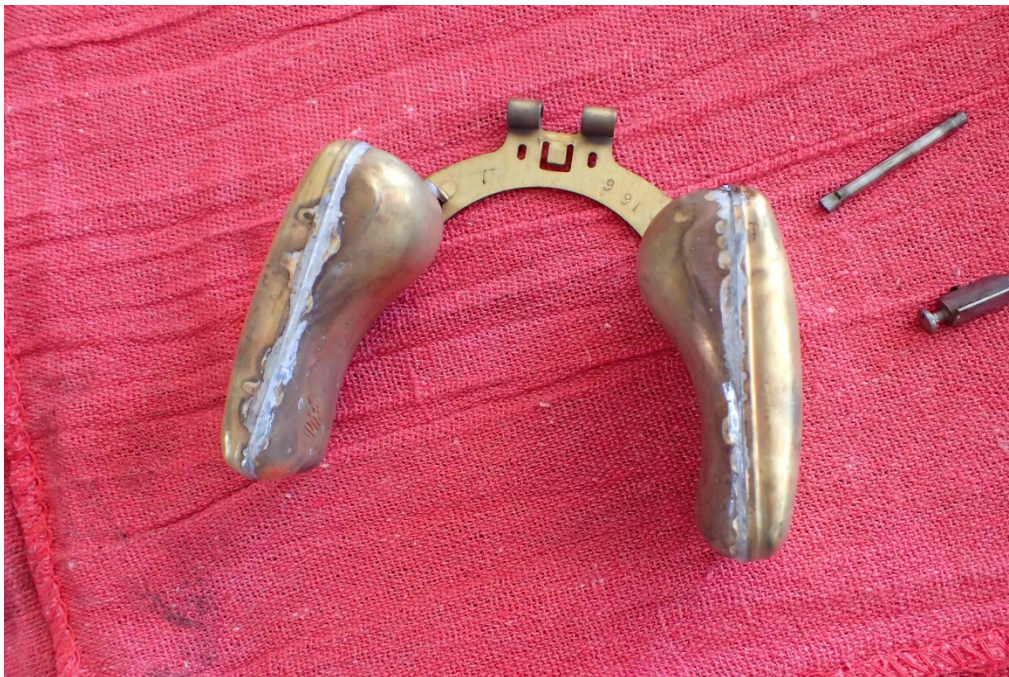
Photo 12 – Carburetor Float

The throttle control cable remained attached at the throttle arm. The mixture control cable had been pulled from the arm. The carburetor was disassembled, and no fuel was present in any of the lines, the bowl, or the accelerator pump chamber. The brass floats were intact, undamaged, and did not contain fuel (Photo 12). There was no foreign debris observed within the bowl, or accelerator pump chamber. The accelerator pump seal was intact and pliable. The float valve seal was pliable and did not display any ridges or deformation, and its associated seat was free of debris (Photo 13). The fuel inlet line had broken away from the carburetor case, and the inlet screen was clear.

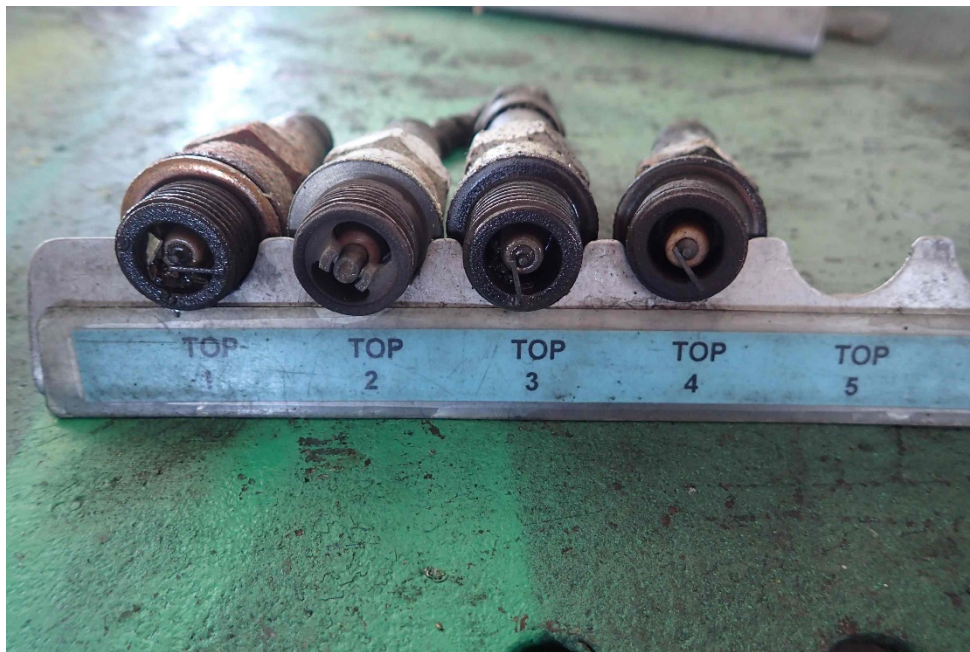
Photo 14 – Top Spark Plugs

The top spark plugs were removed, and examined. All plugs throughout the engine were the thin-wire type, except for the top plug for cylinder number two, which was of the massive electrode type. All electrodes remained mechanically undamaged, dark-colored, and plugs 1 and 3 were wet with oil (Photo 14). The static oil soaking of the spark plugs (as noted) was attributed to the engine positioning at the mishap site and post recovery. Light tan deposits were observed on the inner surface of the number 3 cylinder exhaust pipe, with darker deposits in the exhaust pipes of the other cylinders (Photo 15, 16). No oil residue was present within the pipes, and the inner baffles of the muffler were crushed but intact, and the muffler was free of obstruction.

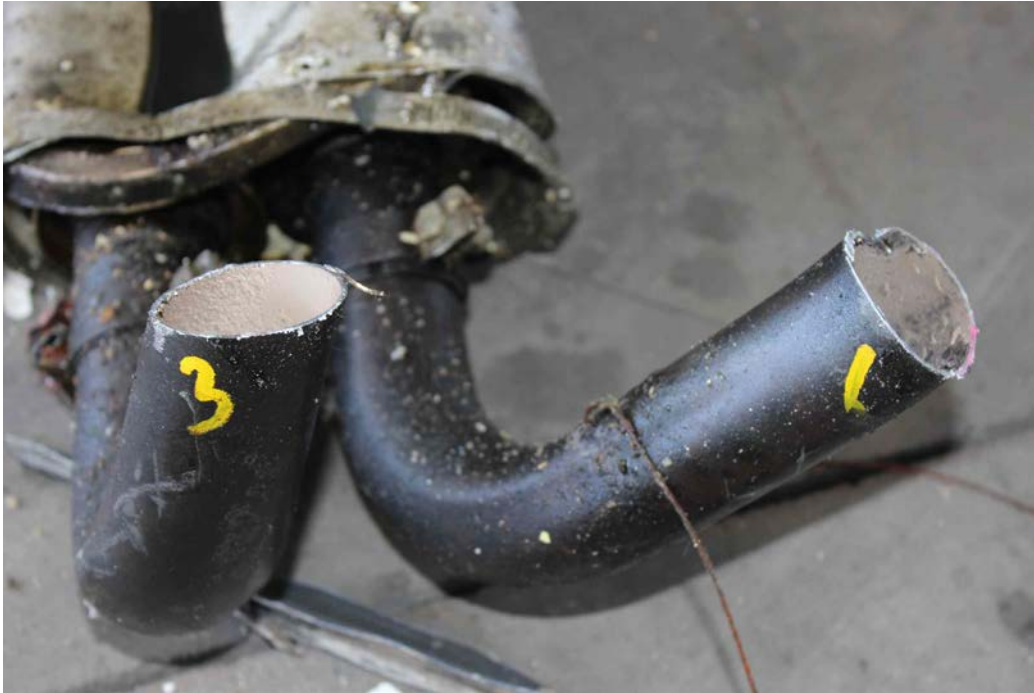
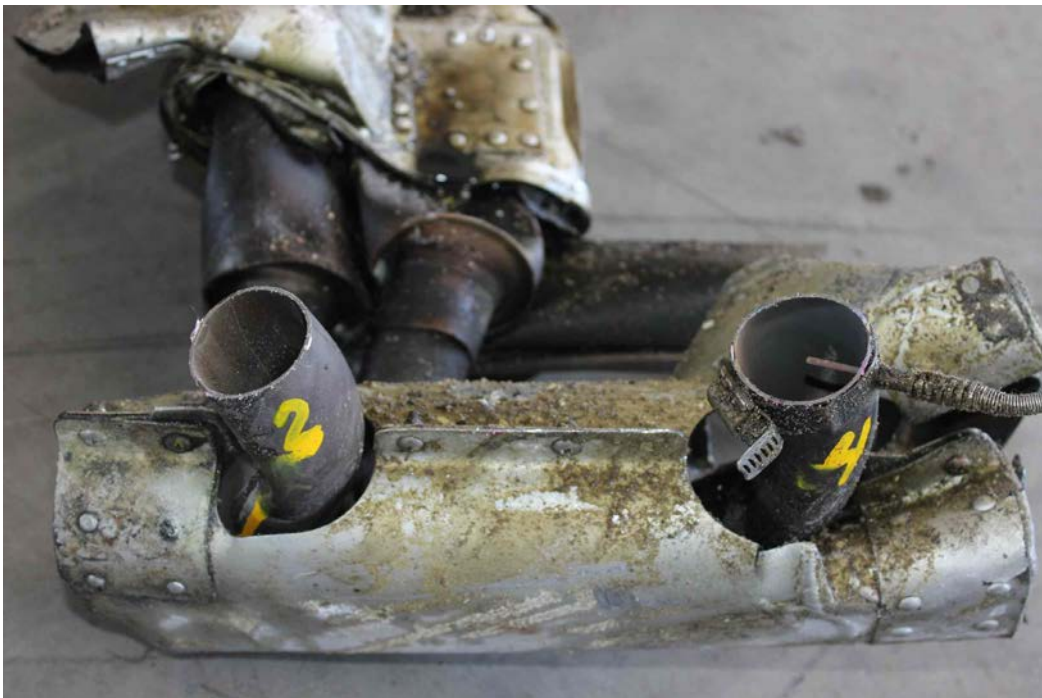
Examination of the recovered airframe and engine was conducted on June 12 and 13 at the facilities of Air Transport, Phoenix, Arizona. Findings included a stiff fuel selector valve, blue fuel staining at the number 3 cylinder inlet manifold, light tan deposits on the inner surface of the number 3 cylinder exhaust pipe, with darker deposits in the exhaust pipes of the other cylinders. No fuel traces were found.

Photo 15 – Cylinder 1 and 3 Exhaust Pipes

Photo 16 – Cylinder 2 and 4 Exhaust Pipes

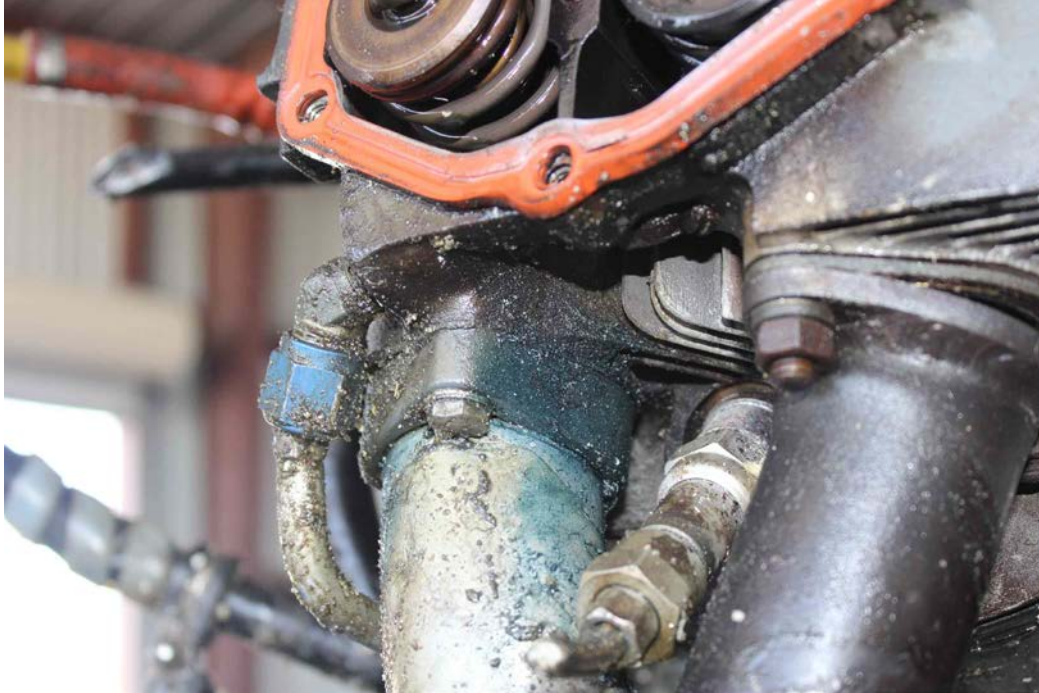
Blue fuel staining was present at the number 3-cylinder inlet manifold pipe (Photo 17). The manifold was removed, and appeared to have sustained impact damage to its flange. The gasket had split at the area of flange separation (Photo 18). The fuel pump was disassembled and did not contain any fuel. All diaphragms and valves were intact and undamaged.

Photo 17 – Cylinder 3 Blue Staining at Inlet Manifold Pipe
