## **NATIONAL TRANSPORTATION SAFETY BOARD**

# **AIRFRAME AND ENGINE EXAMINATION**

**WPR17FA125**

Location: Mountain Ranch, California  
Date: June 9, 2017  
Aircraft: Airplane Beech 95-C55, Registration Number: N3717Q, Serial #: TE-298  
NTSB IIC: WPR17FA125

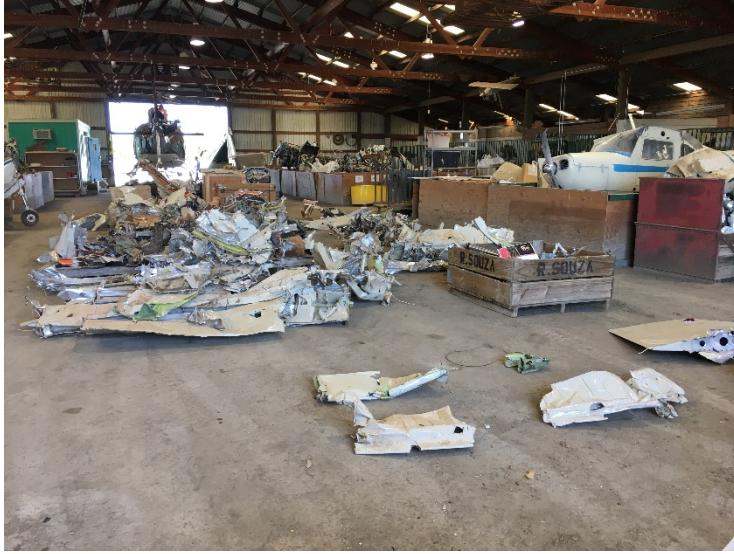
Photo 01 – Wreckage Layout (NTSB)

As a result of impact forces, flight control continuity could not be established. However, flight control cables and associated hardware were accounted for.

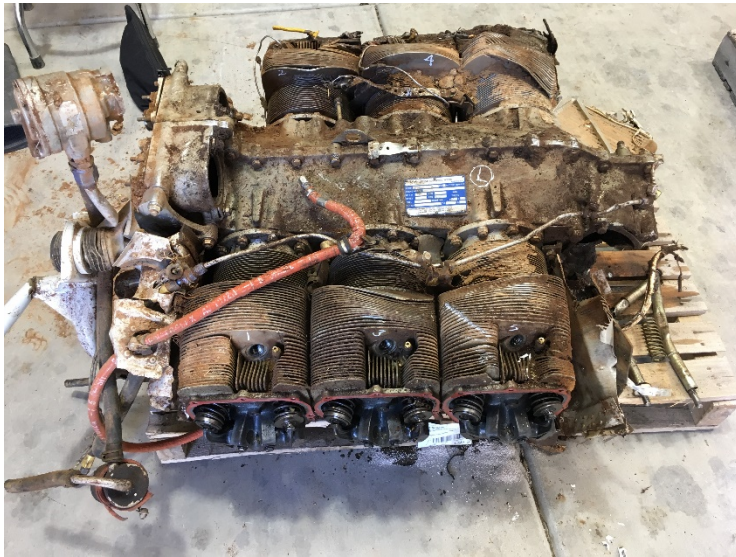
Photo 03 – View of Left Engine (NTSB)

A visual examination of the left engine revealed no obvious holes in the case. Both magnetos separated from the engine. The right magneto was in pieces. The left magneto remained intact. The ignition harness sustained damage at the P-leads. The Spark plugs were removed with normal operating signatures observed. The pistons were borescoped; no stuck intake/exhaust valves were observed, and operating signatures appeared normal. The vacuum pump vanes were intact and coated with residual oil. The drive coupling had separated; however, it was reinserted, manually manipulated and rotated without binding.

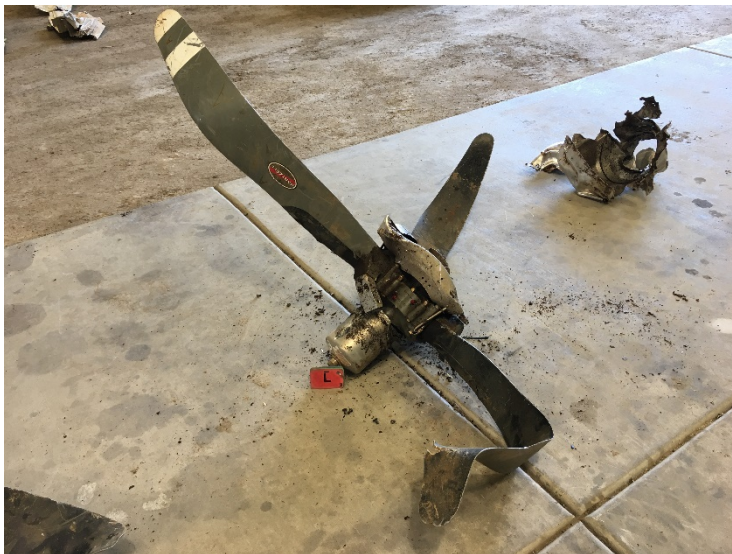
Photo 05 – View of Left Propeller Assembly (NTSB)

The propeller hub assembly including the propeller blades separated from the engine. The propeller blades exhibited torsional twisting along leading and trailing edge nicks and gouges.

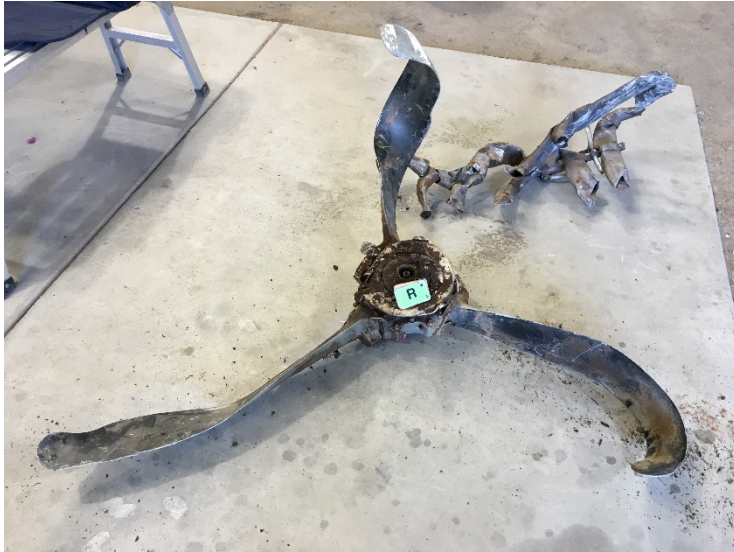
Photo 06 – View of Right Propeller Assembly (NTSB)

The propeller hub assembly separated from the right engine with all three propeller blades remaining attached at the hub. All three propeller blades exhibited torsional twisting with leading and trailing edge nicks and gouges.
