# Continental Motors

## ENGINE EXAMINATION REPORT

| ENGINE MODEL | IO-520-C3 |
| FILE NUMBER | 16-656 |

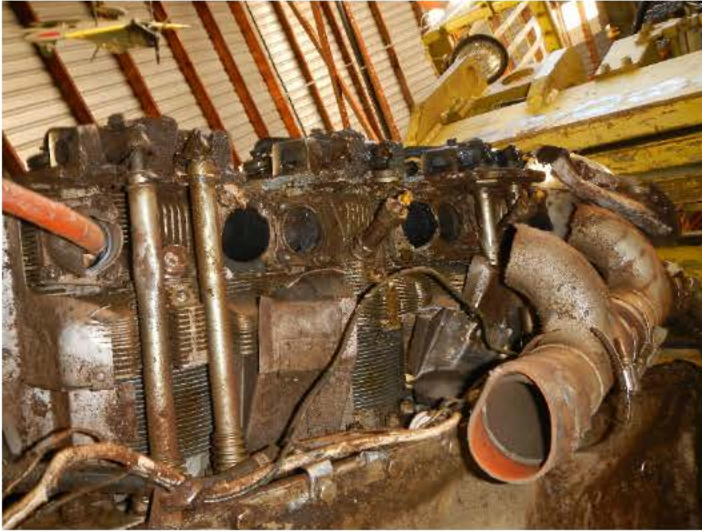
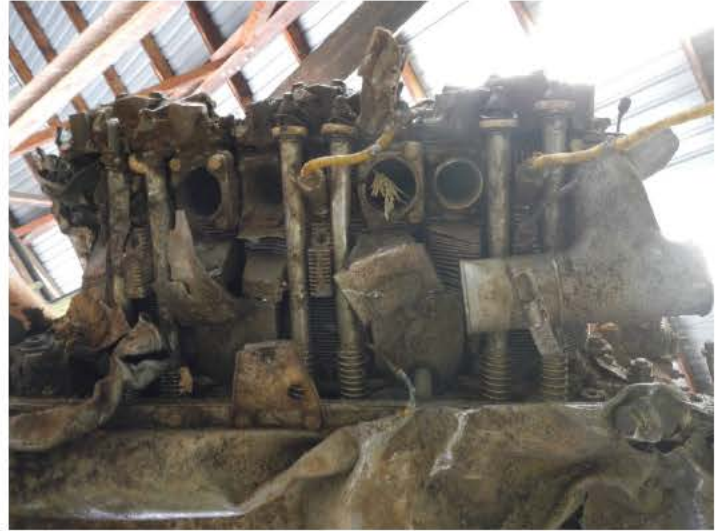
The exhaust system was separated from the engine. The induction system was fragmented. Only one intake riser remained attached to its cylinder. Two other risers were separated from their cylinders but remained attached to the engine by the balance tube. The throttle body was deformed and the throttle valve was in the full open position.

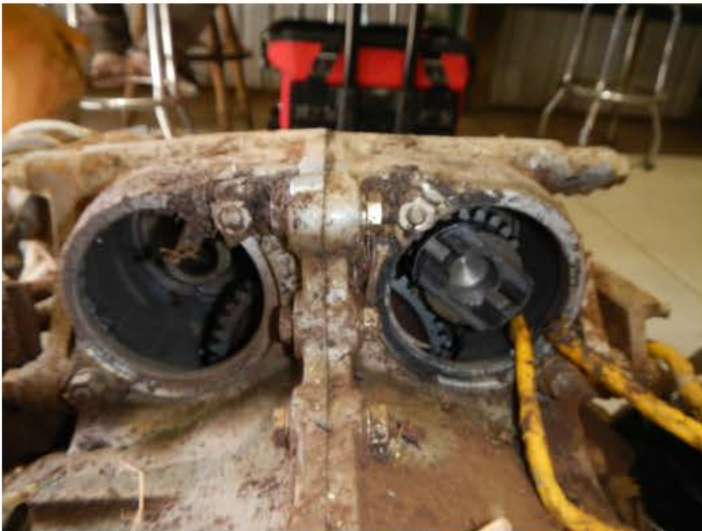
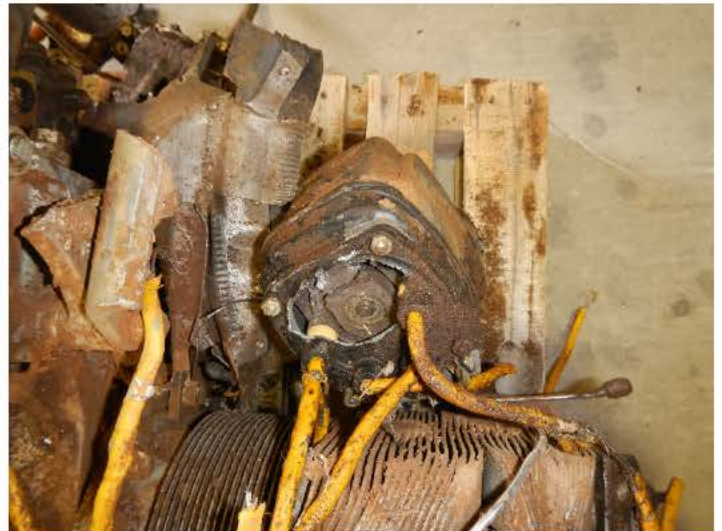
Both magnetos were separated from the topside of the engine and the ignition harness was fragmented. The left magneto remained attached to the engine via a couple of ignition leads. The magneto was disassembled since functional testing was not possible due to damage sustained during the accident sequence. No pre-accident anomalies were noted with the internal components.

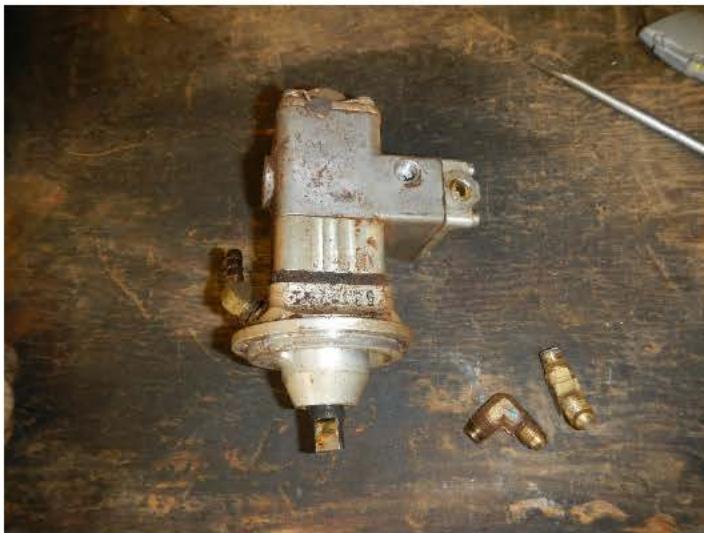
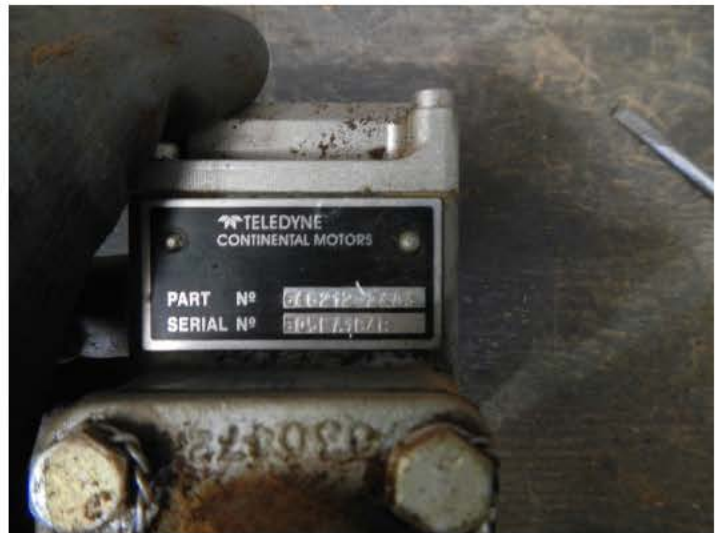
The engine-driven fuel pump remained secured to the backside of the engine. The vapor return fitting was fractured. The pump was removed and the drive coupling remained intact. The pump was disassembled and a bee was found between the pump vanes; however, since it was intact it is presumed that the bee entered the system following the wreckage recovery. No other pre-accident anomalies were noted with any of the internal components.

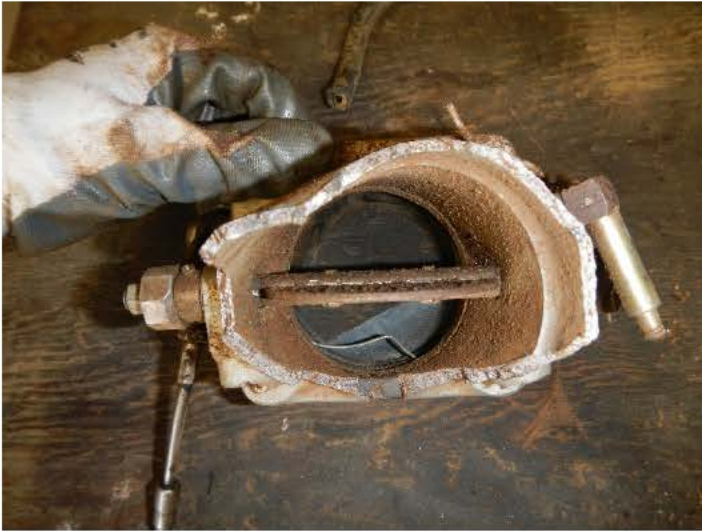
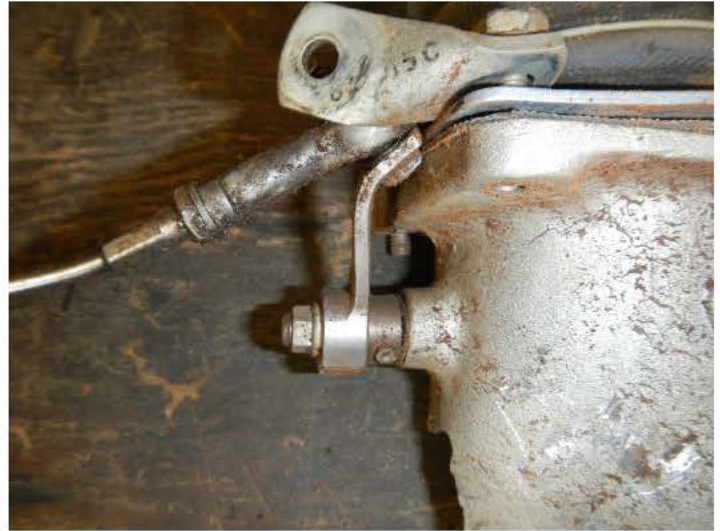
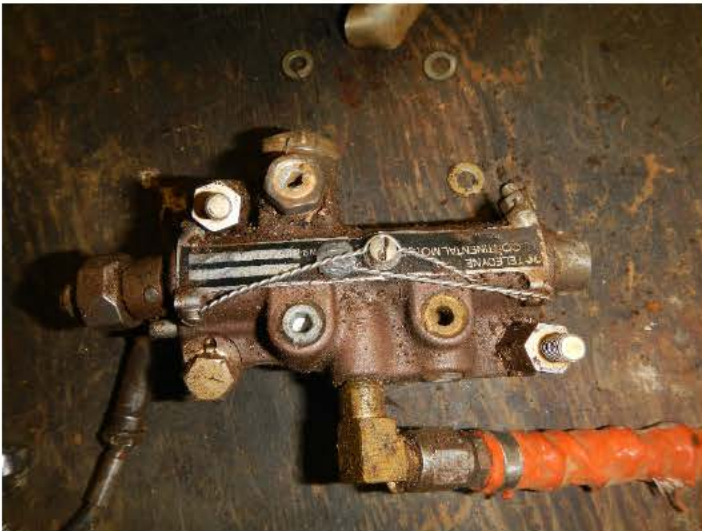
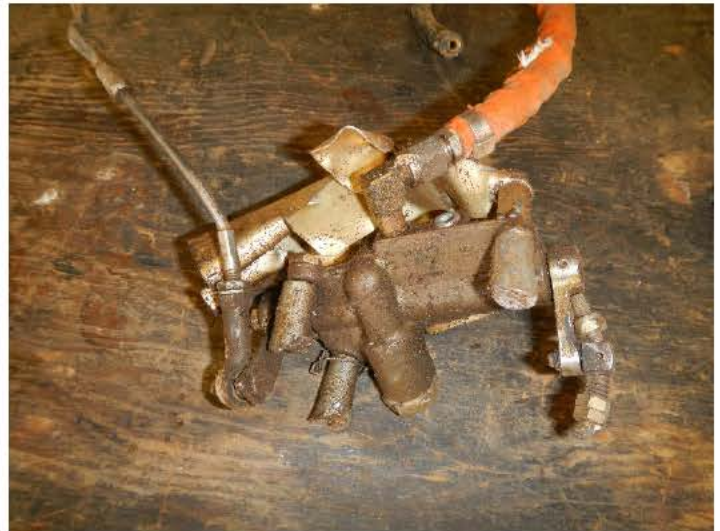
The throttle body and fuel metering unit remained attached to the backside of the engine, but they were separated from each other. The mixture and throttle control cables remained attached to their respective levers, but the levers were bent and deformed. The throttle lever and throttle valve were jammed in place and were found in the full open position. The throttle interconnect linkage was fractured. The fuel metering unit was disassembled. The inlet screen contained a small piece of lint near the base, but the screen was not blocked or obstructed. The mixture and throttle cams were removed as was the metering plug. No pre-accident anomalies were noted with any of the o-rings or metering orifices.

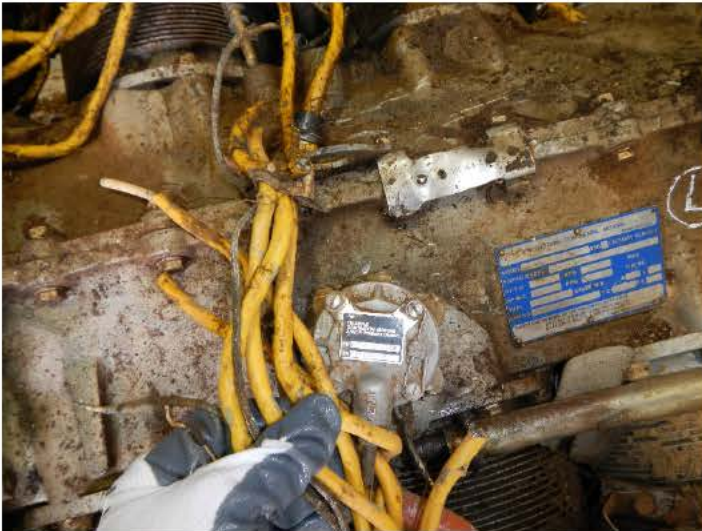
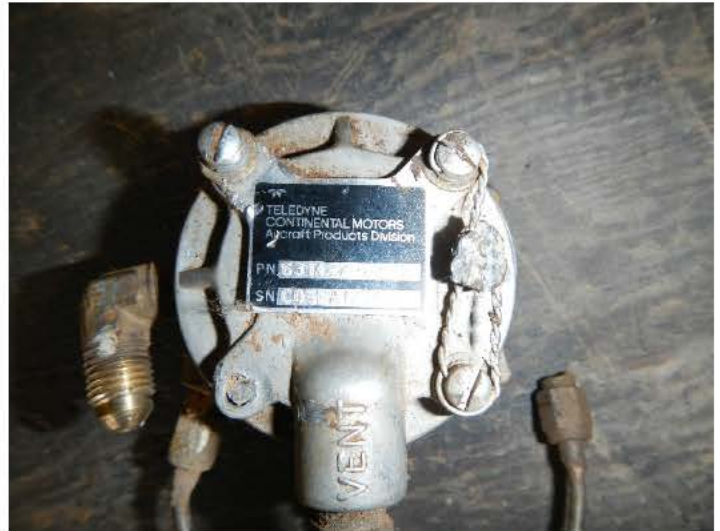
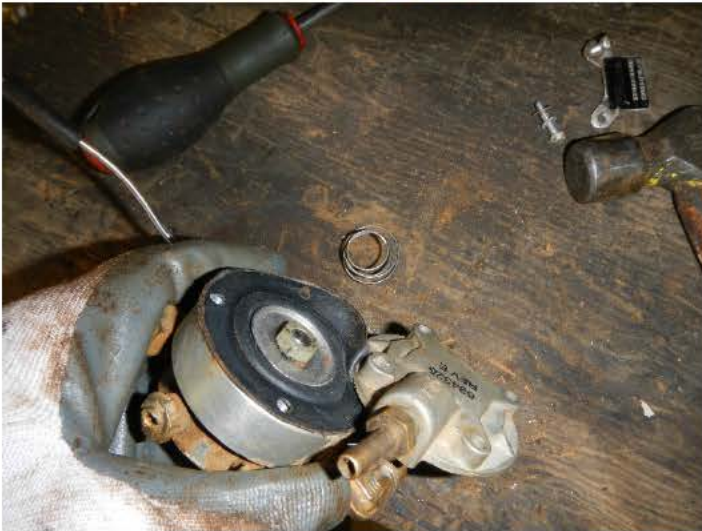
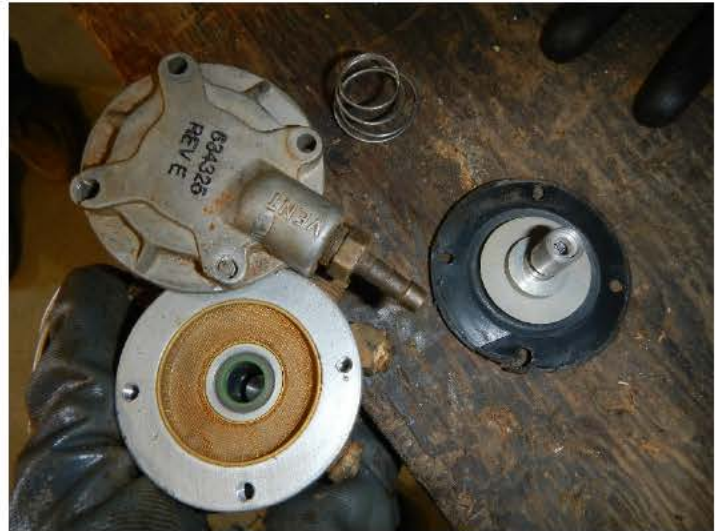
The fuel manifold valve remained attached to the topside of the engine via one injector line. The cap was removed and the diaphragm was intact. The screen was clean and free from obstructions and debris. No pre-accident anomalies were noted with the unit.

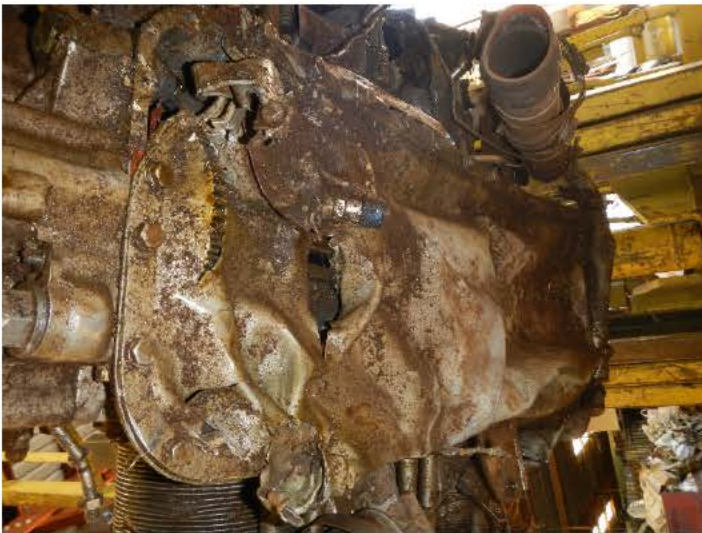
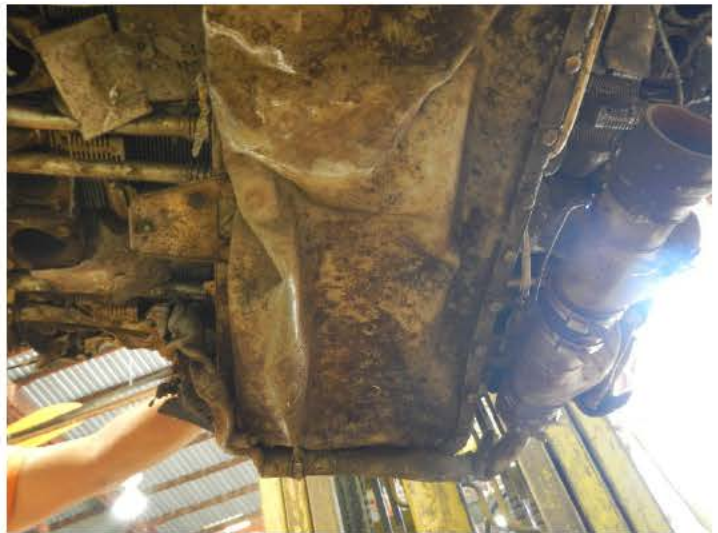
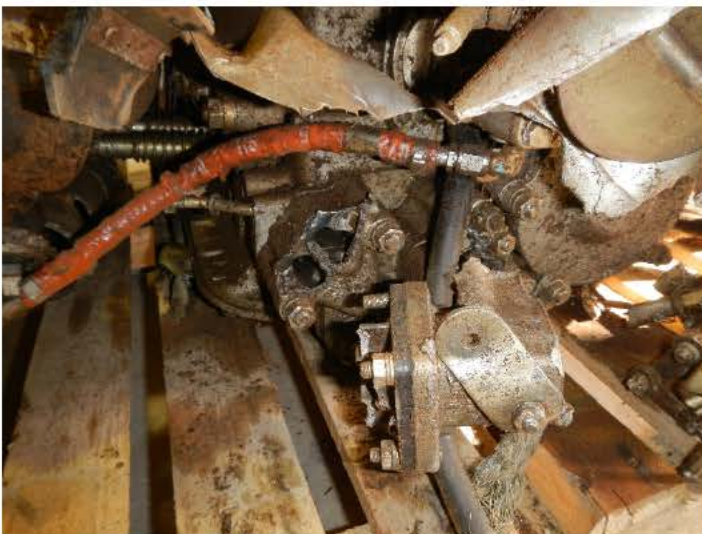
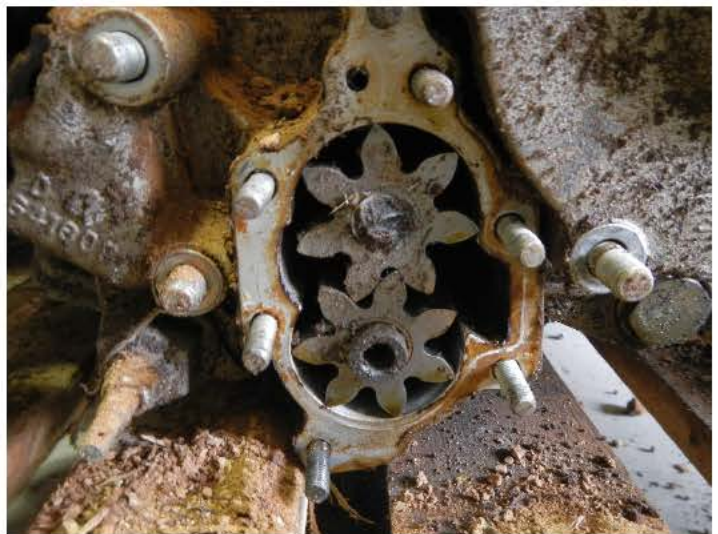
The oil sump was displaced up around the bottom of the engine and there were numerous punctures and tears. The camshaft gear was protruding from the aft end of the sump. The oil pump remained attached to the backside of the engine; however, the pump housing cap was fractured as was the tach drive. The remains of the cap were removed and the gears were examined. The drive gear splines displayed a torsional displacement. The gears were intact and did not display any pre-accident anomalies. The housing walls displayed short arcs of circumferential scoring that coincided with the apexes of the drive gear teeth and the cap remains displayed an arc of displaced and polished metal. The oil cooler was deformed and the mount was fractured. The oil filler neck and oil filter were separated from the engine. None of the observed components displayed signs of thermal discoloration or lubrication system distress.

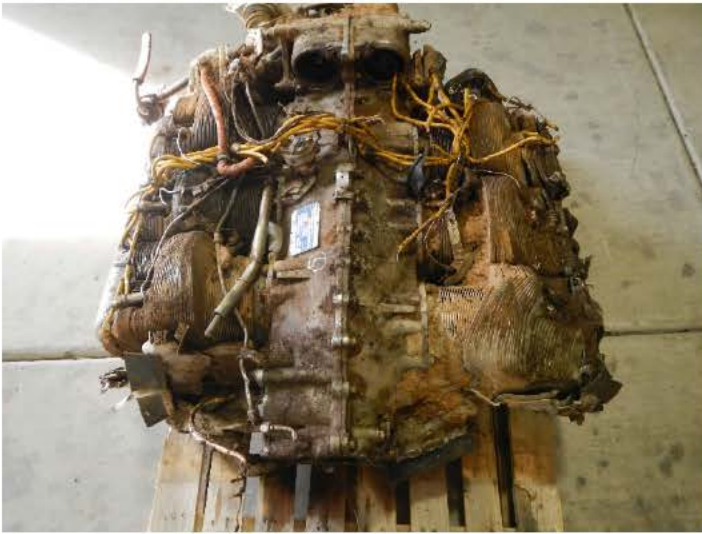
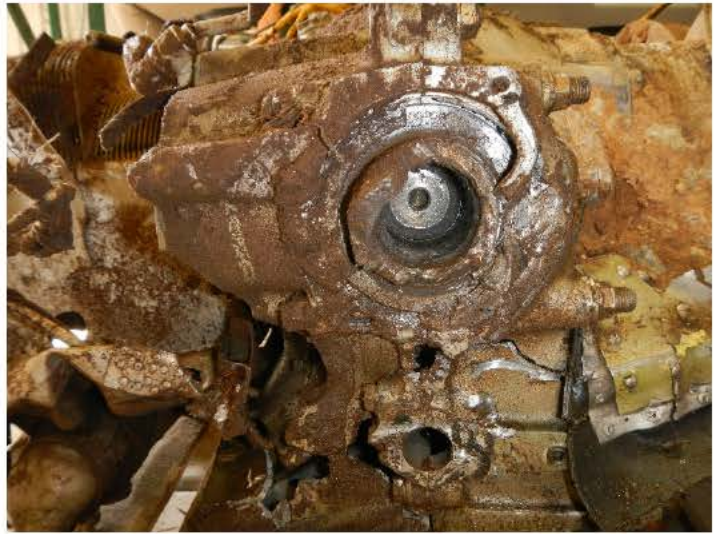
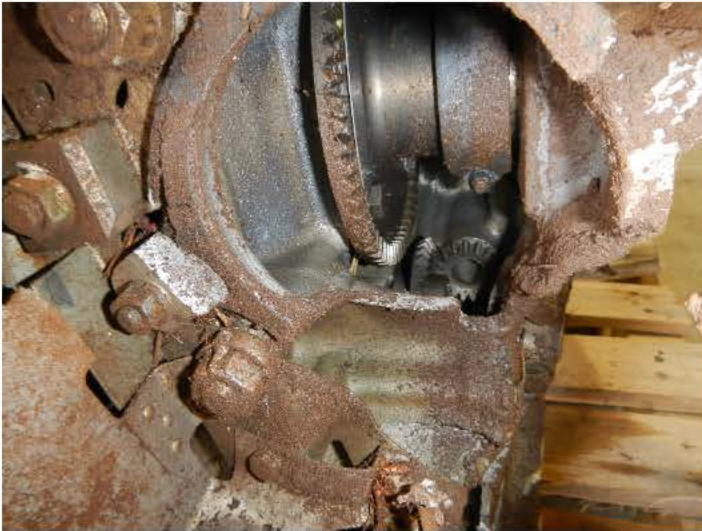
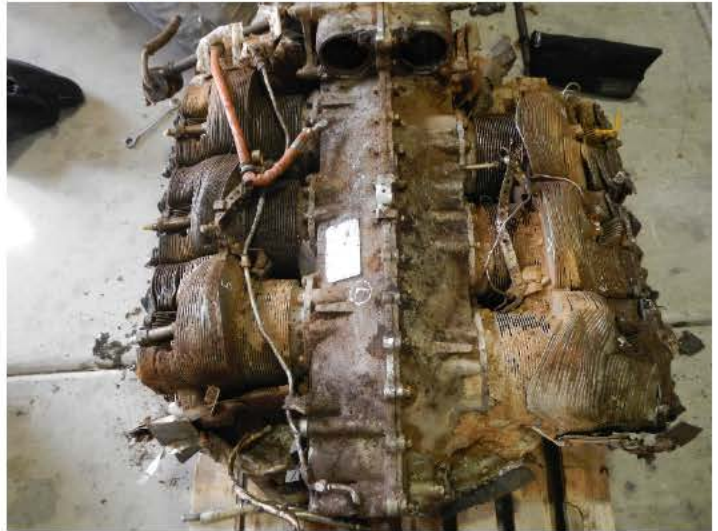
The crankcase sustained impact-related damage to the front end of the crankcase. The bottom portion of the case halves were damaged when the oil sump was displaced upward. Additionally, the area around the engine-driven alternator was also fractured. However, there were no signs of pre-accident operational anomalies with the crankcase.

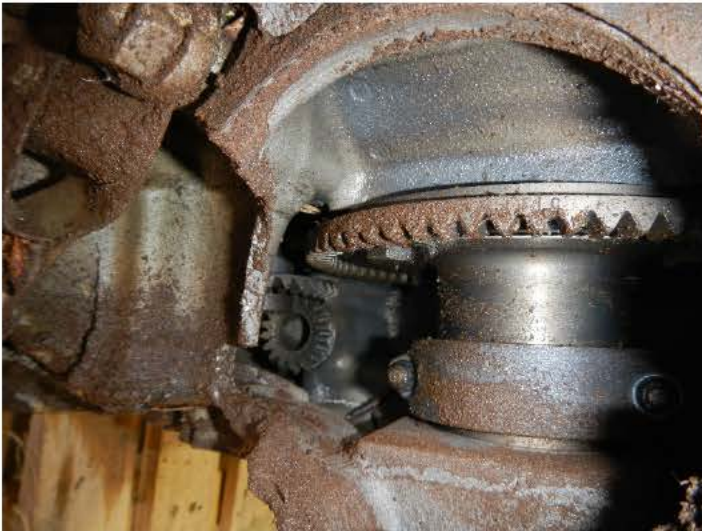
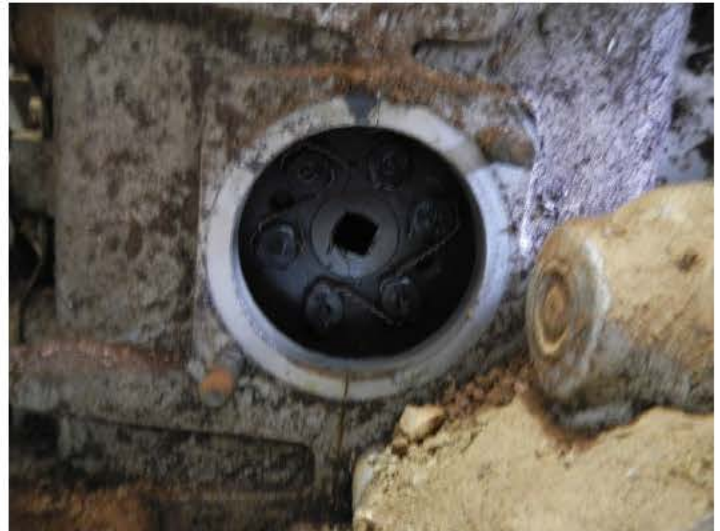
The crankshaft was fractured aft of the propeller flange. Though the crankshaft was not visible in its entirety, the portions that were did not display any signs of thermal discoloration or lubrication distress. The crankshaft gear remained secured in place. The connecting rods were not observed.

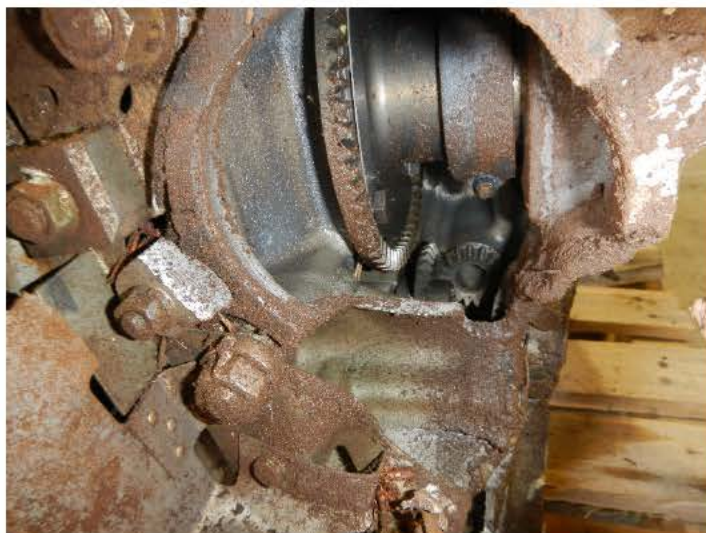
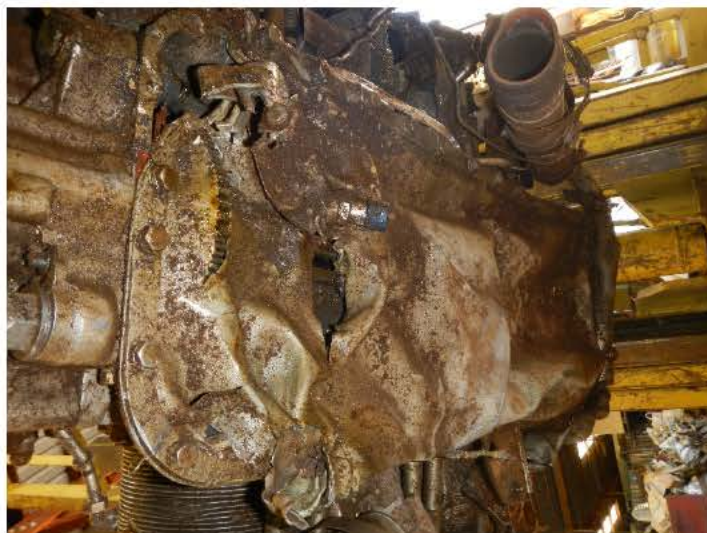
The camshaft and lifters were not observed. Only a portion of the camshaft gear that was protruding from the bottom of the oil sump and the propeller governor drive gear were observed.

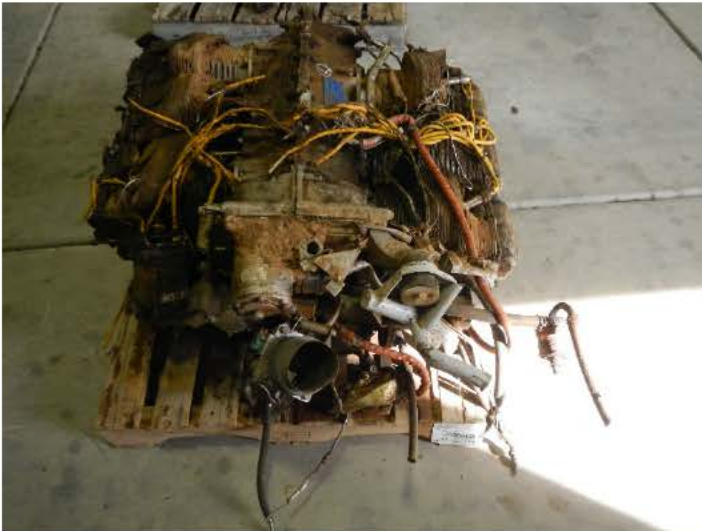
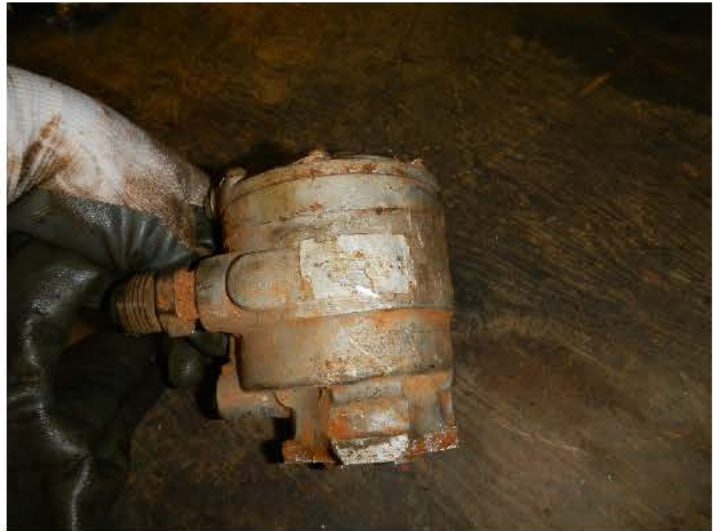
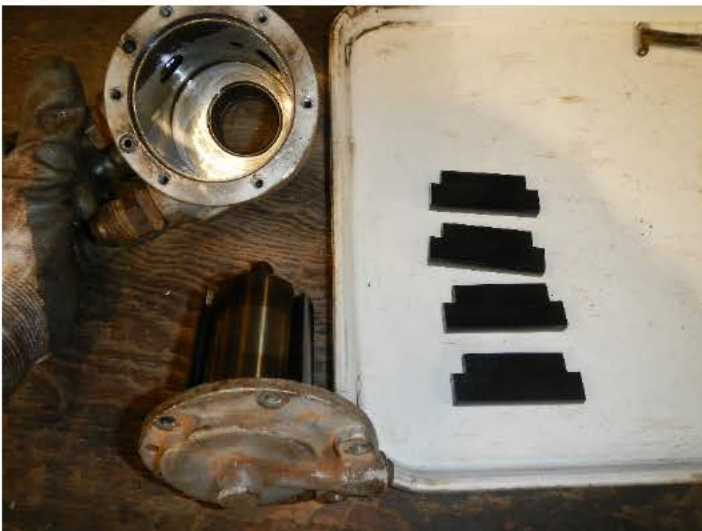
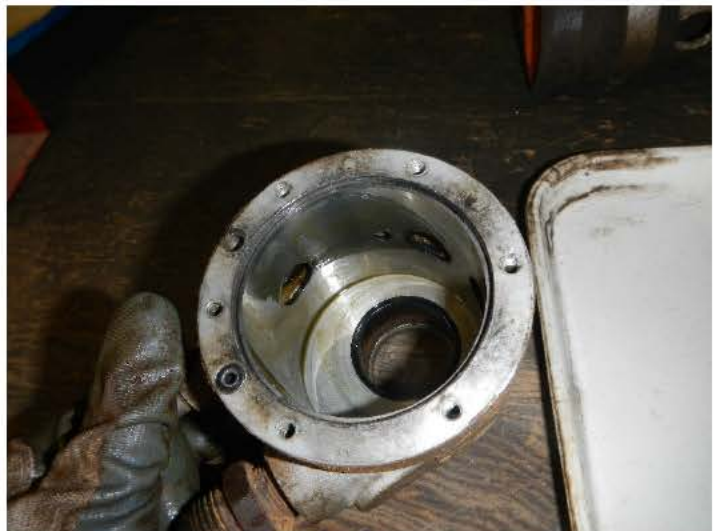
The vacuum pump remained partially attached to the backside of the engine. It was disassembled and the vanes remained intact with no pre-accident anomalies noted. The alternator was separated from the front right side of the engine. One alternator was found within the debris and it did not display any pre-accident anomalies. The starter and starter adapter remained attached to the backside of the engine.

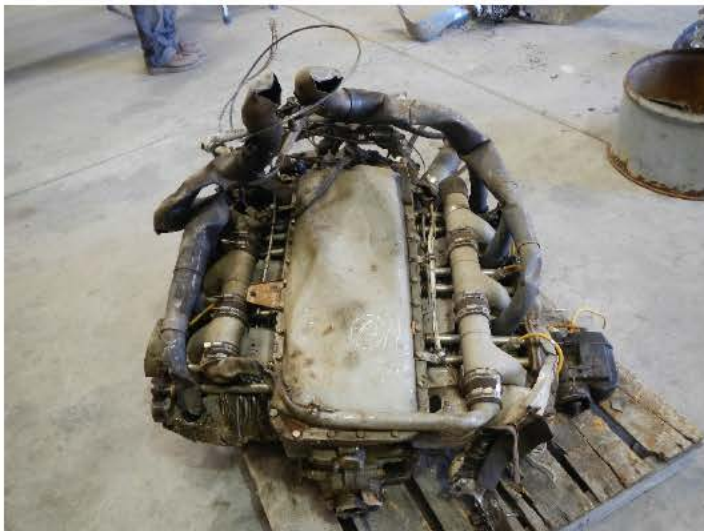
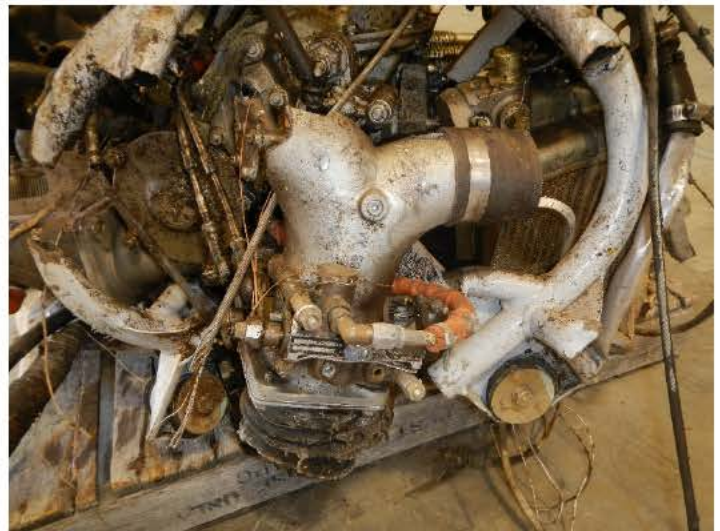
The exhaust system remained attached to the engine but sustained deformation damage. The intake wye plenum was fractured, the elbows were separated, and the balance tube was deformed. The intake tubes remained attached to their respective cylinders with no pre-accident anomalies noted. The throttle valve was in the full open position.

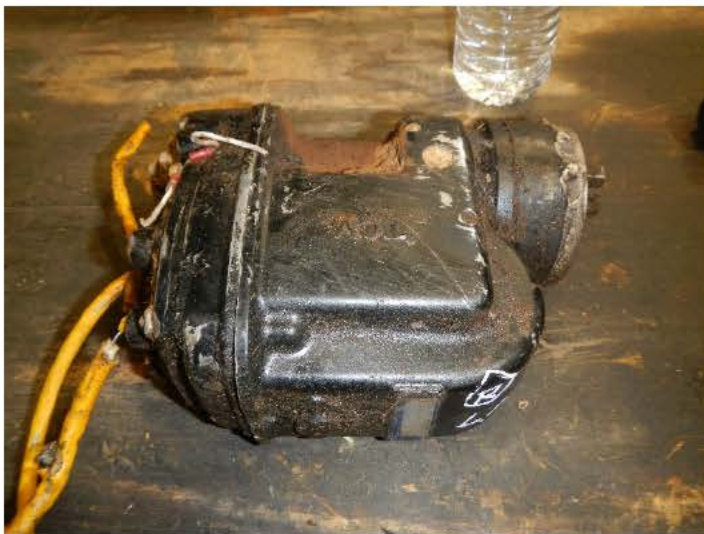
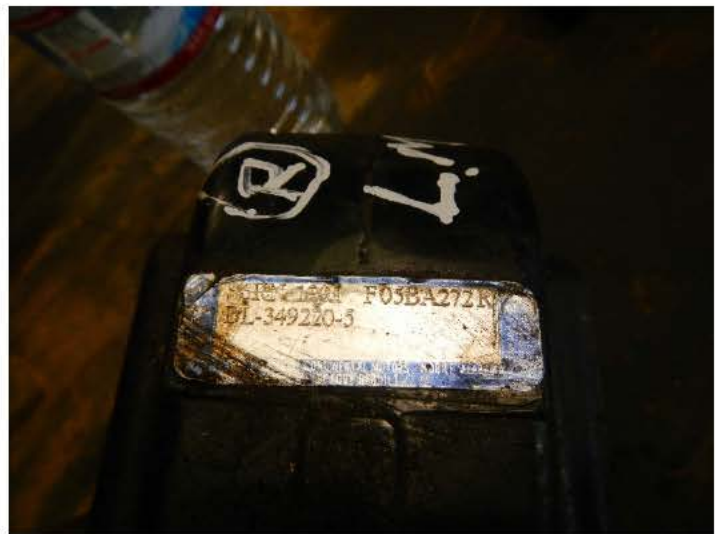
Both magnetos were separated from the topside of the engine and the ignition harness was fragmented. One magneto was found in the wreckage and was identified as the left magneto on the right engine (the serial number was noted in the aircraft maintenance records). That magneto was disassembled since functional testing was not possible due to damage sustained during the accident sequence. No pre-accident anomalies were noted with the internal components.

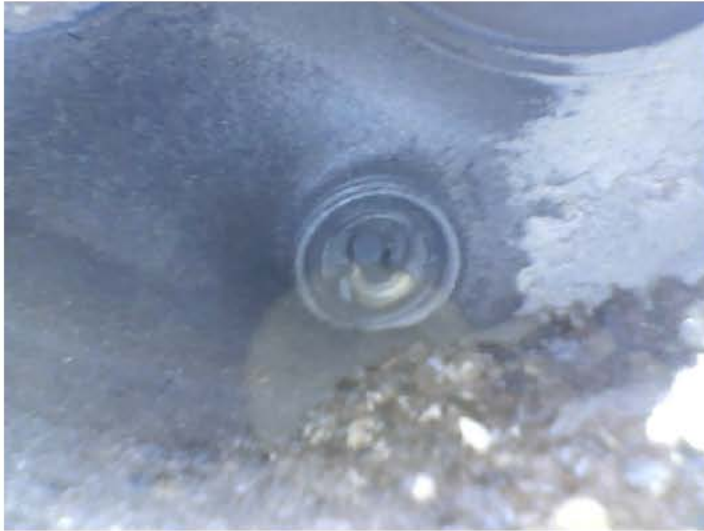
The bottom sparkplugs were removed from their respective cylinders and the top sparkplugs were documented utilizing a lighted borescope. Some of the sparkplugs were covered in dirt from the accident site and some were coated in oil. The #4 and #6 top sparkplugs were missing their center electrodes, as the topside of those cylinders and top sparkplugs sustained significant impact damage. However, there was no sign of lead or carbon fouling on any of the electrodes.

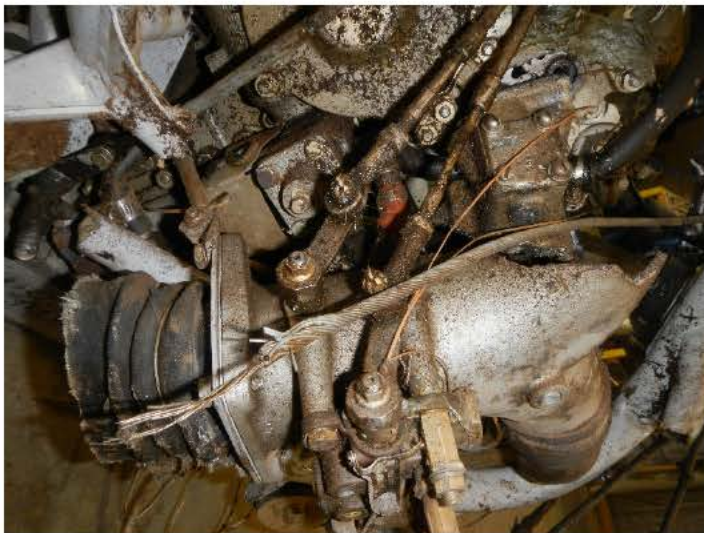
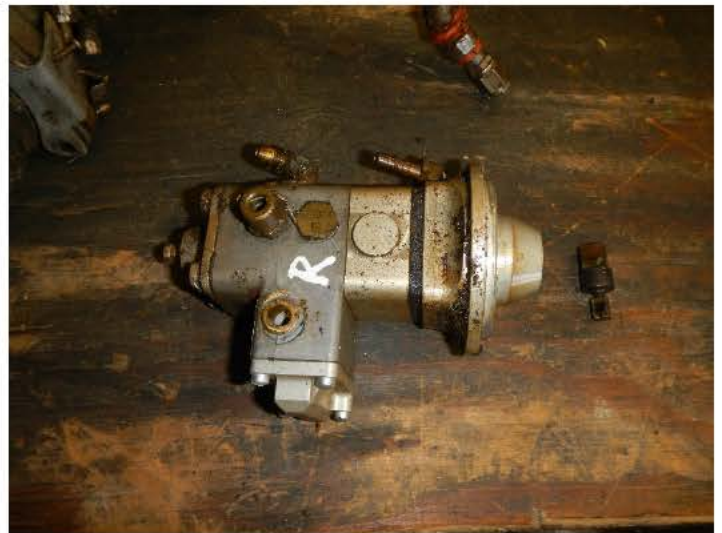
The engine-driven fuel pump remained secured to the backside of the engine. All but one of the fuel line fittings were fractured. The pump was removed and the drive coupling remained intact. The pump was disassembled and organic debris from insects was noted at the top of the swirl chamber near the vapor return jet; however, it is presumed that the debris entered the system following the wreckage recovery. No other pre-accident anomalies were noted with any of the internal components.

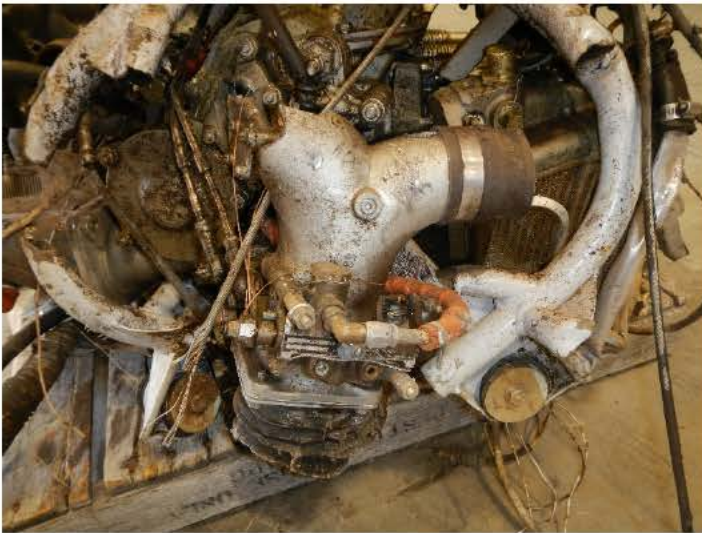
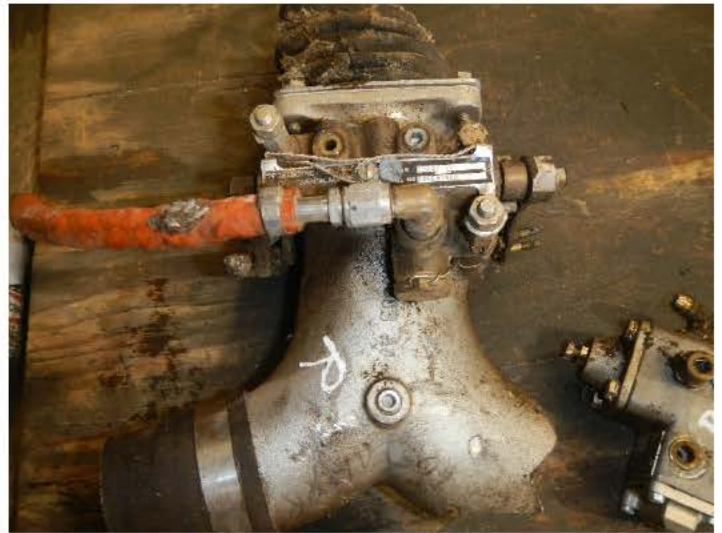
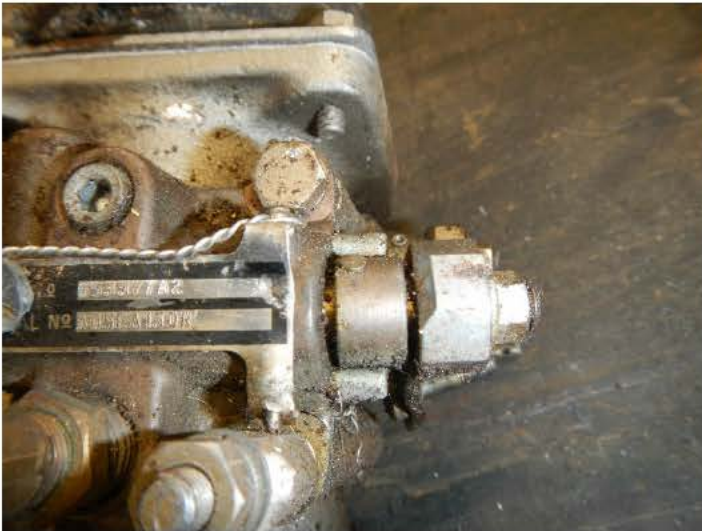
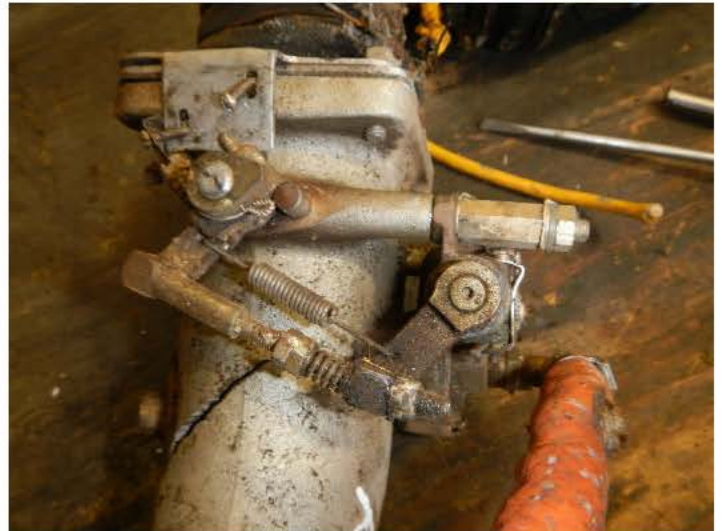
The throttle body and fuel metering unit remained attached to the backside of the engine. The mixture and throttle control cables remained attached to their respective levers, but the levers were bent and deformed. The throttle lever and throttle valve were found in the full open position. The throttle interconnect linkage was bent. The fuel metering unit was disassembled. The inlet screen contained some lint, but the screen was not blocked or obstructed. The mixture and throttle cams were removed as was the metering plug. No pre-accident anomalies were noted with any of the o-rings or metering orifices.

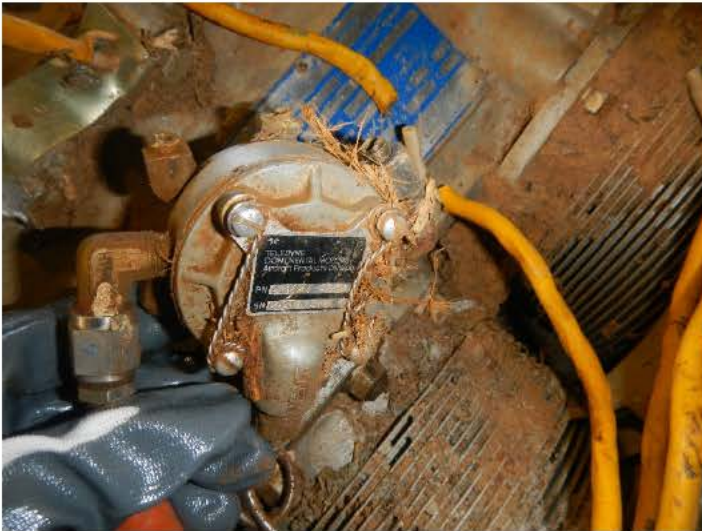
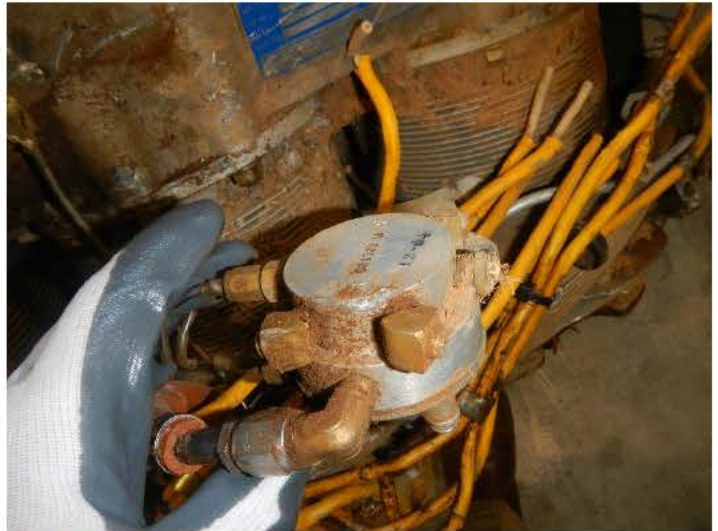
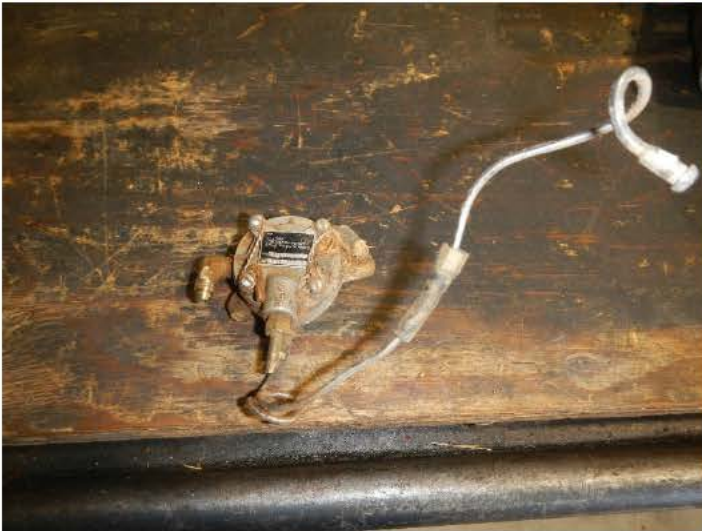
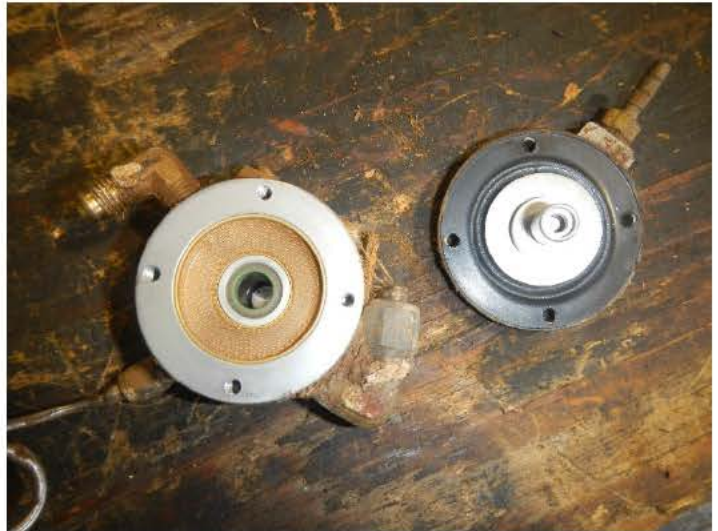
The fuel manifold valve remained attached to the topside of the engine via one injector line and the fuel inlet fitting. The cap was removed and the diaphragm was intact. The screen was clean and free from obstructions or debris. No pre-accident anomalies were noted with the unit.

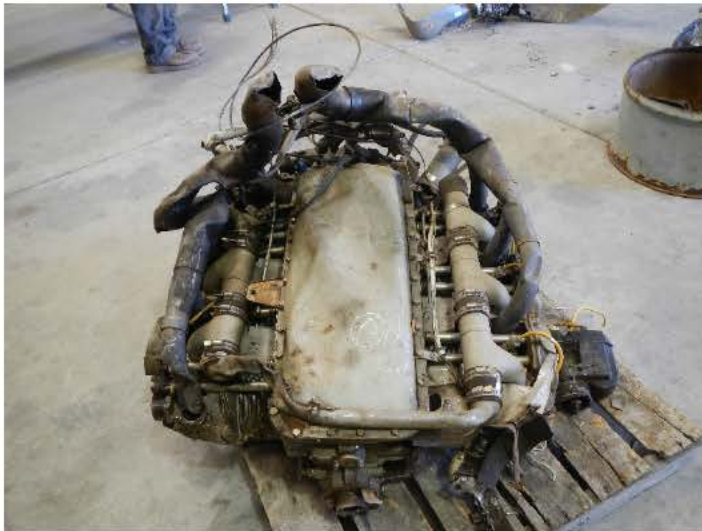
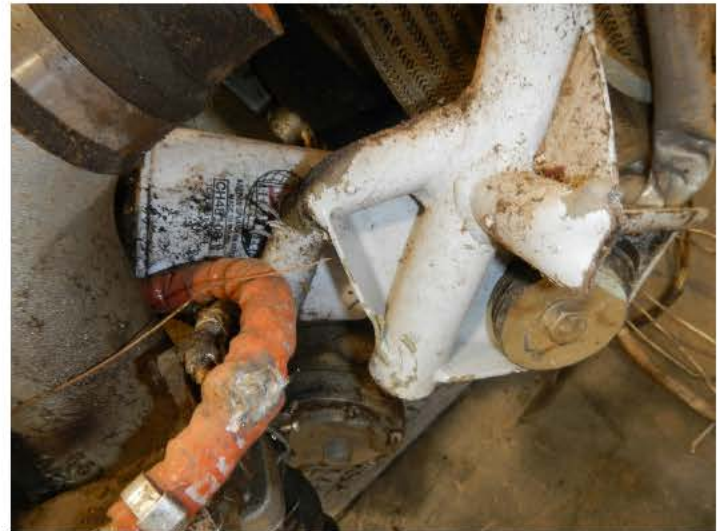
The oil sump remained intact on the bottom of the engine and there were no signs of pre-impact oil leaks. The oil pump remained attached to the backside of the engine; however, the pump housing cap was fractured as was the tach drive. The remains of the cap were removed and the gears were examined. The drive gear splines displayed a torsional displacement. The gears were intact and did not display any pre-accident anomalies. The housing walls displayed short arcs of circumferential scoring that coincided with the apexes of the drive gear teeth. The oil filter remained attached to the adapter and it had the following information hand written on the side for date and tach time, respectively: 1-26-17 and 3937.3. The oil cooler was deformed and the mount was fractured. The oil filler neck was partially separated from the engine. None of the observed components displayed signs of thermal discoloration or lubrication system distress.

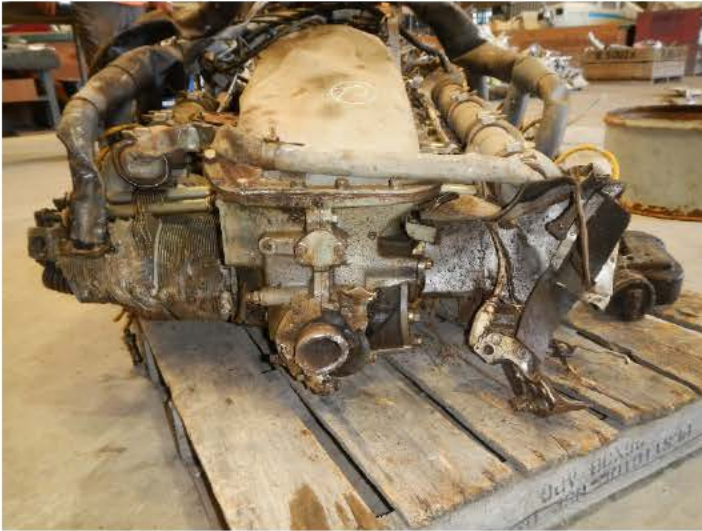
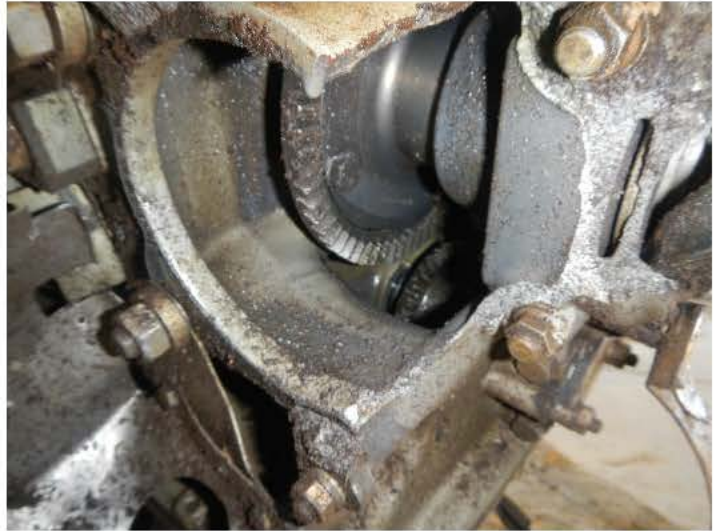
The crankcase sustained impact-related damage to the front end of the crankcase. Additionally, the area around the engine-driven alternator was also fractured. However, there were no signs of pre-accident operational anomalies with the crankcase.

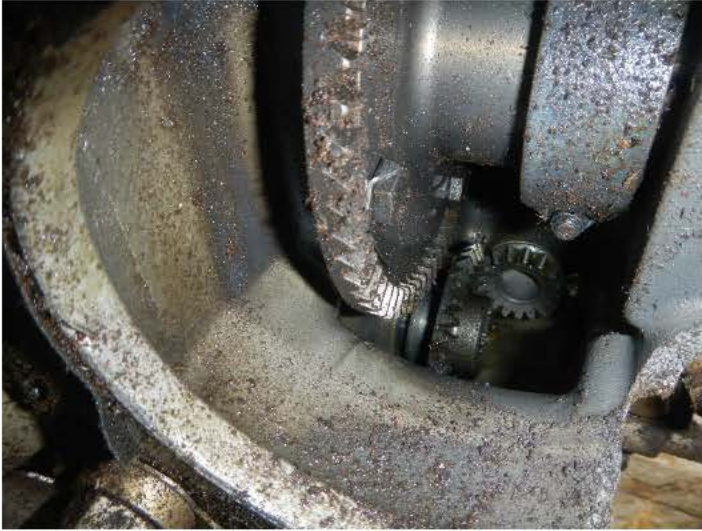
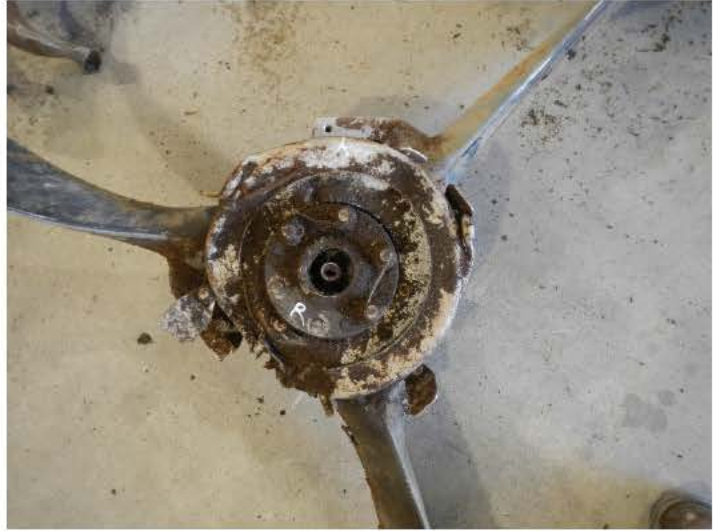
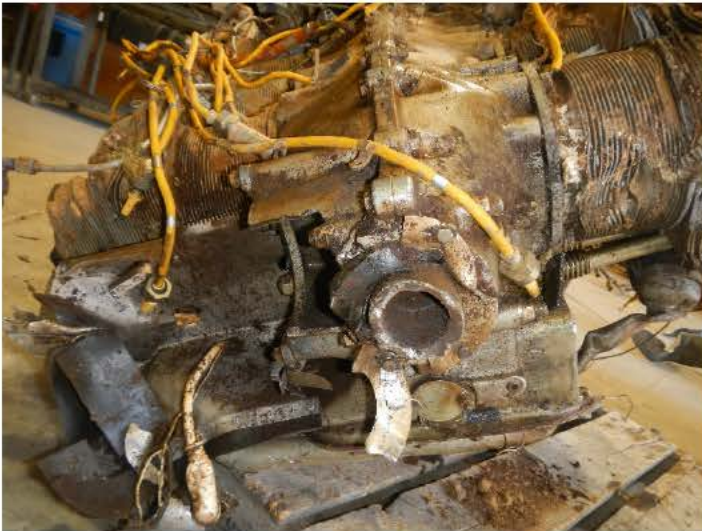
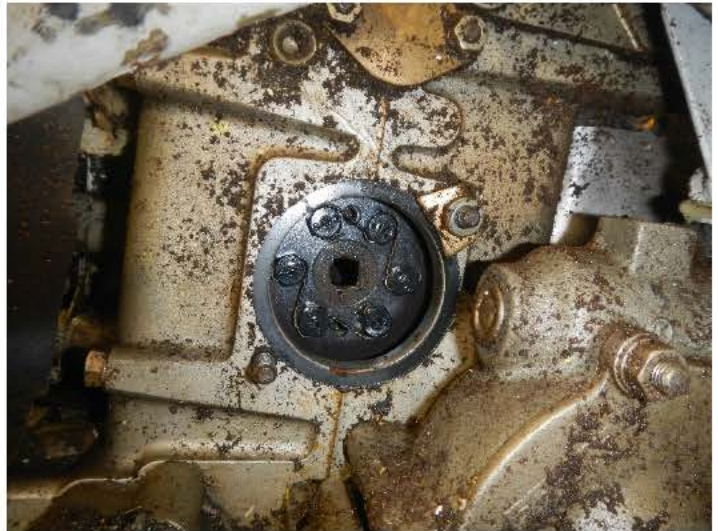
The crankshaft was fractured aft of the propeller flange. Though the crankshaft was not visible in its entirety, the portions that were did not display any signs of thermal discoloration or lubrication distress. The crankshaft gear remained secured in place. The connecting rods were not observed.

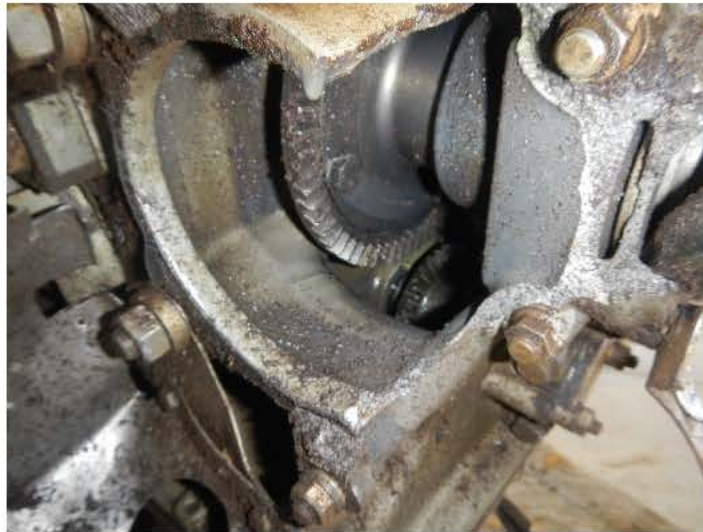
The camshaft and lifters were not observed. The propeller governor drive gear was observed.
