# Continental Motors

## ENGINE EXAMINATION REPORT

| ENGINE MODEL | IO-520-C3 |
| FILE NUMBER | 16-656 |

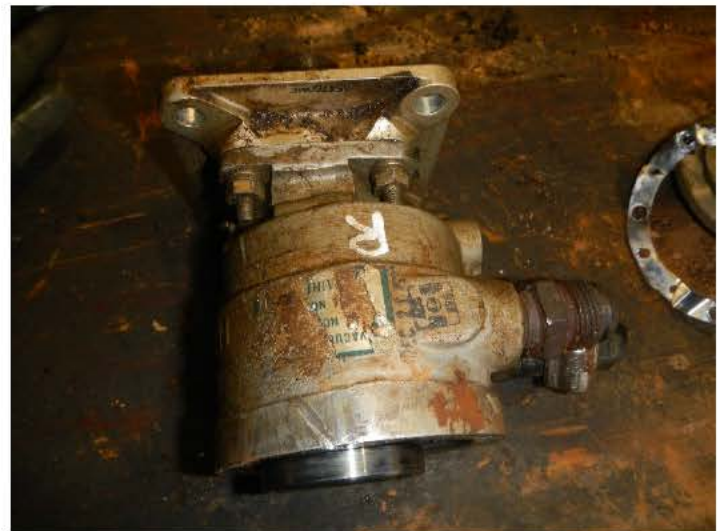
The vacuum pump remained partially attached to the backside of the engine. It was disassembled and the vanes remained intact with no pre-accident anomalies noted. The alternator was separated from the front right side of the engine. One alternator was found within the debris and it did not display any pre-accident anomalies. The starter and starter adapter remained attached to the backside of the engine.
