## **NATIONAL TRANSPORTATION SAFETY BOARD**

# **AIRWORTHINESS**

## **Group Chairman's Factual Report**

**WPR17FA128**

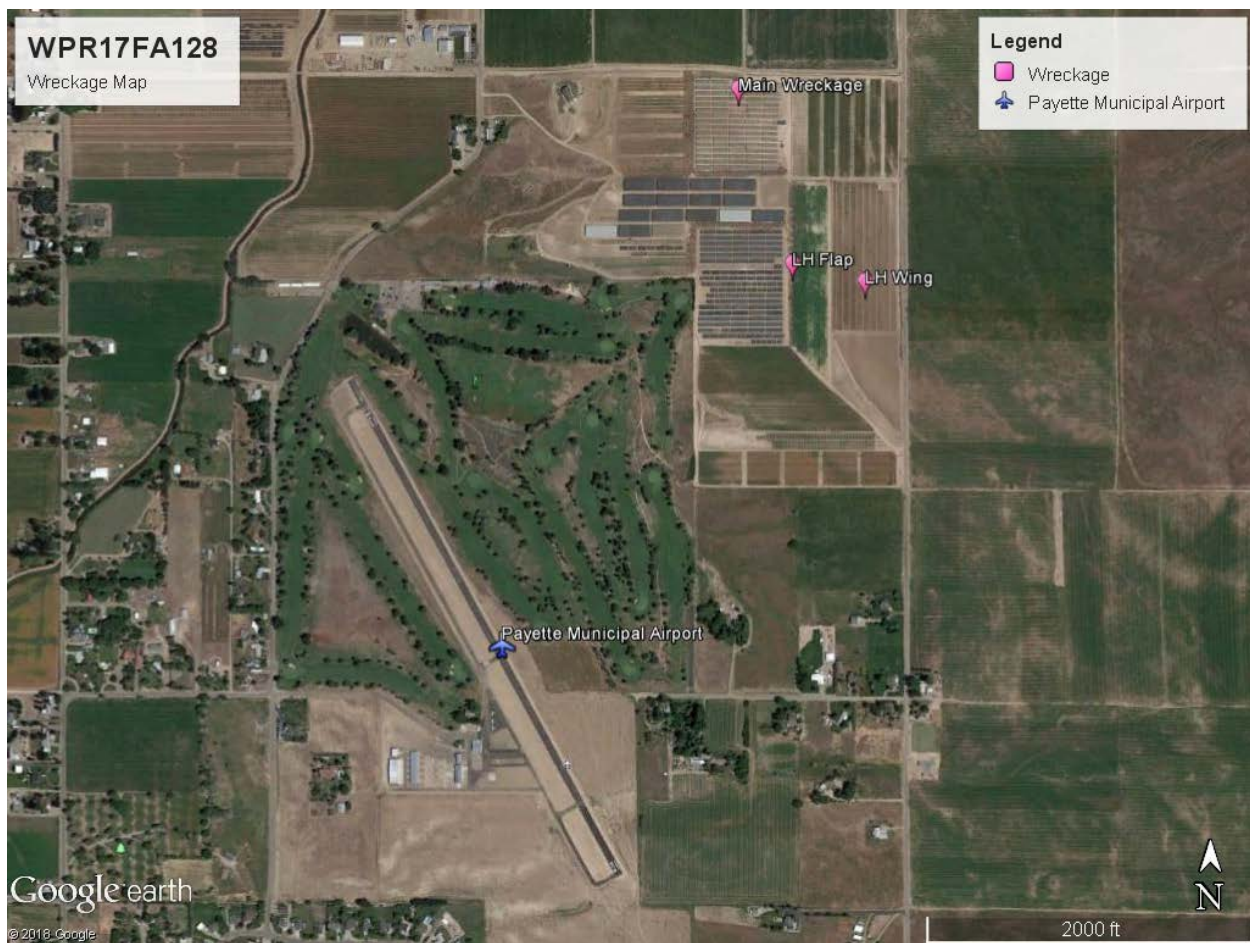
**Figure 2 – Wreckage Map**

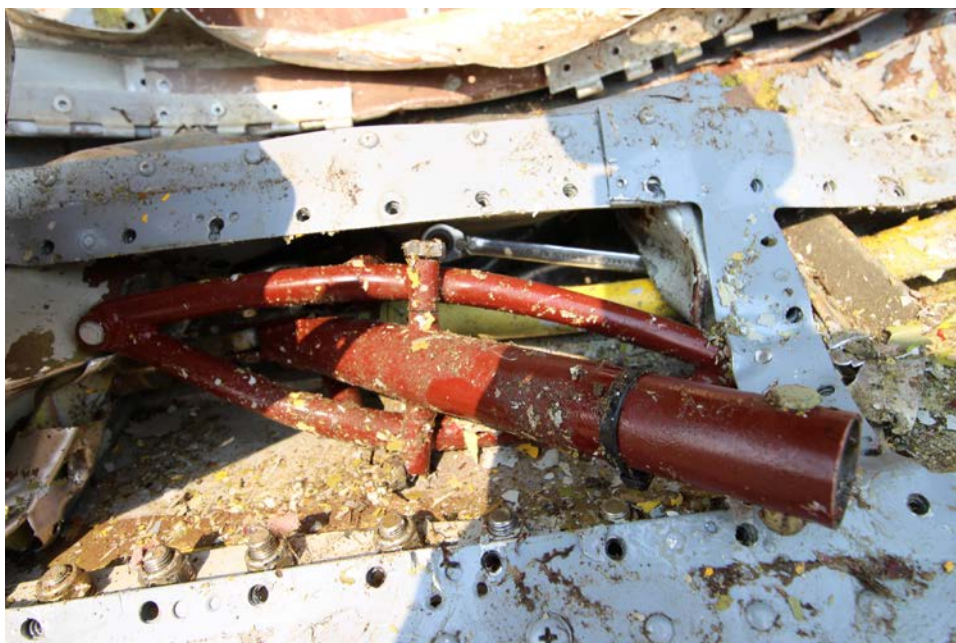
**Figure 3 – Lower control stick area with wrench**

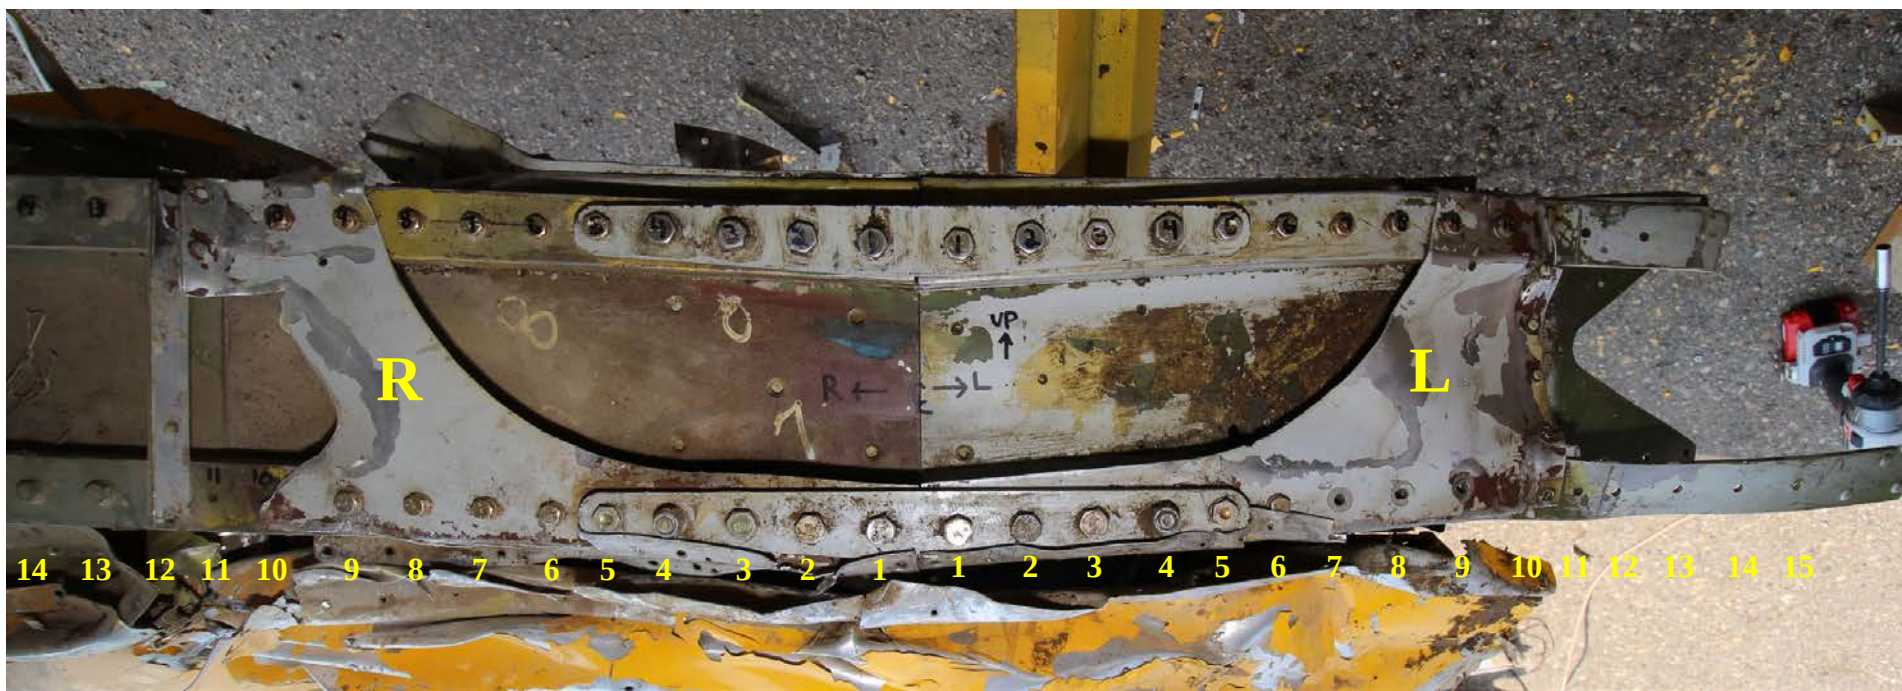
**Figure 4 – Center portion of main wing spar, viewed looking aft**

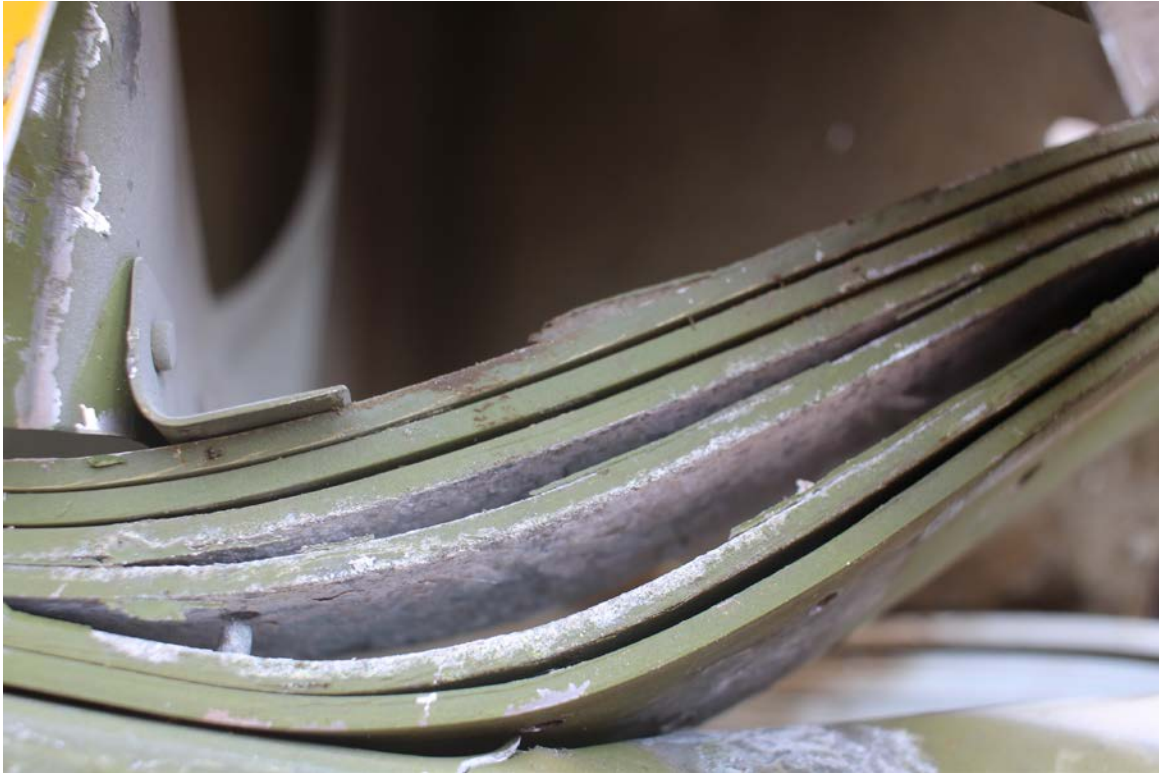
**Figure 5 – Corrosion in left upper spar cap layers**

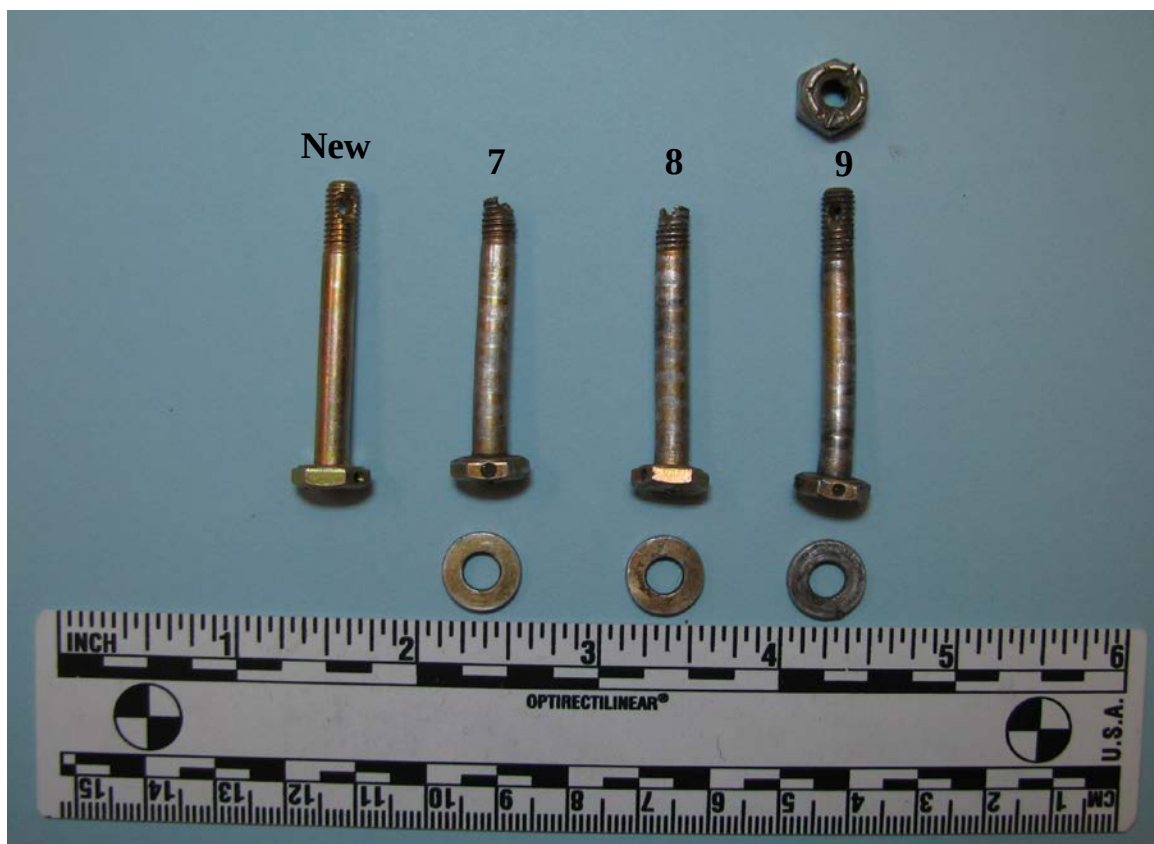
**Figure 6 – New bolt and bolts removed from left lower spar cap**
