# NATIONAL TRANSPORTATION SAFETY BOARD

## MATERIALS LABORATORY FACTUAL REPORT

Report No. 18-029

Place : Arlington, Arizona  
Date : June 27, 2017  
Vehicle : Vans RV-7, N731RV  
NTSB No. : WPR17FA134  
Investigator : Maja Smith, AS-WPR

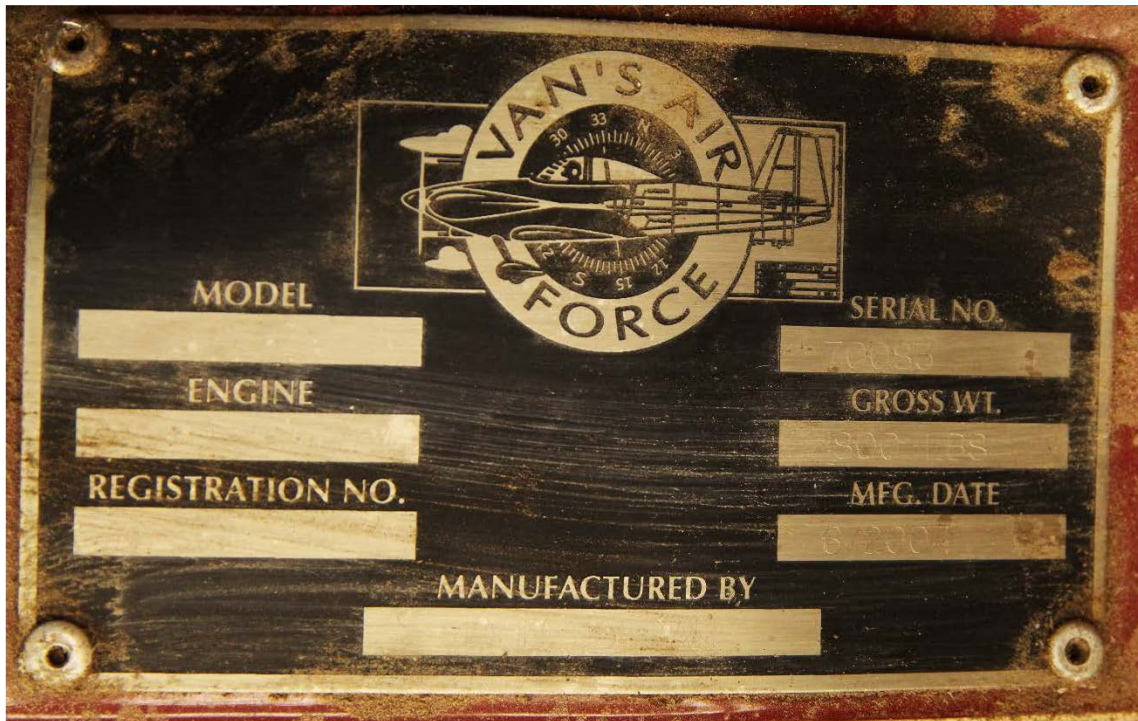
Figure 1 shows the manufacturing label of the airplane on one of the received empennage parts. The label stated the model number was "RV-7", the engine was a Lycoming O-360-A1A, registration number "N731RV", the serial number was "70083", the gross weight was 1800 lbs., and was manufactured by John Jordan in June 2004. The components of the airplane tail section that were received had fractured in multiple locations, including stiffeners, spars, and attachments, as well as across skins and rivets.

Figure 1 – The manufacturing label on the airplane empennage.

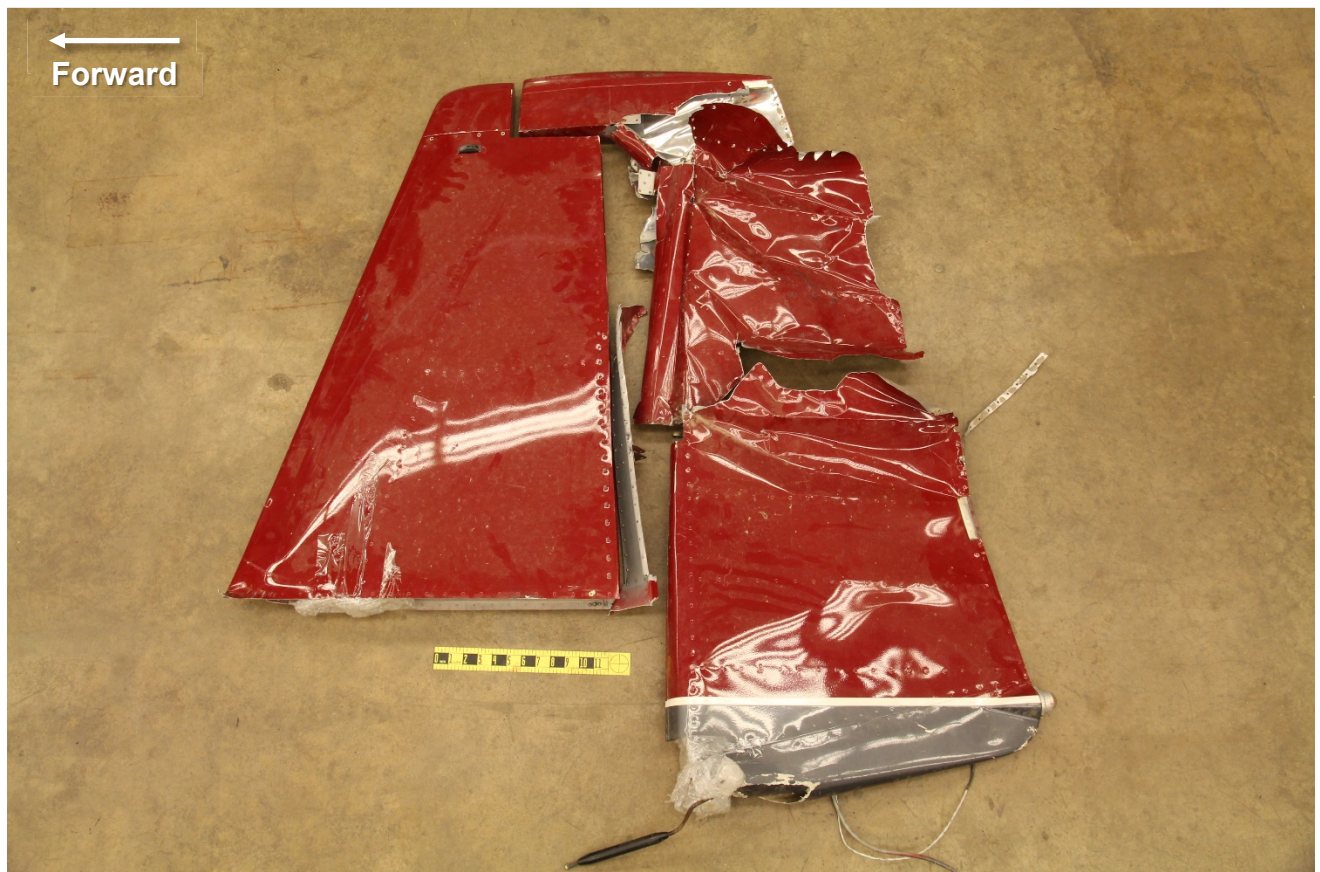
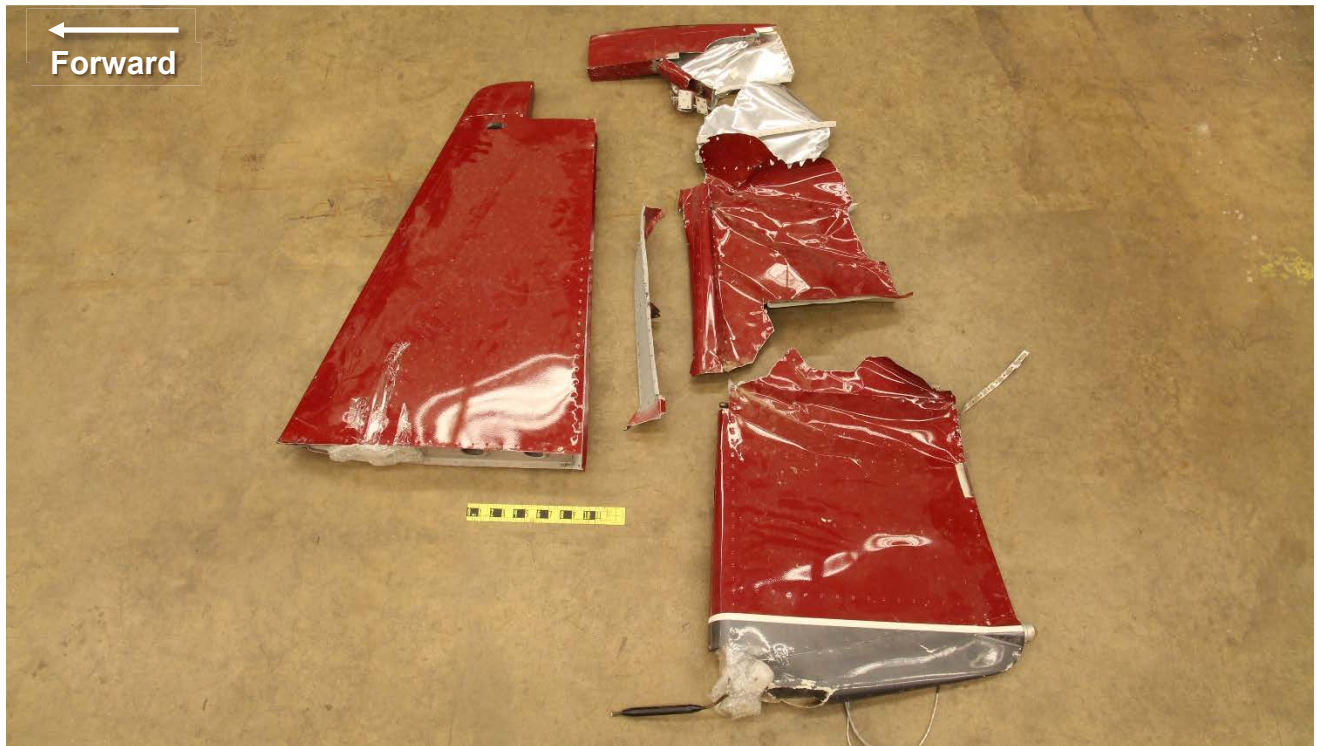
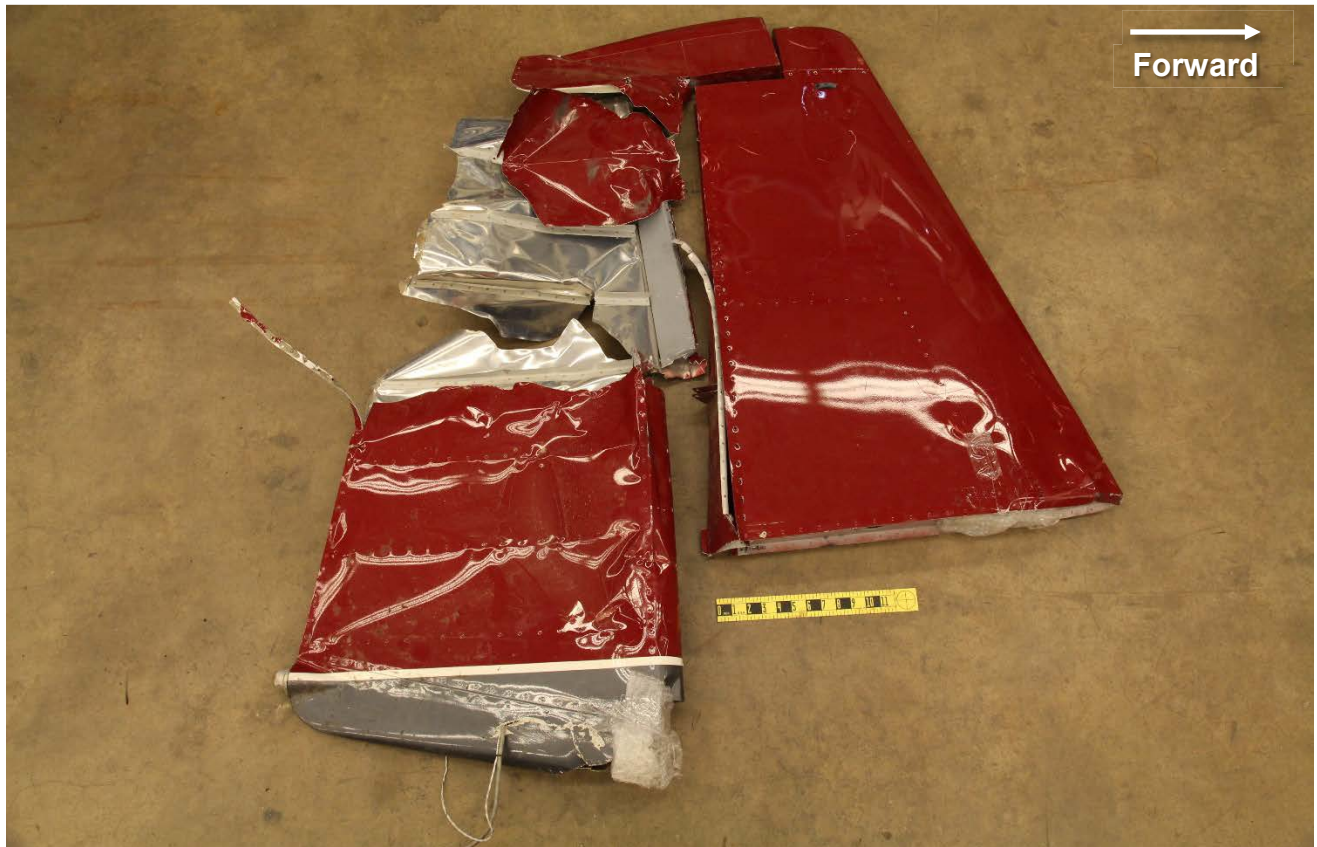
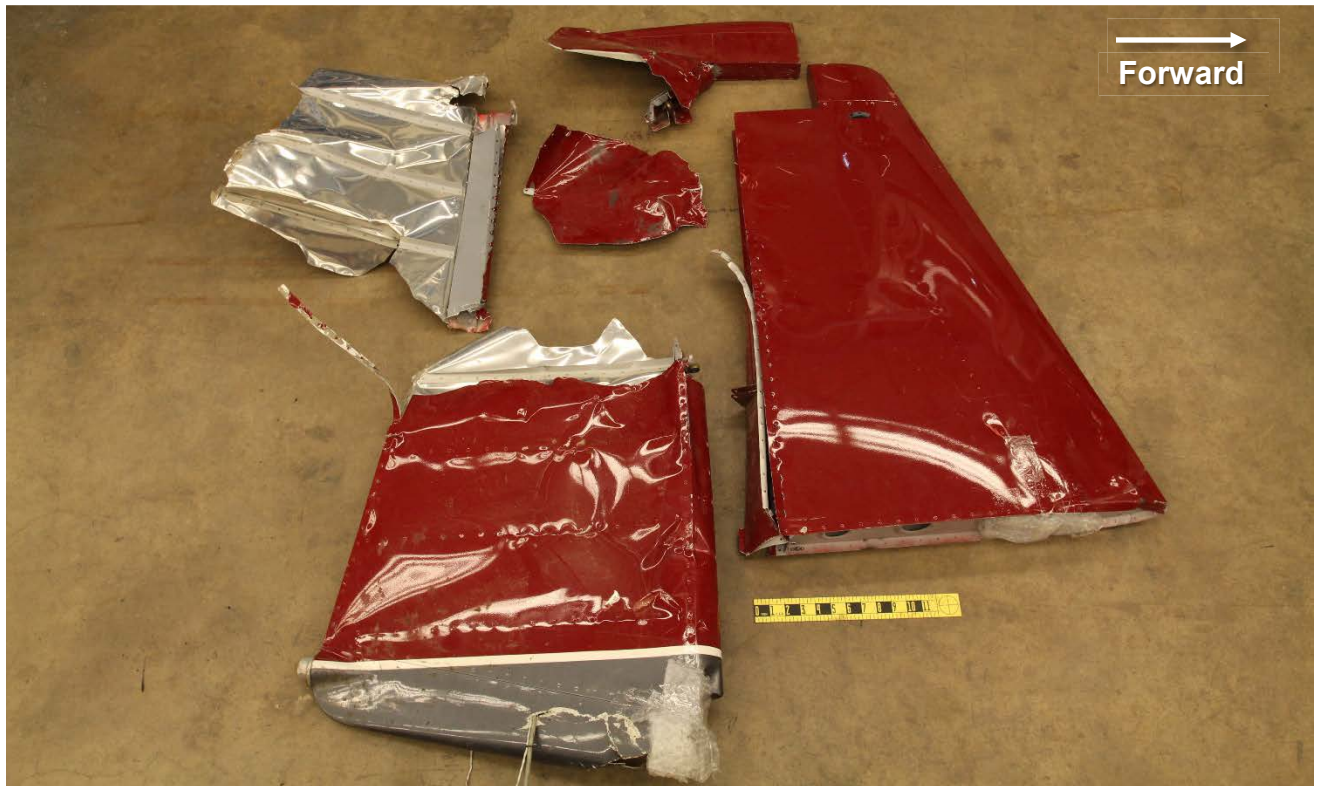
Figure 2 through Figure 5 show the parts from the vertical stabilizer, as received. Figure 2 and Figure 4 show the vertical stabilizer with rudder from the left and right sides, respectively, arranged closely to represent where the parts of received wreckage were originally positioned. Figure 3 and Figure 5 show the same pieces but spread apart to emphasize the fracture surfaces and part deformation.

As seen from the figures of the vertical stabilizer and rudder, the skins had fractured in multiple locations. The forward vertical spar in the rudder had fractured just below the attachment point (shown in Figure 6). The fracture exhibited out of plane deformation and buckling, consistent with secondary fracture such as from ground impact.<sup>1</sup>

Figure 2 – The components of the vertical stabilizer, view on the left, positioned close.

Figure 3 – The components of the vertical stabilizer, view on the left, positioned apart.

Figure 4 – The components of the vertical stabilizer, view on the right, positioned close.

Figure 5 – The components of the vertical stabilizer, view on the right, positioned apart.

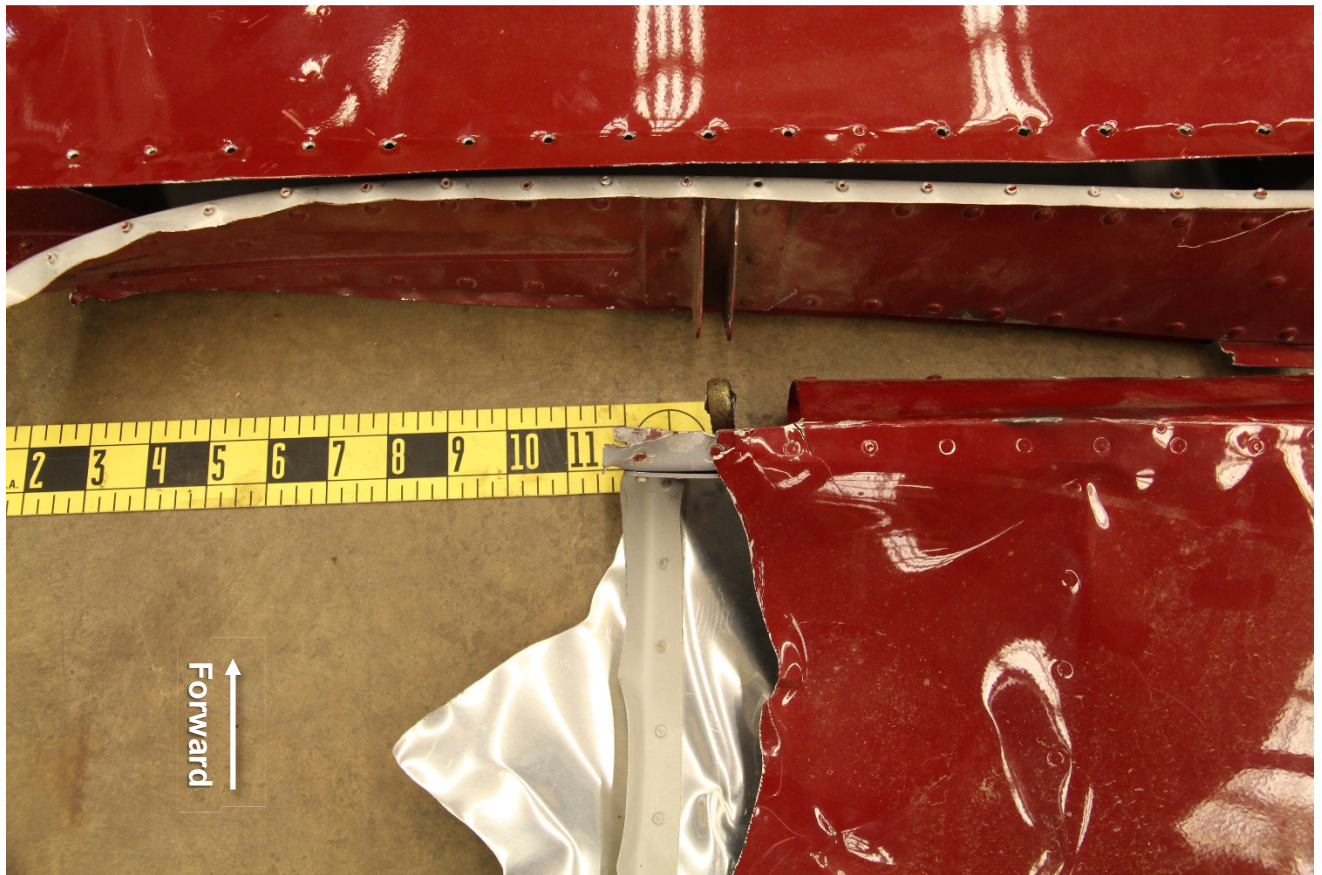
The fisheye bearing at the rudder attachment point did not exhibit any signs of fracture, nor did the mating attachment flange bolt holes on the aft vertical stabilizer vertical spar. These bolt holes, however, were elongated oriented in the aft direction. These features were consistent with shear stresses on the bolt in this location. The bolt was not recovered or received by the NTSB Materials Laboratory.

Figure 6 – The lower fisheye bearing attachment point, where the rudder assembly attached to the vertical stabilizer aft vertical spar (top of figure).

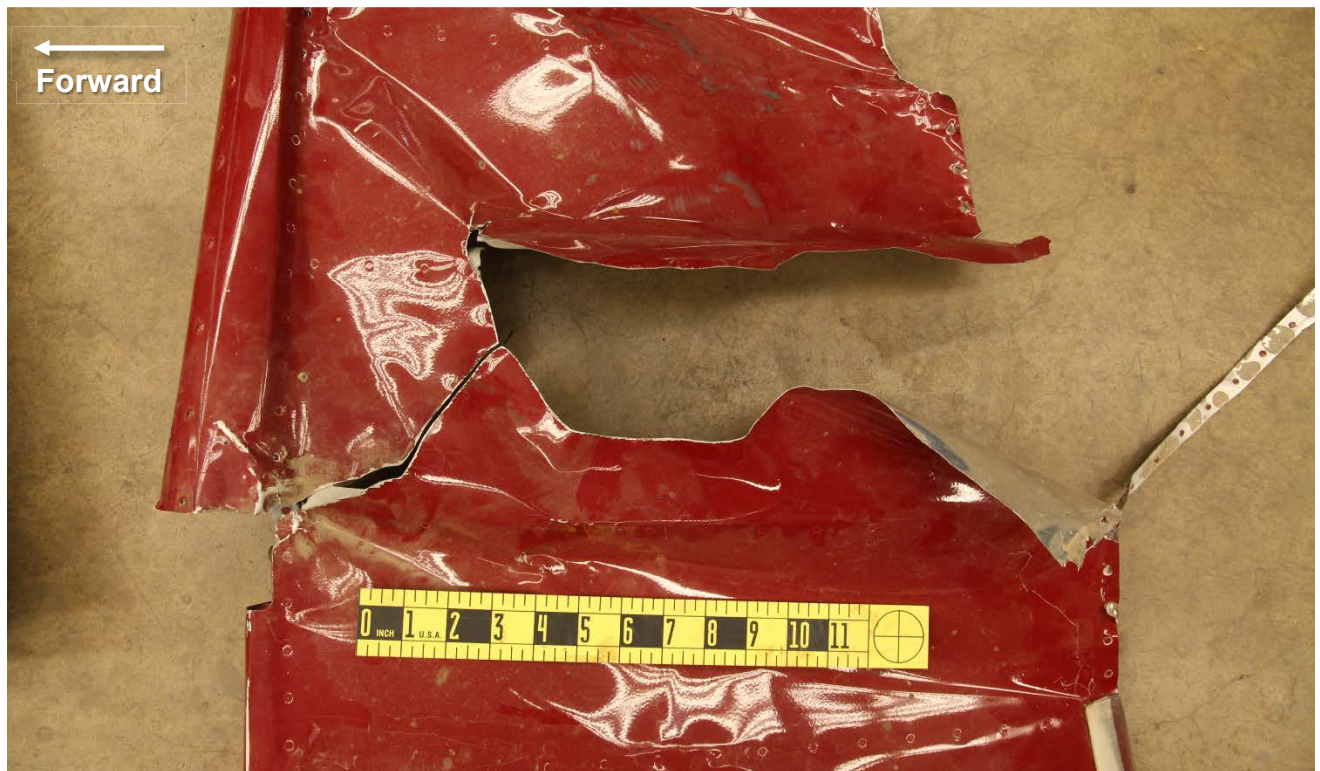
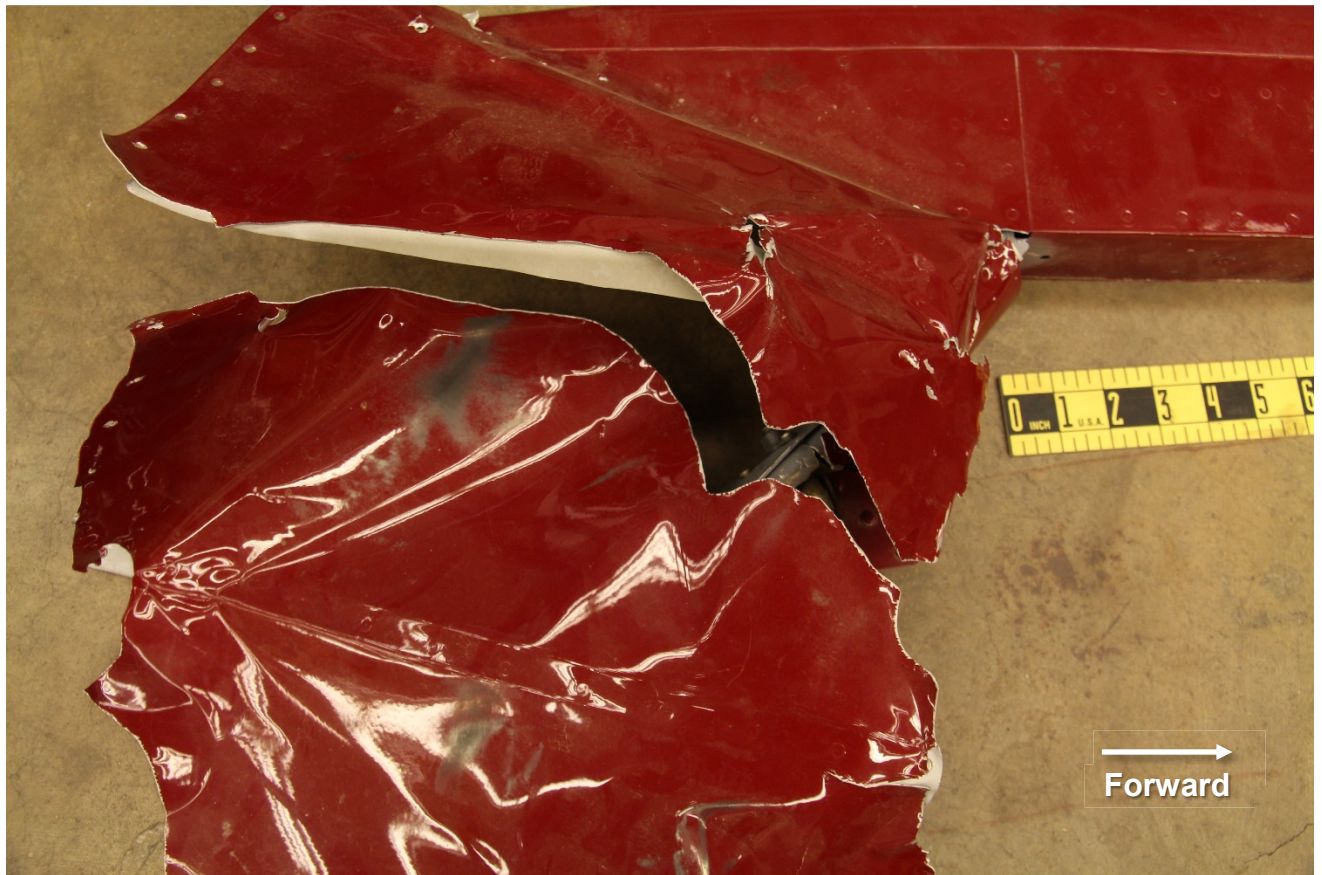
Many of the horizontal stiffeners in the rudder had also fractured in multiple locations. Many of these fractures were collocated with tears and fractures of the skin in the rudder. Figure 7 and Figure 8 illustrate mating tear fractures in the rudder skins, consistent with the locations of horizontal stiffener fractures. Similar to the fracture of the rudder forward vertical spar, the fractured horizontal stiffeners exhibited out of plane deformation and buckling along multiple directions. The skin material adjacent to its skin fracture surfaces also exhibited buckling in multiple directions and out of plane deformation. The fractures of the skins were oriented in multiple directions. These features were consistent with secondary fractures, such as from ground impact, not consistent with a primary fracture (such as in-flight breakup).

Figure 7 – Closer view of the fracture of the rudder skin on the left side.

Figure 8 – Torn and fractured portion of the skins on the upper portion of the right side of the rudder.

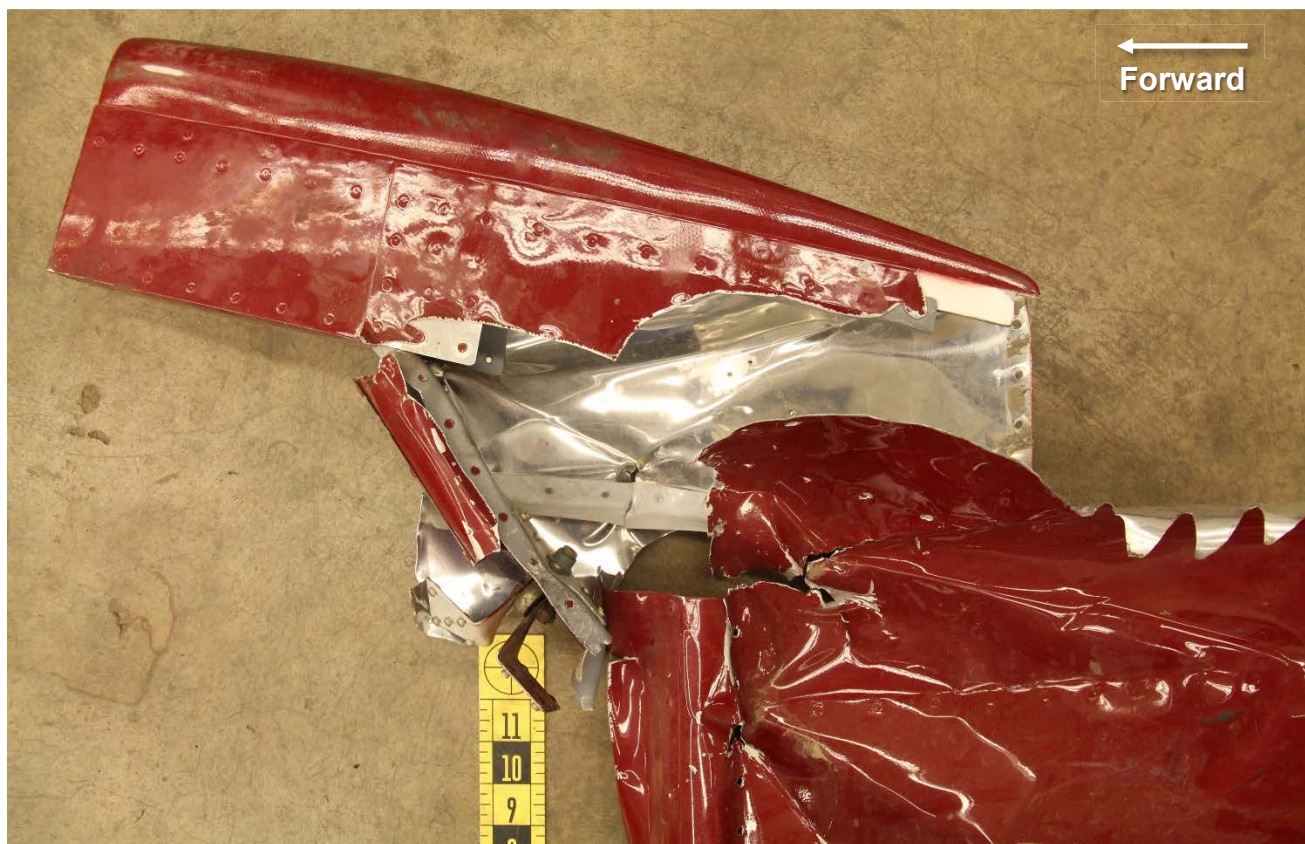
The uppermost portion of the tail rudder is shown in Figure 9. This shows tearing fractures in the skin, accompanied by bending and twisting near the fractures of the horizontal and vertical stiffeners. The skin on the right side of Figure 9 exhibited a general sawtooth shape, consistent with the mating skin fracture surface shown on Figure 10. This sawtooth fracture pattern was consistent with fracture of the rudder skin about the rivets in the upper portion of the rudder. Again, buckling in multiple directions and out of plane deformation were prominent on all the fractured components in this region, consistent with secondary fractures. The sawtooth pattern and buckling in the upper rudder fractures were consistent with a general forward-to-aft shearing of the upper rudder.

Figure 9 – The topmost portion of the rudder that fractured from the lower portion of the rudder on the left side. The sawtooth shape of the fracture on the right matched the skin fracture around rivets in Figure 10.

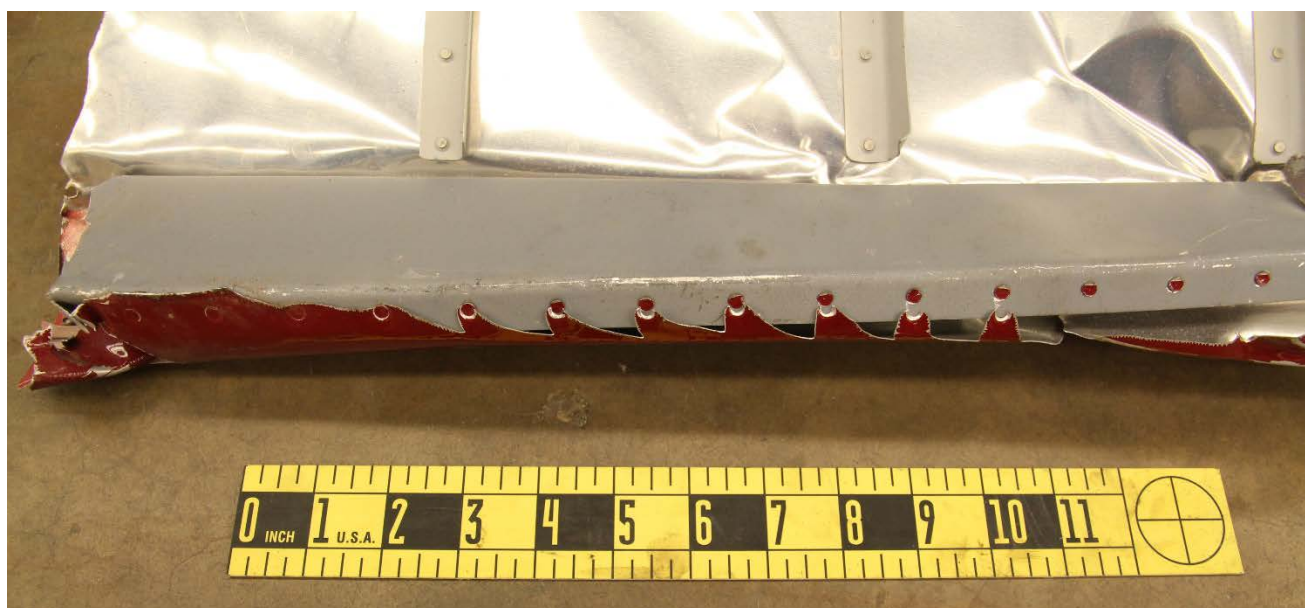
Figure 10 – Sawtooth shaped fractured of the wing skin on the rudder, exhibiting a fracture path around the rivets.

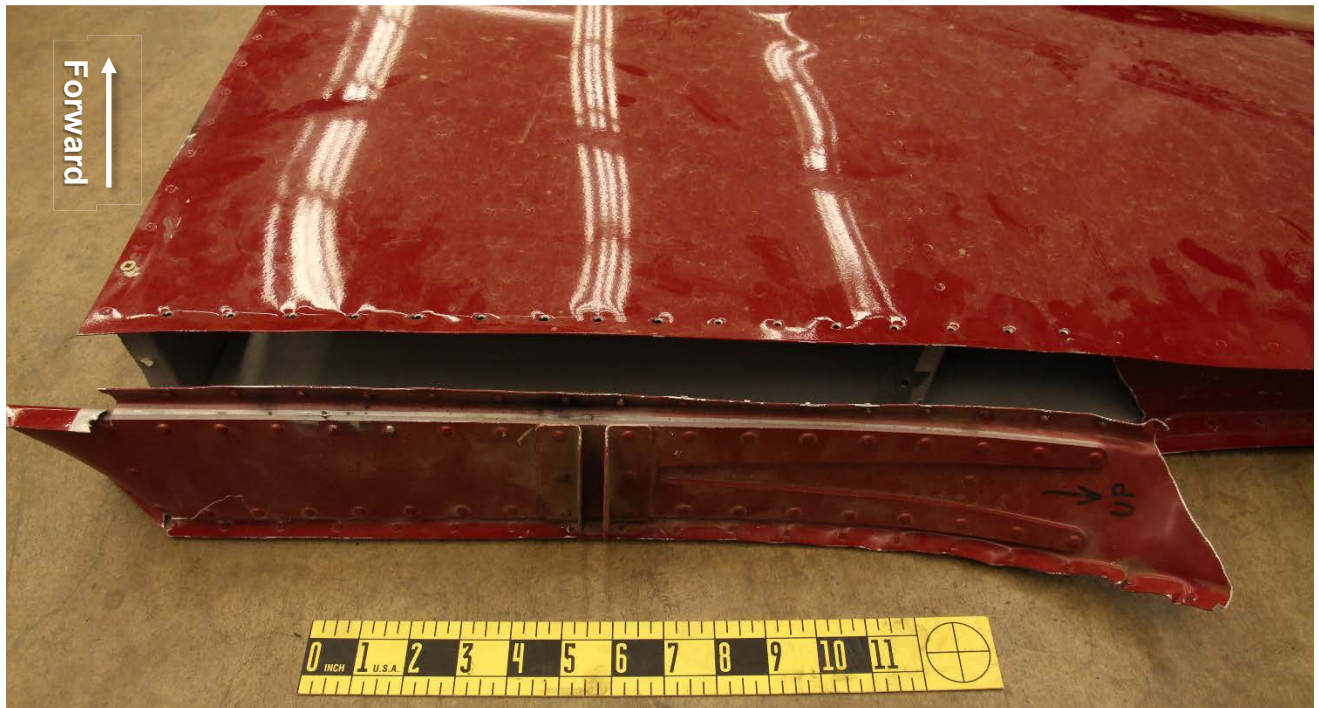
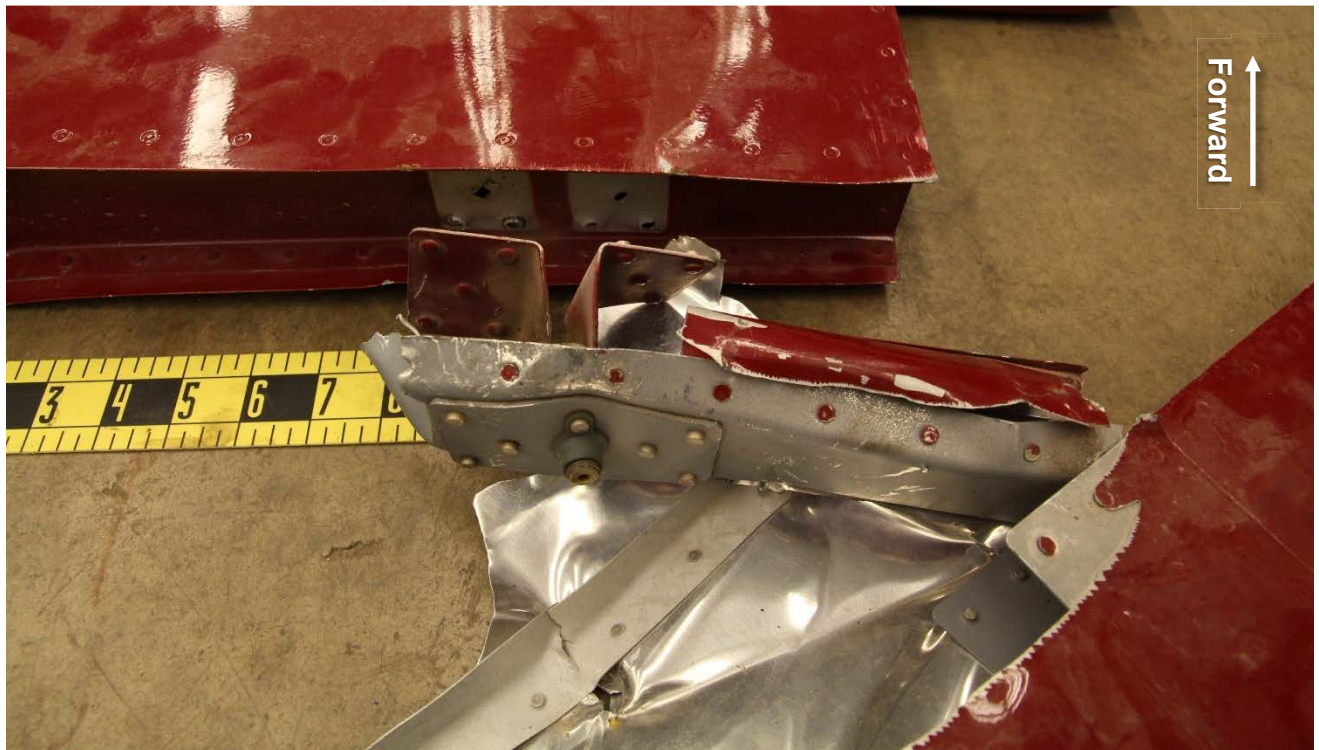
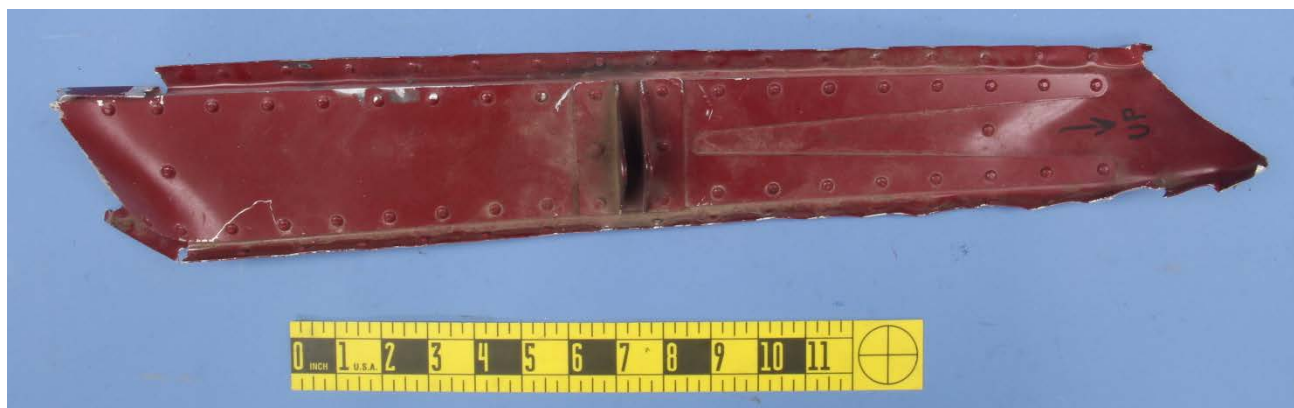
Most of the vertical stabilizer assembly was intact, exhibiting some minor dents to the exterior of the skins. The two exceptions were the aft vertical spar (see Figure 11 through Figure 13), as well as a forward vertical spar fracture on the underside (see Figure 14 and Figure 15). A section of the aft vertical spar had separated from the rivets on the left and right sides. The upper portion of the liberated aft spar exhibited an angled fracture, and the bottom of the spar exhibited a fracture with an inward and outward facing portion of the wing skin, consistent with a twisting motion. These fracture surfaces exhibited a general slanted morphology, with a dull luster, consistent with overstress fracture.

Figure 11 – Position of the lower portion aft vertical spar of the vertical stabilizer, which had fractured about the support rivets and torn away from the stabilizer (right side).

Figure 12 – Position of the upper portion face of the vertical stabilizer, showing rudder attachment flanges that had separated from the aft vertical spar.

Figure 13 – The separated section of the aft vertical spar from the vertical stabilizer, viewed aft looking forward.

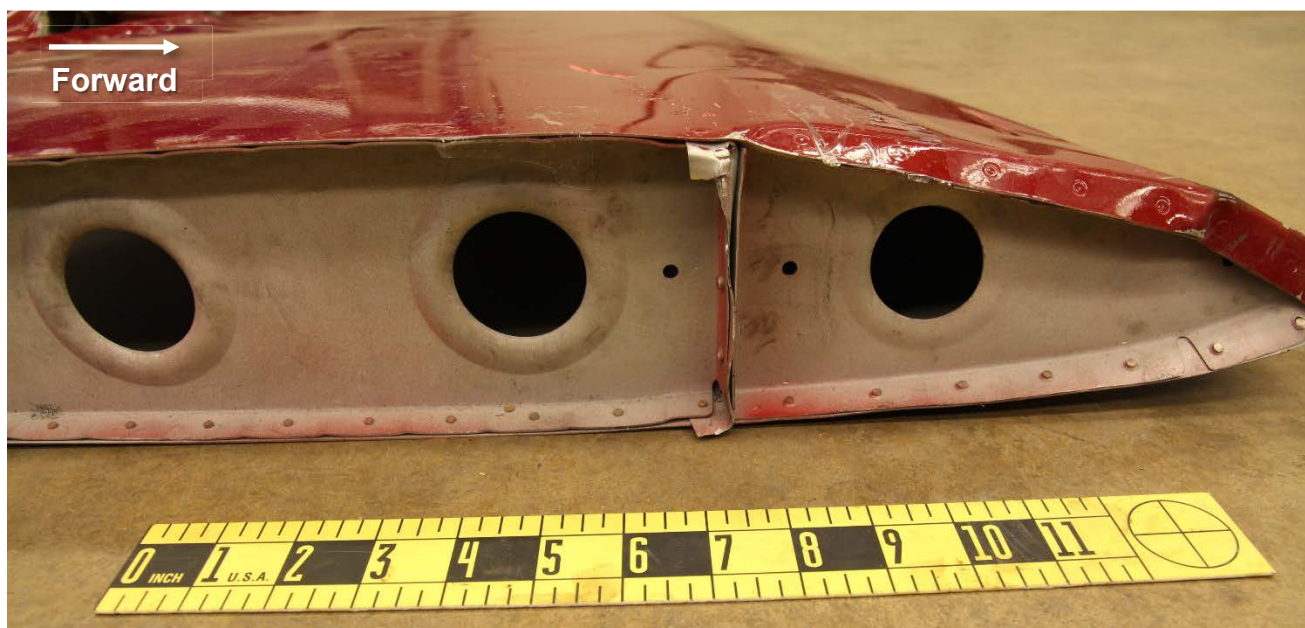
Figure 14 – Exposed area of the bottom face of the vertical stabilizer, showing the forward vertical spar fracture surface.

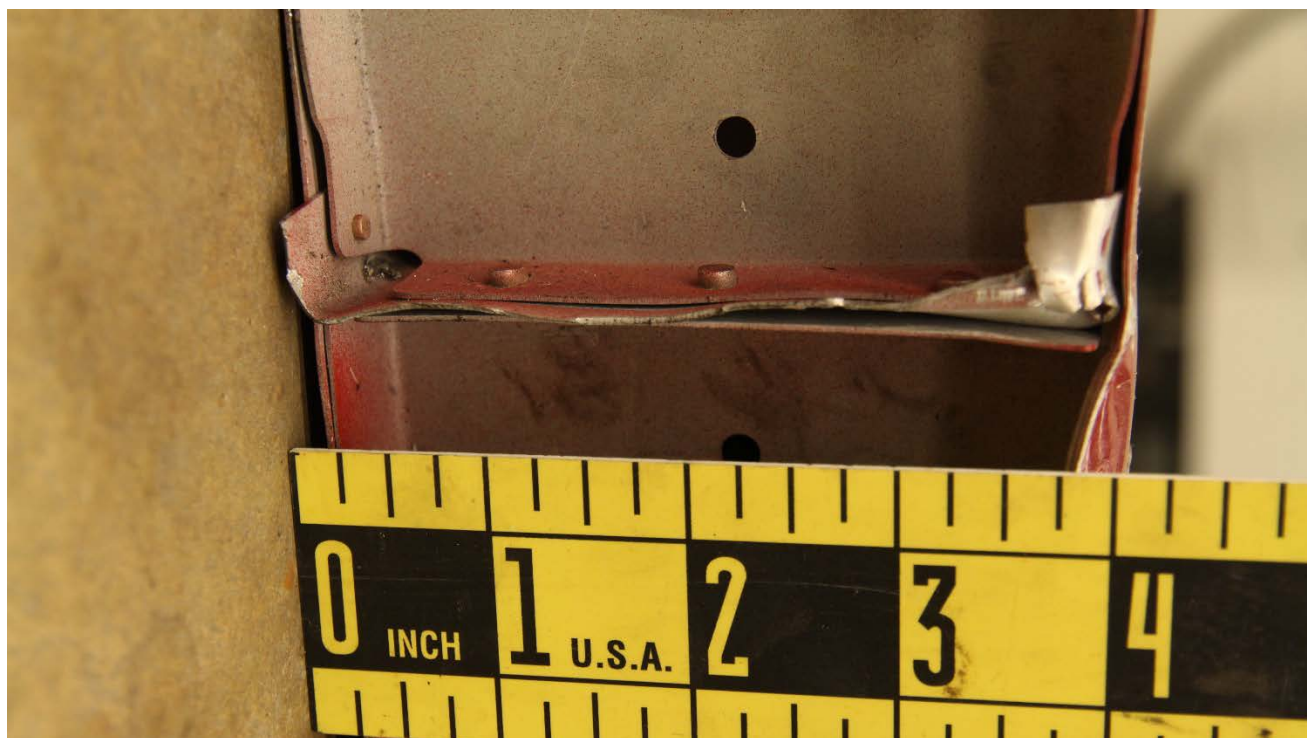
The underside forward spar fracture of the vertical stabilizer (Figure 15) exhibited features consistent with overstress fracture. The material adjacent to the fracture surface had buckled in directions out of plane, consistent with secondary fracture.

Figure 15 – Closer view of the fracture surface from the forward vertical spar from Figure 14.

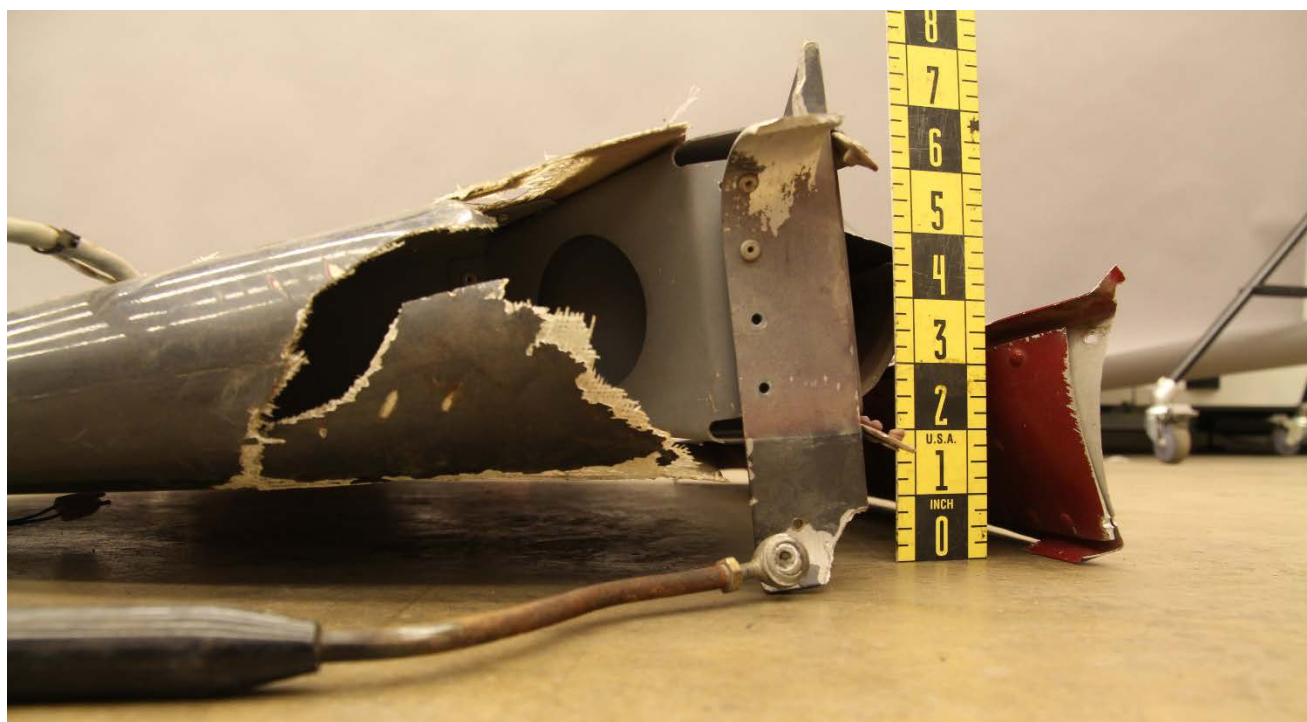
The aft underside of the tail rudder is shown in Figure 16. The bottom of the rudder was made of a fiber-reinforced polymer composite, which had fractured towards the forward side. The erratic orientation of the fracture surface, along with the right side of the fracture bending outward while the left side bent inward, suggests fracture from impact.

Figure 16 – Closer view of underside of the tail rudder, showing fracture to the composite skin, bending and tearing of the support plate and the fracture surface of aft vertical spar.

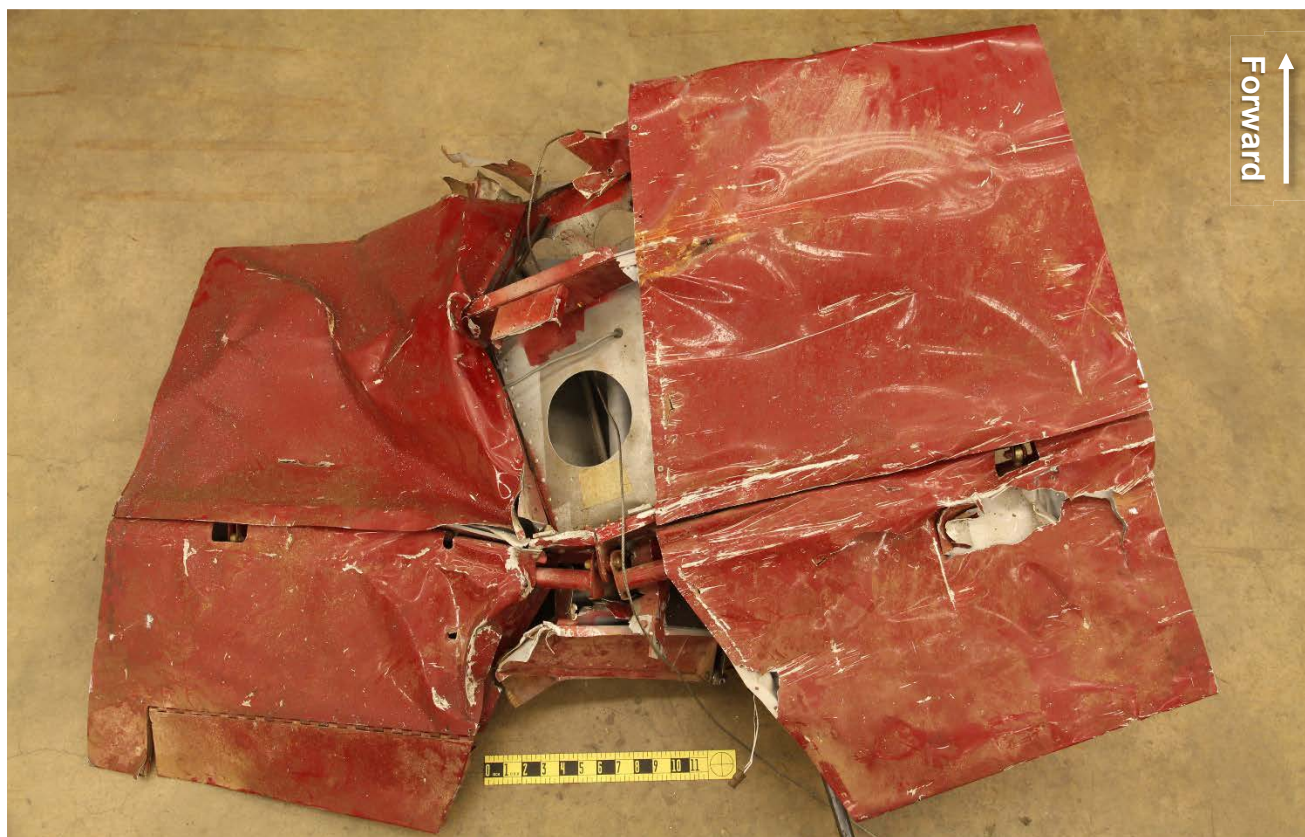
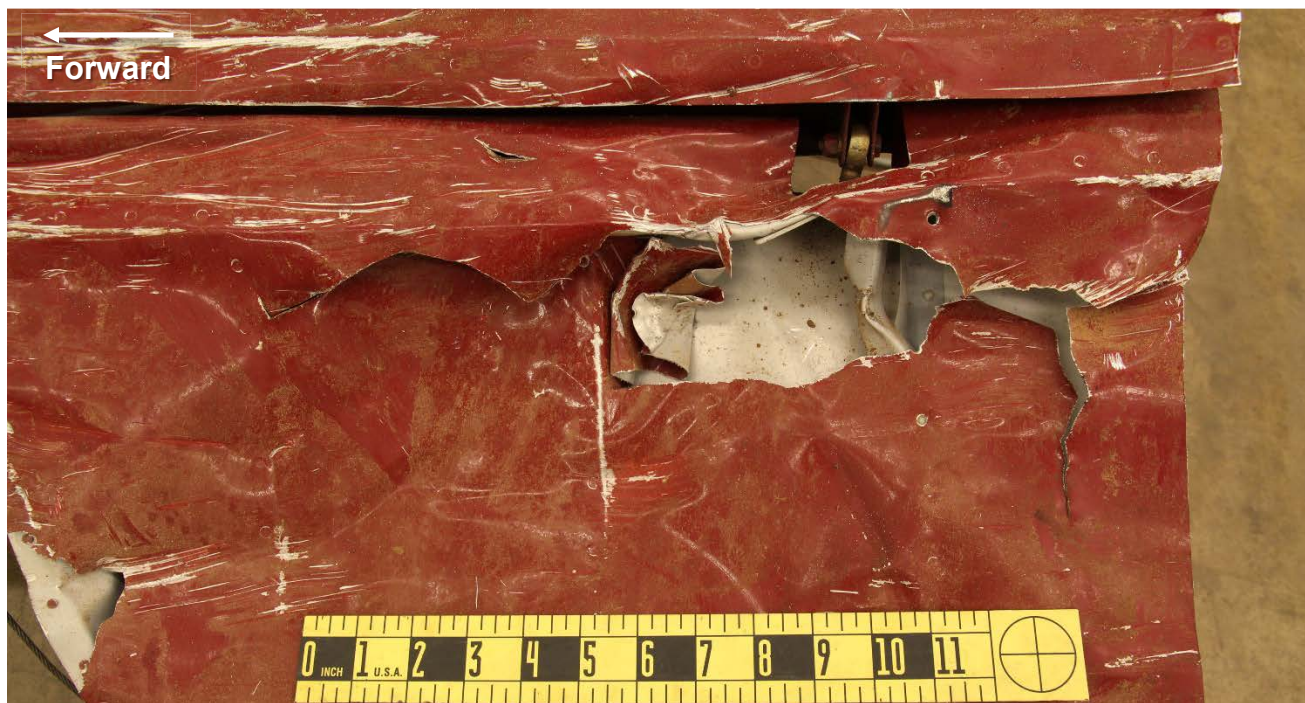
The horizontal stabilizer assembly is shown in Figure 17, as received. The elevators were still connected to the center tailcone section. The upper side of the horizontal stabilizer skins exhibited sliding marks, buckling, and localized tearing, as typified by the right elevator in Figure 17. The witness marks were consistent with the top side of the horizontal stabilizer having contacted the ground or ground objects, and the sliding scrape marks (Figure 17 and Figure 18) were consistent with this portion of the airplane sliding from left to right.

Figure 17 – A view of the horizontal stabilizer assembly of the empennage, as received, viewed from the top.

Figure 18 – The top side of the right elevator in Figure 17, showing sliding marks, buckling and tearing of the skin.

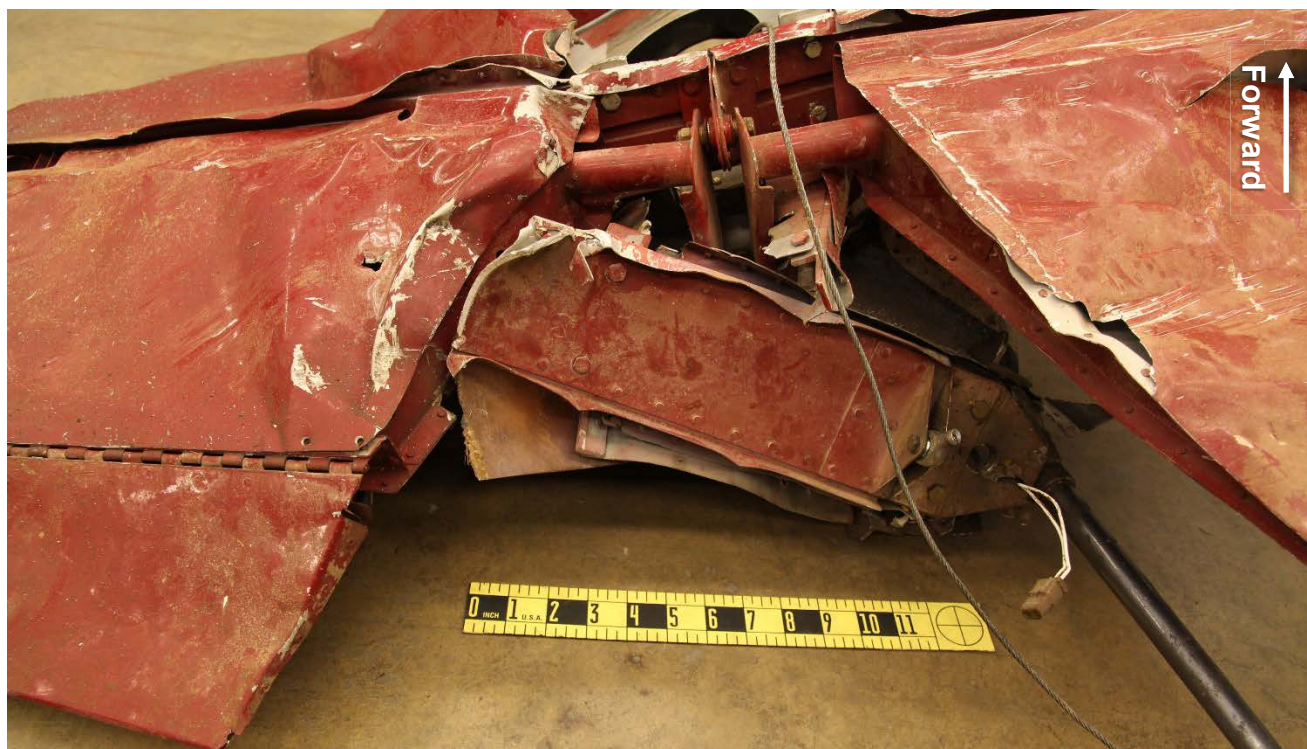
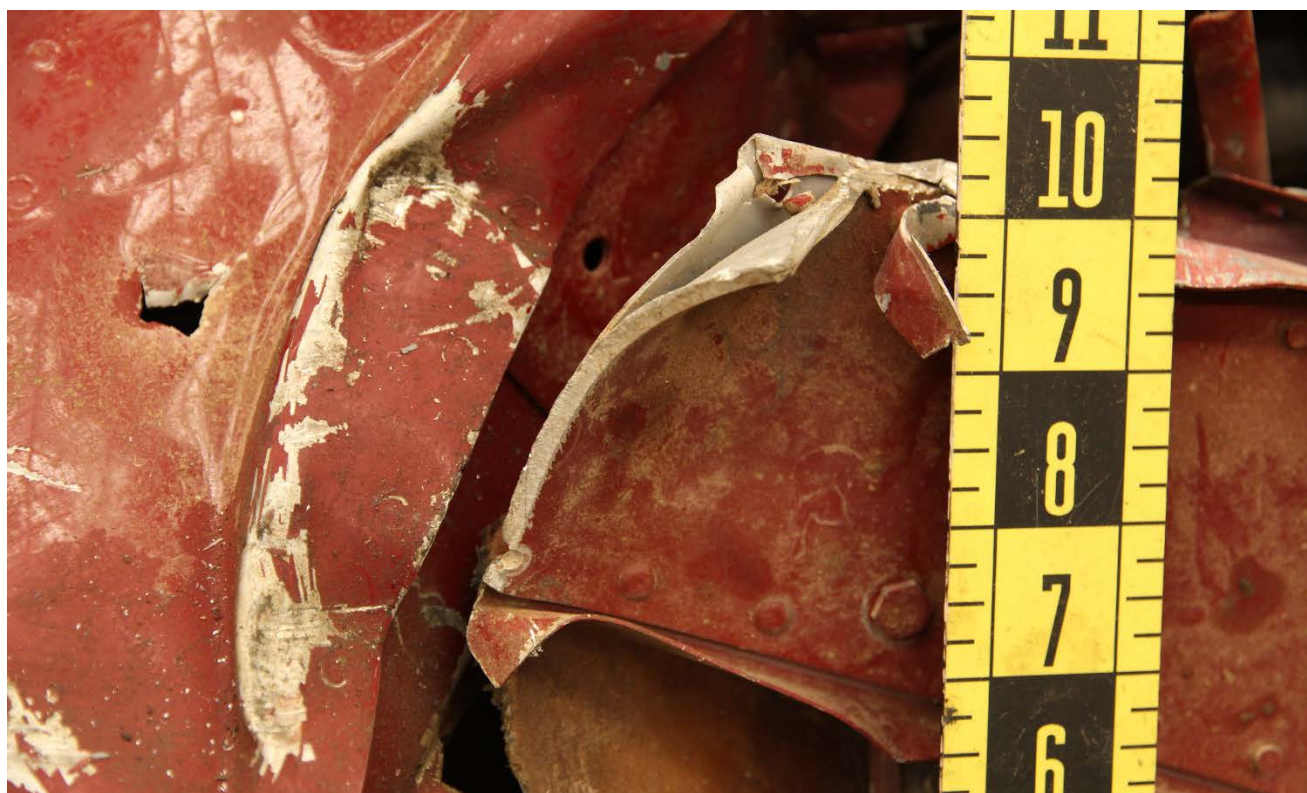
The lower section of the aft vertical spar from the vertical stabilizer was still affixed to the horizontal stabilizer assembly, as shown in Figure 19 and Figure 20. This fracture surface was sectioned for further examination. Figure 21 and Figure 22 show the closer views of the lower fracture surface of the aft vertical spar from the vertical stabilizer. Both fractures exhibited a general slanted orientation, with a dull luster and rough surface texture. One of the sides of the fracture surface had bent aft ward. The opposite side, about a rivet hole, was flat.

Figure 19 – Aft view (facing forward) of the center of the empennage horizontal stab assembly.

Figure 20 – The fracture surface of the lower section of the aft vertical spar from the vertical stabilizer, still affixed to the horizontal stabilizer assembly.
