# NATIONAL TRANSPORTATION SAFETY BOARD

## MATERIALS LABORATORY FACTUAL REPORT

Report No. 18-029

Place : Arlington, Arizona  
Date : June 27, 2017  
Vehicle : Vans RV-7, N731RV  
NTSB No. : WPR17FA134  
Investigator : Maja Smith, AS-WPR

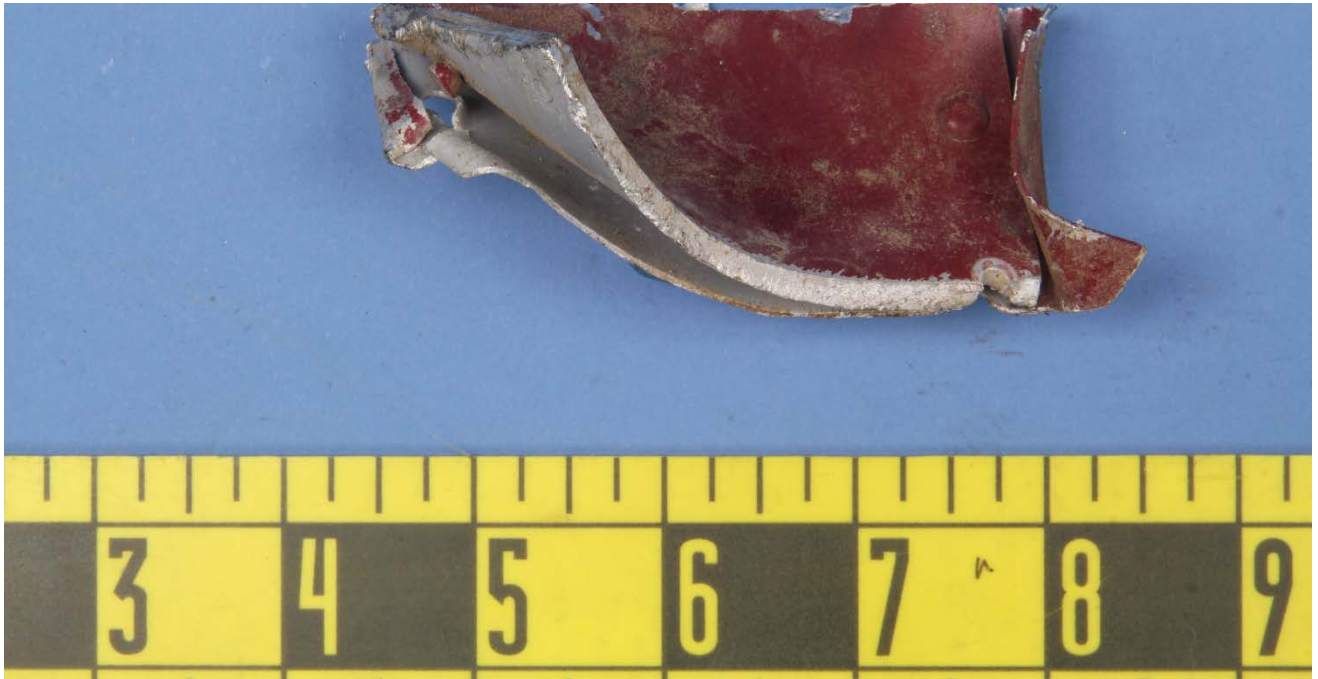
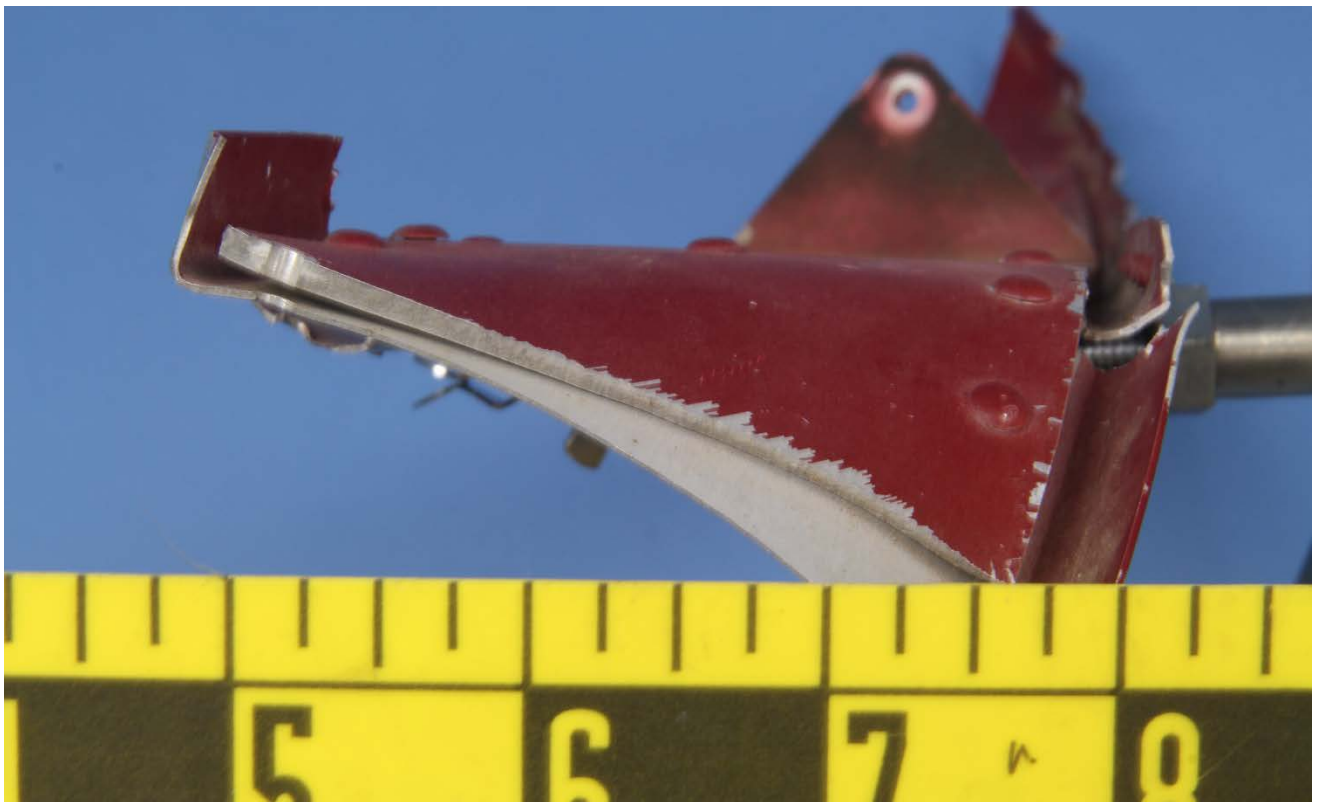
The lower section of the aft vertical spar from the vertical stabilizer was still affixed to the horizontal stabilizer assembly, as shown in Figure 19 and Figure 20. This fracture surface was sectioned for further examination. Figure 21 and Figure 22 show the closer views of the lower fracture surface of the aft vertical spar from the vertical stabilizer. Both fractures exhibited a general slanted orientation, with a dull luster and rough surface texture. One of the sides of the fracture surface had bent aft ward. The opposite side, about a rivet hole, was flat.

Figure 21 – The lower fracture surface from the aft vertical spar from the vertical stabilizer shown in Figure 20.

Figure 22 – The upper mating fracture surface of the separated section of the aft vertical spar from the vertical stabilizer, shown in Figure 16.

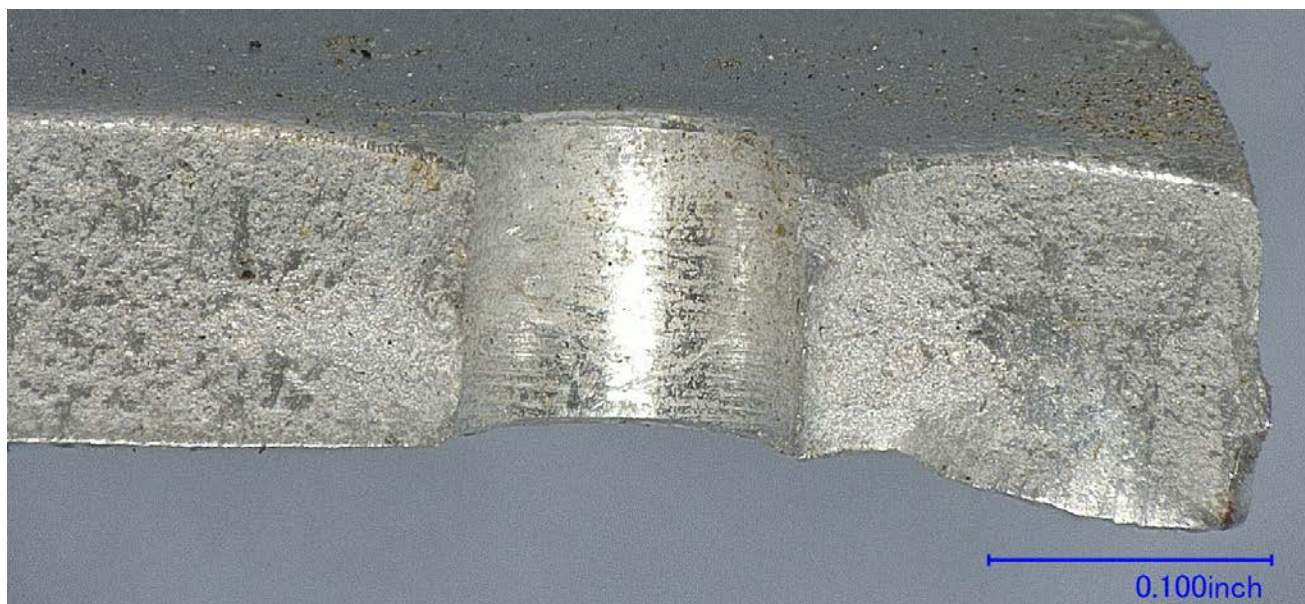
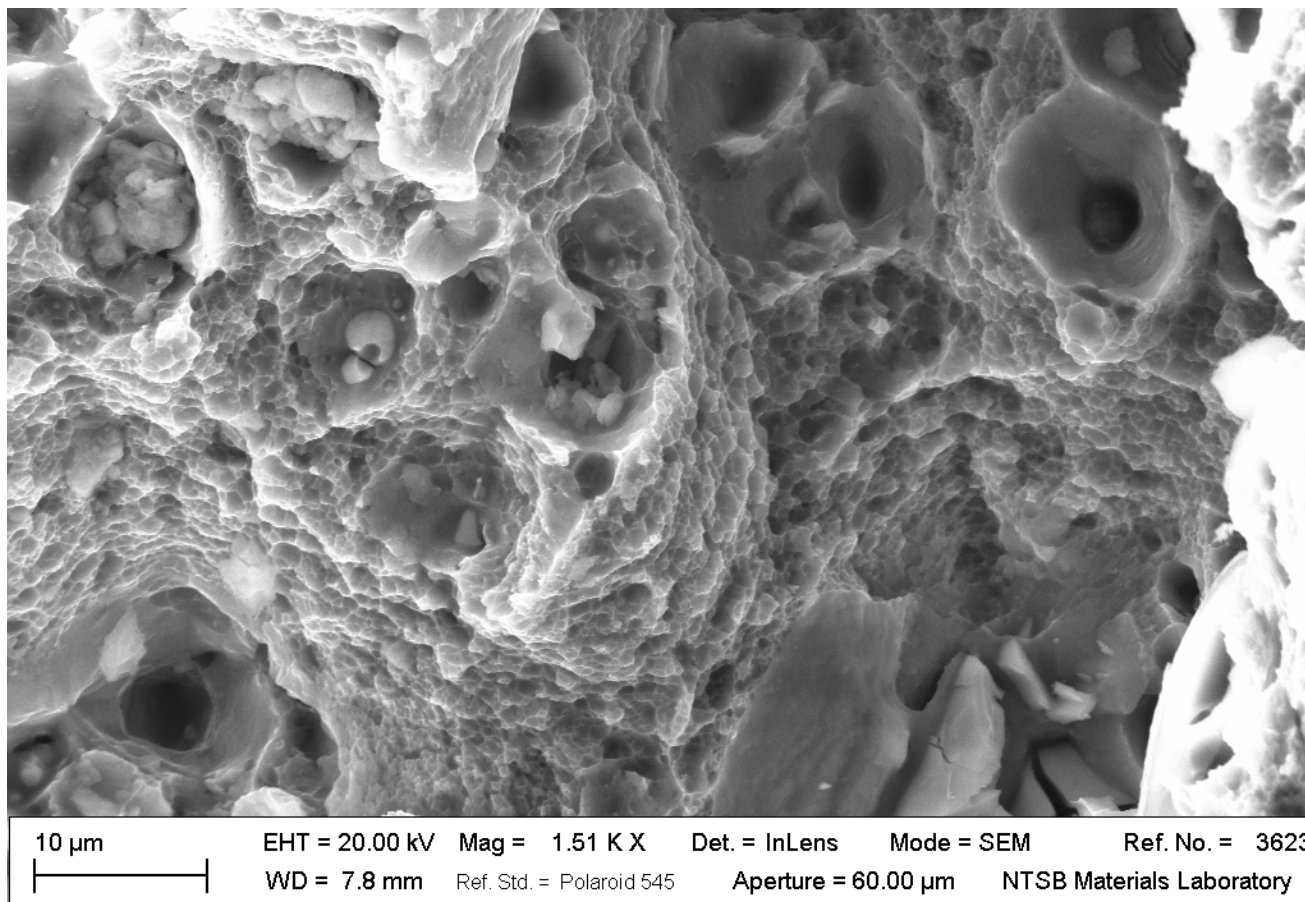
Figure 23 shows a closer view of the fracture surface about the rivet hole. Close to the rivet hole, the vertical stabilizer section exhibited local necking and thinning. There were no indications of pre-existing cracks or fractures adjacent to the rivet hole. The fracture surface was examined using a scanning electron microscope (SEM). As typified in Figure 24, the fracture surface exhibited dimple rupture, consistent with tensile overstress. No indications of other features consistent with other fracture modes were found.

Figure 23 – Portion of the fracture about the rivet hole on the fracture surface in Figure 22.

Figure 24 – Secondary electron (SE) micrograph of dimple rupture typical on the fracture surface on Figure 23.

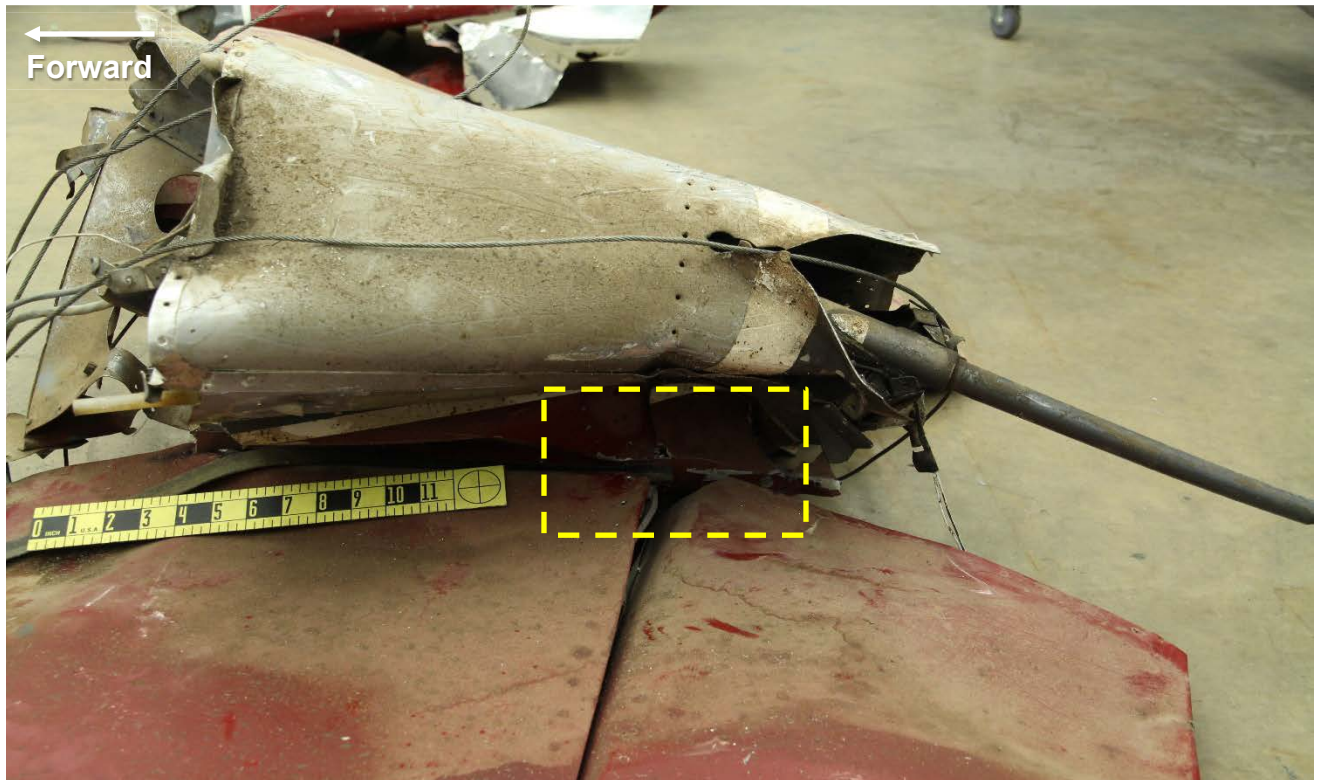
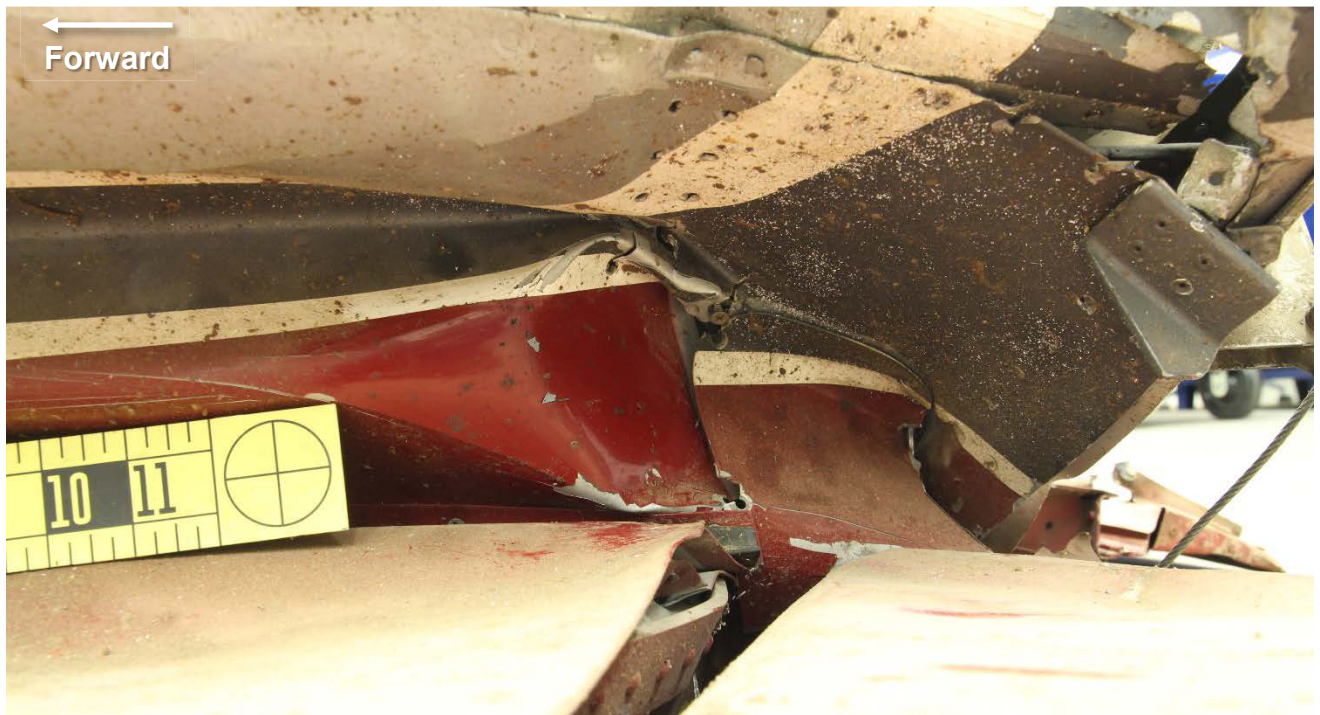
Figure 25 shows the right underside of the horizontal stabilizer assembly. Where the right stabilizer attached to the tailcone, there was a small dent or impression. This dent measured approximately 5 inches long, 4 inches across, and 2 inches deep (see Figure 26). With assistance of personnel from the Feather Identification Lab at the Smithsonian Institute National Museum of Natural History, several pieces of material suspected of being avian organic matter were extracted from the region. These pieces were found on the outside of the airplane skin, as well as underneath in crevices where the panels had been joined by rivets. Specimens were also extracted from portions of the tailcone, inboard of the dent (see Figure 27).

Figure 25 – A view of the underside of the horizontal stabilizer assembly, showing a impressed or dented region in the structure. The boxed area is shown in Figure 26.

Figure 26 – Closer view of the dent in the underside of the horizontal stabilizer, showing the location where organic material was extracted.

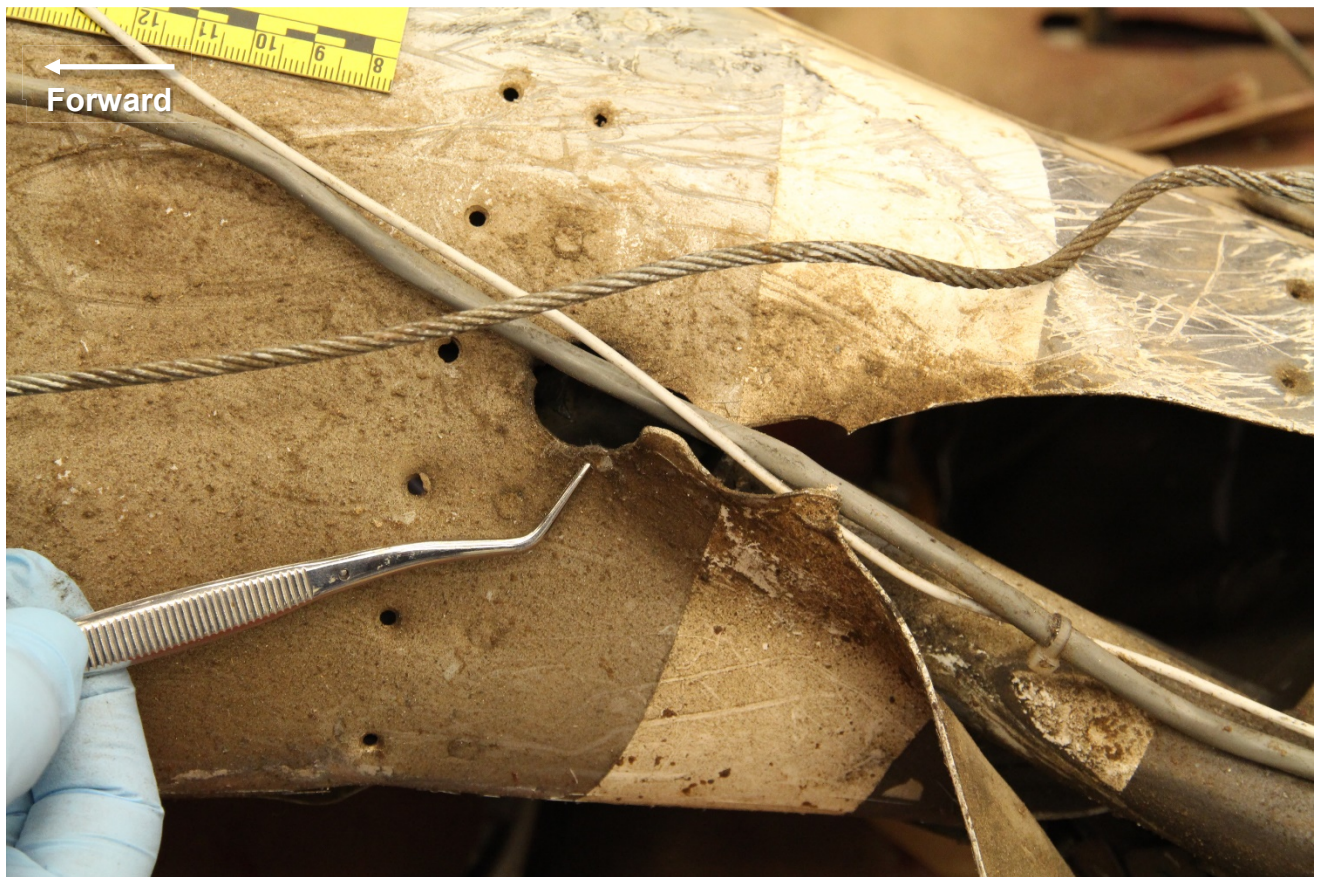
The extracted specimens were inspected at the Feather Identification Lab at the Smithsonian Institute National Museum of Natural History. The results were consistent with that of a rock pigeon or *Columba livia*, which were common in the area of the accident. These results were detailed in two reports, attached as Appendix A and Appendix B.

Figure 27 – An example of organic material, consistent with avian material, extracted from the underside of the empennage tailcone.

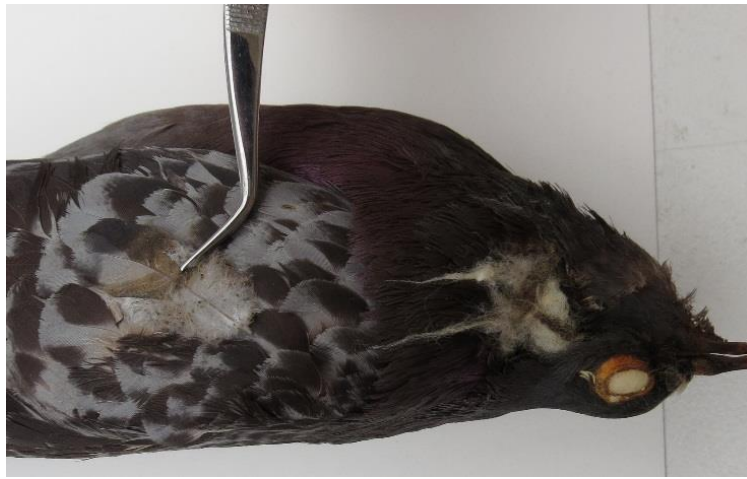
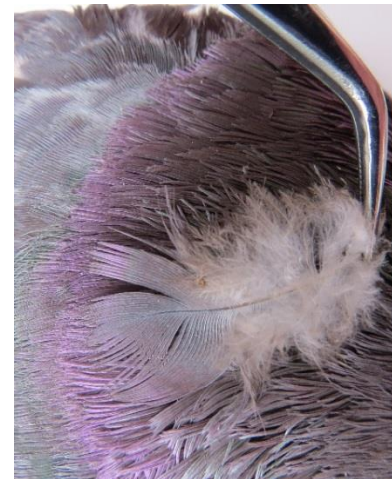
One of the bags contained 5 (five) whole feathers and some downy feather material. All of the whole feathers matched perfectly to a single museum specimen (USNM 274142) of Rock Pigeon (*Columba livia*; photos below). Additionally, microscopic examination of the feather samples was consistent with Rock Pigeon.

Photo left: Wing feather sample (at forceps) from wreckage compared with museum specimen of Rock Pigeon (USNM 274142). Photo right; Pink, iridescent upper back feather (at forceps) from wreckage compared to museum specimen of Rock Dove (USNM 274142).

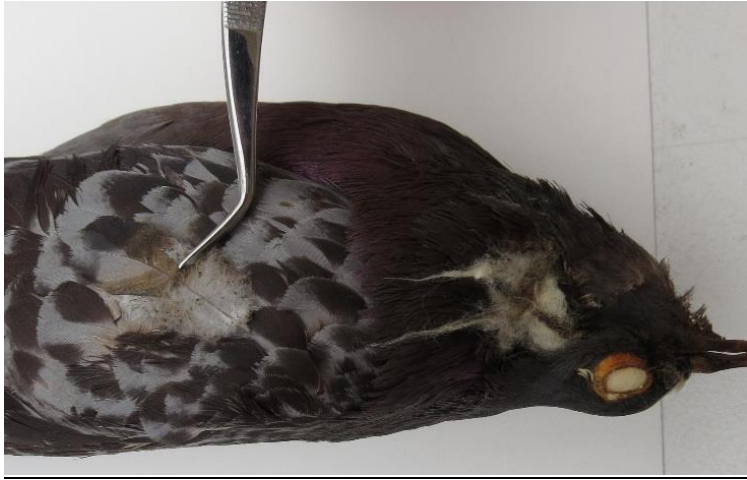
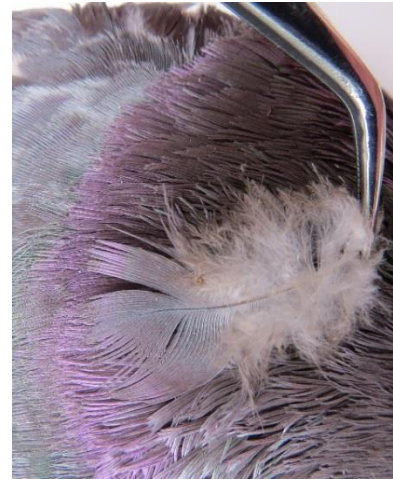
One of the bags contained 5 (five) whole feathers and some downy feather material. All of the whole feathers matched perfectly to a single museum specimen (USNM 274142) of Rock Pigeon (*Columba livia*; photos below). Additionally, microscopic examination of the feather samples was consistent with Rock Pigeon.

Photo left: Wing feather sample (at forceps) from wreckage compared with museum specimen of Rock Pigeon (USNM 274142). Photo right; Pink, iridescent upper back feather (at forceps) from wreckage compared to museum specimen of Rock Dove (USNM 274142).
