## **NATIONAL TRANSPORTATION SAFETY BOARD**

# **ACCIDENT SITE EXAMINATION SUMMARY**

**WPR17FA134**

| Aircraft: | N731RV; Vans RV-7 |

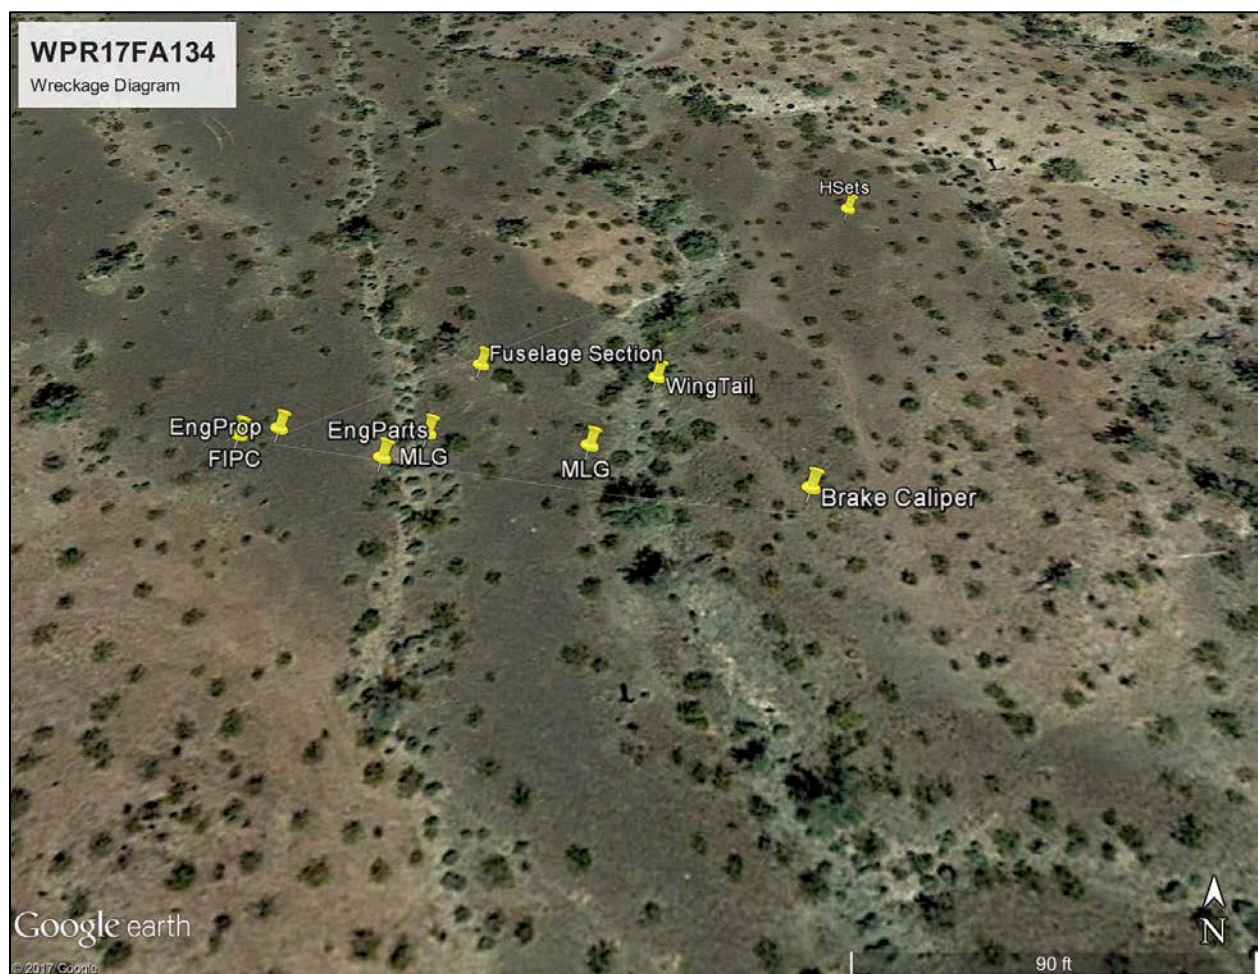
Figure 1-Wreckage Diagram

Examination of the accident site revealed that the airplane impacted level desert rocky terrain on the base of a north facing hill. The debris path contained two gullies running south to north. The airplane had been destroyed by high impact forces and spread out in a triangular pattern. The debris field was 264 feet long and 270 feet wide.

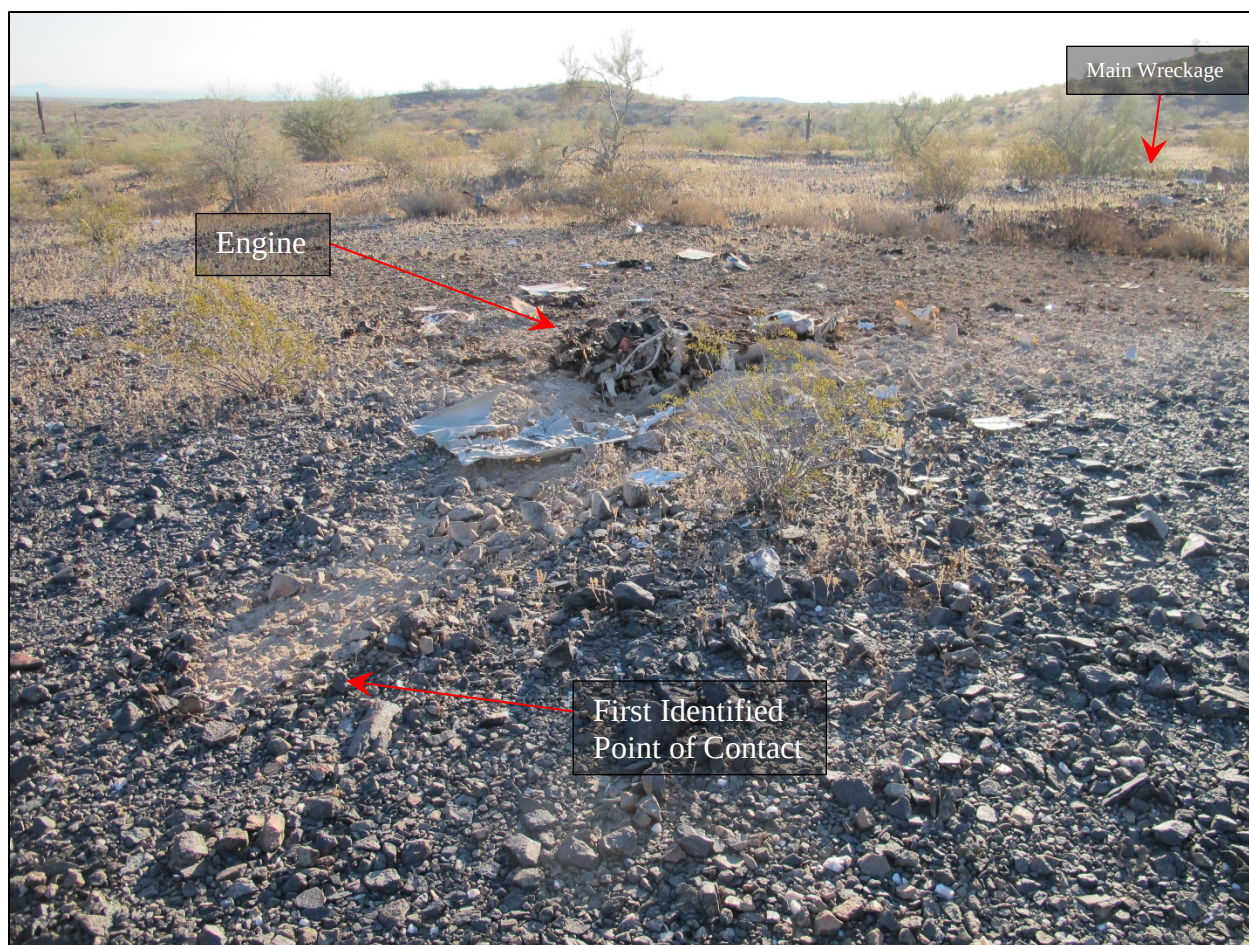
**Figure 2-First Identified Point of Contact**

The direction of the wreckage debris path was oriented a heading of a about 77 degrees magnetic from the first identified point of contact (FIPC) to the main wreckage. The FIPC was an area of disturbed ground about 10 inches wide and about 10 feet long, that contained red lens fragments. At the end of the area of disturbed ground was the impact crater, measuring about 4 feet in diameter, containing the propeller assembly and engine. One of the propeller blades revealed heavy gouging on the leading edge, and chordwise scoring. The other blade had forward bending at the midsection, leading edge scoring and missing material at the tip.

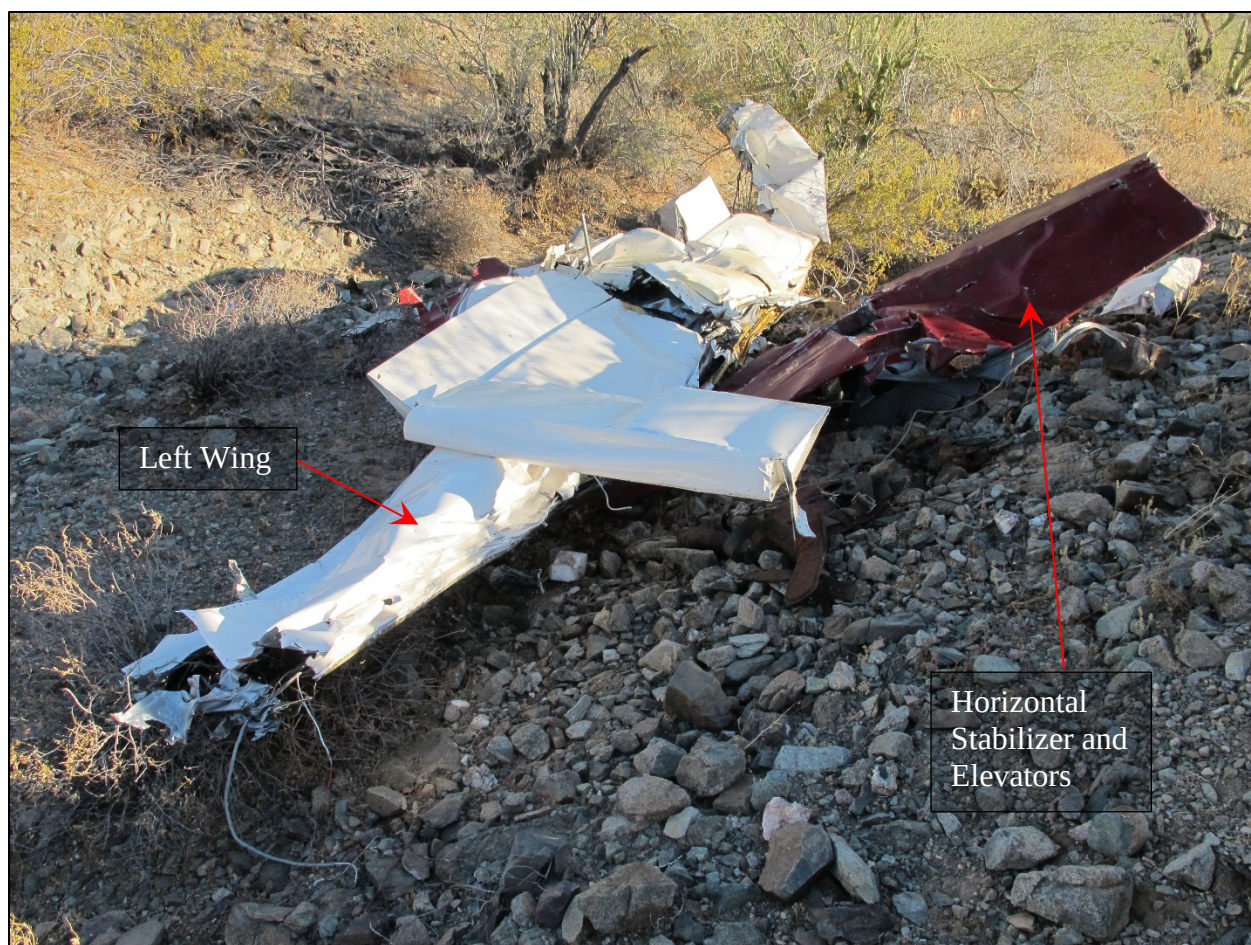
**Figure 3-Main Wreckage**

The main wreckage was found 146 feet from the FIPC and in the bottom of a 10-foot-deep gully. The main wreckage had impact damage and consisted of the horizontal stabilizers and both elevators, cabin area structure and the wing. The horizontal stabilizer and associated structure remained attached to the main wreckage by flight control cables and electrical wires. Flight control continuity was attained to the forward cabin area, through flight control cables and impact damaged control rods. The left aileron remained attached to the wing by its inboard attachment. The right aileron separated from the wing and was found near the main wreckage. Both flaps remained attached to wing and evidence to suggest that they were in the retracted position during impact. The right flap separated at its outboard attachment and was bent upwards at its midsection. The leading edge of both wings separated revealing the aft side surfaces of the fuel tanks. The leading edges of both wings had crush damage from the tip to the root. Both wing tips separated and attachment structure had impact damage. The right wing outboard section was bent downward. The forward side of the cabin floor area had crush damage.

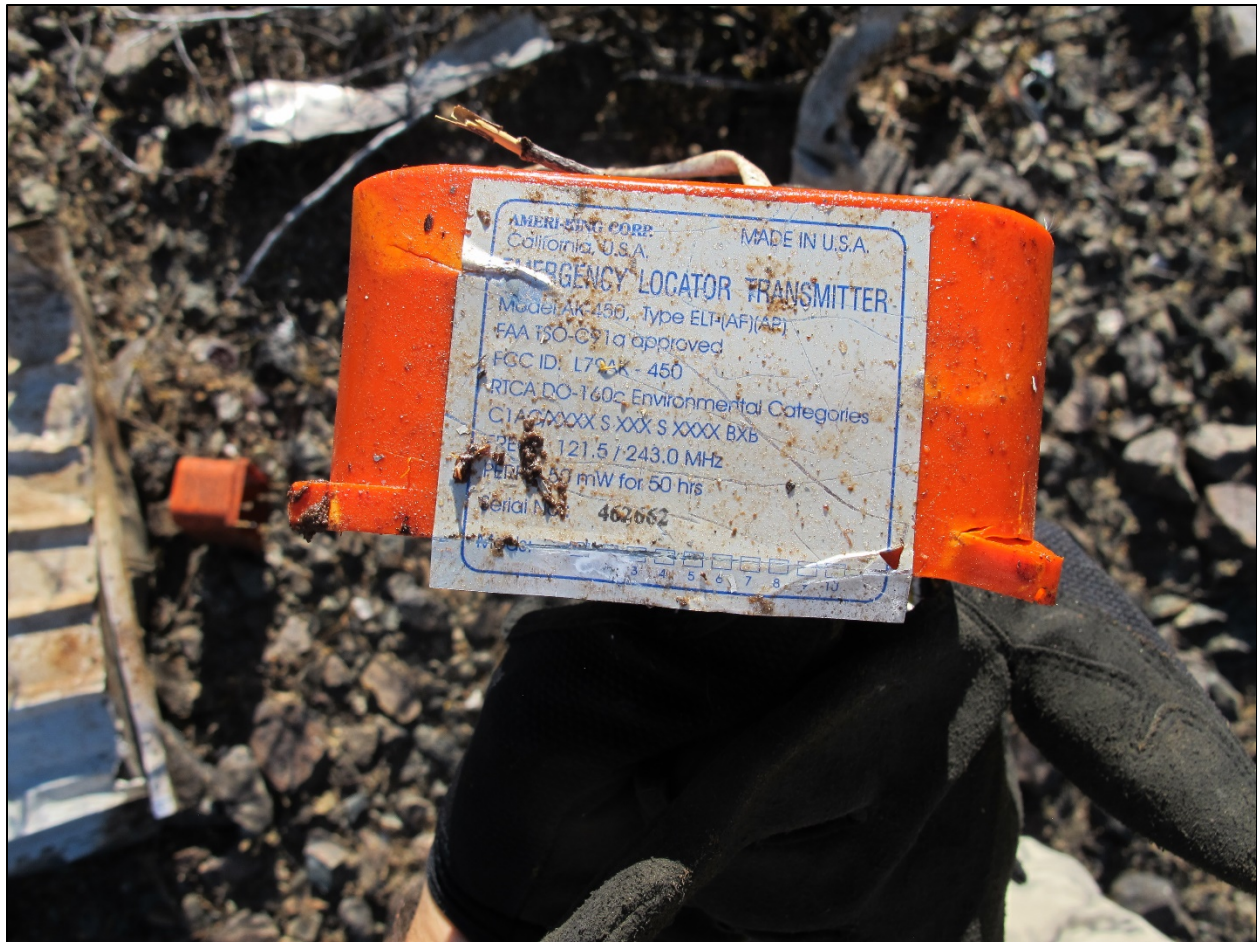
**Figure 5-ELT**

The ELT separated from the main wreckage and was found in sections throughout the debris field.

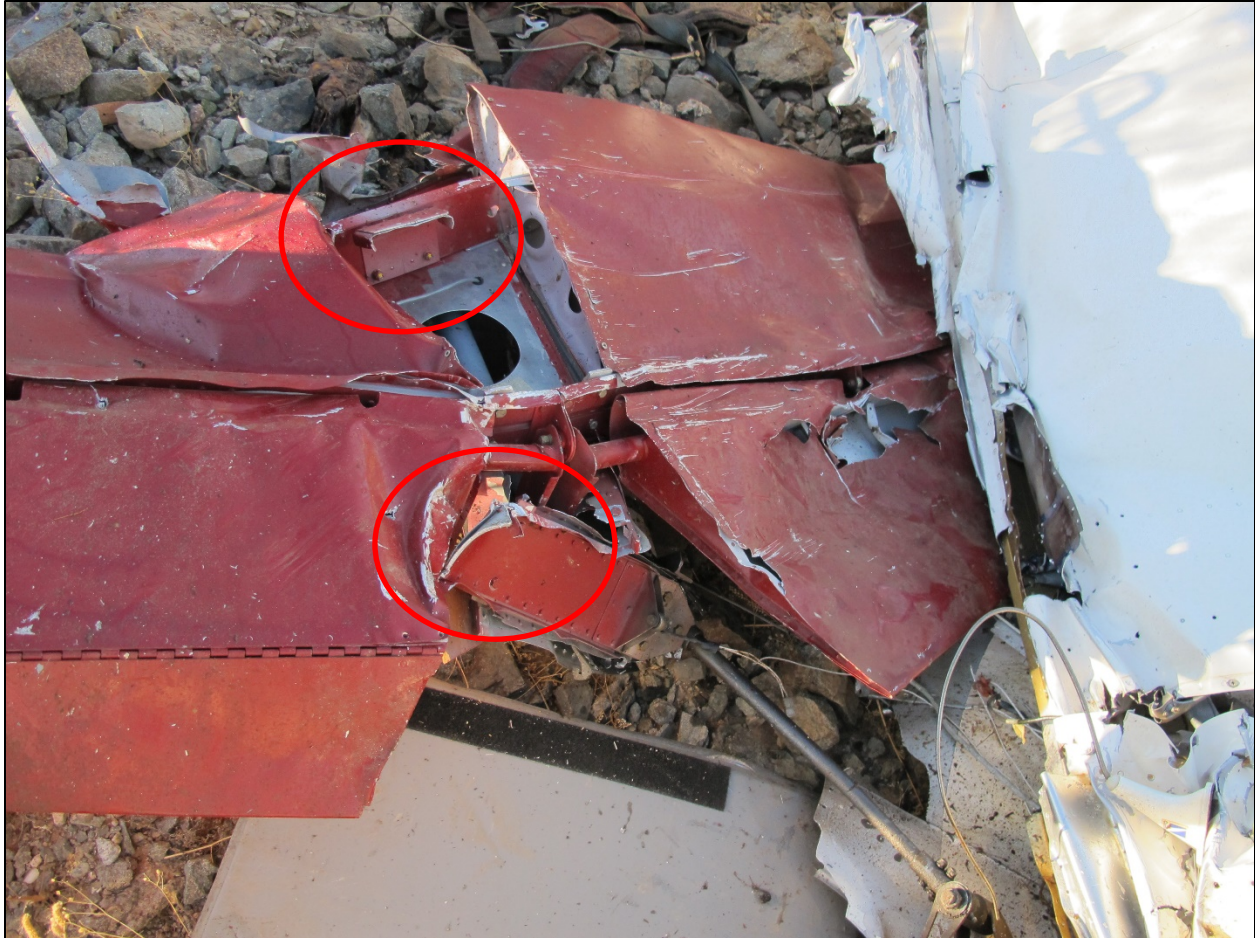
**Figure 6-Horizontal Stabilizer and Elevators**

The plexiglass canopy, vertical stabilizer and rudder were not found during the examination of the accident site. The vertical stabilizer support brackets were bent rearward.
