## **NATIONAL TRANSPORTATION SAFETY BOARD**

### **ENGINE/AIRFRAME EXAMINATION SUMMARY**

**WPR17FA134**

Location: Arlington, AZ  
Date: June 27, 2017  
Aircraft: N731RV; Vans RV-7  
NTSB Investigator-in-Charge: Maja Smith

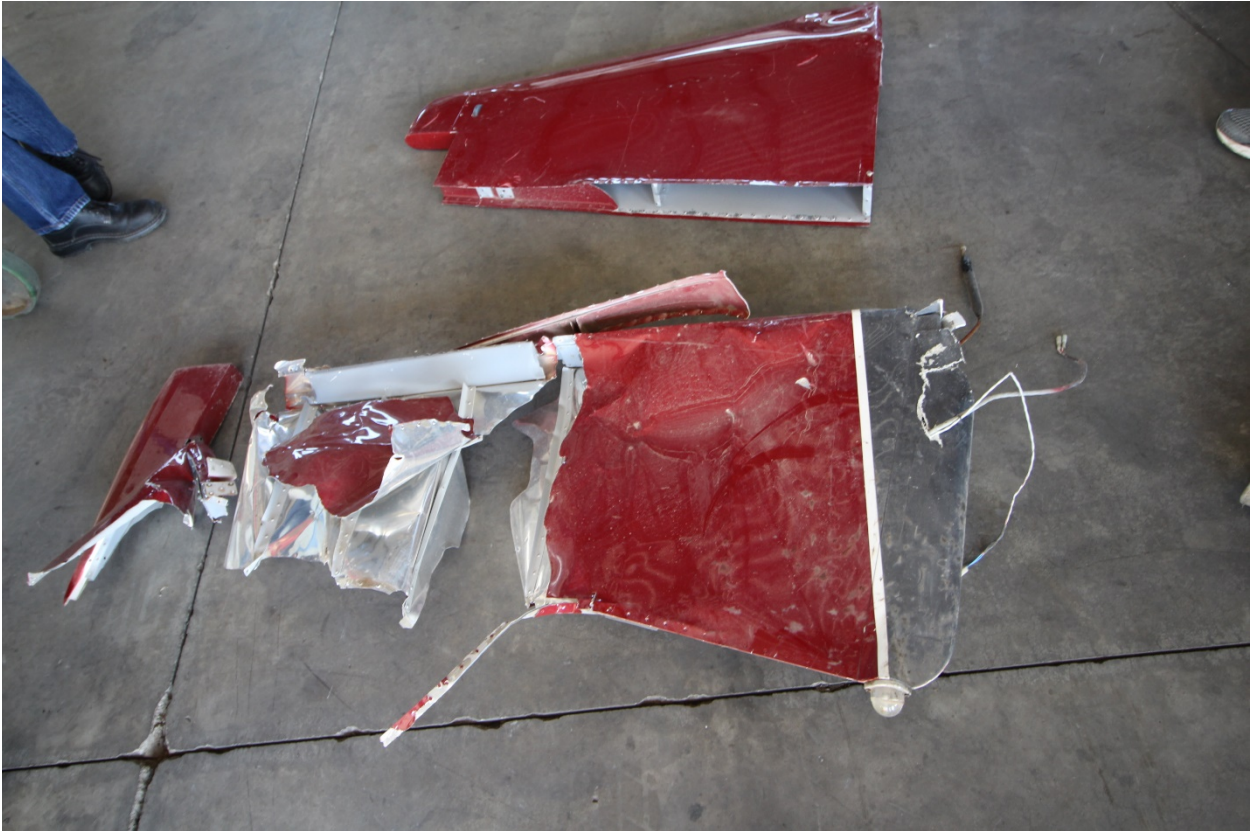
The empennage was found with the main wreckage, but the vertical stabilizer, rudder, and counterweight were located about 1.3 miles from the main wreckage. The Rudder was separated into three sections. Approximately 33% of the right-side rudder skin was not recovered from the accident site.

**Figure 1: View of Empennage Section Found About 1.3 Miles from Main Wreckage.**

The rudder counter balance was intact with the upper 25% of the rudder assembly. The upper rudder attaches bearing remained intact with the hinge brackets ripped from the Vertical Stabilizer (VS) rear spar. The middle rudder bearing remained intact and attached to the rudder along with the upper portion of the VS rear spar attach was broken just above the VS rear spar doubler. The bottom section of the rudder broke away at the failure of the bottom bearing. The vertical stabilizer forward spar broke away from the horizontal stabilizer front spar at the spar attach point. The VS rear spar broke into two sections.

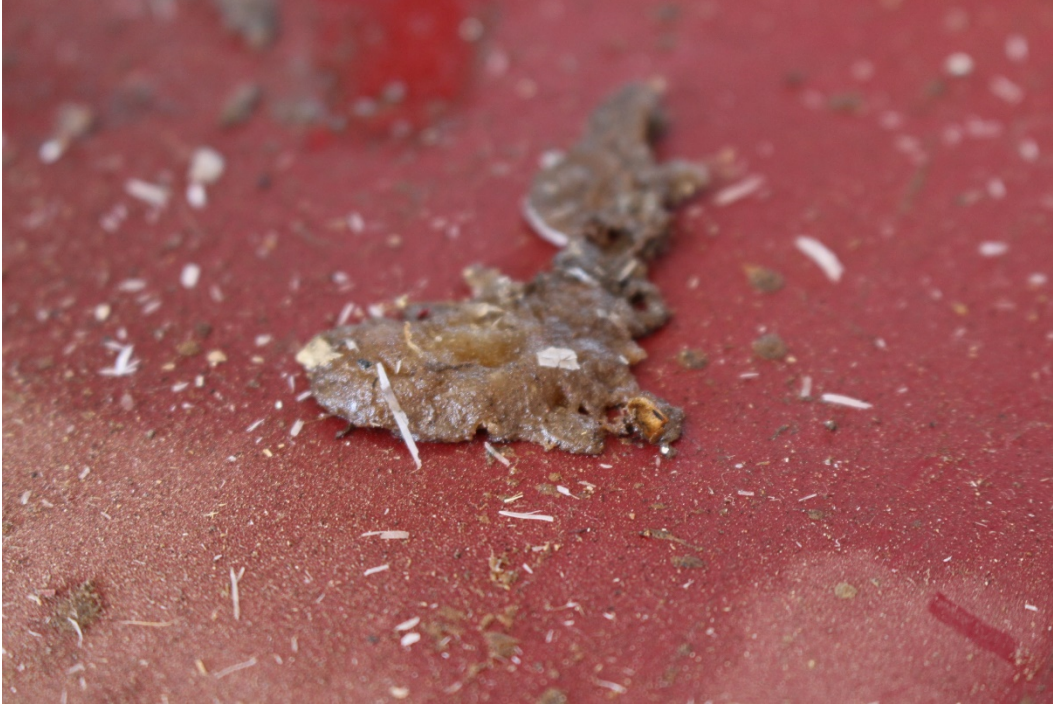
Possible snarge (bird matter and fragments) attached to underside of right horizontal stabilizer ahead of center bearing attach point. Possible bird feathers were found in the cockpit under the passenger seat. Bone matter found in engine bay between cylinders and on the oil cooler. Possible snarge also found on upper rear bulkhead behind the pilot's head.

Figure 2: View of Snarge Found on Horizontal Stabilizer.

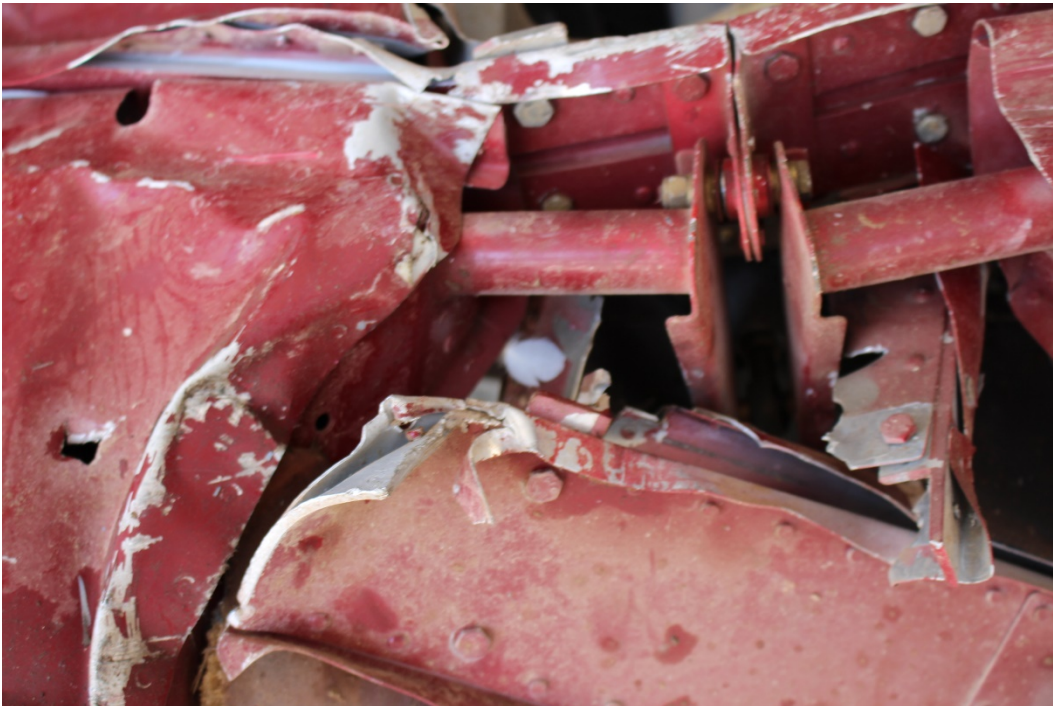
Figure 3: View of Feather Found in Empennage.
