**NATIONAL TRANSPORTATION SAFETY BOARD**  
Vehicle Recorder Division  
Washington, DC 20594

## **Onboard Image Recorder**

**Specialist's Factual Report**  
**By Bill Tuccio, Ph.D.**

| NTSB Number: | WPR17FA139 |

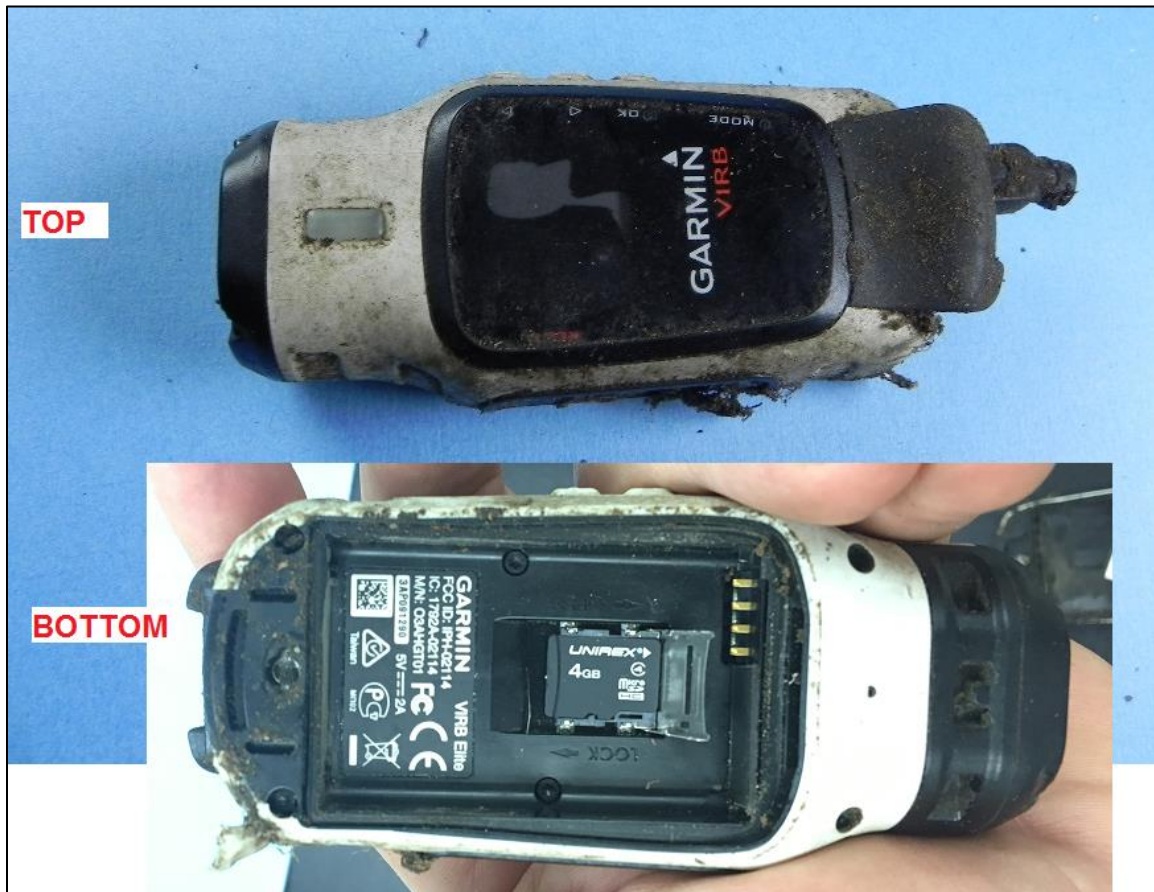
Upon arrival at the NTSB Vehicle Recorder Division, it was evident that the Garmin VIRB Elite had suffered minor impact damage, as shown in figure 1. A 4 GB removable microSD Card was intact in the device, as shown in the bottom view from figure 1.

Figure 1. Garmin VIRB Elite as received (top view on top, bottom view on bottom).

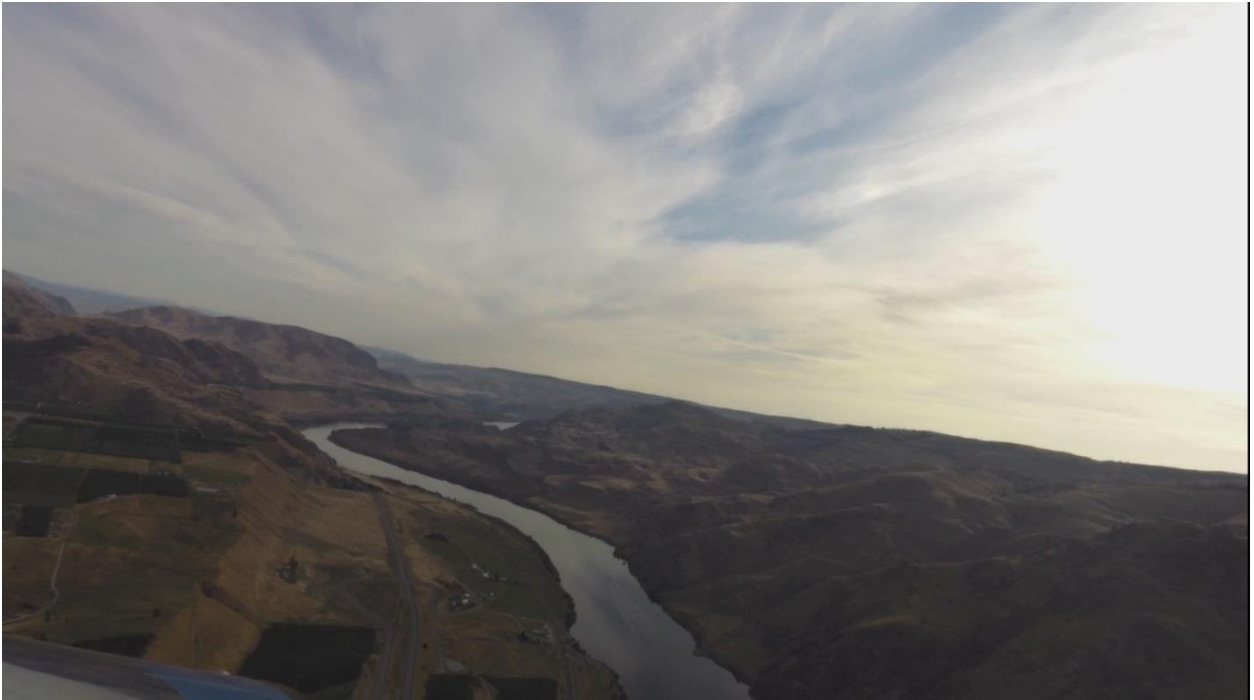
By 10:00, the aircraft was flying away from S10 airport and Pilot 2 said, "okay. So I let off the wing. Flies nice and straight. I push out and it comes right back" (the nose moved up and back down to level). Pilot 1 commented, "pull back and let go and it goes right back" (the nose moved down and back up to level). Pilot 2 commented, "it goes right back. Almost puts you in a stall." At the time, the aircraft was flying over a river valley, as shown in figure 2.

Figure 2. Recorded image between 10:00 and 10:35.

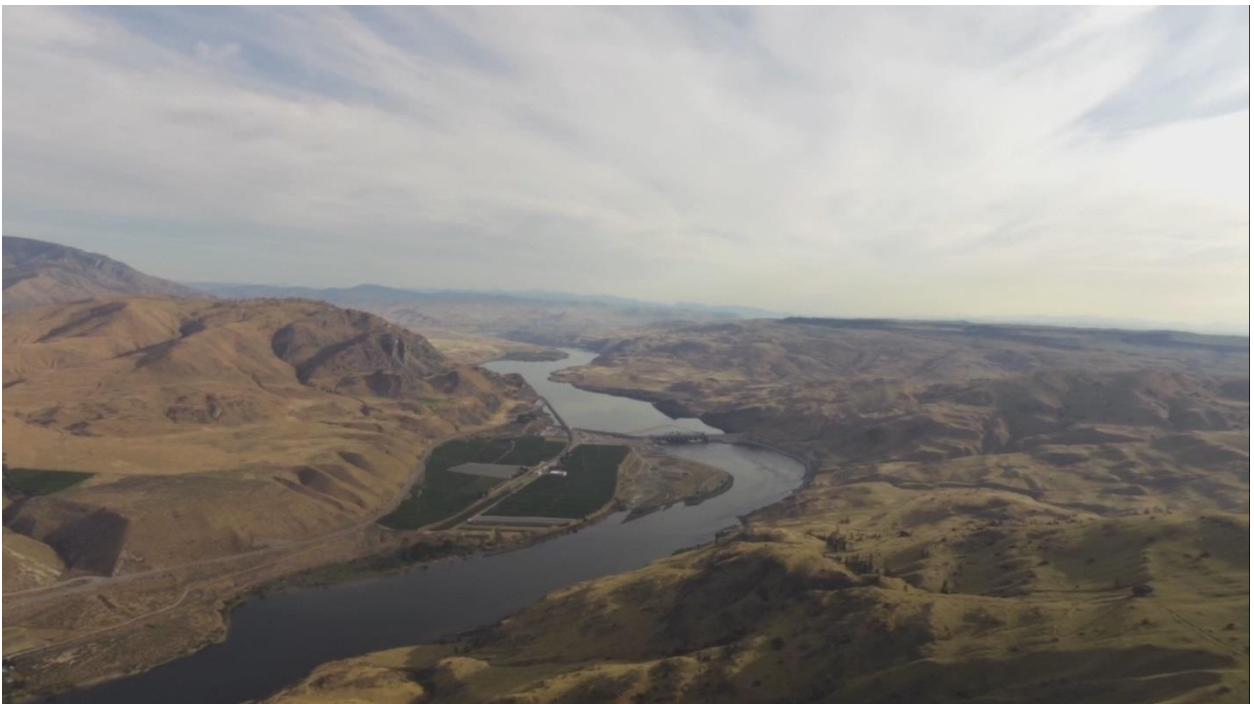
At 18:06, the AWOS began to play in response to three microphone clicks. The AWOS reported wind calm, altimeter 29.91. At this time, the aircraft was heading away from S10 airport as shown in figure 3.

**Figure 3. Recorded image at 18:06.**

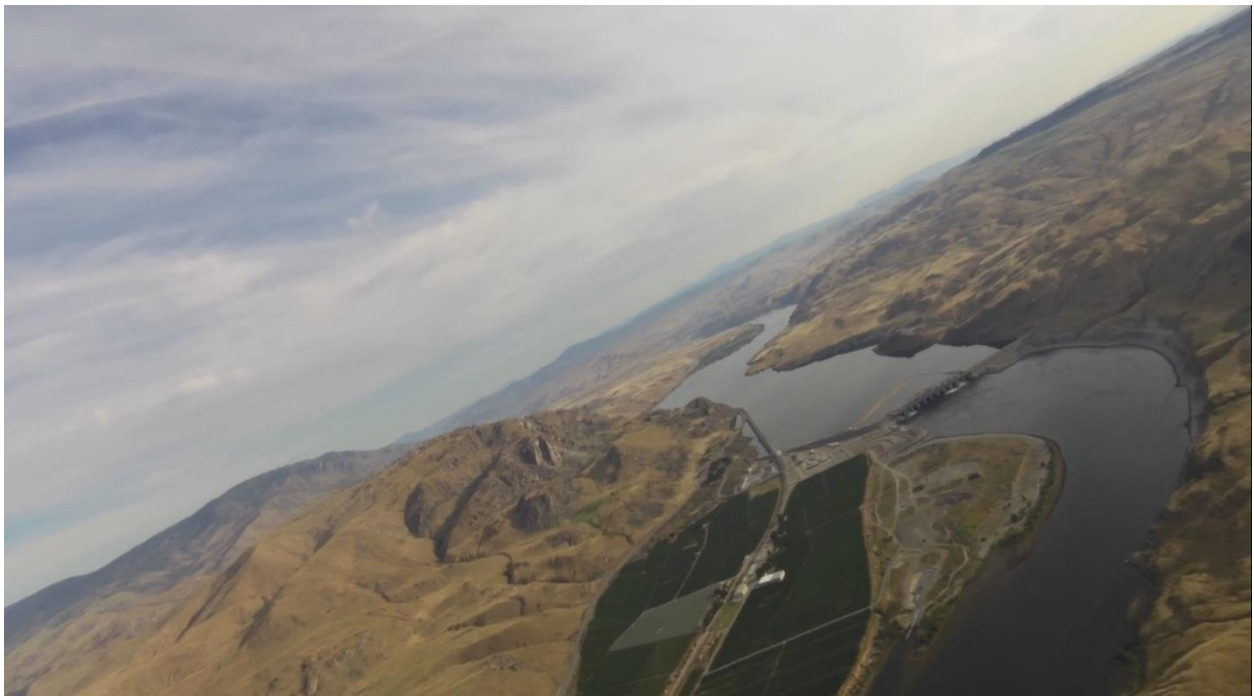
At 19:05, Pilot 1 said (as the plane banked right), “Okay so in other words if we turn it steep...like so.” Figure 4 shows the aircraft attitude at 19:09.

**Figure 4. Recorded image at 19:09.**

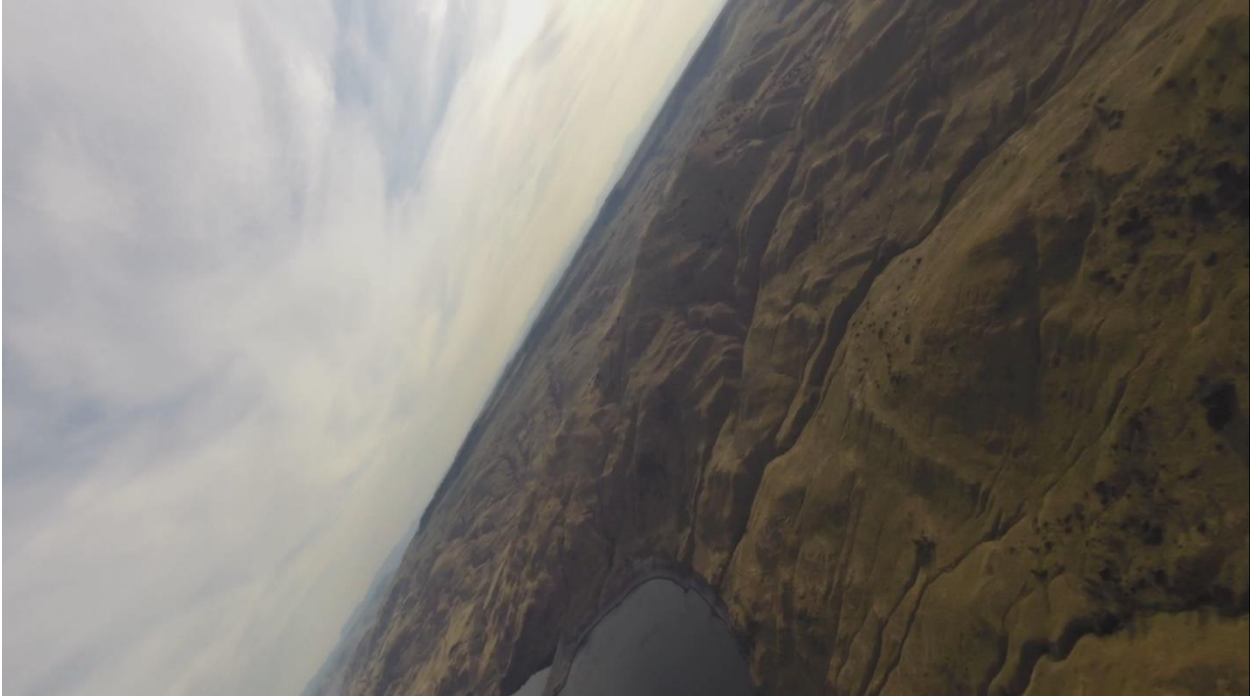
At 19:10, Pilot 1 said, “and shove out on the bar.” At this time, the rate of turn increased. Pilot 1 continued, “and stall it.” Figure 5 shows the aircraft attitude at 19:12.

**Figure 5. Recorded image at 19:12.**

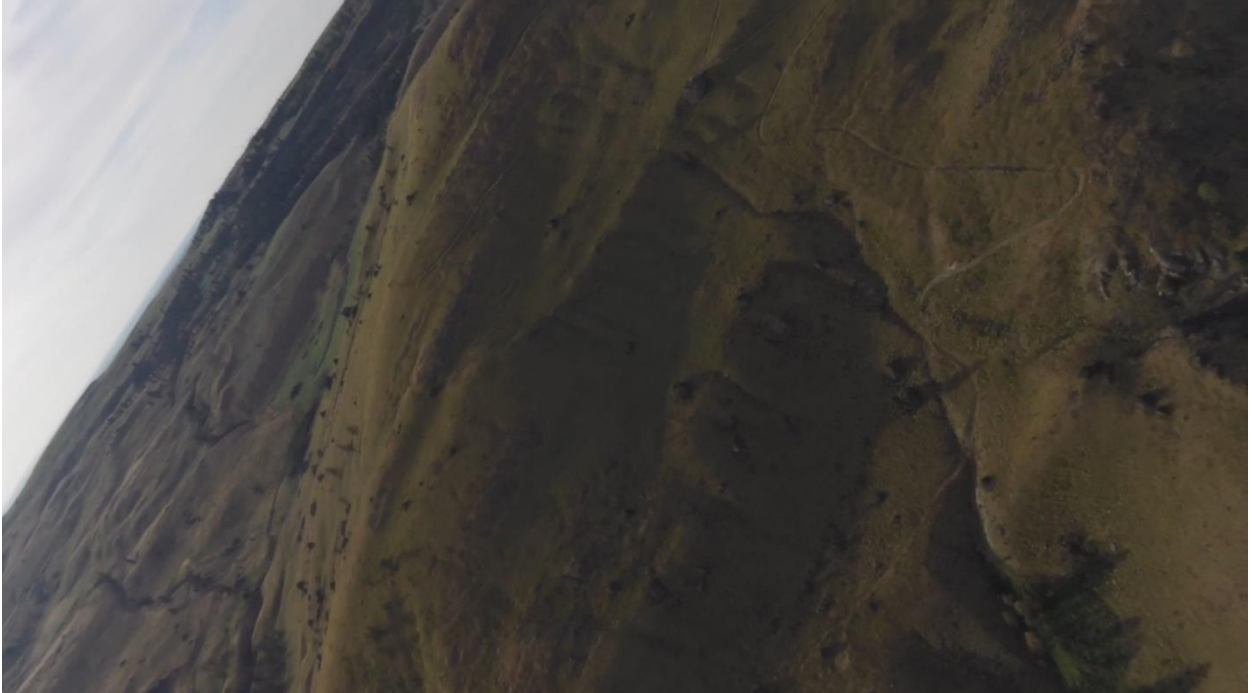
At 19:13, Pilot 1 said, "There's a stall. Right there." Pilot 2 responded with surprise and an expletive. Figure 6 shows the aircraft attitude and position at 19:16.

**Figure 6. Recorded image at 19:16.**

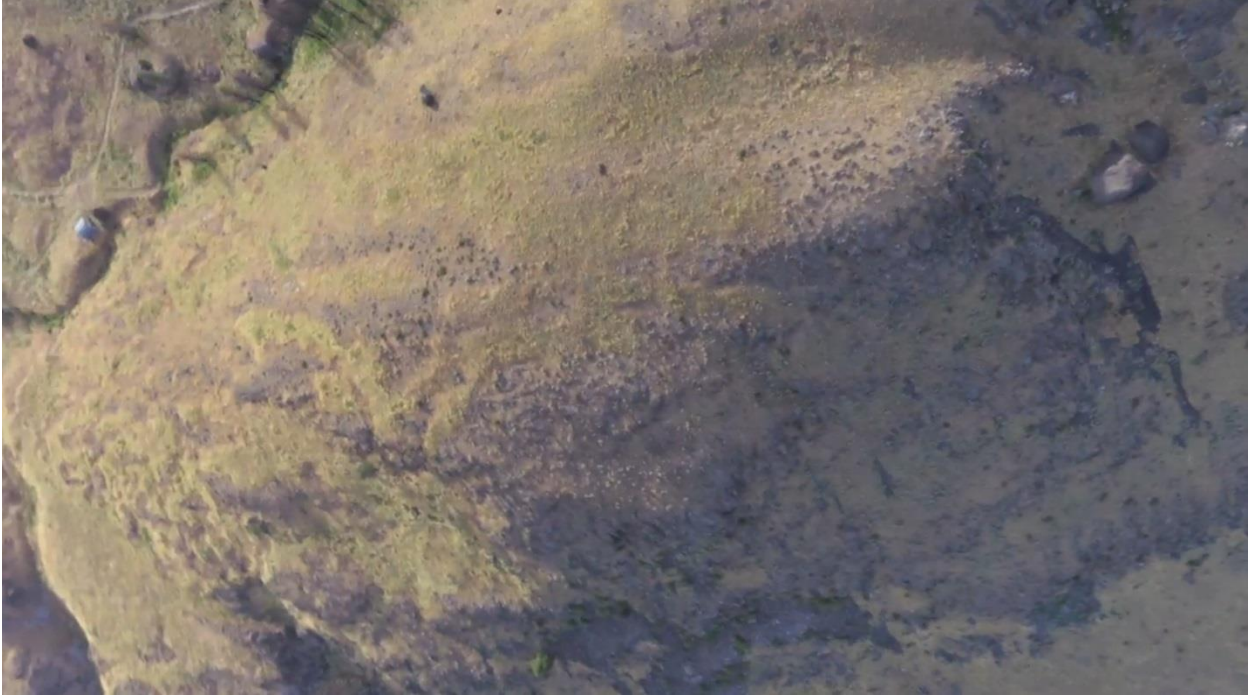
At 19:22, Pilot 2 repeated his prior exclamation louder. At the time the aircraft was rotating right and straight down, as shown in figure 7.

**Figure 7. Recorded image at 19:22.**

At 19:23, Pilot 1 exclaimed “back.” The video ended about the time the aircraft impacted the ground in a right rotation—after about a total of two and one half rotations from entry into the maneuver at 19:05—as the pilots grunted/moaned.<sup>5</sup>
