## **NATIONAL TRANSPORTATION SAFETY BOARD**

# **AIRFRAME AND ENGINE EXAMINATION**

**WPR17FA146**

Location: Pt Mugu, CA  
Date: July 8, 2017  
Aircraft: Quicksilver Sport MX II, N2812, Serial # 1763  
NTSB IIC: Michael Huhn

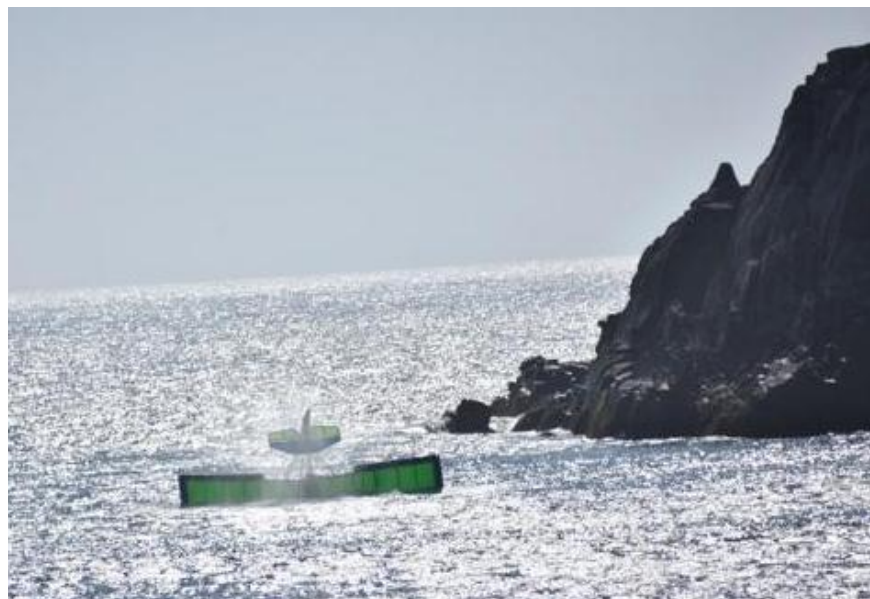
**Figure 1 - Aircraft at Impact**

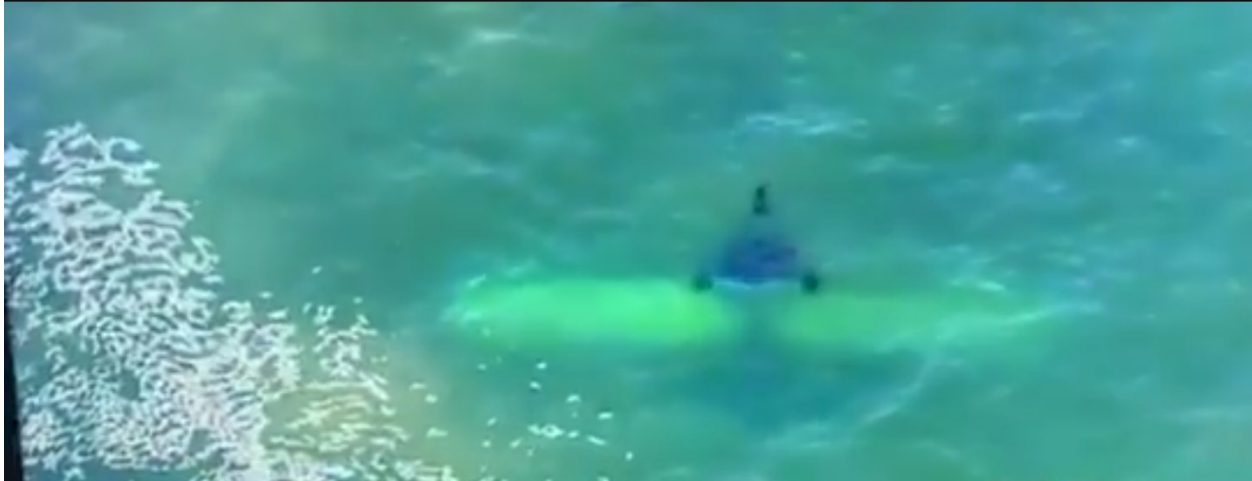
The aircraft ditched into the Pacific Ocean just offshore of Pt. Mugu about 1647 local time. Although it sank shortly thereafter, post accident photos of the aircraft depicted a highly intact aircraft. Sometime overnight, the aircraft washed ashore onto the rocky coast; the airplane and engine sustained severe damage due to the wave action, rocks, sand, and salt water. The aircraft was removed from the shore the morning of July 9, transported to the SKFC hangar, and rinsed with fresh water. Detailed examination of the engine, as well as some airframe components, was conducted by the NTSB at the hangar on July 10, 2017. No evidence of preimpact mechanical malfunction was noted during the examination, but it was determined that the ocean immersion and wave action obscured or destroyed a significant amount of evidence.

**Figure 2 - Submerged but Intact Aircraft**

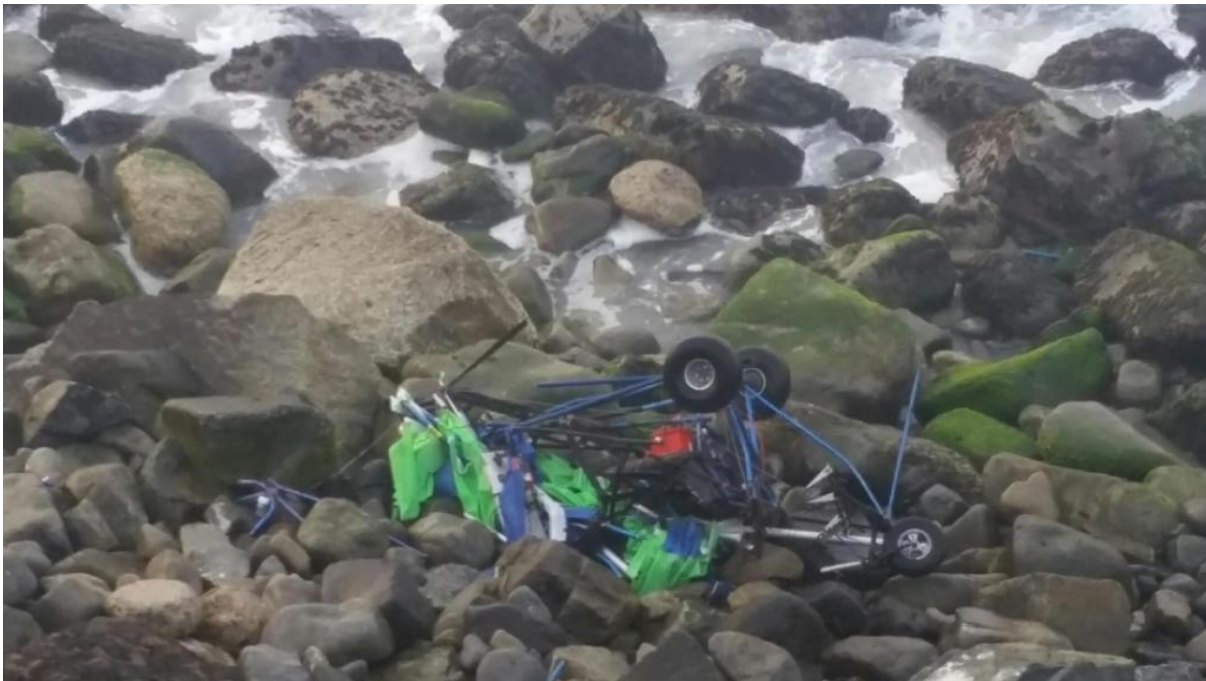
The aircraft was discovered the morning after the accident, situated on the rocks just above the waterline, consistent with it having been washed in during high tide and then caught on the rocks as the tide receded. The airframe sustained severe damage; when discovered it was a large mass of fractured tubing held together by some connectors, the wing cloth, and the numerous structural and control cables.

**Figure 3 - Aircraft Washed Up On Shore**

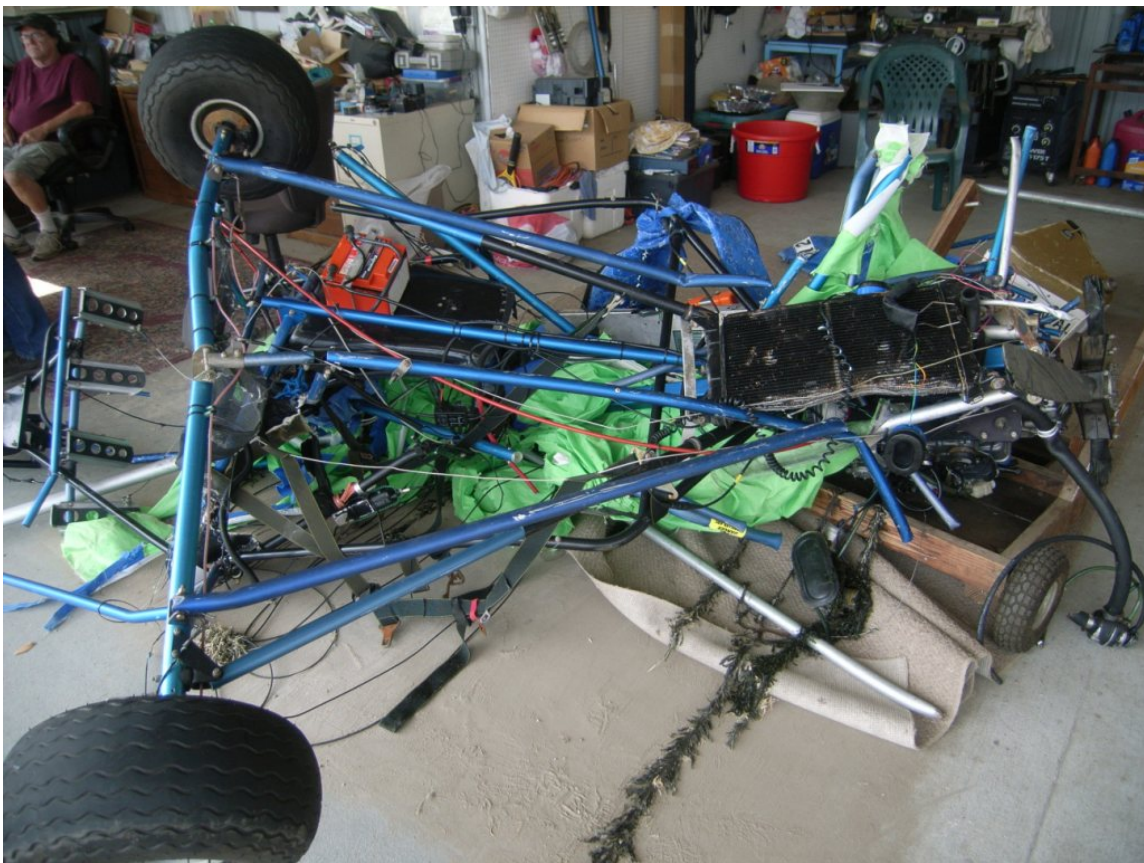
Some components (such as the instrument panel) were missing, and some (such as the seats, propeller, and fuel tank) sustained cracks or fracture-separated portions. The wing cloth was shredded, and the engine bore numerous impact marks on all exposed sides. Corrosion, and salt and sand infiltration, were nearly omnipresent.

Each of the three wheel assemblies remained attached to its respective axle, and all three tires remained inflated. The fuselage and wing structures lost all their shape due to the numerous fractures and bends of the structural tubing.

**Figure 4 - Aircraft Post-Recovery**

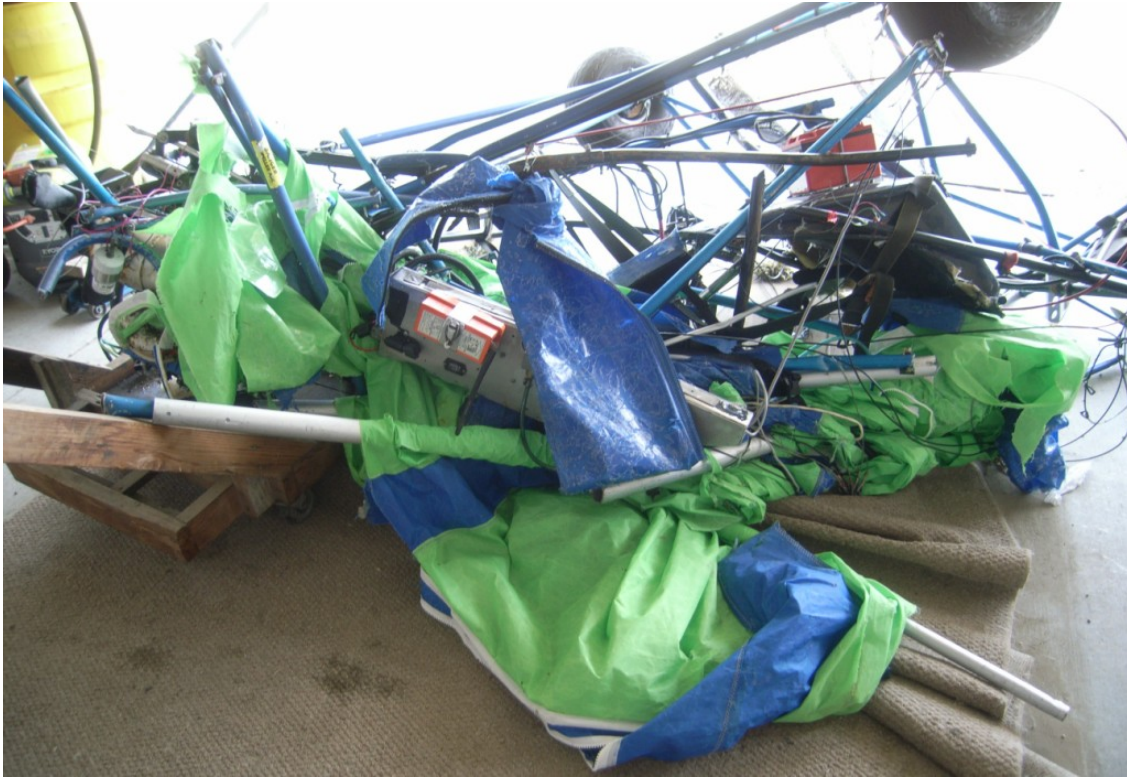
**Figure 5 - Aircraft Post Recovery**

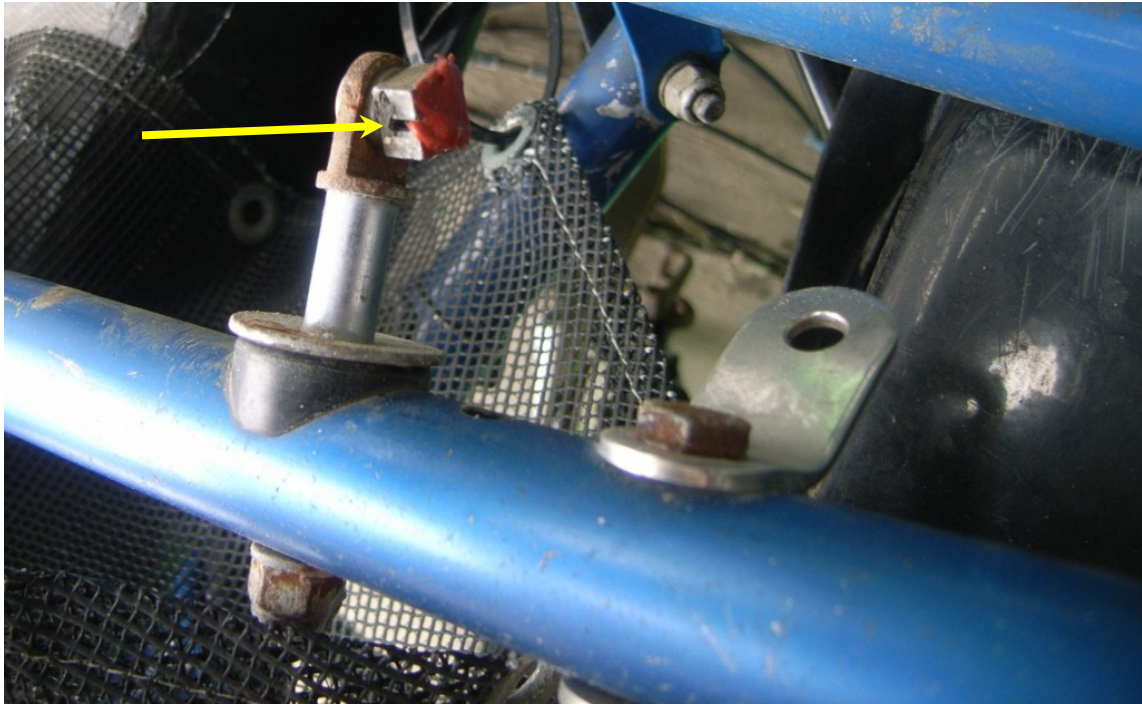
Each pilot station was provided a separate throttle lever. The two levers were attached to each end of a transversely-mounted rod, outboard of each seat. The rod attached to the fuselage, and was free to rotate about the rod's central axis. A single throttle push-pull control cable attached to a fitting at the approximate lateral center of the throttle control rod. The throttle rod was partially fracture-separated from its fuselage pivot mount. Both throttles remained securely affixed to their respective ends of that rod. The throttle cable had been pulled from its rod connection, but its swaged end remained captive in the connector on the rod. The adjustable fitting for the throttle cable end adjacent to the throttle control rod remained securely attached to the fuselage tubing. The throttle mechanical stop arms remained securely attached to the rod. Their functionality/range could not be determined due to the damage to the aircraft.

**Figure 6 - Throttle Bar and Cable Clamp (note absent cable, yellow arrow)**

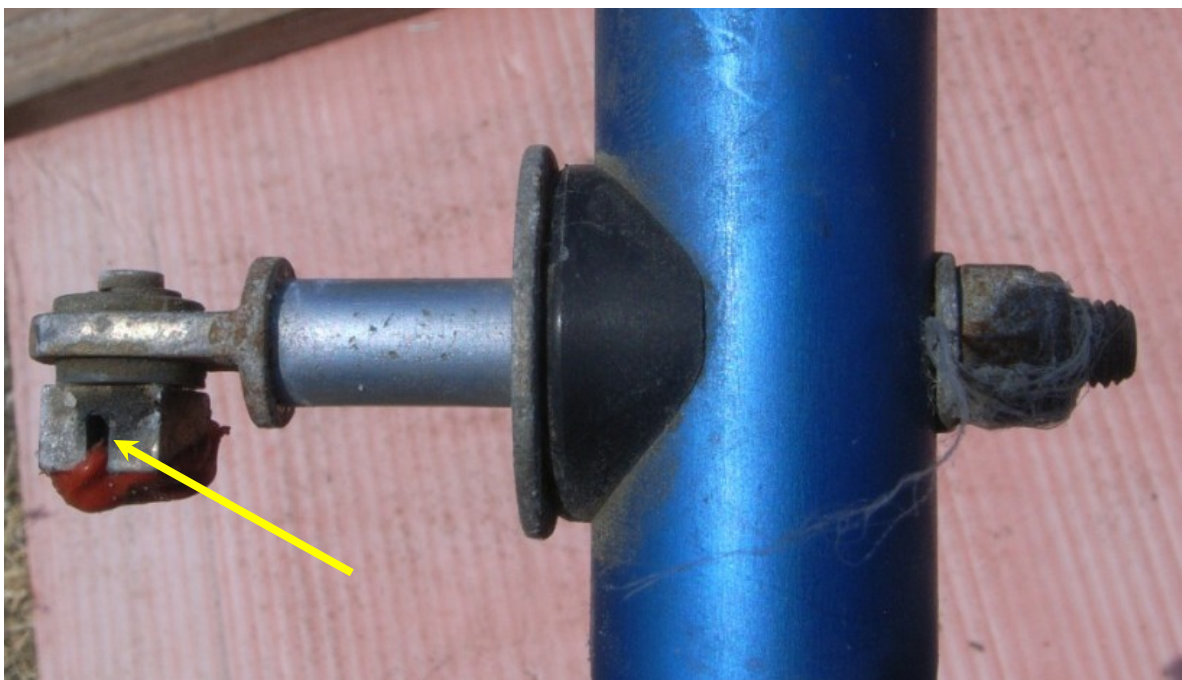
**Figure 7 - Throttle Bar and Cable Clamp (note absent cable)**

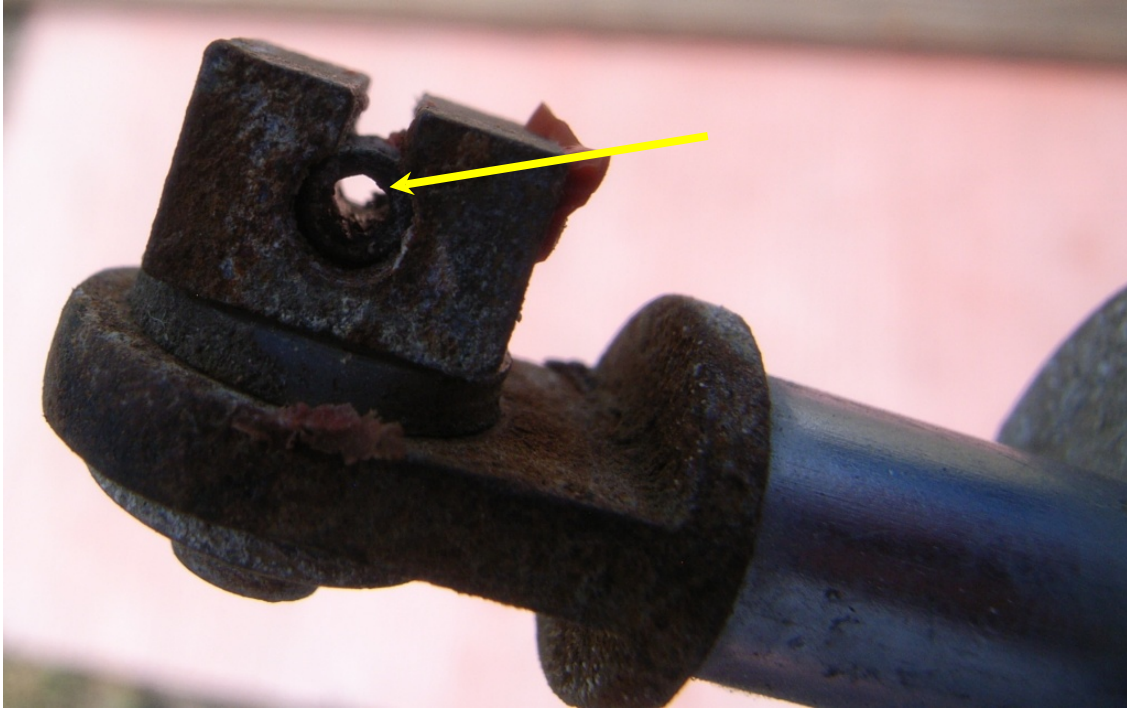
**Figure 8 - Throttle Bar and Cable Clamp (note absent cable)**

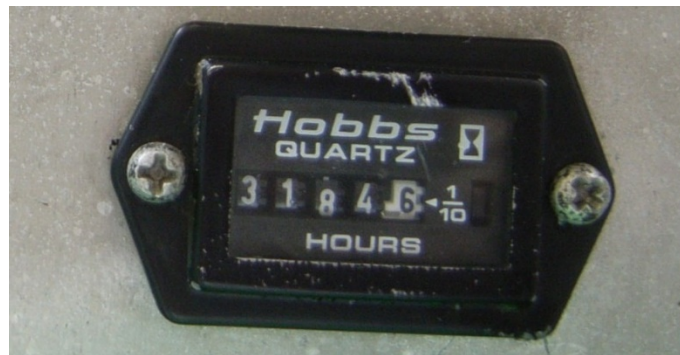
- Hobbs brand engine hour meter. Attached, intact, registered 3184.6 hours
- ELT Artex ELT-200 TSOC91a 121.5 MHz
- Facet brand electric fuel pump (see engine section for details)
- Ignition switch set to "R", key absent
- "Light Switch" found in aft (off) position
- "Fuel Pump" switch, found in forward (on) position
- "Master Switch" position indeterminate

Figure 14 - Hobbs Meter

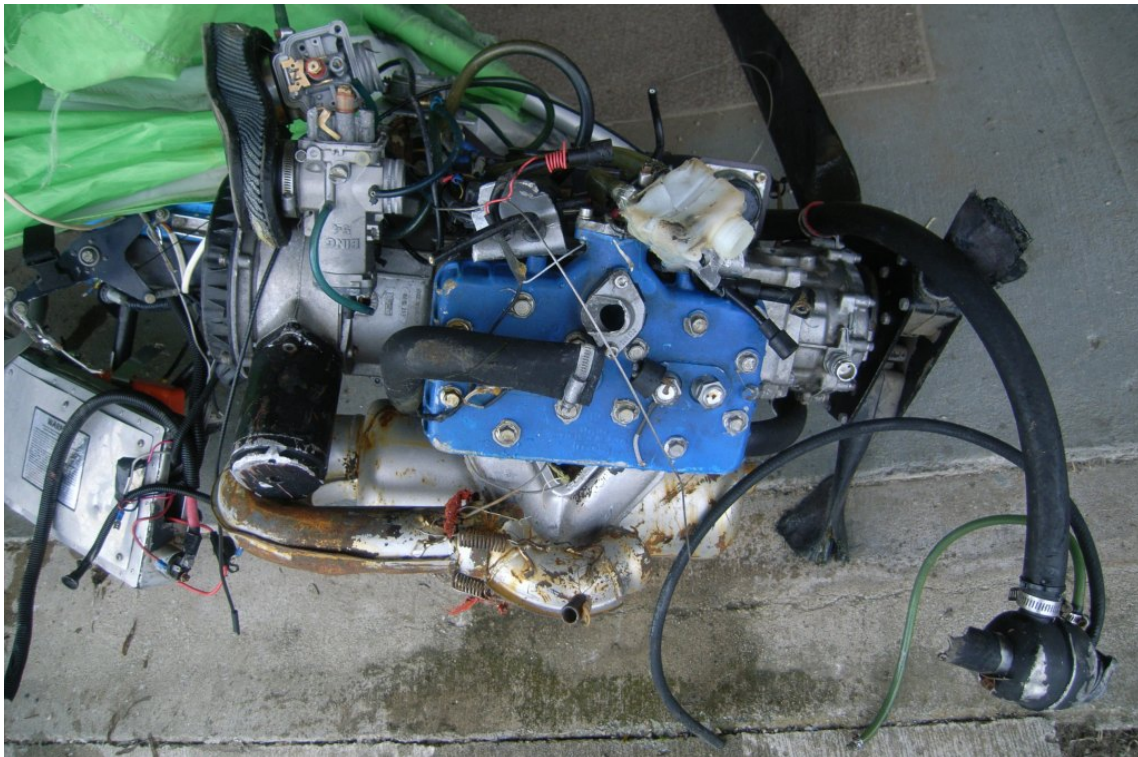
The engine remained attached to its mounting pad, which remained attached to the fuselage structure. The propeller hub remained attached to the engine gearbox flange, but all three composite blades were fracture-separated from the propeller hub. The engine exhibited significant impact damage, corrosion, and sand infiltration. The engine was unable to be rotated manually. There was no external evidence of any catastrophic failure of any engine components.

**Figure 18 - Engine Overview**

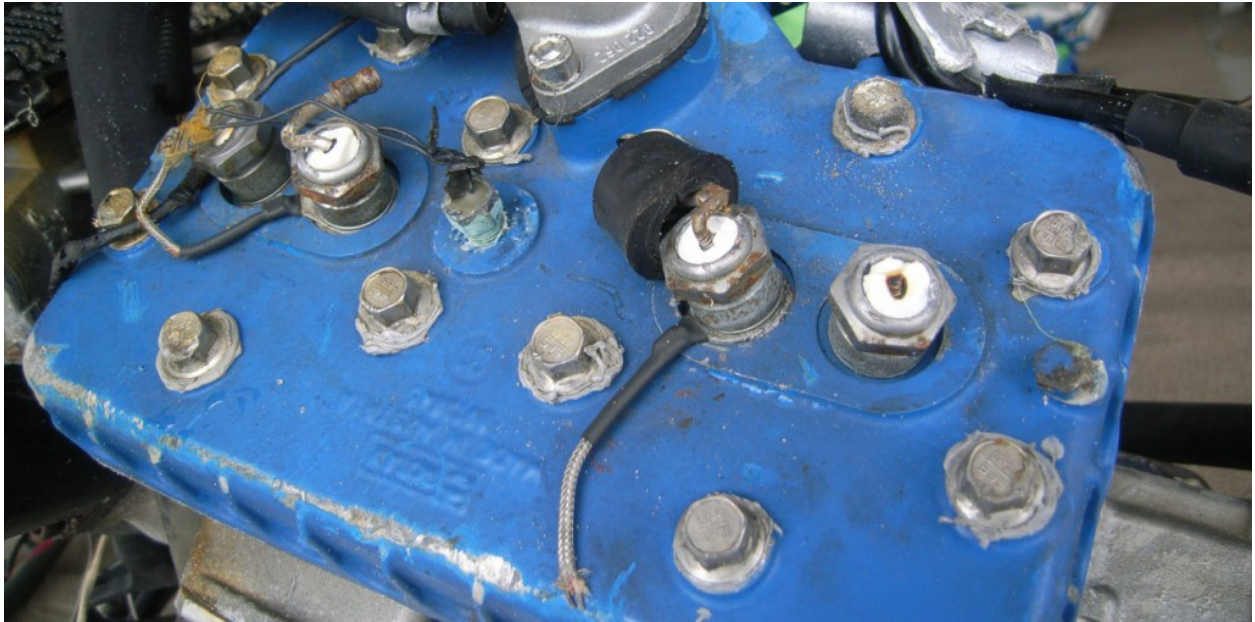
The integrated generator was not examined. Both coils remained attached and appeared intact. The ignition leads to the spark plugs were partly damaged and/or separated from the engine. All four spark plugs were found securely installed, but all four were missing the bulk of their upper insulator sections, which were all fracture-separated, consistent with rock impact damage. No spark plug model numbers were available on the remaining portions. The four spark plug bases were removed and examined. All were contaminated and/or corroded, consistent with salt water immersion. The gaps of the remaining electrodes were measured, but due to corrosion, those values may not be indicative of their in-service gaps. These were:

**Figure 22 - Fractured Spark Plugs (PTO side to right)**

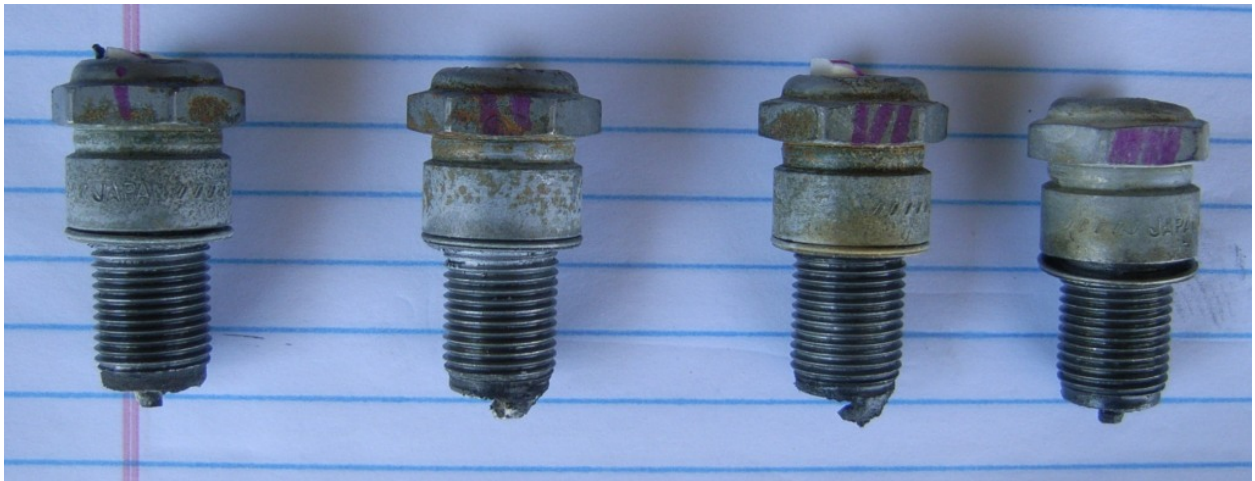
- SP I (PTO end, aft) 0.022"
- SP II (PTO end, forward) 0.024"
- SP III (MAG end, aft) undetermined due to corrosion
- SP IIII (MAG end, forward) 0.024"

The Rotax-specified spark plug gap value was 0.016" to 0.020"

**Figure 23 - Spark Plugs I to IIII (left to right)**

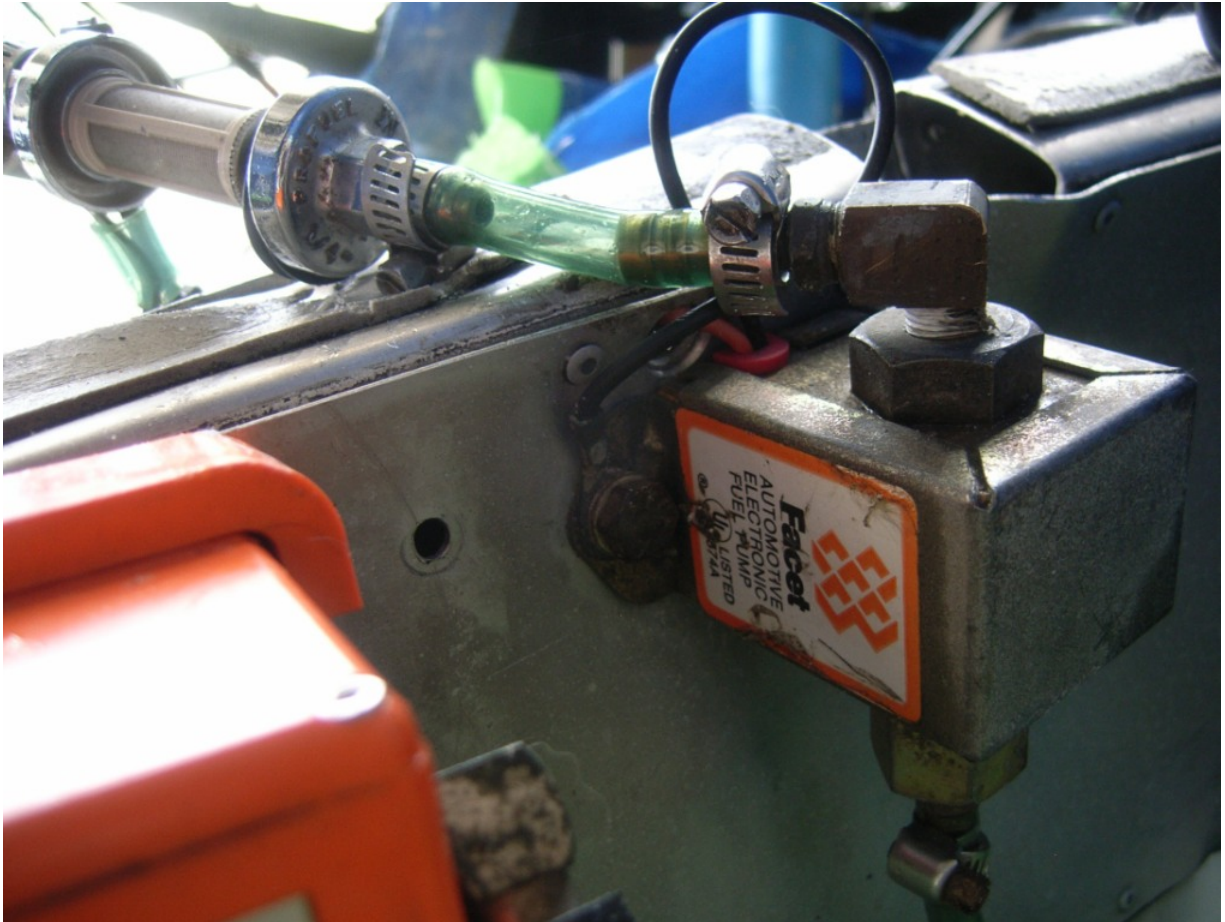
The fuel lines between the fuel tank and fuel pump (negative pressure side) were secured with non Rotax approved gear type worm clamps and tie wraps. These clamps do not tighten uniformly and could cause air to leak into the fuel system especially when there are multiple connecting joints.

In the Rotax repair manual **section 10.2.4) Examination of fuel line between tank and fuel pump:** it states "This section of pipe is under considerable negative pressure when the engine is running hard, and the tiniest flaw in any joint will cause air to be sucked into the system, considerably reducing the capacity of the fuel pump. Air leaks are much more dangerous when the fuel tank is mounted below the fuel pump and carburetor."

The same non-Rotax approved worm-type clamps were observed to be installed on the aircraft fuel system lines during the July 2017 post-accident examination.

Figure 28 - Fuel System with Worm Clamps

In the Rotax repair manual section **10.2.5) Elimination of air leaks in the fuel line:** It states that "Some commercial clips are often not very satisfactory on small pipes, as they tend to tighten up oval, creating a possible leak. "Crimp on" clips can be unsatisfactory if incorrectly applied, and are difficult to remove for servicing. Replace all doubtful fuel line clamps with good quality approved ones." Rotax recommended clips are P/N 938 195 which are a spring type clamp.

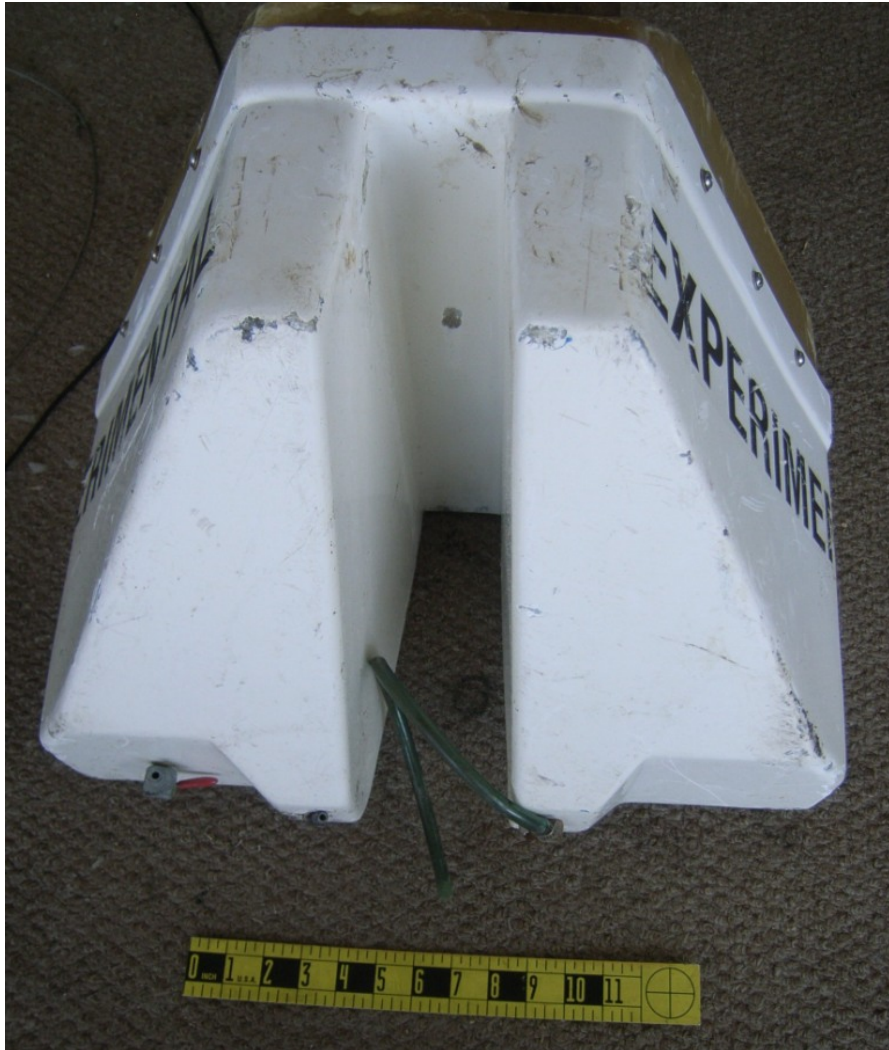
The composite fuel tank was observed to have been separated from the aircraft, but it was not determined when or by whom, or if it was separated by the wave action. The tank was equipped with two dedicated sump drains. The tank was empty, and the external surface exhibited several damage locations consistent with shore rock damage. No punctures or through-cracks were observed. The filler neck cap was absent and not recovered. The fitted valve at the tank bottom was present but corroded, and lacking its fuel line.

**Figure 29 - Fuel Tank**

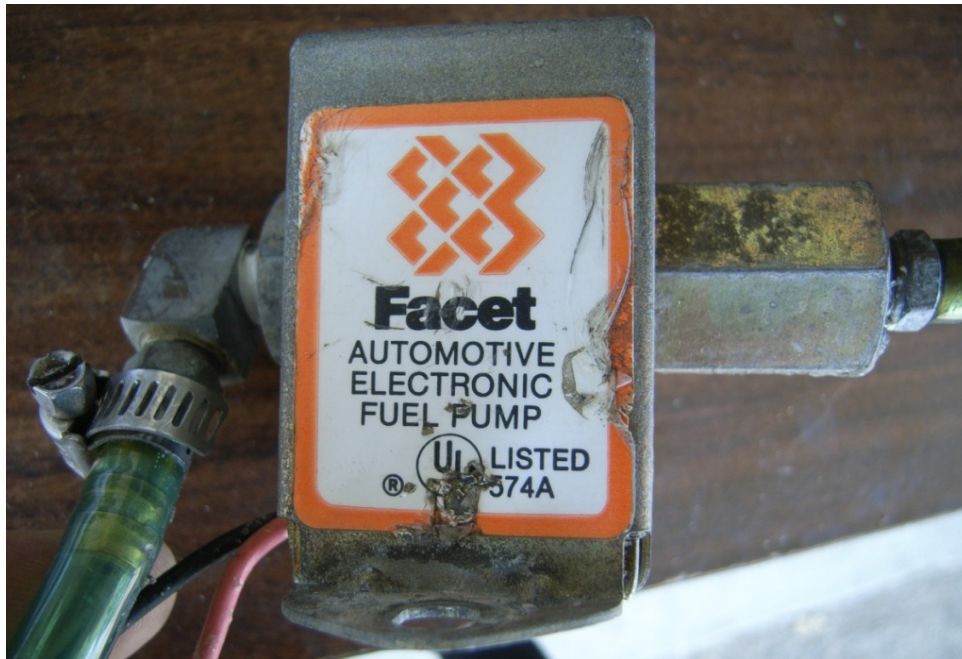
The electric fuel pump was a Facet brand part number 40105. According to the Rotax 582 engine installation manual "If the fuel tank is considerably lower than the engine an electric pump should be used. This pump is to be connected in parallel as in case of series connection the fuel pressure would be excessive." The manual did not define "considerably." The pump was plumbed in series with the rest of the fuel system. The pump was removed from the aircraft and 12VDC were applied in an attempt to test it. No noise or vibration of the pump was observed on the application of the voltage.

**Figure 30 – Electric Aux Fuel Pump**

According to specifications on the Facet/Purolator web site, the minimum pump output pressure is 3.0 psi, the maximum pressure is 4.5 psi, and the pump flow capacity is 30 gph. The specification also cited an "average wet lift" of 12 inches. "Wet lift" is the distance below the pump that the pump can draw fluid from; in this case the pump can pull fluid from a source 12 inches below the pump. With the aircraft in a level pitch attitude, the bottom of the electric pump was situated about 12" above the bottom (and outlet) of the fuel tank.

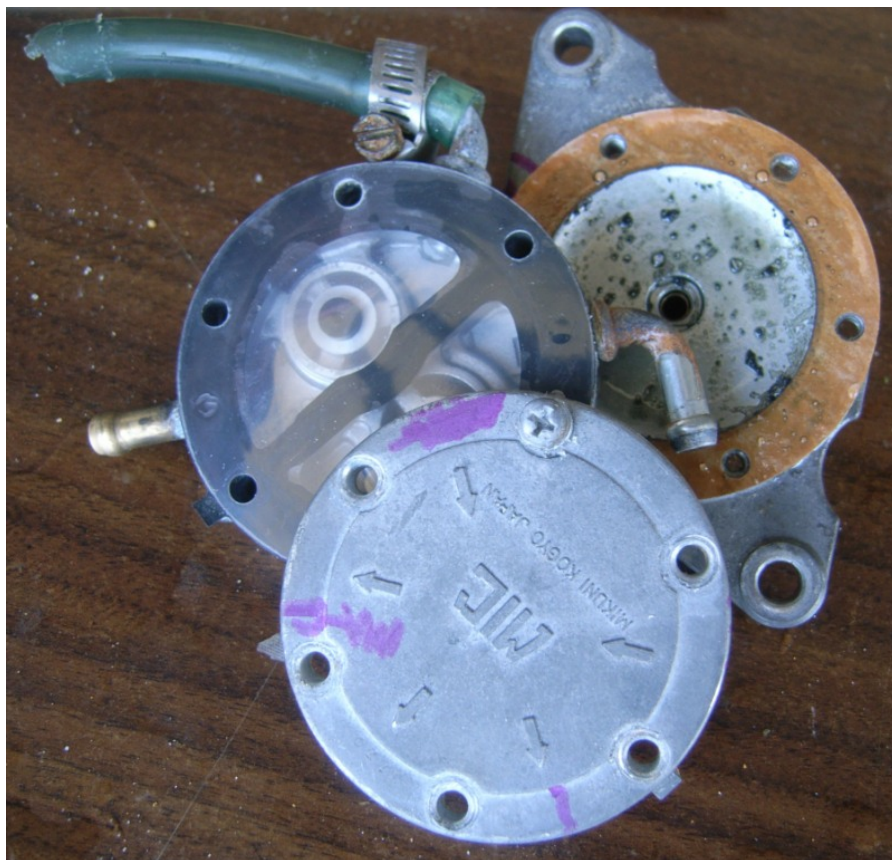
The engine-driven fuel pump (EDP) remained attached to its mount on a plate at the lower forward section of the engine. The pump cover bore information that appeared to be the manufacturer ("MIC Mikuni Kogyo Japan") but no part numbers were observed on the exterior. The single input fuel line and the two output fuel lines remained securely attached to the pump. The two output lines to the carburetors were intact and attached to the appropriate sites on the carburetors, but the input line was torn and terminated about 3 inches from the pump. The pneumatic line for pump actuation remained connected to the appropriate fittings on the pump and the engine crankcase. The pump was removed from the engine and partly disassembled. There was liquid in the pump that appeared to be a mix of avgas and seawater. All internal pump diaphragms and flapper valves were intact and flexible. The flapper valve orientation was correct, and their action tested satisfactorily with low pressure air. The internal chambers contained sand similar to that found throughout the wreckage, and corrosion consistent with salt water exposure. No mechanical anomalies with the pump were observed.

**Figure 31 - Engine Driven Fuel Pump**

Regarding the installation location of the EDP, the Rotax installation manual stated that "if possible, the pump should be located below the fuel tank level." The EDP location was near the bottom of the engine, which was above the top of the fuel tank.

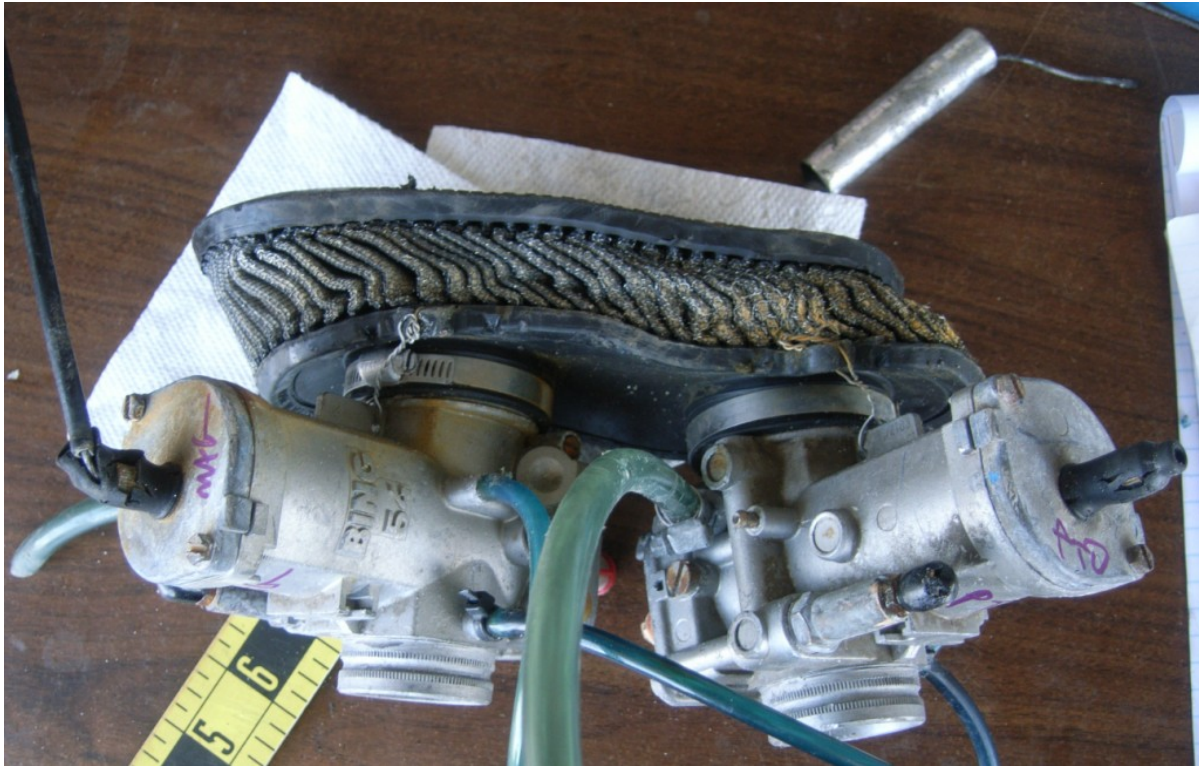
The two carburetors were found separated from the engine at their flexible boot ("carburetor socket") connections, but remained attached to the engine by cables and fuel lines. The single air filter remained attached to the two carburetors. The air filter was crushed and otherwise deformed, contained sand, and exhibited corrosion, consistent with salt water immersion and wave action at the shoreline. The air filter was Rotax part # 825 723, which was the correct part for that engine.

**Figure 34 - Carburetors and Air Filter**

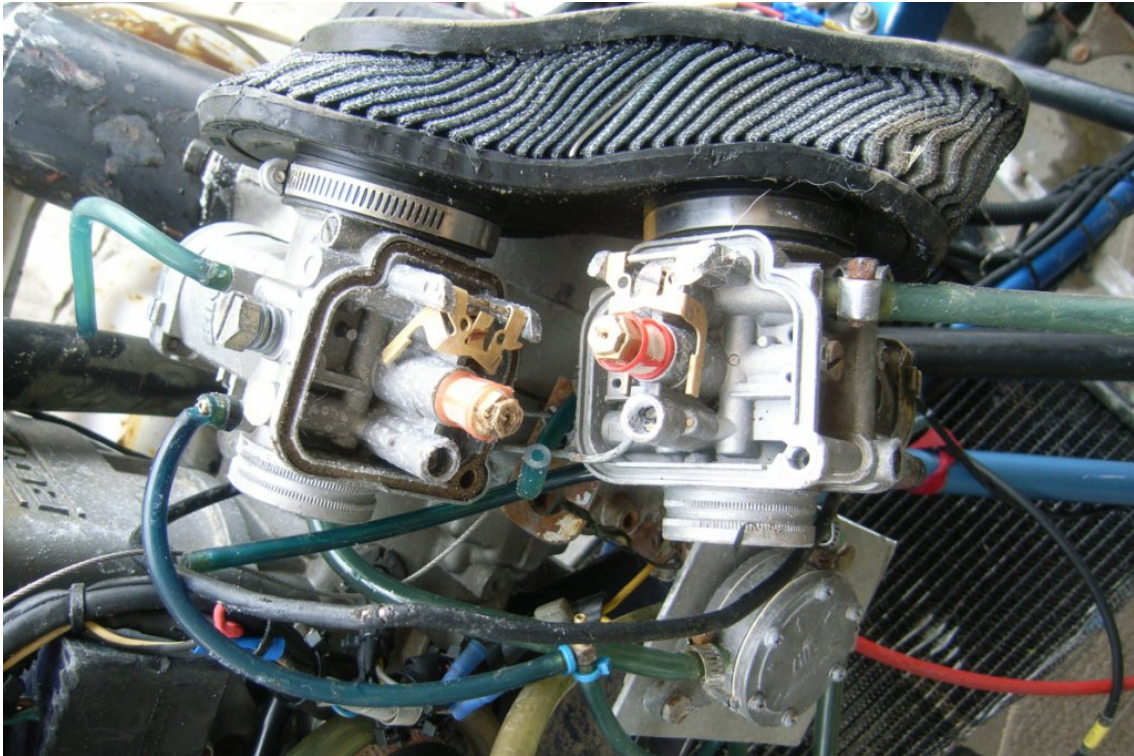
Both carburetors were missing their bowls, and their internal float mechanisms and other components were crushed, deformed, and corroded, again consistent with the accident environment. The Bowden cable was displaced but remained attached to the MAG carburetor, but the Bowden cable was separated from the PTO carburetor. The carburetor pistons ('throttle slides') on both carburetors were firmly stuck in the wide open throttle position. The main jets of both carburetors were stamped as size "165," and were unobstructed. Per Rotax guidance, 165 was the proper main jet size for this engine and carburetor installation. The cover plates were secured on both carburetors, and removal revealed no failed springs or other abnormalities.

**Figure 35 - Carburetors (note missing bowls)**

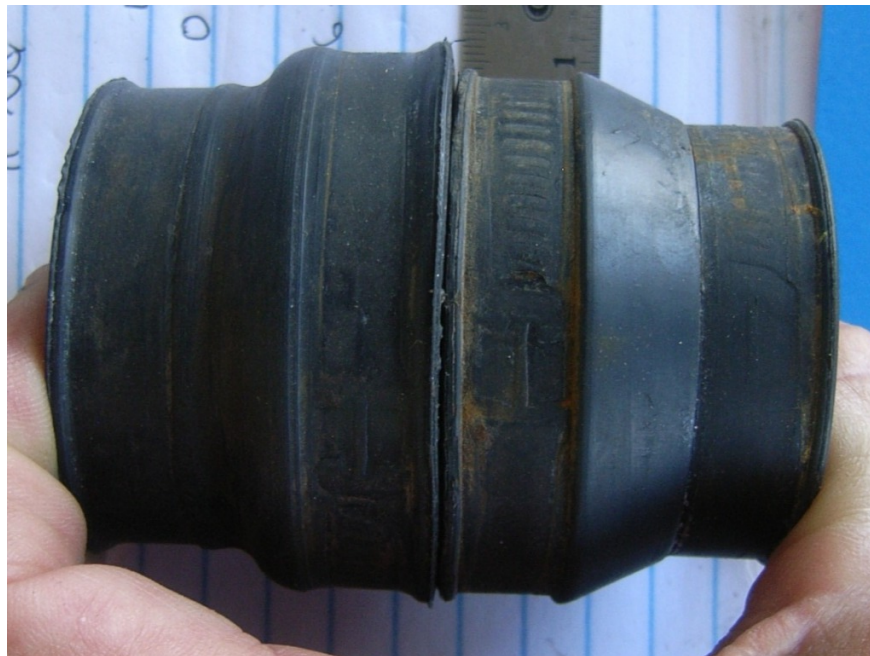
The two sockets remained installed on the engine, and retained all four attaching worm clamps. The sockets were removed and examined; both were flexible, and no through-cracks were observed. Examination of the maintenance records indicated that the carburetor socket for the PTO carburetor was replaced on July 2, 2017 by the SKFC mechanic. That work was completed at a Hobbs meter reading of 3183.9 hours. The logbook entry did not contain any information regarding an operational check of the new installation. Discussions with the mechanic and another SKFC member revealed that no operational check was conducted, and that the installed socket was not brand new. According to the aircraft 'Flight Log', the next aircraft/engine run (unknown if actually flown) was on July 6, 2017, for 0.2 hours. The next entry on the Flight Log was for the accident flight.

The number on the newly-installed PTO socket (867696) matched the part number specified in the Rotax Parts manual. Comparison of the newly-installed socket with the socket from the MAG carburetor indicated that the two were slightly different dimensionally (in diameters), but of the same height, and that the number (07-100-21) on the MAG socket did not match the Rotax-specified part number. The socket did not bear any manufacturer identification, so no cross-check of applicability was able to be conducted.

Figure 40 - Carburetor Sockets (PTO & MAG respectively)

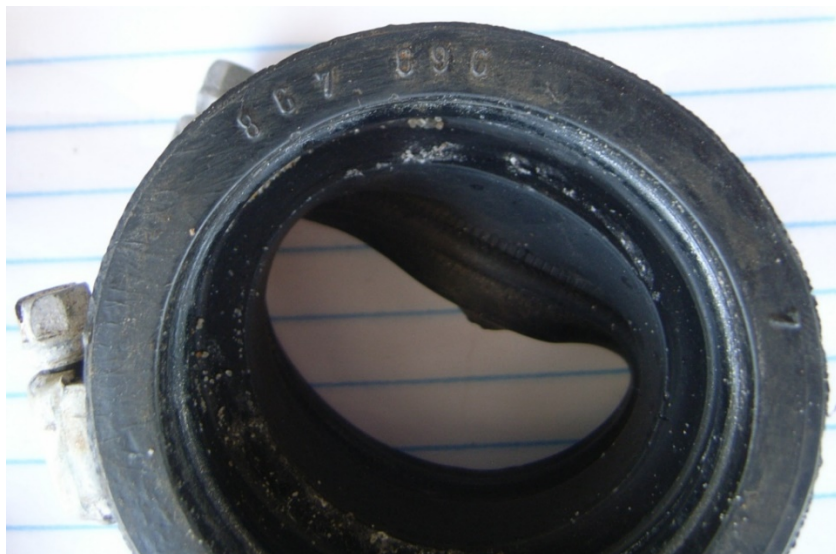
Figure 41 - PTO End Socket (correct PN)

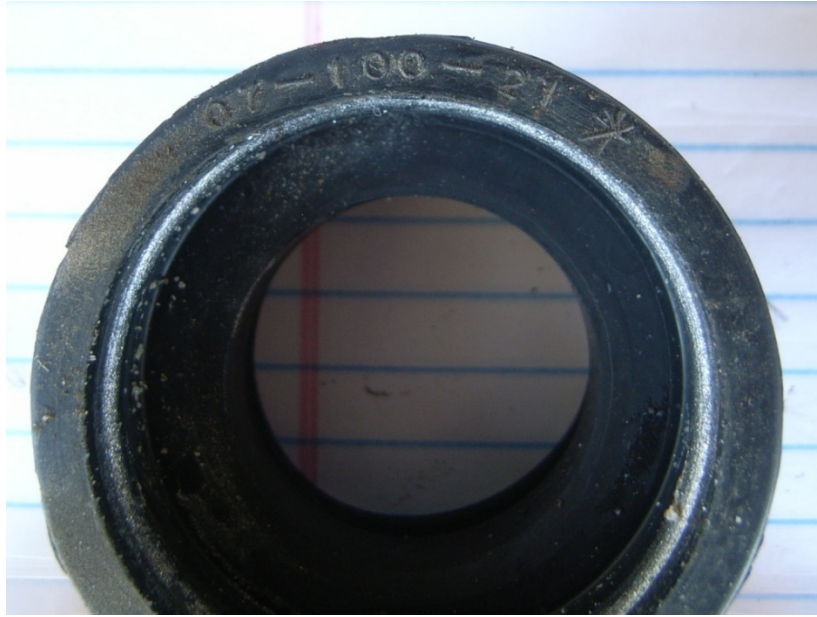
**Figure 42 - MAG End Socket (incorrect PN)**

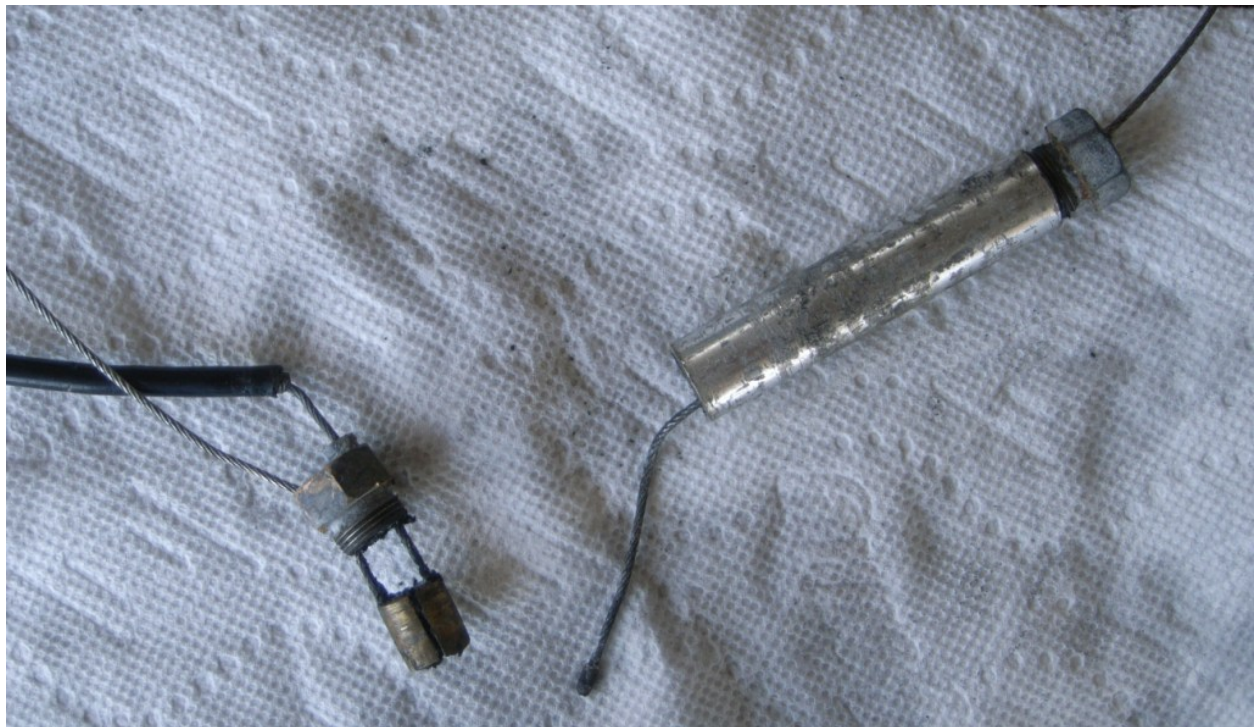
The throttle cable splitter device was examined. It was mechanically intact but was very stiff in operation, likely due to salt water immersion and sand infiltration; its pre-accident functionality and range could not be determined.

**Figure 43 - Throttle Cable Splitter (disassembled)**

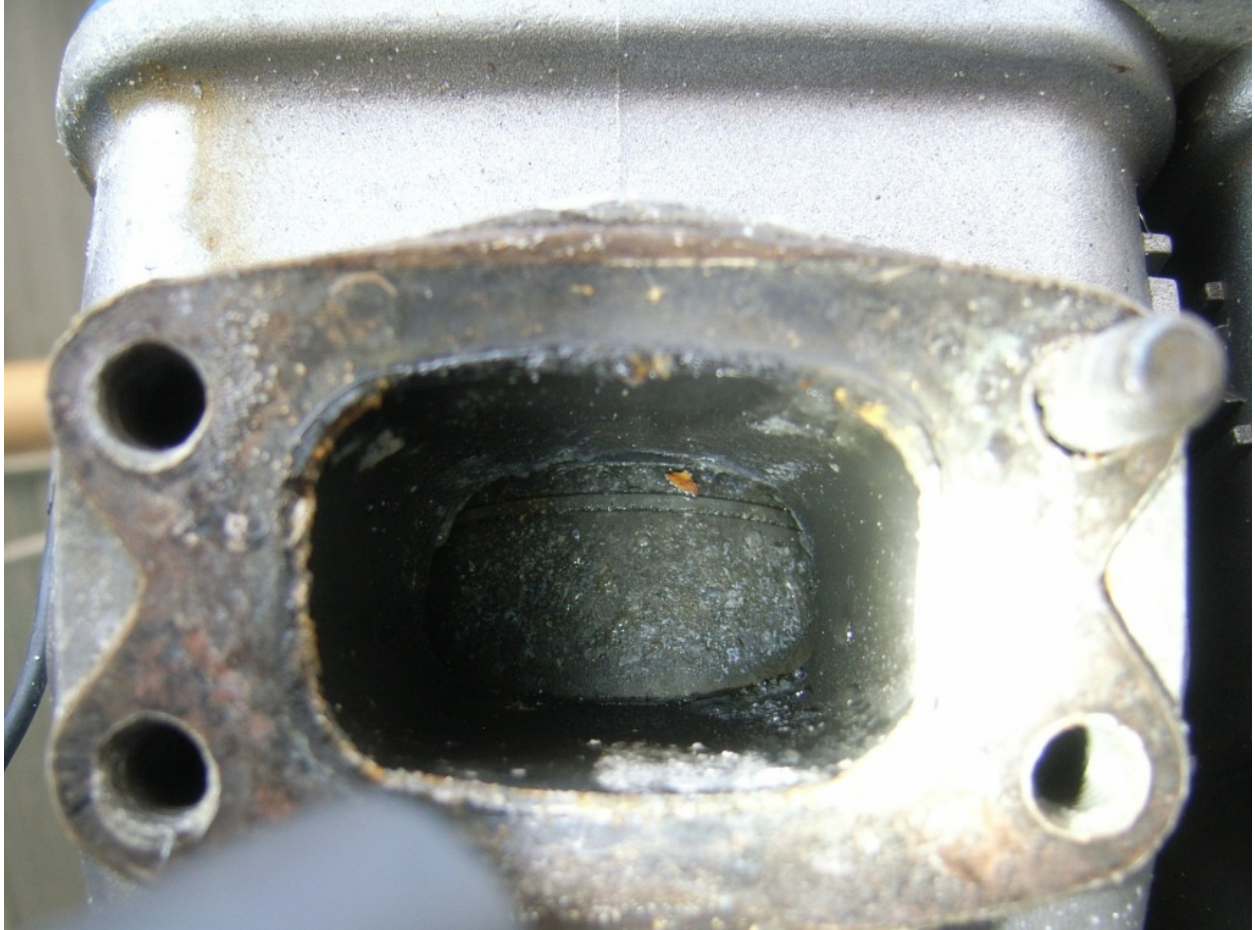
The exhaust Y pipe was removed to gain access to the pistons. The pistons and cylinders were examined for any signs of oil starvation, seizure marks and stuck piston rings. No evidence of oil starvation, piston seizure, or stuck piston rings was observed.

**Figure 44 – MAG End Piston (via exhaust port; note lack of scoring, typical)**
