## **NATIONAL TRANSPORTATION SAFETY BOARD**

# **AIRFRAME AND ENGINE EXAMINATION**

**WPR17FA146**

Location: Pt Mugu, CA  
Date: July 8, 2017  
Aircraft: Quicksilver Sport MX II, N2812, Serial # 1763  
NTSB IIC: Michael Huhn

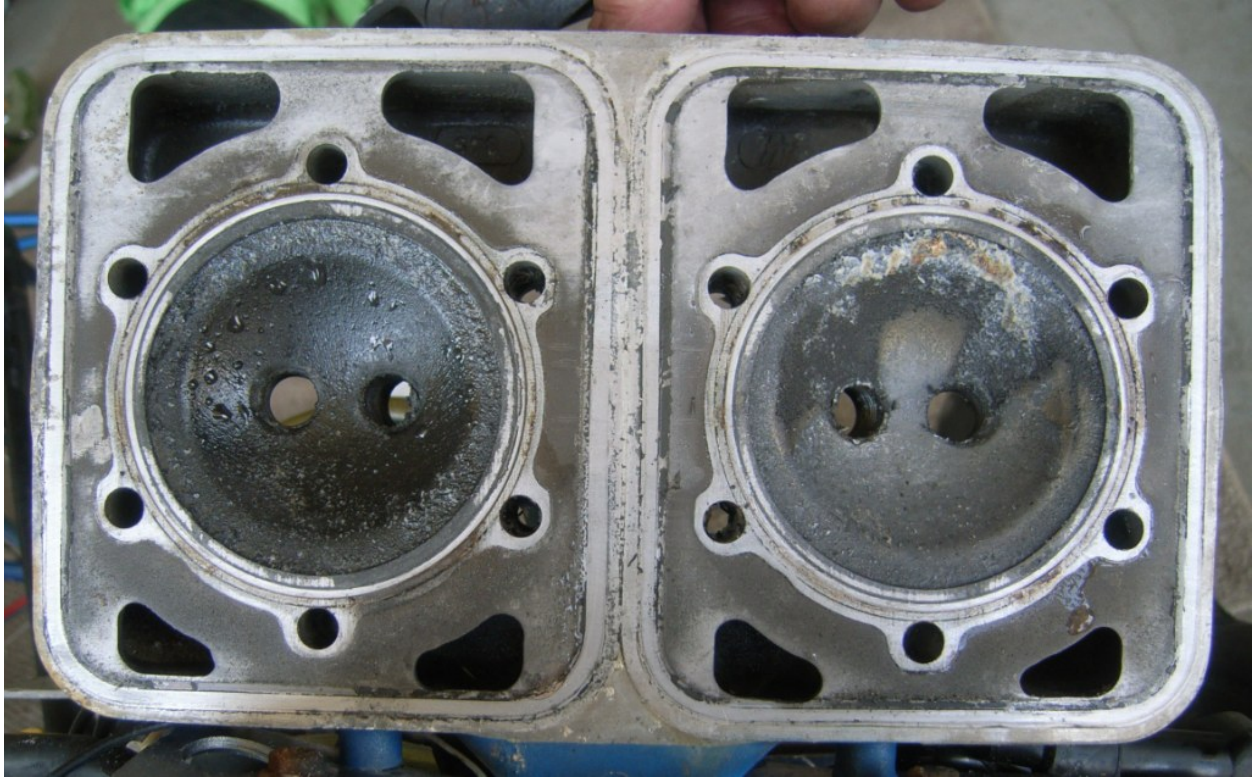
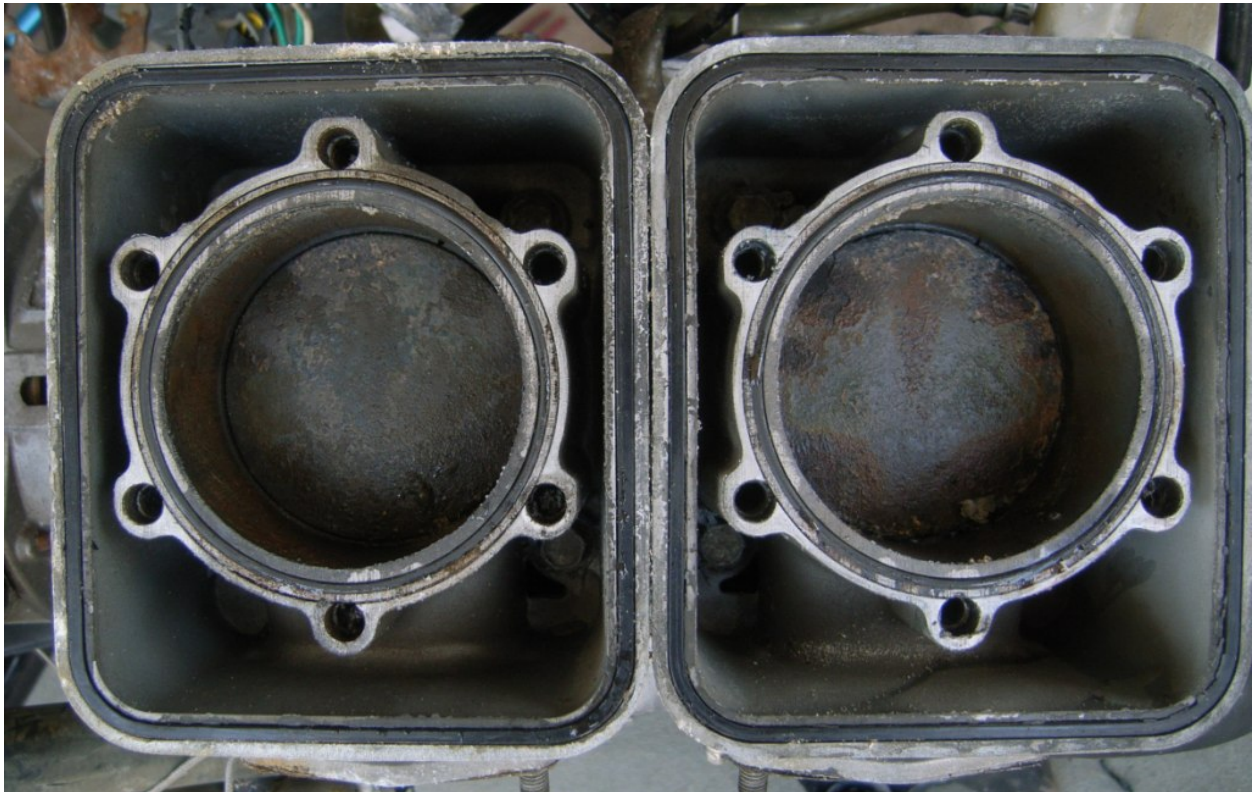
The cylinder head was intact and securely attached. No evidence of any leaks was observed along the head/cylinder joints. The head was removed, and the exposed cylinders, pistons, and head cylinder domes were examined. No evidence of any mechanical anomalies was observed.

Figure 46 - Head Domes (PTO to right)

Figure 47 - Cylinders and Pistons (PTO to right)

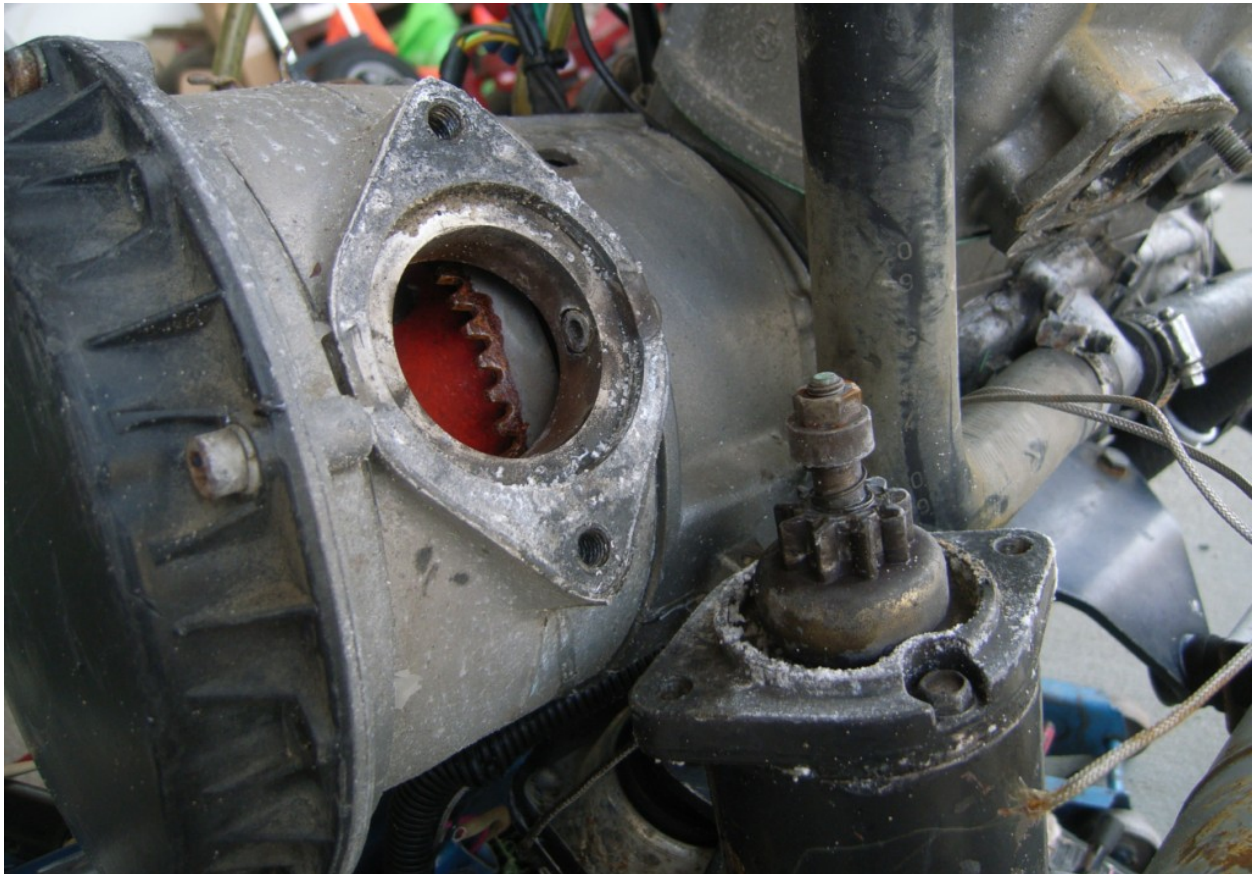
The engine was equipped with both a manual pull-start mechanism and an electric starter. The electric starter was unbolted from the engine and examined. The starter 'Bendix drive' was found in the retracted position, decoupled from the engine ring gear. Neither gear showed any evidence of distress due to abnormal contact. There was evidence of salt water immersion and resultant corrosion inside the gear housing.

Figure 48 - Electric Starter (Removed)
