## **NATIONAL TRANSPORTATION SAFETY BOARD**

### **Field Report**

**WPR17FA149**

Location: Herriman, Utah  
Date: 7/13/2017  
Aircraft: Aviat Aircraft Inc., A-1B, Registration Number: N211AM  
NTSB IIC: Tealeye Cornejo

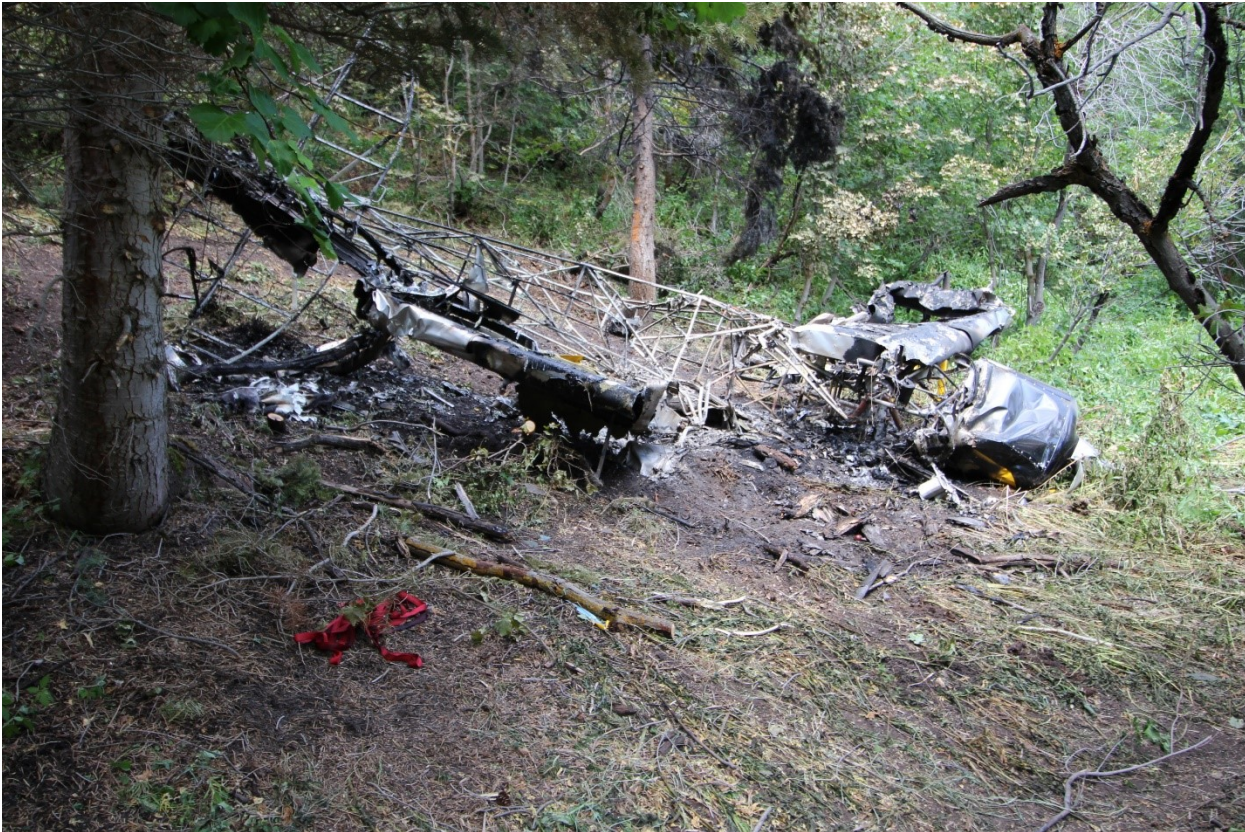
All major structural components of the airframe were accounted for, and were collocated with the main wreckage. The airplane impacted an area of down sloping heavily wooded terrain about 12 miles southwest of the South Valley Regional Airport. The wreckage was oriented on a 060° magnetic heading. A post-impact fire ensued, and the airplane was destroyed.

Figure 2. View of airplane at accident site.
