## **NATIONAL TRANSPORTATION SAFETY BOARD**

### **Examination Notes**

**WPR17FA149**

5   Aircraft:   Aviat Aircraft Inc., A-1B, Registration Number: N211AM

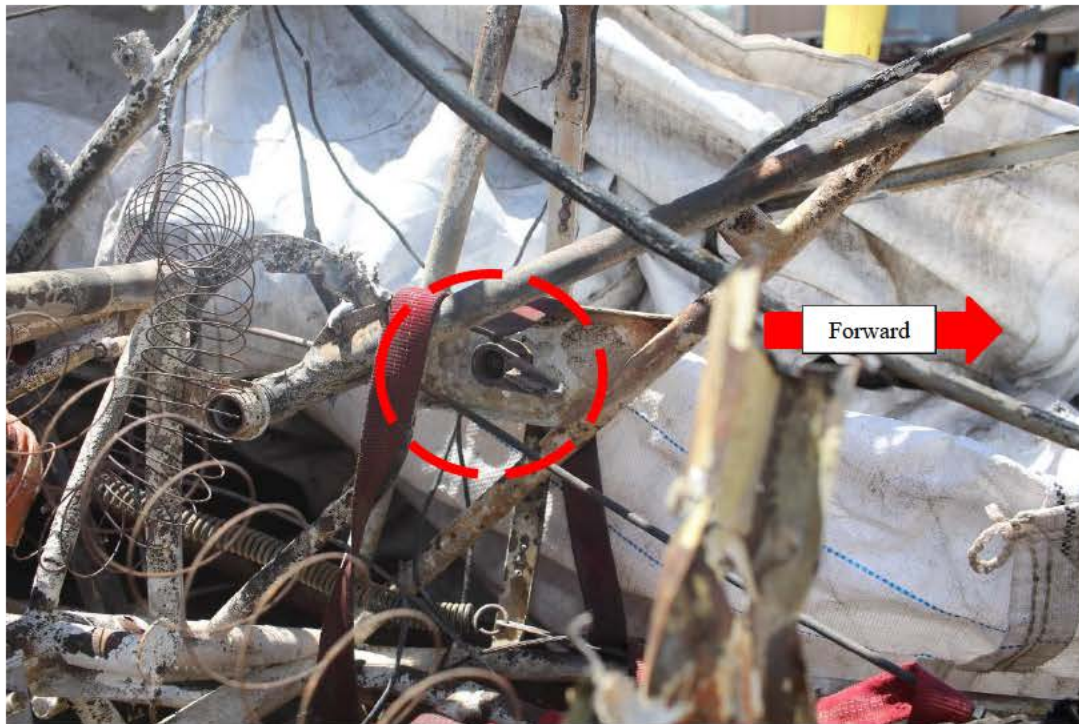
16  
17   The fuel selector valve was pointing to the forward (horizontal) position.

Figure 1: View of fuel selector

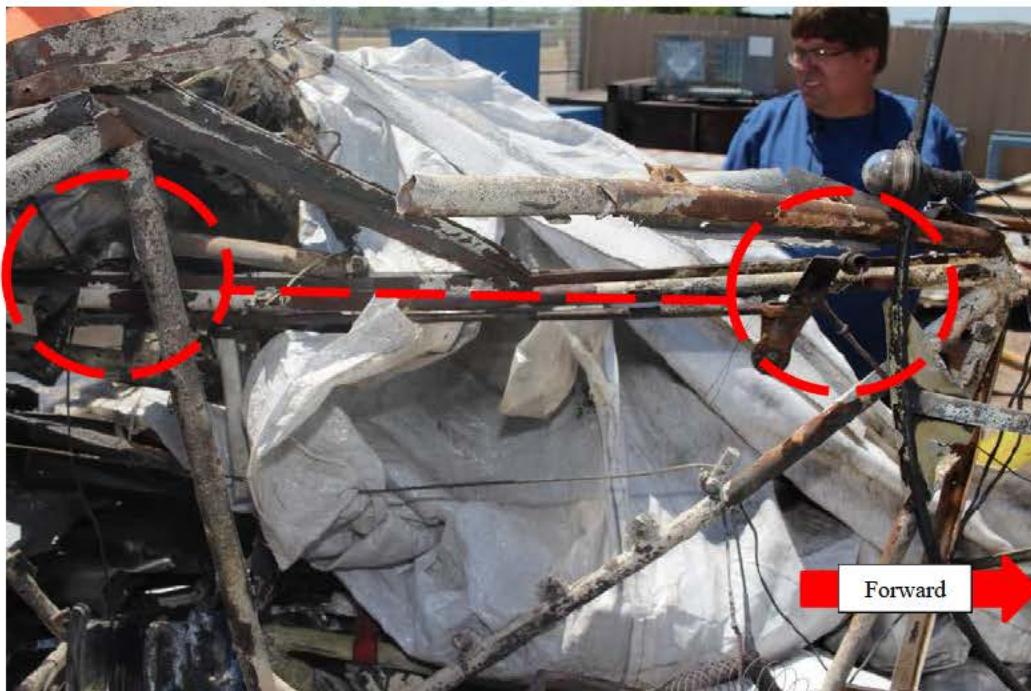
The throttle linkages in the cockpit were connected and moved from stop to stop.

Figure 2: View of forward throttle quadrant still connected to aft throttle.

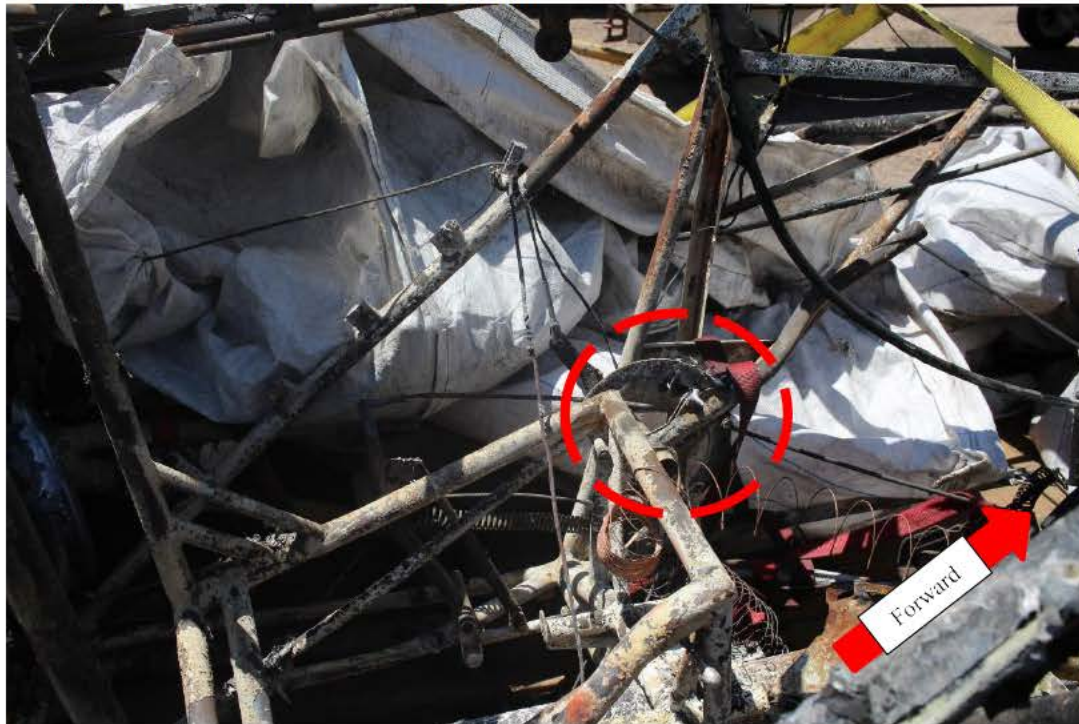
The flap handle was in the full forward position.

Figure 3: View of flap selector in the retracted position.

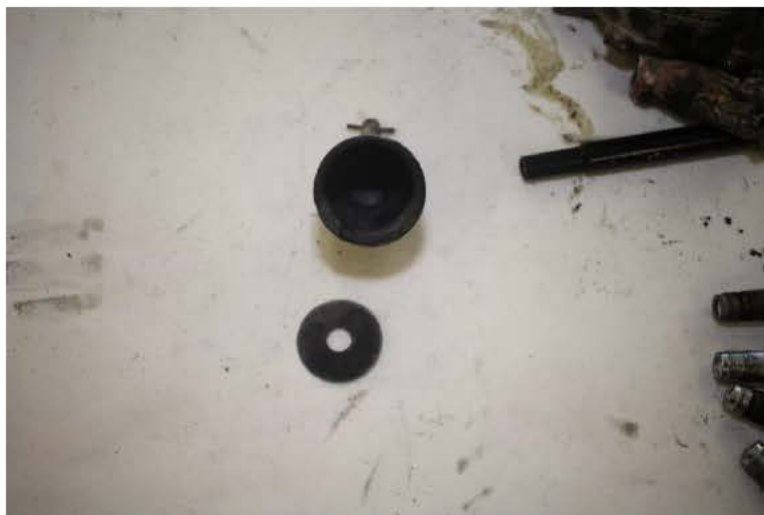
The gascolator screen was in place, but the rubber gasket had melted into the bowl.

Figure 4: View of extensive thermal damage to the gascolator screen and bowl.

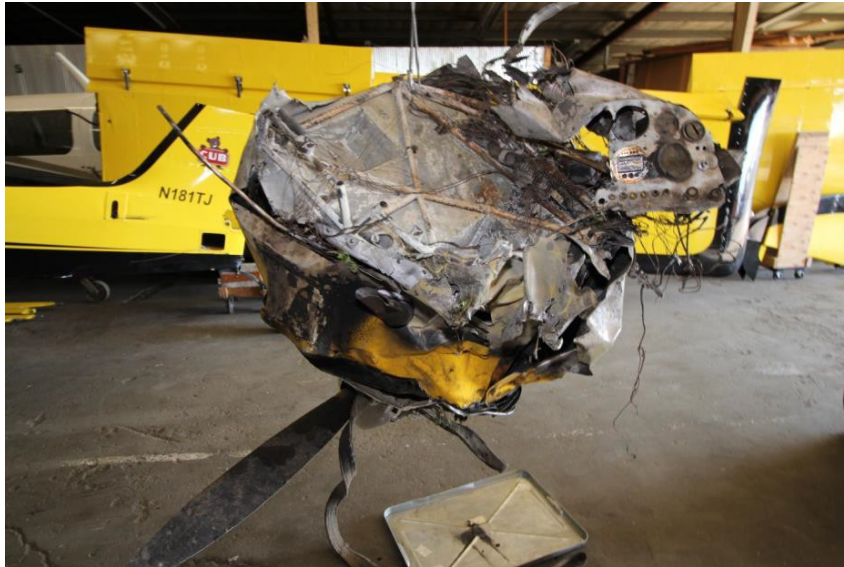
Investigators slung the engine from a hoist. The right front of the engine at cylinder number one was crushed inboard and aft. The intake tubes for all cylinders were not bent; The number one exhaust tube was displaced slightly aft. The exhaust system and carburetor on the bottom of the engine remained attached and in place with slight upward crush damage to the carburetor heat box, and ductile crush damage to the tailpipe. The engine components between the firewall and rear baffling and the back of the engine were charred.

**Figure 5: View of engine slung from a hoist.**

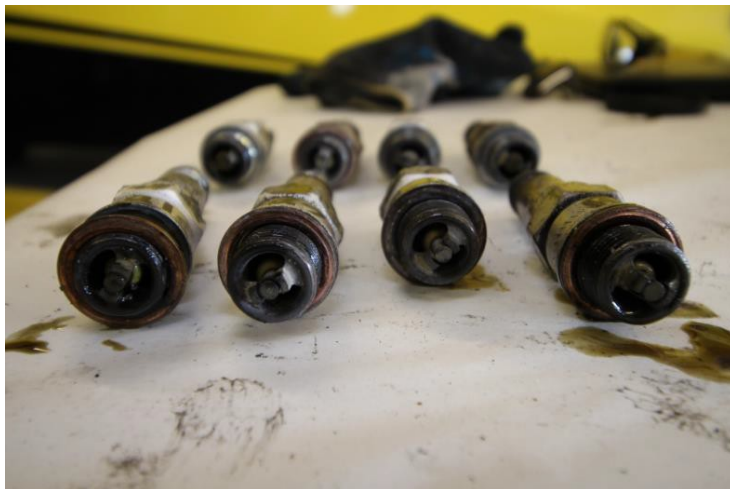
Investigators removed the valve covers and top spark plugs. They manually rotated the crankshaft with the propeller, and oil squirted out of cylinder number four. The crankshaft rotated freely, and the valves moved approximately the same amount of lift in firing order. The gears in the accessory case turned. Investigators obtained thumb compression on all cylinders in firing order.

**Figure 6A: View of top spark plugs.**

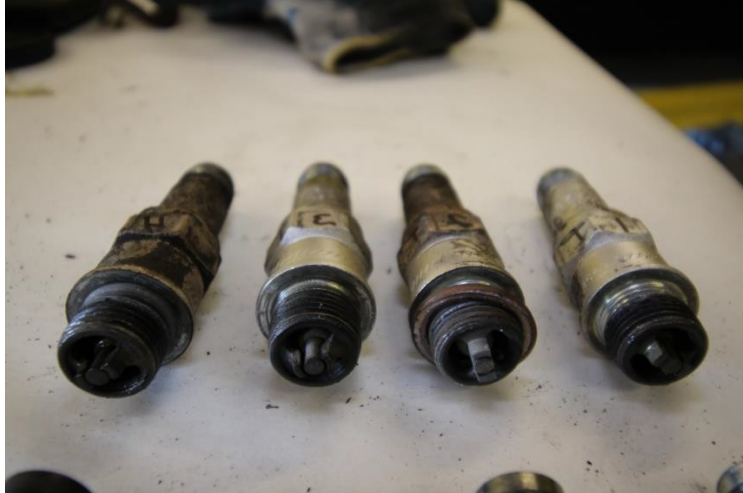
Investigators removed the bottom spark plugs. The spark plugs were Champion REM38E. The center electrodes on all plugs were circular with no mechanical deformation; cylinders number one and four were oily. The spark plug electrodes were gray for cylinders number two and three, which corresponded to normal operation according to the Champion Aviation Check-A-Plug AV-27 Chart.

Figure 6B: View of Bottom Spark Plugs

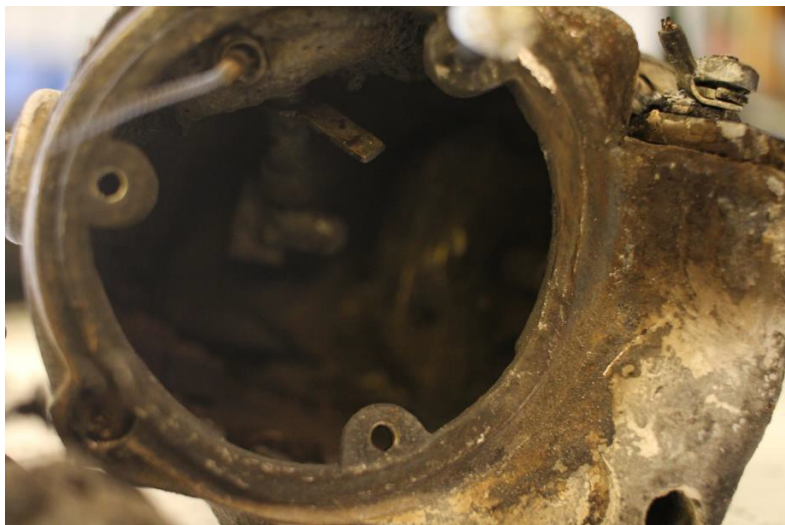
The left magneto was a Slick model 4373 serial number 00062678; it was charred. The impulse couple did not engage.

Figure 7: View of left magneto.

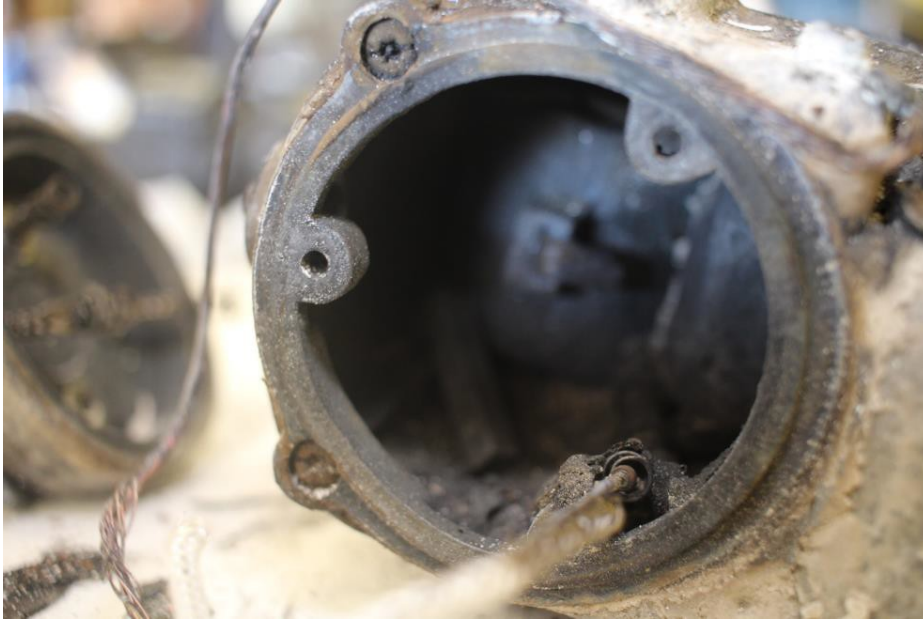
The right magneto was a Slick model 4370, serial number 00071433; the shaft was bound, and it sustained fire damage to the cap. Investigators manually rotated the magnetos, and neither magneto produced spark at any post. Upon disassembly, the internal components of both magnetos were melted.

**Figure 8: View of right magneto**

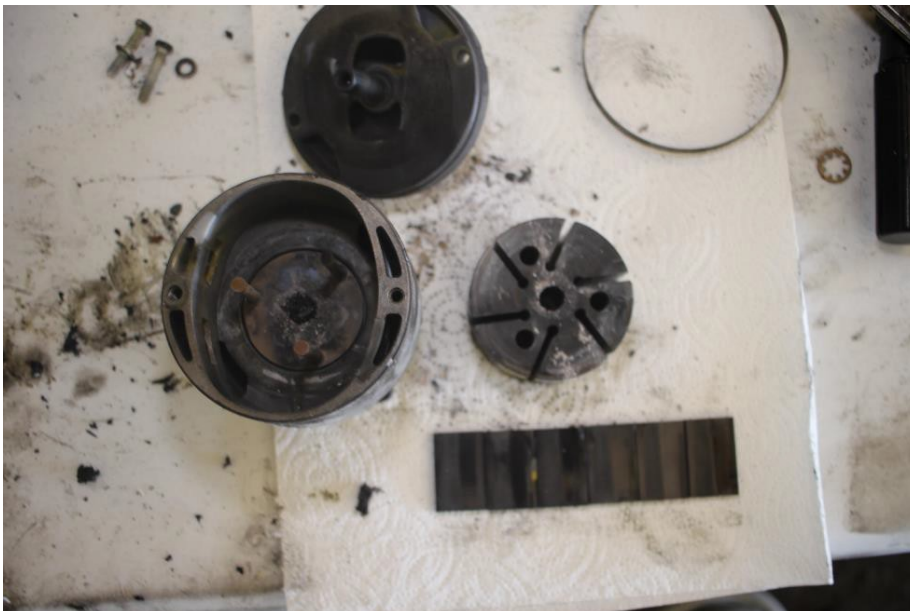
The vacuum pump sustained fire damage, and the plastic drive gear melted away. The vanes remained in position, and the rotor was not cracked.

**Figure 9: View of vacuum pump.**

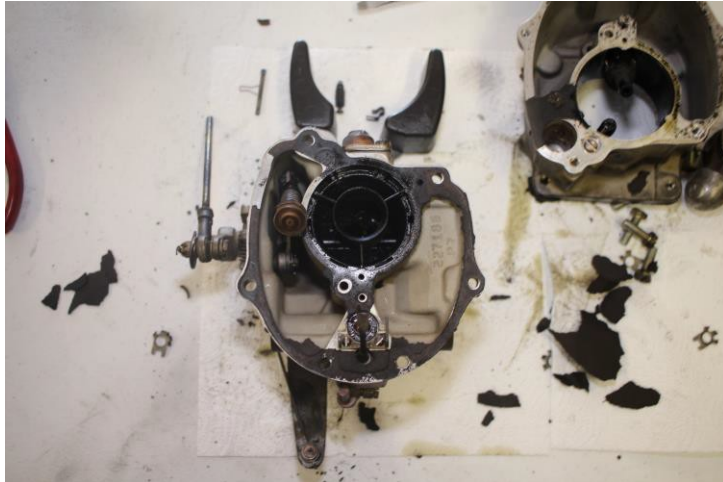
83 The carburetor was a Precision MA4-5, part number 10-6054, serial number 75104415. The air  
84 intake filter was burned. The throttle and mixture controls moved freely from stop to stop. The  
85 carburetor heat control movement was restricted due to crush damage. The inside of the  
86 carburetor was covered by a black viscous fluid. The fuel inlet screen exhibited about 60% black  
87 discoloration and blockage; it was charred and desoldered, and the hose to it was burned and  
88 melted. The inlet fitting was completely blocked with a black substance. Investigators  
89 disassembled the carburetor for further examination. The composite floats sustained some  
90 thermal damage. All internal gaskets were charred or consumed by fire. The bowl contained no  
91 fluid and was clean. The needle valve would not move; it was removed, and the rubber tip was  
92 melted to the seat.

93  
94  
95 **Figure 10: View of Precision carburetor (MA4-5, part number 10-6054, serial number 75104415).**  
96

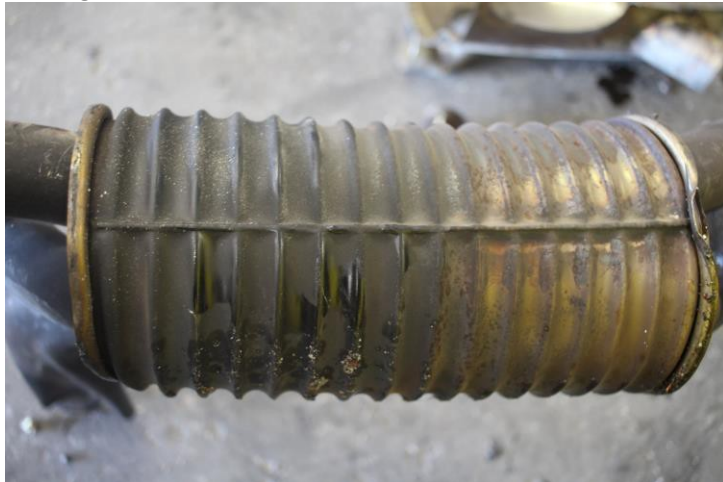
Investigators removed the cover to the muffler and did not observe any cracks or signs of leaks.

97  
98  
99 **Figure 11: View of muffler.**
