## **NATIONAL TRANSPORTATION SAFETY BOARD**

### **ONSITE EXAMINATION NOTES**

**WPR17FA150**

Location: Schellville, CA  
Date: July 13, 2017  
Aircraft: N821SG  
NTSB IIC: Albert Nixon

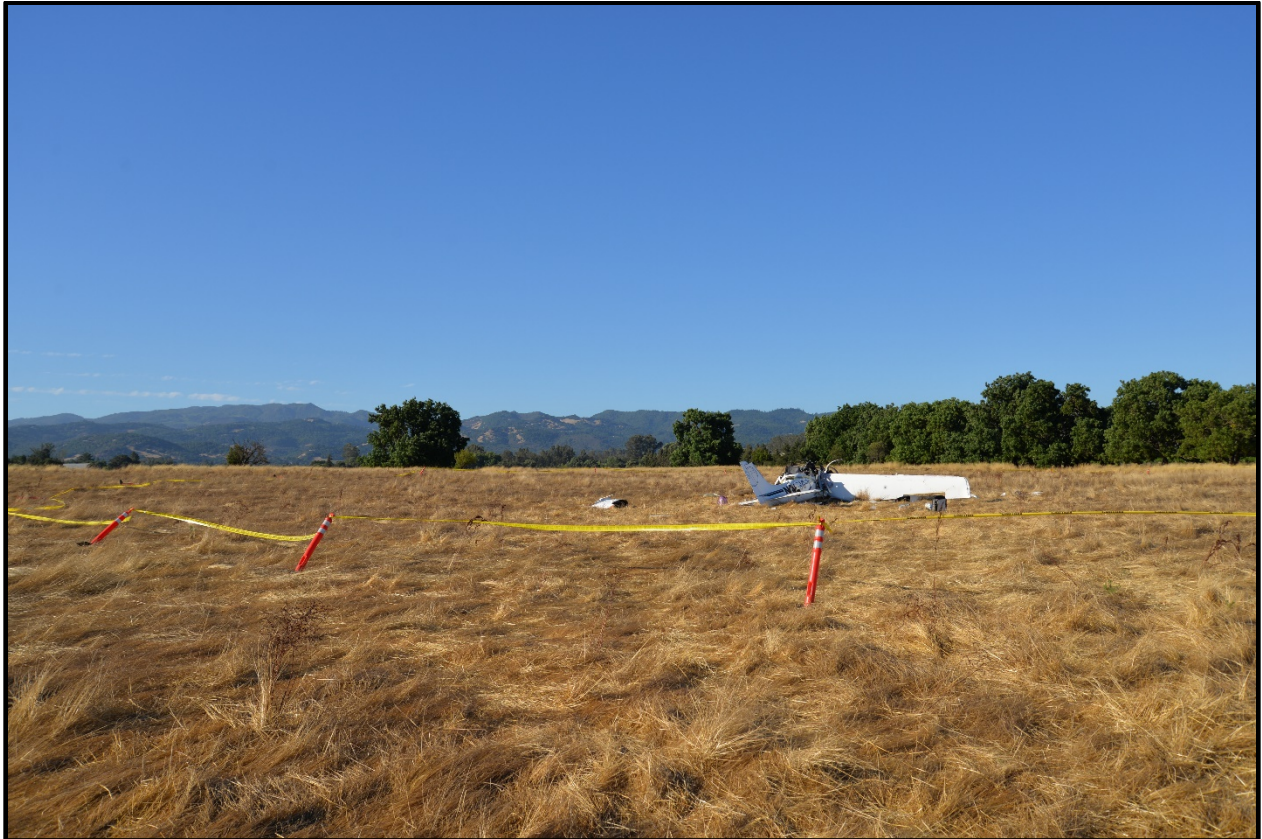
Figure 1: Airplane Wreckage Viewed from the Right Aft Side.

The fuselage came to rest on a heading of about 006° magnetic. The right wing remained partially attached and the left wing was separated. The empennage was separated from the fuselage aft of the avionics bay. Flight control continuity was established from the individual flight controls to the center portion of the cabin.

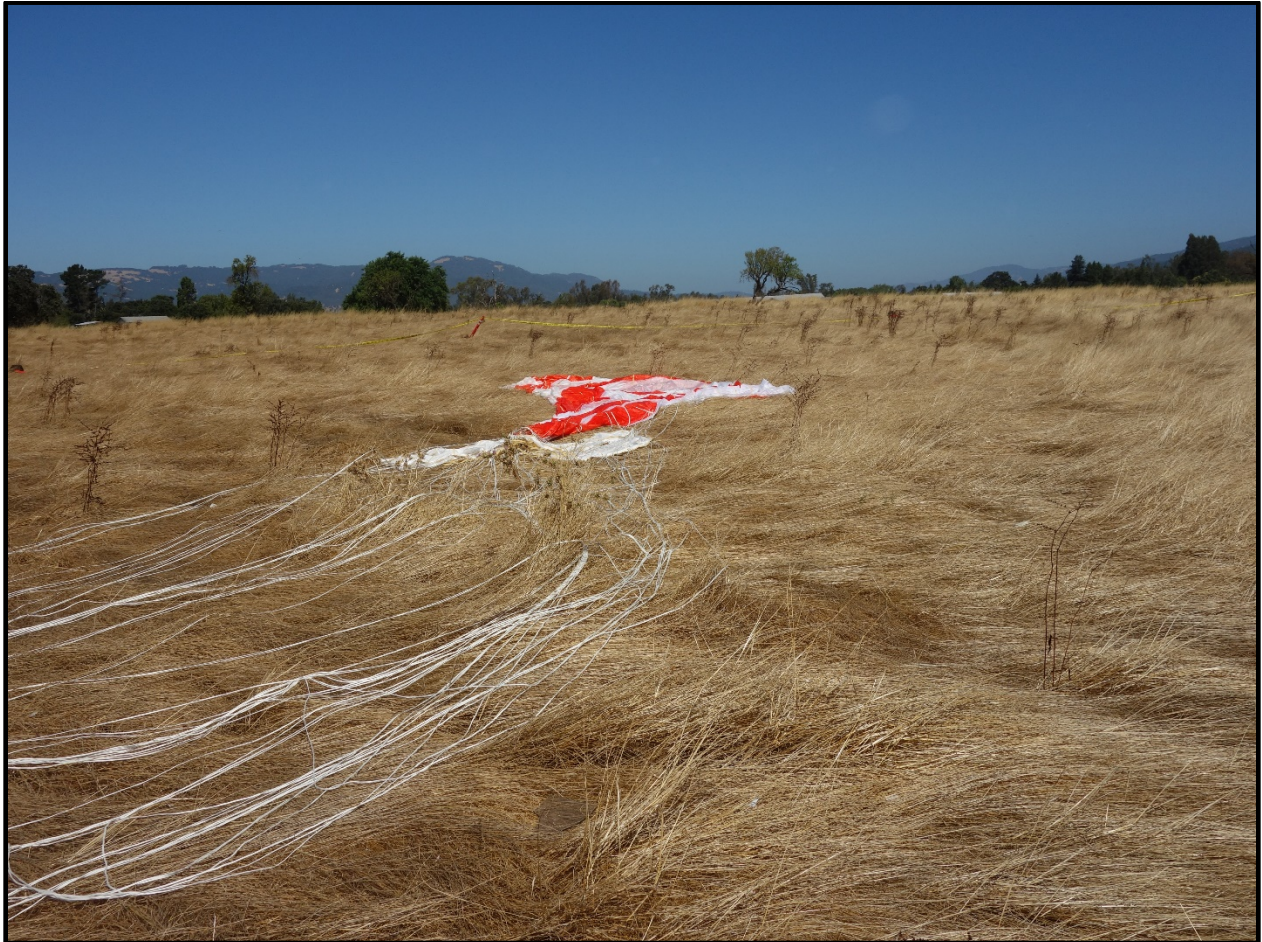
The Cirrus Aircraft Parachute System (CAPS) was found deployed. The parachute was fully extracted, and the canopy was found lying on the ground completely out of the bag. The slider was found near the canopy's skirt. All suspension lines and risers were extracted from the airplane. The aft harness remained snubbed (linked). The deployment bag and rocket motor were located about 200 ft east of the main wreckage. The rocket motor propellant was observed to be expended. The CAPS enclosure cover was located about 250 ft east of the main wreckage. The strike plate of the enclosure cover exhibited an impact mark consistent with rocket impact. The CAPS activation handle was in the holder however, the activation cable was observed fractured.

Figure 2: CAPS Parachute Spread out in Wheat Field.
