# Continental Motors

## ENGINE EXAMINATION REPORT

| ENGINE MODEL | TSIO-550-K1B |
| FILE NUMBER | 17-039 |

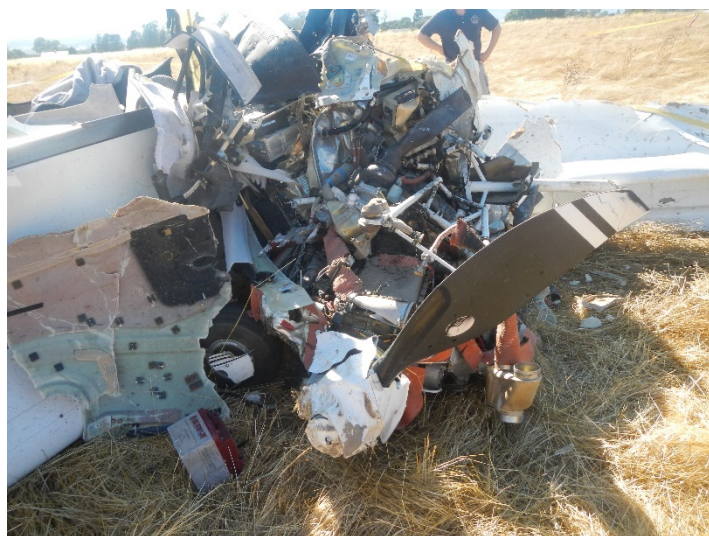
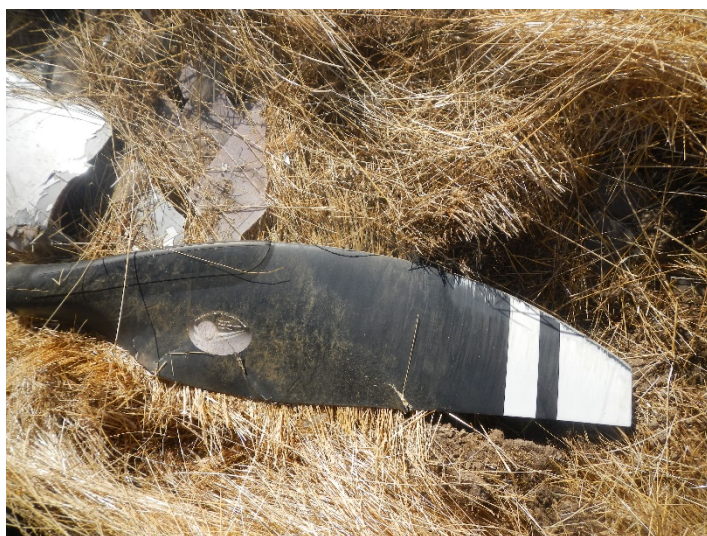
When the engine was righted, it was noted that the right magneto was separated from its mounting pad and its mounting flange was fractured in an area that coincided with the attaching hardware. The ignition harness remained attached to the magnetos, but the leads sustained impact-related pinching and tearing damage.

There were no external pre-accident anomalies noted with the engine or engine-related systems.

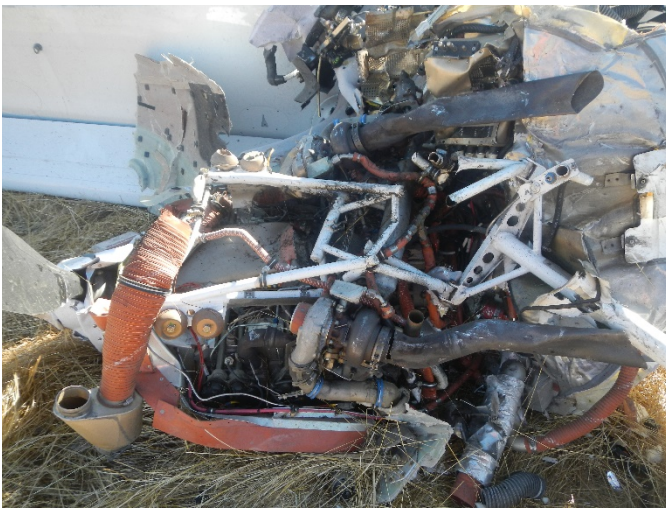
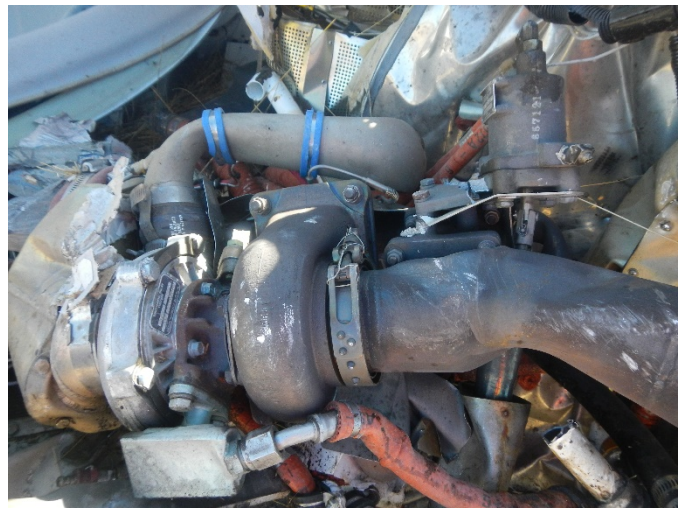
#### EXHAUST SYSTEM

The exhaust tailpipes were flattened, and the right tailpipe was fractured at the flange weld. The left and right v-band couplings remained in place on the tailpipe and turbocharger exhaust flanges. The right side exhaust risers remained intact, though they all sustained deformation damage. The left side exhaust manifold was separated from the #2 cylinder exhaust riser and the left side exhaust risers were deformed. The wastegate remained attached to the exhaust system, but the exhaust manifold was deformed and the wastegate actuator mount was fractured. There were no pre-accident anomalies noted with the system.

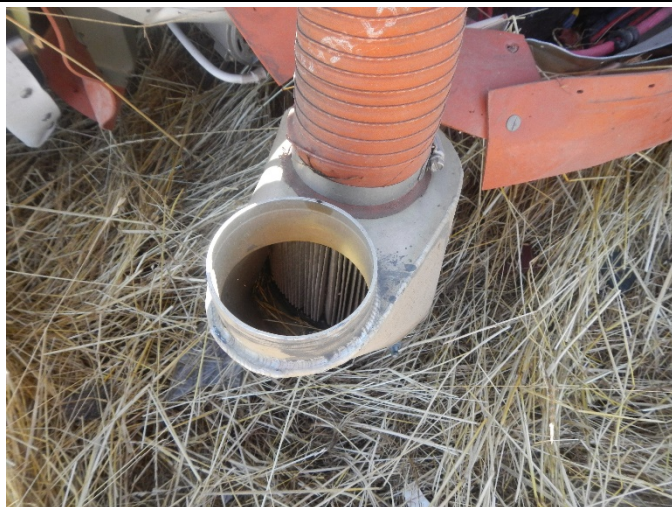
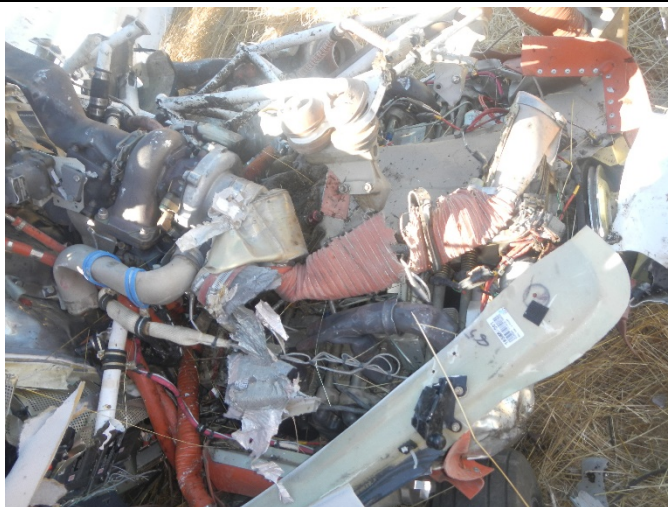
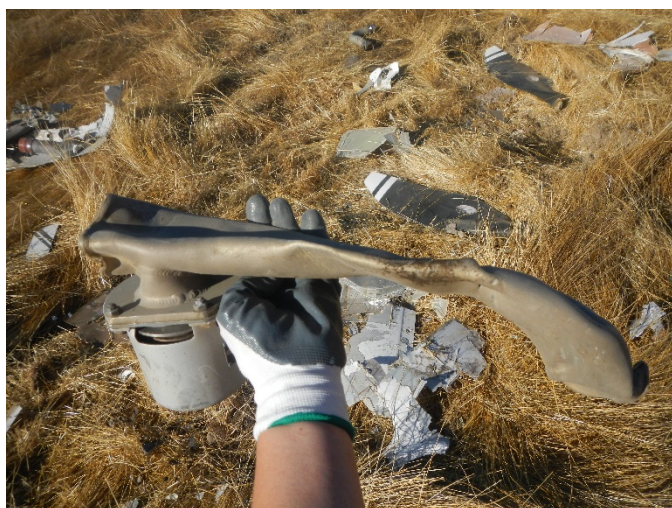
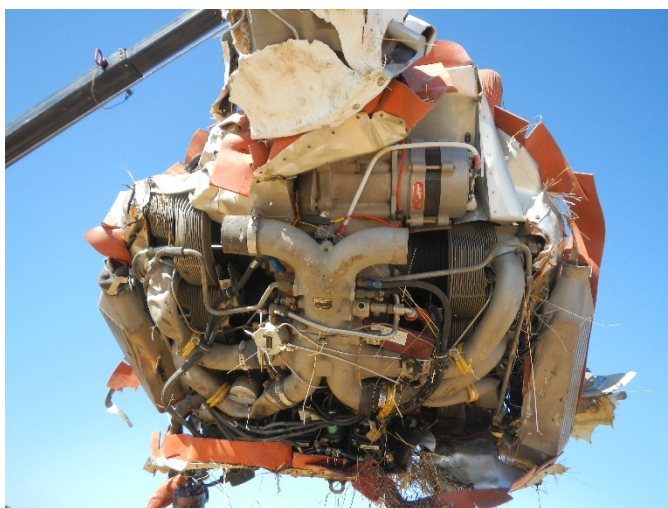
### INDUCTION SYSTEM

**Condition:** The right intake filter was separated from the turbocharger, but it remained attached to the engine via scat tubing. The filter housing was deformed, but there were no pre-accident anomalies or blockages noted. The left intake filter housing was crushed and remained in place around the left turbocharger compressor inlet. No pre-accident anomalies or blockages were noted when it was removed and inspected. The compressor outlets were separated from the tubing that led to the left and right intercoolers. There were no blockages noted in the intercoolers. The left and right intake elbows that led to the throttle body were separated from the engine. The elbow that contained the overboost valve was flattened and found near the initial impact area. There were no obstructions noted in the throttle body. The throttle lever/shaft functioned normally, with no pre-accident anomalies noted. There were no signs of induction leaks on any of the intake tubes and many sustained deformation damage. The upper deck and induction system reference lines remained in place, though some of the fittings sustained deformation or cracking damage during the accident. There were no pre-accident anomalies noted with the induction system.

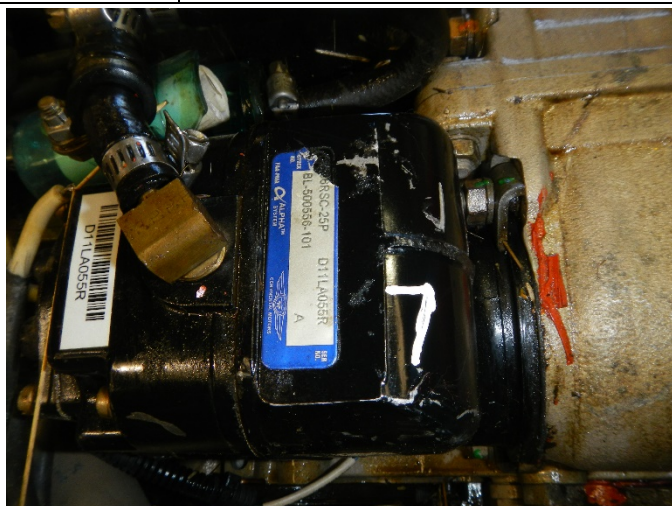
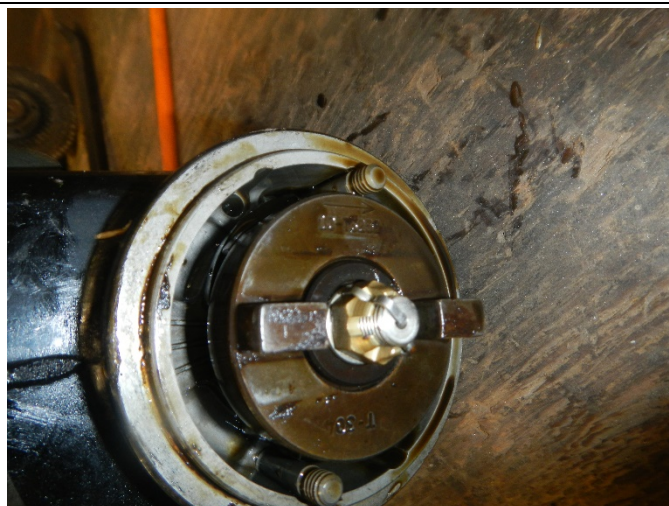
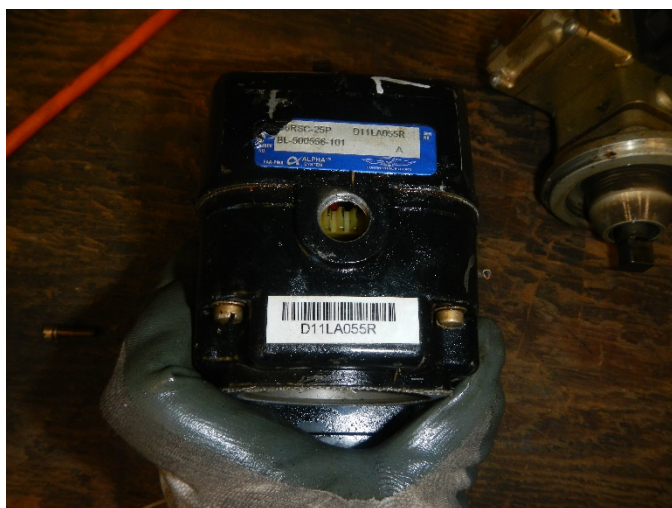
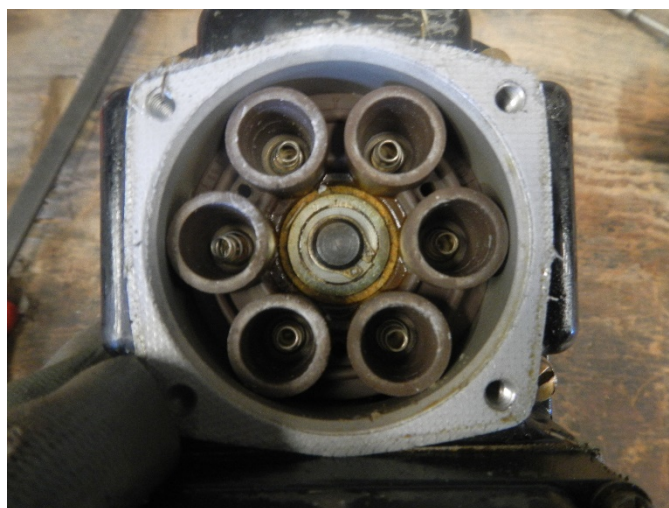
| LEFT MAGNETO | Manufacturer: Continental Motors S6RSC-25P | P/N: BL-500556-101 | S/N: D11LA055R |
|---|---|---|---|
| Condition: | The left magneto remained attached to the topside of the crankcase and manual manipulation of the magneto did not result in any slipping on the mounting pad. The ignition harness cap remained secured to the magneto as did the pressurization lines. The pressurization nozzle was removed from the magneto housing so the distributor gear teeth were visible. Rotation of the crankshaft resulted in a coinciding rotation of the distributor gear with an audible snap of the impulse coupling. All of the distributor gear teeth were intact with no pre-accident anomalies noted. The magneto produced a spark at two of the top sparkplugs from two of the intact ignition leads during crankshaft rotation. The damaged ignition harness was removed and the magneto was removed from the engine. Manual rotation of the drive shaft resulted in a spark from each of the distributor towers in firing order. | | |

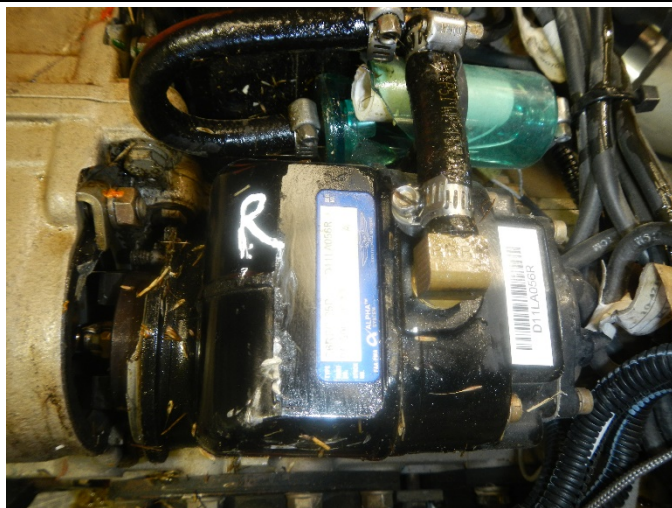
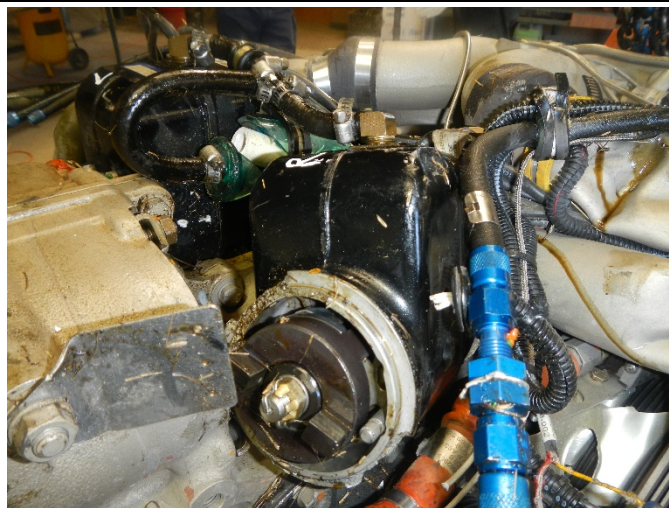
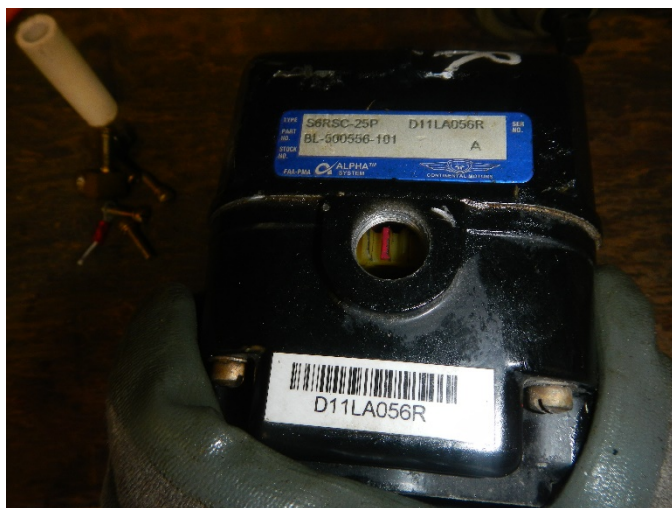
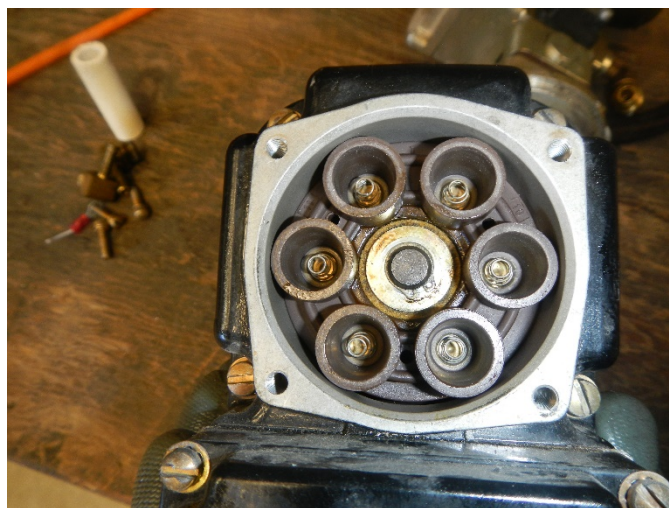
## RIGHT MAGNETO

**Condition:** The right magneto was separated from the engine and the flange was fractured in the area of the mounting hardware. The drive shaft was intact with no pre-accident anomalies noted. The pressurization line was in place. The damaged ignition harness and pressurization nozzle were removed. All of the distributor gear teeth were intact with no signs of pre-accident anomalies. The drive shaft was manually rotated and the magneto produced a spark from each of its distributor towers in firing order.

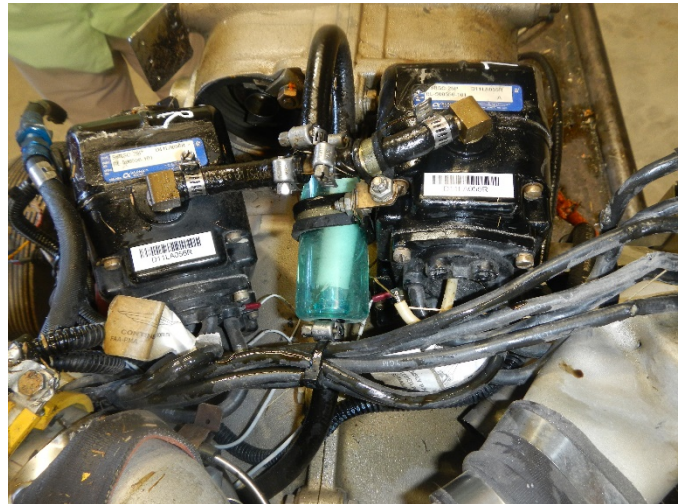
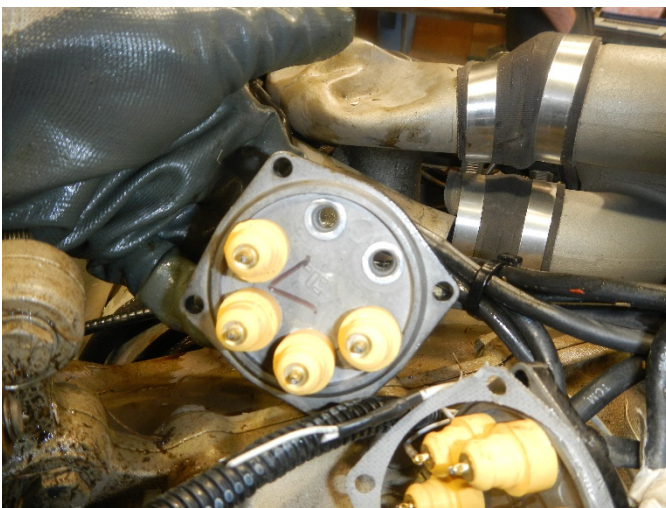
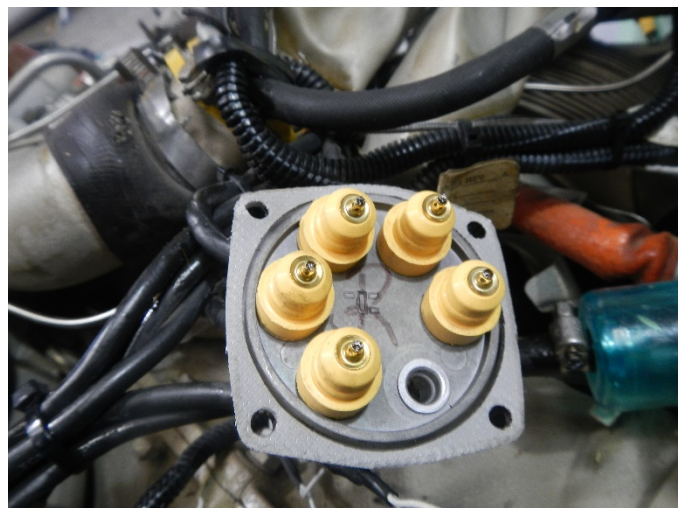
## IGNITION HARNESS

The ignition harness caps remained attached to their respective magnetos. Two leads were pulled away from the left magneto cap and one lead was pulled away from the right magneto cap. Many of the leads displayed pinching or tearing damage. The caps were removed from the magnetos and neither displayed any pre-accident anomalies or tracking.

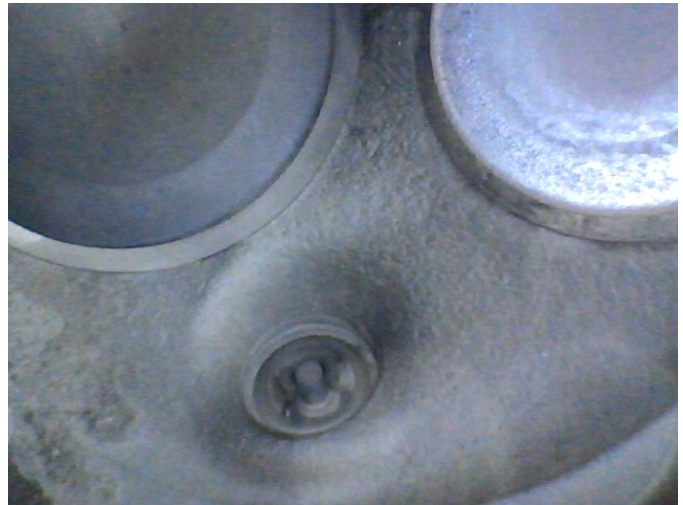
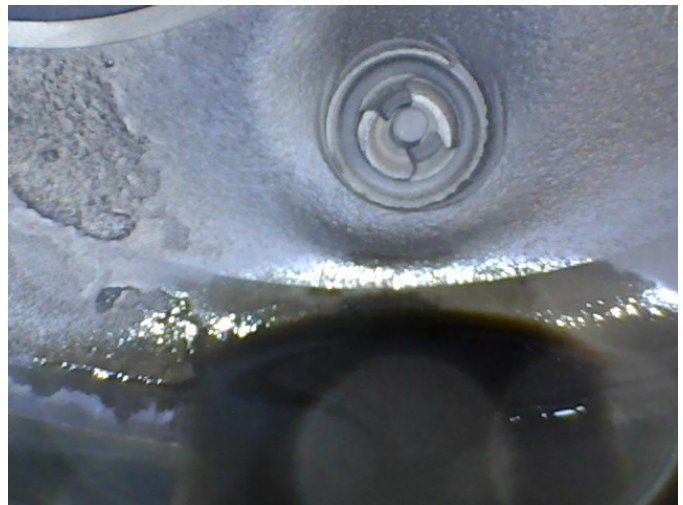
## SPARKPLUGS

The sparkplugs remained secured to their respective cylinders and the ignition terminals remained attached to the sparkplugs. Removal of the top sparkplugs' ignition terminals revealed that 4 of the 6 sparkplug insulators were fractured. The top sparkplugs were removed and all displayed normal wear with no sign of carbon or lead fouling; however, the electrode insulators were dark, which was consistent with a slightly rich fuel/air mixture. The two sparkplugs that retained intact insulators were reattached to the left magneto's intact ignition leads. The crankshaft was manually rotated and a spark was observed from each sparkplug during the snap of the impulse coupling. The bottom sparkplugs were documented with lighted borescope and are depicted in the right photo column below. The #6 bottom sparkplug was surrounded by debris that was consistent in color and consistency as separated combustion deposits.

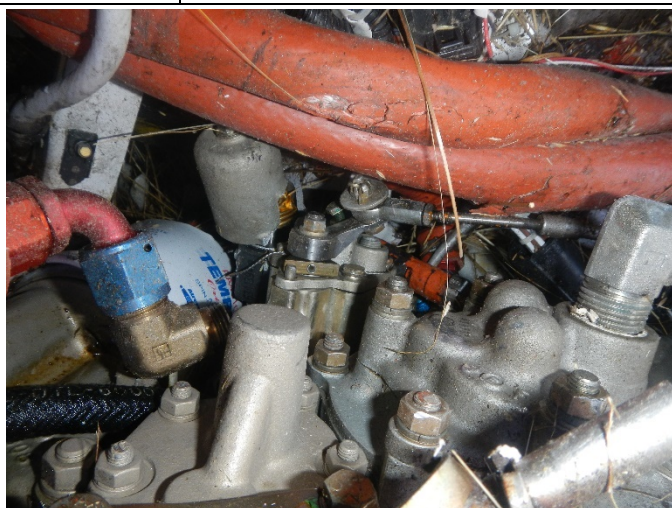
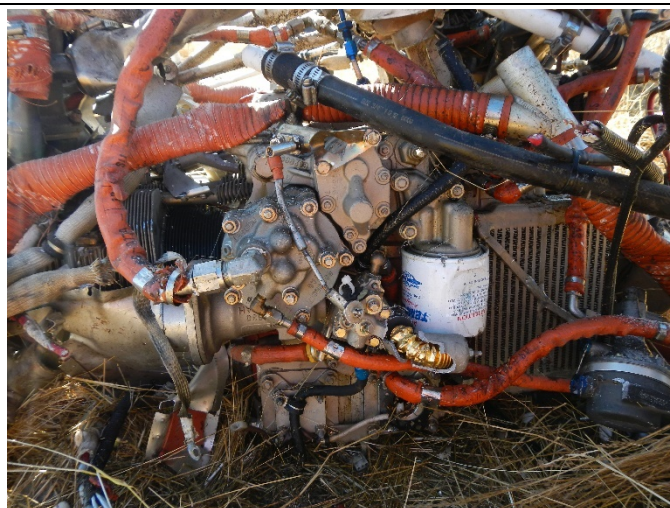
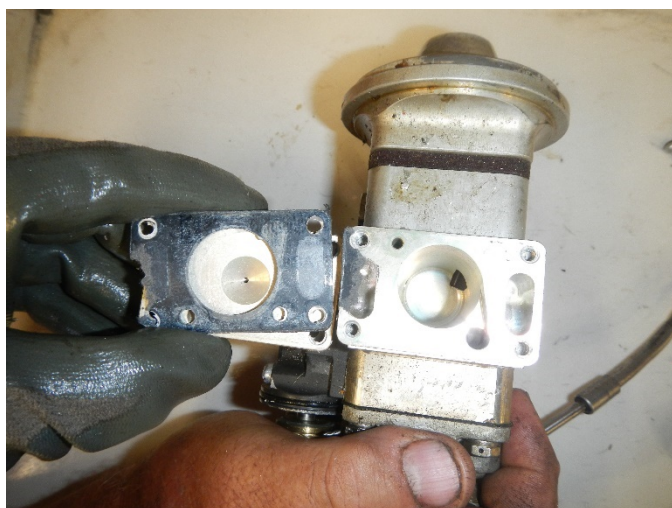
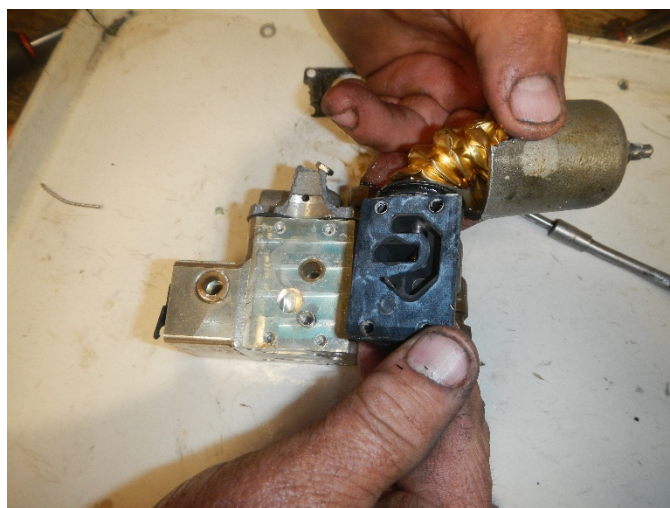
### FUEL PUMP

The fuel inlet and vapor return lines were separated from the engine-driven fuel pump and the mixture control cable rod end remained attached to the mixture control lever. The mixture control cable was separated from the rod end and the rod was bent and the lever was deformed. The aneroid bellows housing was fractured and the bellow was distorted and stretched to the side. The low pressure relief valve set screw was bent. The pump was removed from the backside of the engine and fuel consistent in color and odor as 100LL AVGAS poured from the fittings. The drive coupling was intact and manual manipulation of the coupling resulted in rotation of the drive shaft with a sucking sound emanating from the pump fittings. The pump was disassembled and the vanes were intact with no pre-accident anomalies noted. The pump was clean with no signs of contamination.

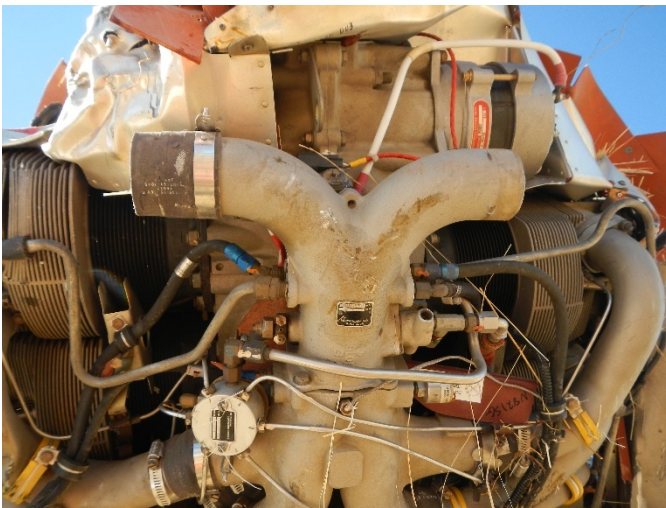
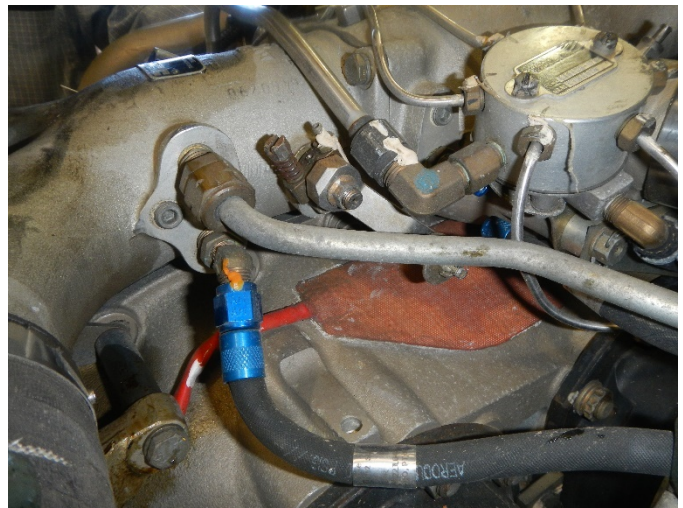
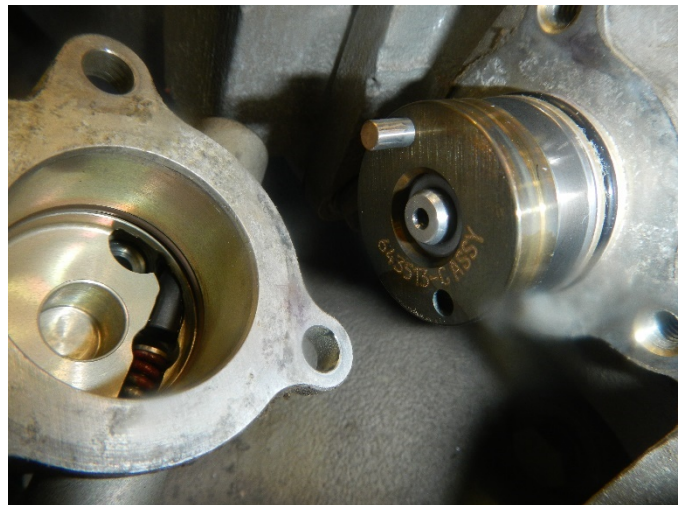
### THROTTLE BODY METERING UNIT

The throttle body remained attached to the topside of the engine with no pre-impact anomalies or signs of fuel leakage noted. The flange attaching the throttle body to the plenum was cracked on the left side and the throttle body mount was damaged. The throttle cable remained attached to the throttle lever. The throttle lever was manipulated after the cable was disconnected and the throttle shaft rotated with no signs of slipping noted. The throttle shaft was bent slightly. The reference lines to and from the throttle body remained secured as did the fuel lines; however, the upper deck reference fitting on the left side was cracked and the reference line was displaced down toward the cylinders. Fuel was present in the lines to and from the fuel metering unit. Disassembly of the fuel metering unit revealed no pre-accident anomalies and fuel was present in the metering unit.

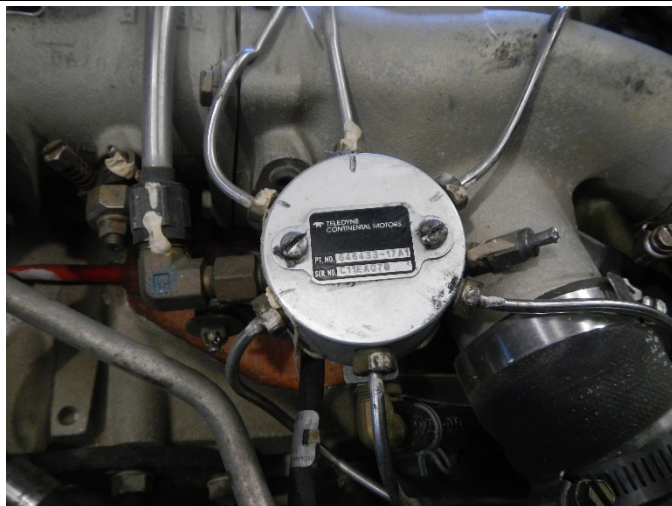
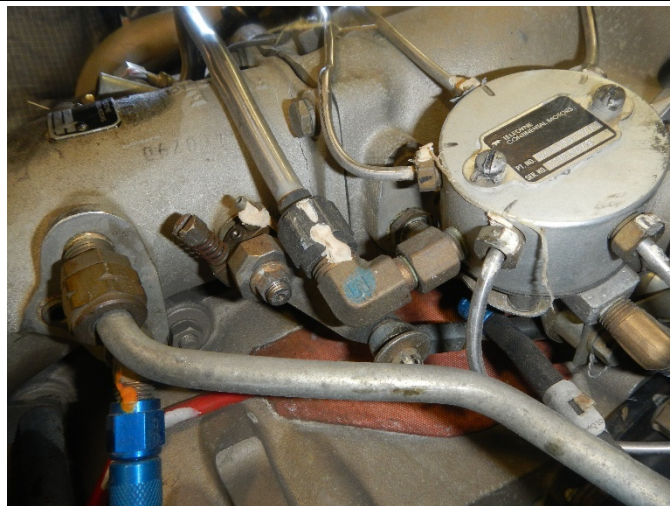
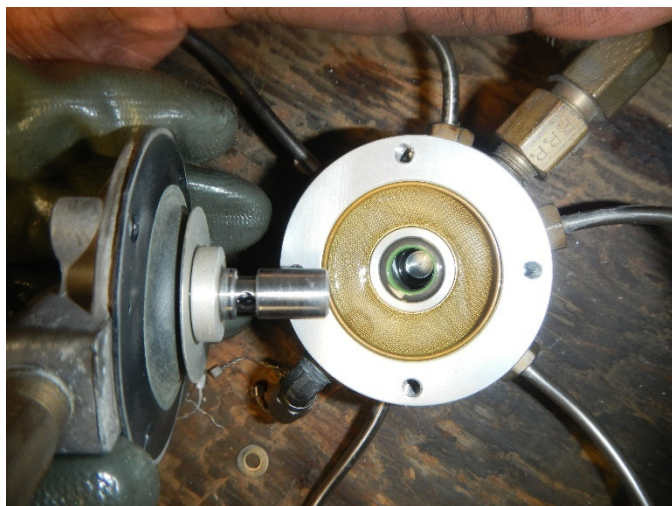
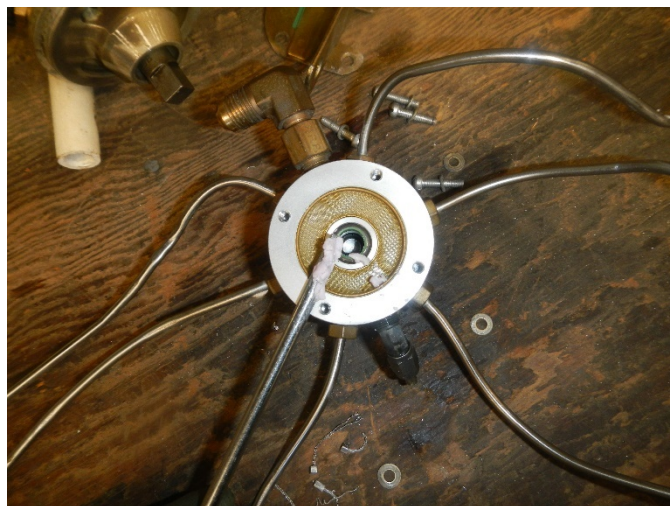
## FUEL MANIFOLD VALVE

**Condition:** The fuel manifold valve remained secured on the topside of the engine with the fuel injection lines intact. Fuel was present in the line between the fuel metering unit and the fuel manifold valve. Disassembly of the fuel manifold valve revealed it was full of fuel, the screen was clear, and the diaphragm and plunger were in place with no pre-accident anomalies noted with any of the internal components. There was no indication of water contamination when a water detecting paste was placed in the fuel found in the fuel manifold valve.

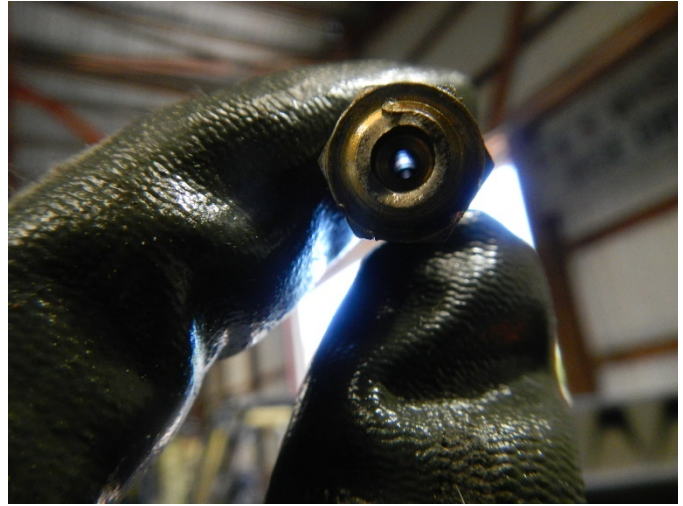
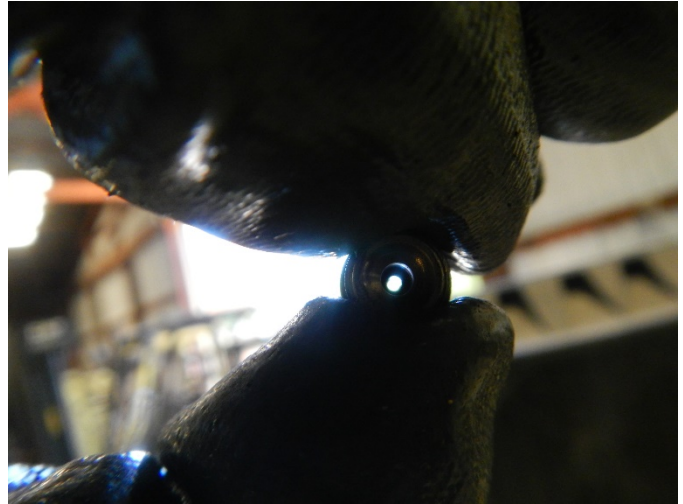
### FUEL NOZZLES AND LINES

The fuel injection lines remained in place and intact though they received deformation damage. All of the fuel injector nozzles remained attached to the lines, though the #1 fuel injector nozzle was fractured where it threaded into the cylinder. The upper deck reference line remained secured to each nozzle, but it sustained deformation damage. No pre-accident anomalies were noted externally. The nozzles were removed from their respective cylinders and all were clear and free from any obstructions

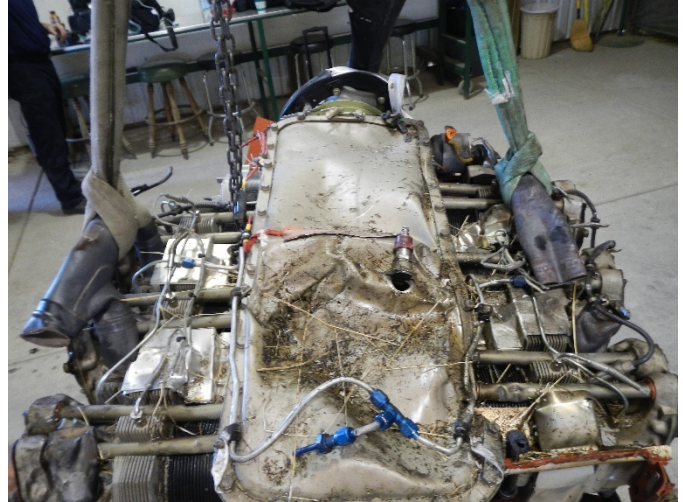
#### OIL SUMP

The oil sump drain plug was displaced and the oil sump was breached. The oil sump was displaced up toward the bottom of the engine.

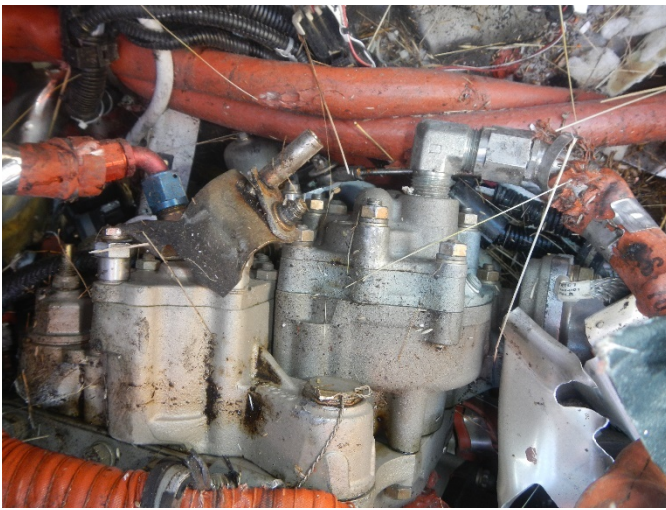
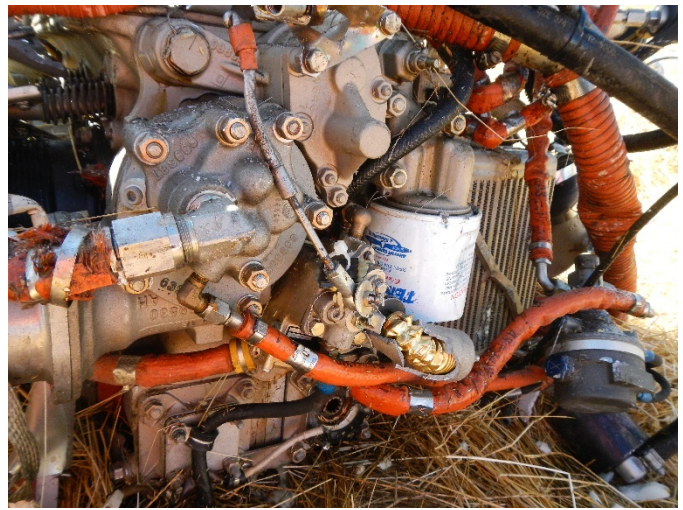
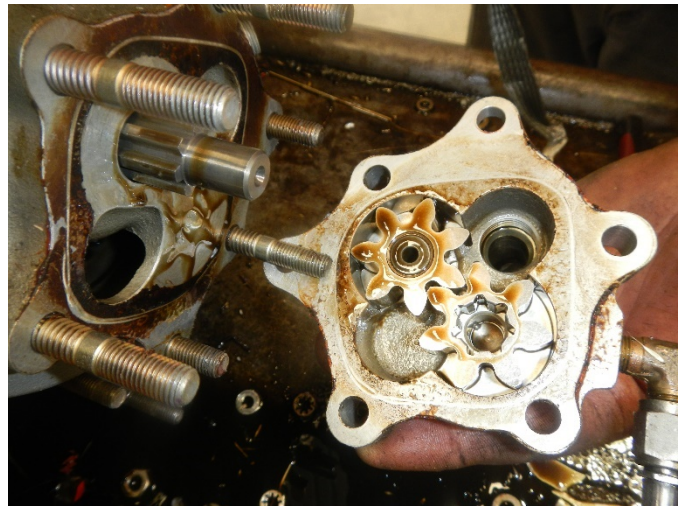
### OIL PUMPS

The engine oil supply pump remained attached to the backside of the engine with no signs of oil leaks noted. The oil pump housing cap was removed and residual oil coated the internal components with no signs of lubrication distress or pre-accident anomalies. The oil pressure relief valve did not display any evidence of unusual seating.

The oil scavenge pump was in place on the backside of the starter adapter with no signs of an oil leak noted. Removal of the housing cap revealed residual oil coating the internal components with no signs of lubrication distress or pre-accident anomalies.

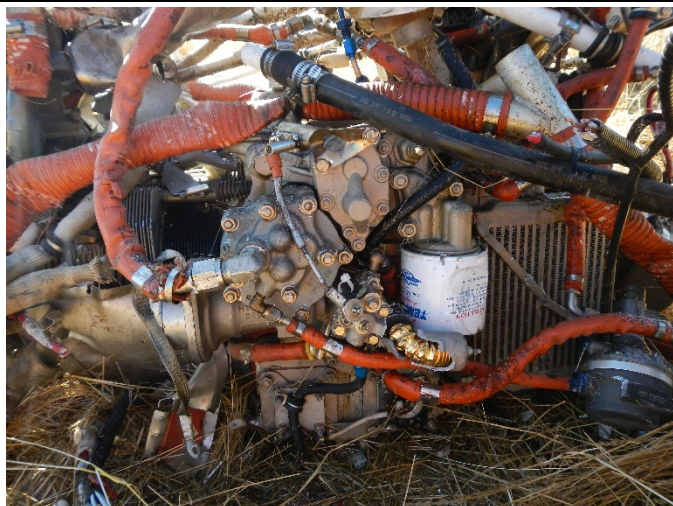
## OIL FILTER

Condition: The oil filter remained in place on the adapter and the safety-wire was intact. Residual oil poured out from the filter with no pre-accident anomalies noted.

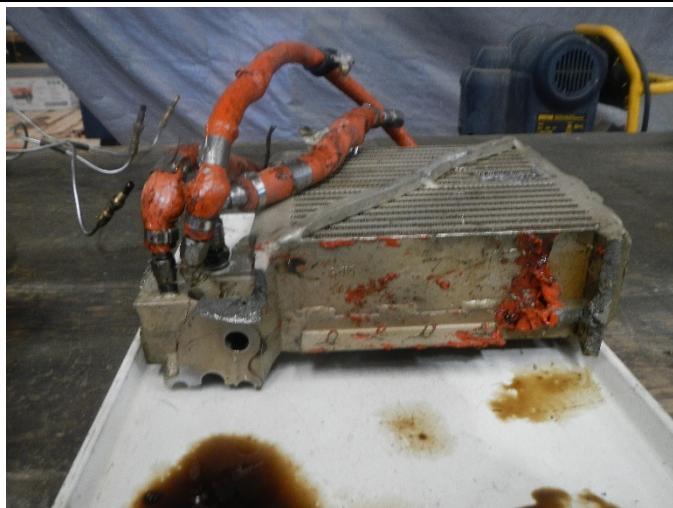
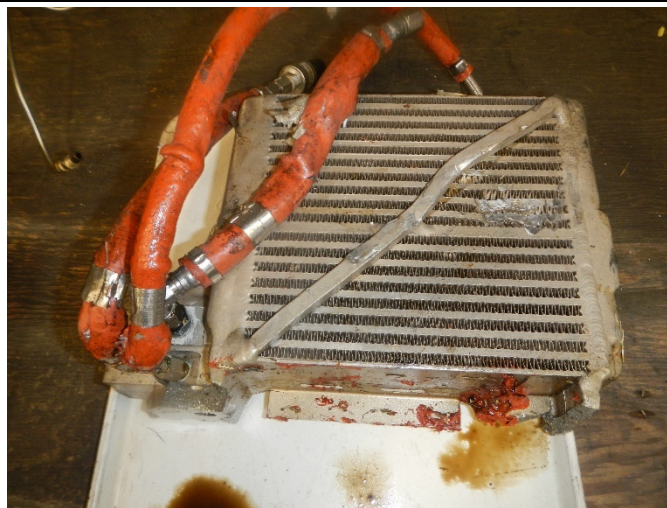
## OIL COOLER

Condition: The oil cooler remained in place on the backside of the engine, but its mounting system was fractured and the cooler could be pulled away from the engine without removing its mounting hardware. The cooler sustained impact-related deformation damage, but was otherwise unremarkable.

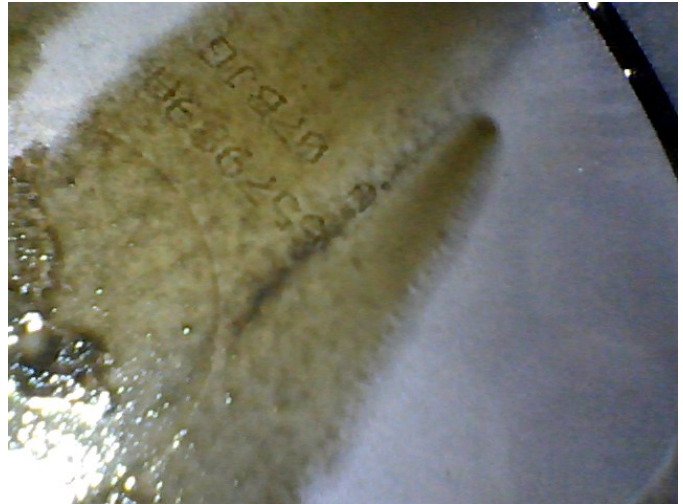
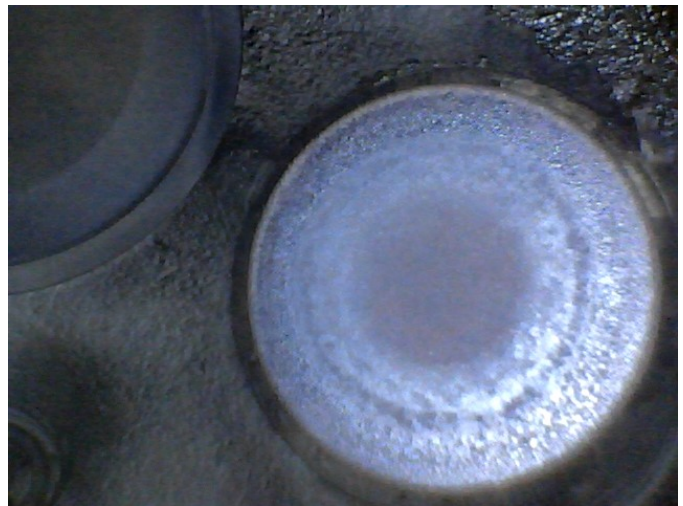
#### CYLINDER #1

Condition: The cylinder remained attached to the crankcase with no external signs of operational distress noted. The rocker covers were removed and no pre-accident anomalies were noted with the valve springs or rockers. Residual oil coated the overhead components. The top sparkplug was removed and a borescope inspection of the cylinders was conducted and documented. No pre-accident anomalies were noted with the piston, barrel, valves or valve seats. Thumb compression was obtained and valve train continuity was confirmed during rotation of the crankshaft.

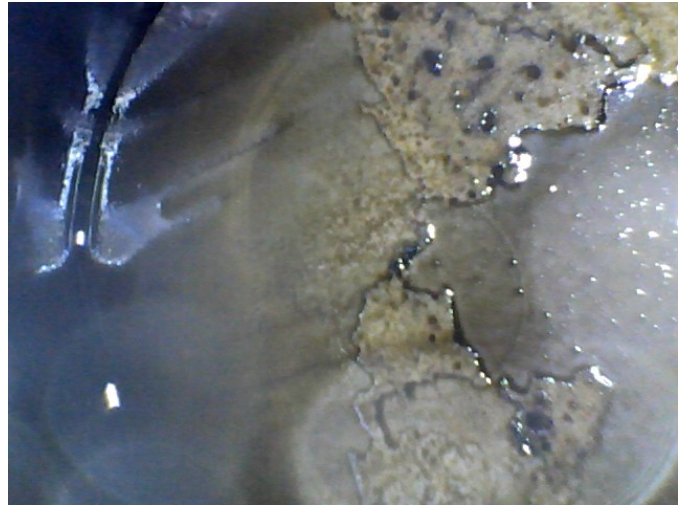
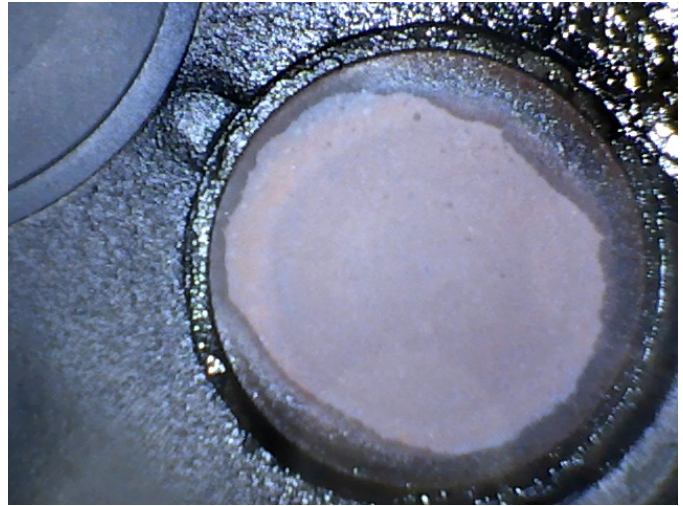
### CYLINDER #3

Condition: The cylinder remained attached to the crankcase with no external signs of operational distress noted. The rocker covers were removed and no pre-accident anomalies were noted with the valve springs or rockers. Residual oil coated the overhead components. The top sparkplug was removed and a borescope inspection of the cylinders was conducted and documented. No pre-accident anomalies were noted with the piston, barrel, valves or valve seats. Thumb compression was obtained and valve train continuity was confirmed during rotation of the crankshaft.

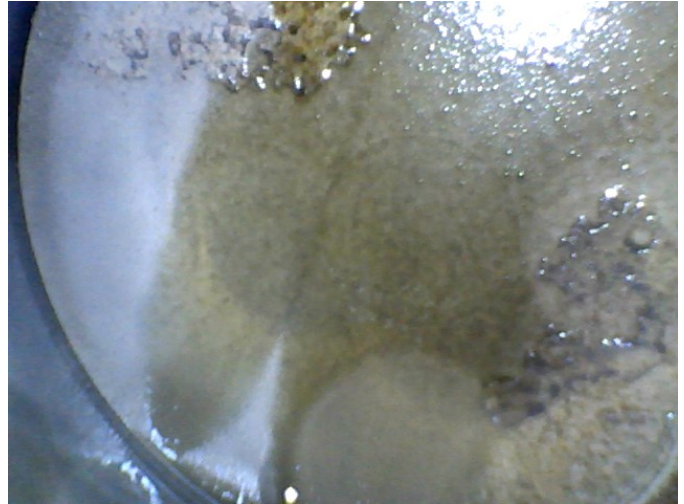
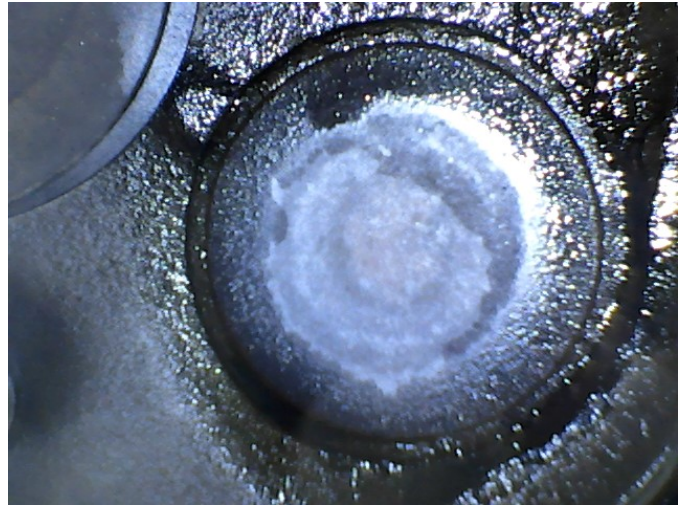
### CYLINDER #5

Condition: The cylinder remained attached to the crankcase with no external signs of operational distress noted. The rocker covers were removed and no pre-accident anomalies were noted with the valve springs or rockers. Residual oil coated the overhead components. The top sparkplug was removed and a borescope inspection of the cylinders was conducted and documented. No pre-accident anomalies were noted with the piston, barrel, valves or valve seats. Thumb compression was obtained and valve train continuity was confirmed during rotation of the crankshaft.

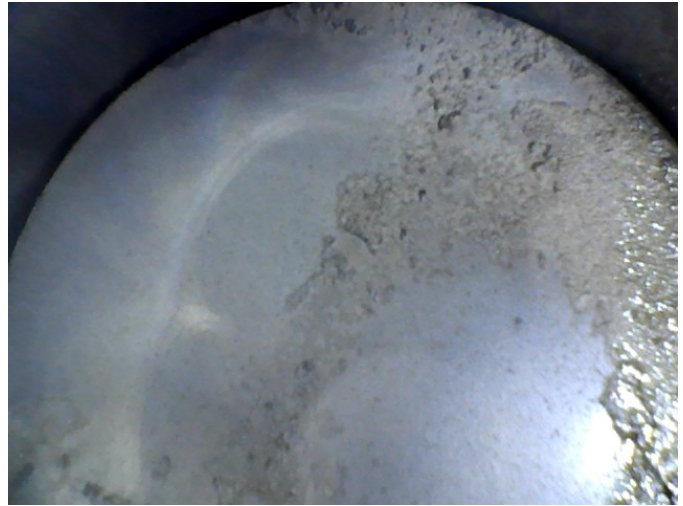
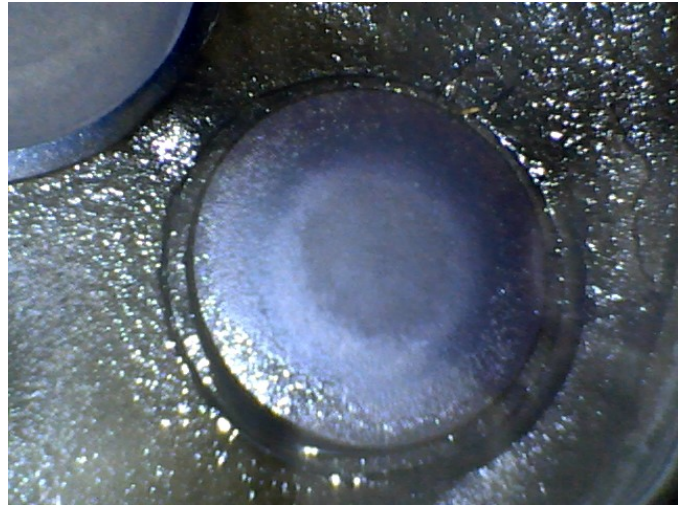
### CYLINDER #2

Condition: The cylinder remained attached to the crankcase with no external signs of operational distress noted. The rocker covers were removed and no pre-accident anomalies were noted with the valve springs or rockers. Residual oil coated the overhead components. The top sparkplug was removed and a borescope inspection of the cylinders was conducted and documented. No pre-accident anomalies were noted with the piston, barrel, valves or valve seats. Thumb compression was obtained and valve train continuity was confirmed during rotation of the crankshaft.

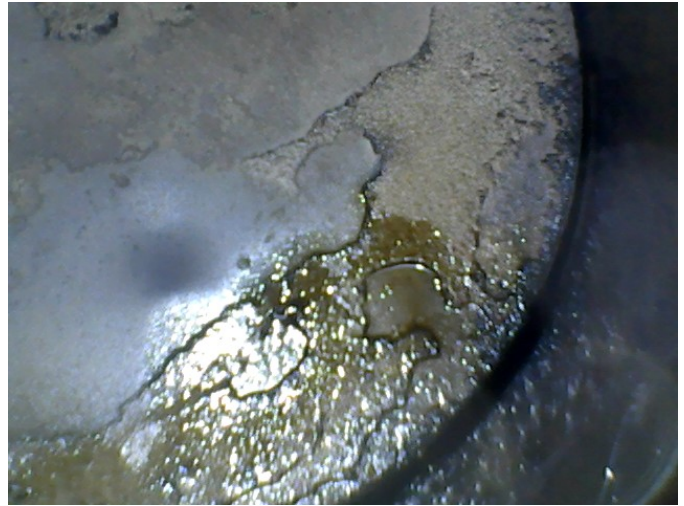
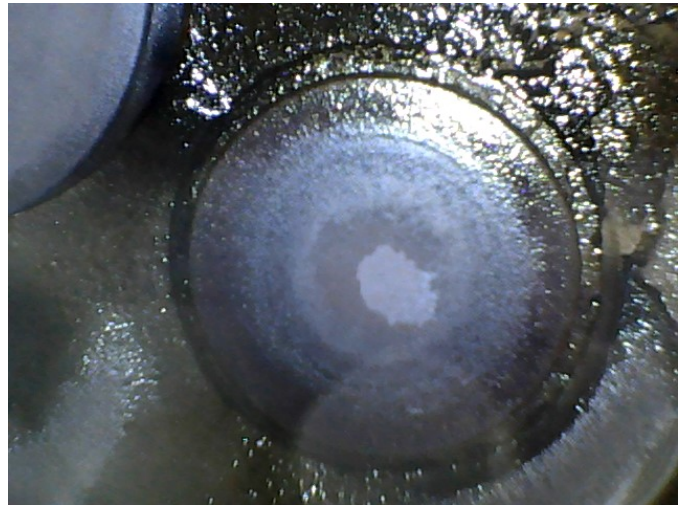
### CYLINDER #4

Condition: The cylinder remained attached to the crankcase with no external signs of operational distress noted. The rocker covers were removed and no pre-accident anomalies were noted with the valve springs or rockers. Residual oil coated the overhead components. The top sparkplug was removed and a borescope inspection of the cylinders was conducted and documented. No pre-accident anomalies were noted with the piston, barrel, valves or valve seats. Thumb compression was obtained and valve train continuity was confirmed during rotation of the crankshaft.

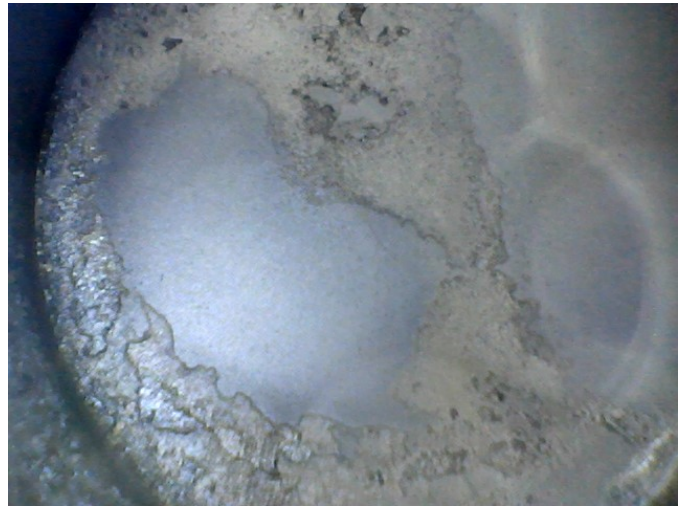
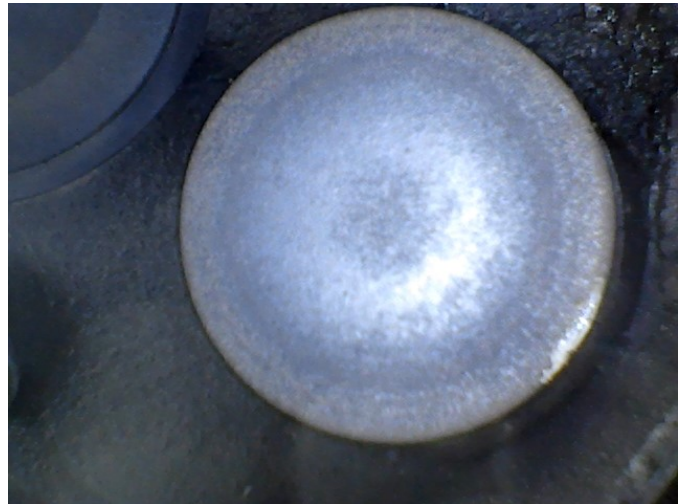
### CYLINDER #6

Condition: The cylinder remained attached to the crankcase with no external signs of operational distress noted. The cooling fins on the topside sustained cracking and displacement damage. The rocker covers were removed and no pre-accident anomalies were noted with the valve springs or rockers. Residual oil coated the overhead components. The top sparkplug was removed and a borescope inspection of the cylinders was conducted and documented. No pre-accident anomalies were noted with the piston, barrel, valves or valve seats. Debris consistent with loose combustion deposits were noted on the bottom of the cylinder and around the bottom sparkplug. Thumb compression was obtained and valve train continuity was confirmed during rotation of the crankshaft.

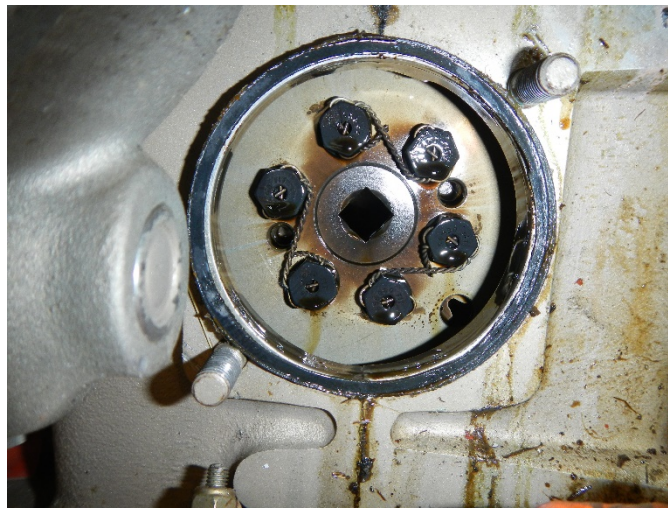
The crankshaft remained intact and continuity was confirmed from the propeller flange aft to the crankshaft gear and out to each connecting rod and piston during crankshaft rotation. No binding or pre-accident anomalies were noted.
