# Continental Motors

## ENGINE EXAMINATION REPORT

| ENGINE MODEL | TSIO-550-K1B |
| FILE NUMBER | 17-039 |

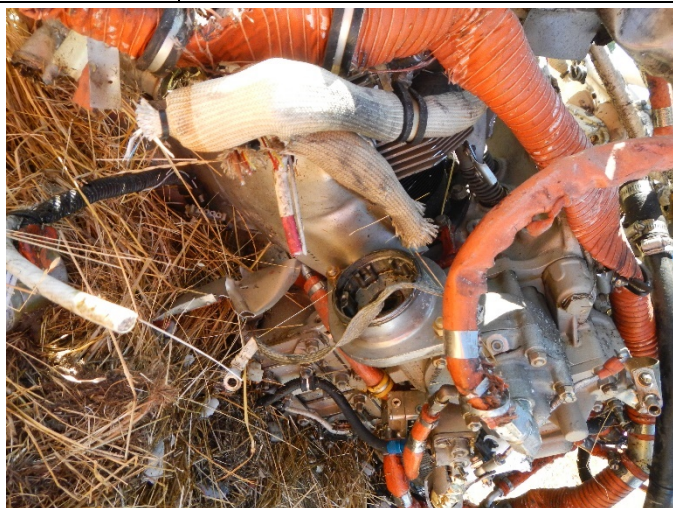
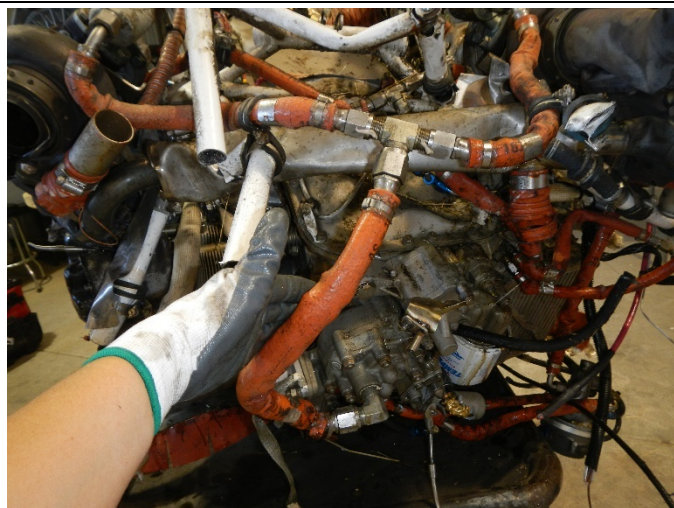
| <b>STARTER</b> | Manufacturer: Energizer | P/N: Not Recorded | S/N: Not Recorded |

| Condition: | The starter motor was separated from the adapter and the mounting flange remained intact but the motor housing was fractured and separated. No pre-accident anomalies were noted with the unit. | | |
| Condition: | The starter adapter remained attached to the back side of the engine with no pre-accident anomalies or oil leaks noted. The scavenge pump housing and oil line remained in place. | | |

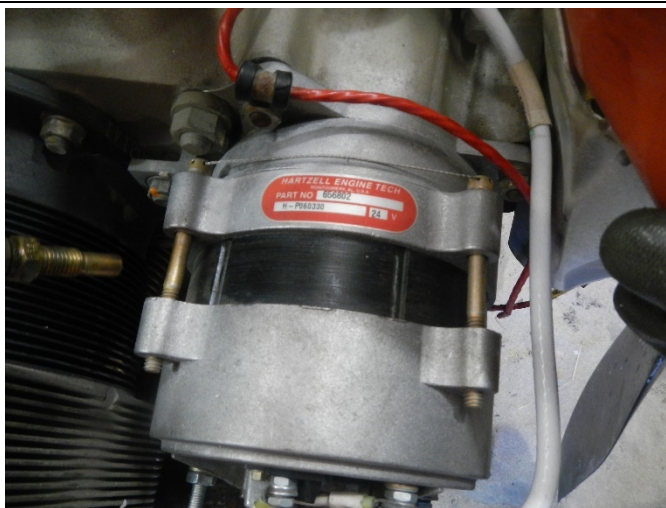
| <b>ALT/GEN #1</b> | Manufacturer: Hartzell | P/N: 656802 | S/N: H-P060330 |

| Condition: | The engine-driven alternator remained in place on the front right side of the engine and no pre-accident anomalies were noted externally with the unit. | | |

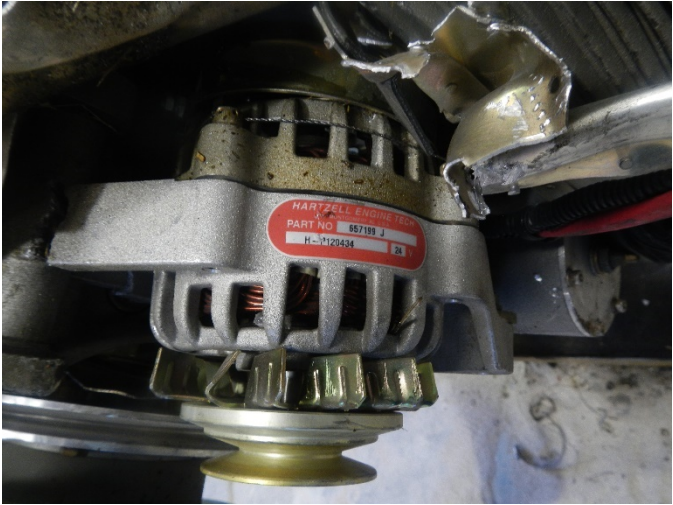
| ALT/GEN #2 | Manufacturer: Hartzell | P/N: 657199 J | S/N: H-P120434 |

| Condition: | The belt-driven alternator remained in place on the front left side of the engine with no pre-accident anomalies noted. | | |

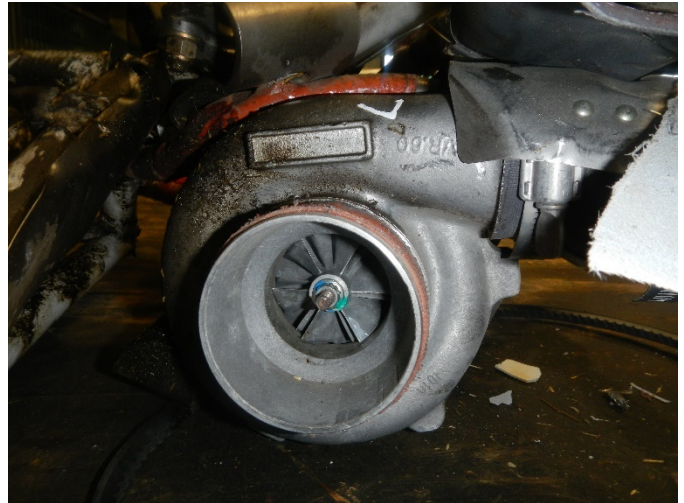
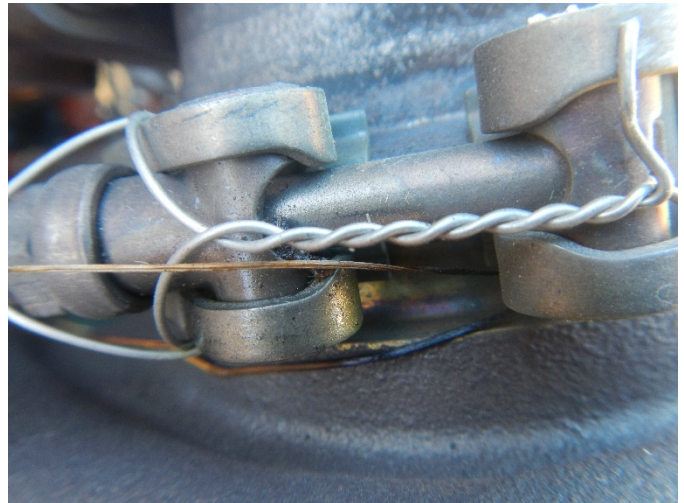
## LEFT TURBOCHARGER

The turbocharger remained attached to the engine mount system and the inlet filter was deformed around the compressor inlet. The filter housing was removed and the compressor and shroud did not reveal any pre-accident anomalies. The oil supply and return lines for the turbocharger bearing remained in place with no signs of leaking. Burnt grass was observed on the v-band clamp area of the turbine shroud. The compressor was manually manipulated and the compressor rotated freely with no binding noted.

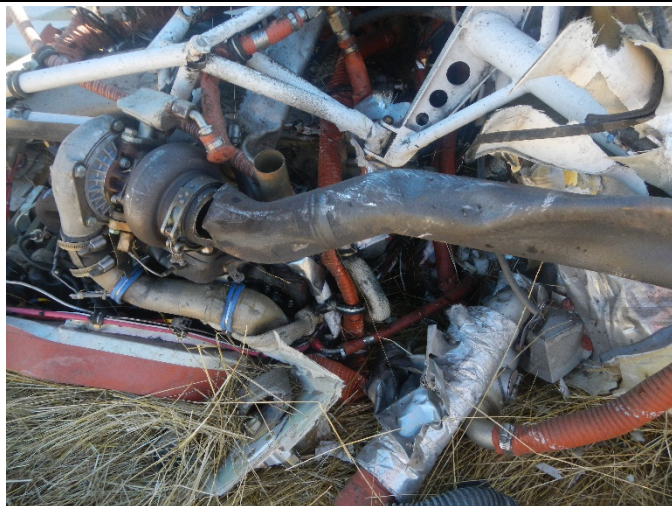
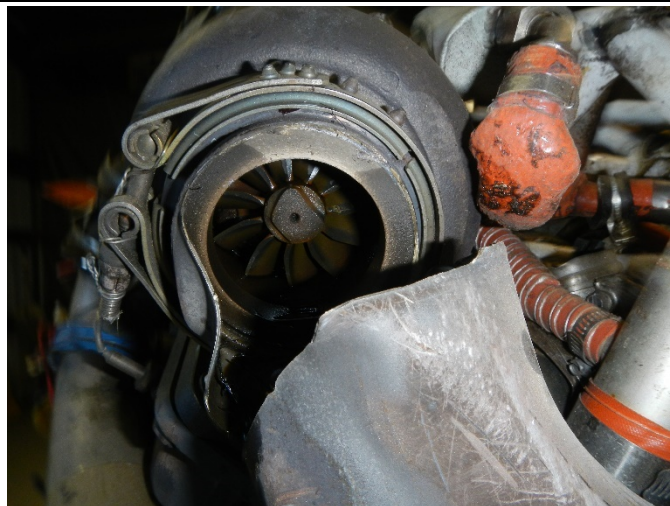
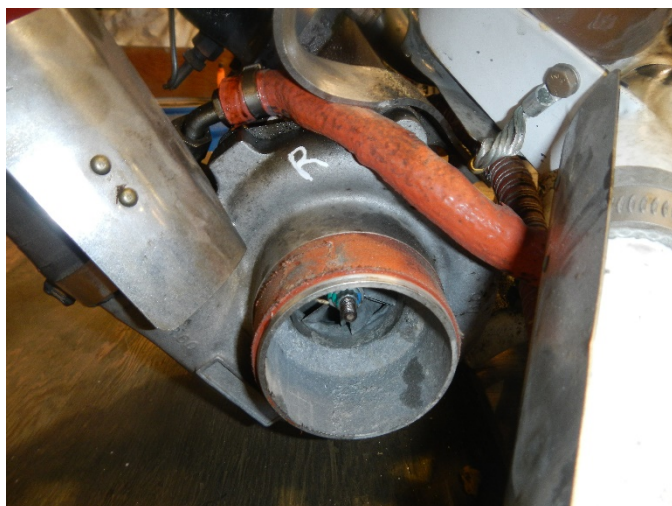
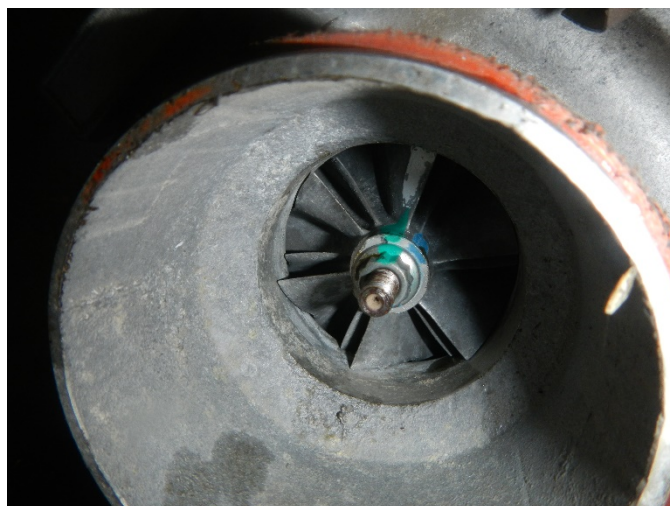
## RIGHT TURBOCHARGER

The right turbocharger remained attached to the engine mount system. The exhaust tailpipe was fractured aft of the v-band coupling. The oil supply and return lines for the turbocharger bearing remained in place with no signs of leaking. The compressor was manually manipulated and the compressor rotated freely with a coinciding rotation of the turbine.

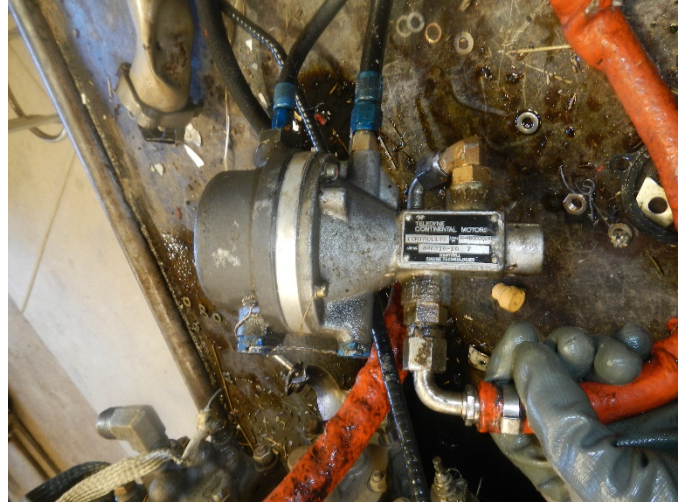
## TURBO CONTROLLER

The pressure controller was separated from the firewall but the oil and reference lines to and from the controller remained intact and in place.

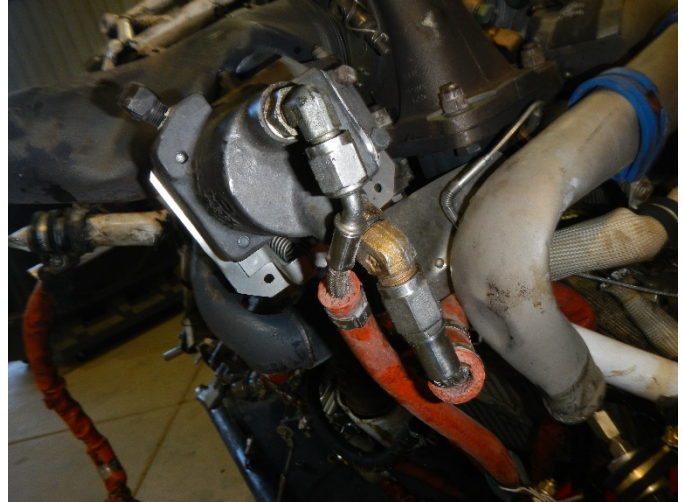
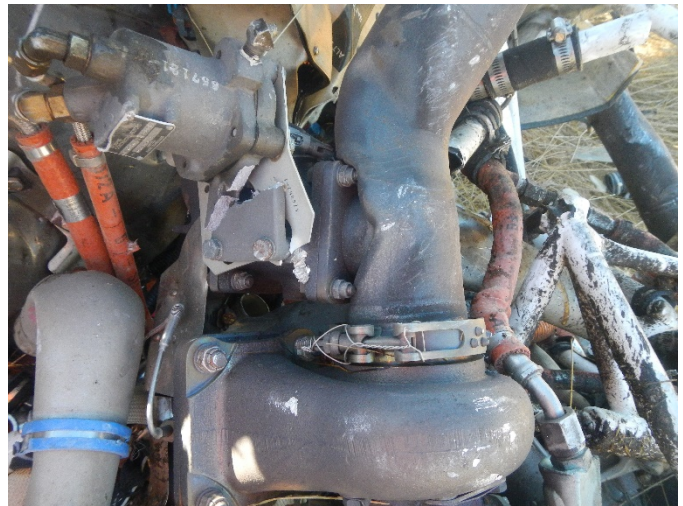
## WASTEGATE

Condition: The wastegate actuator linkage remained intact and the oil lines to and from the actuator remained in place and intact. The mount for the wastegate actuator was fractured and the linkage was displaced slightly. Compressed air was applied to the actuator ports with actuation noted.

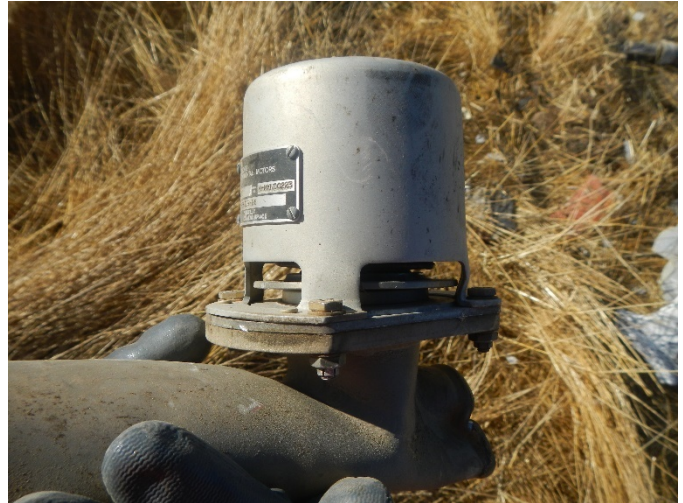
### OVERBOOST VALVE

The intake tube and overboost valve were separated from the induction system. It was found near the initial impact area and the tube was flattened. No pre-accident anomalies were noted with the unit and the spring and poppet remained intact.

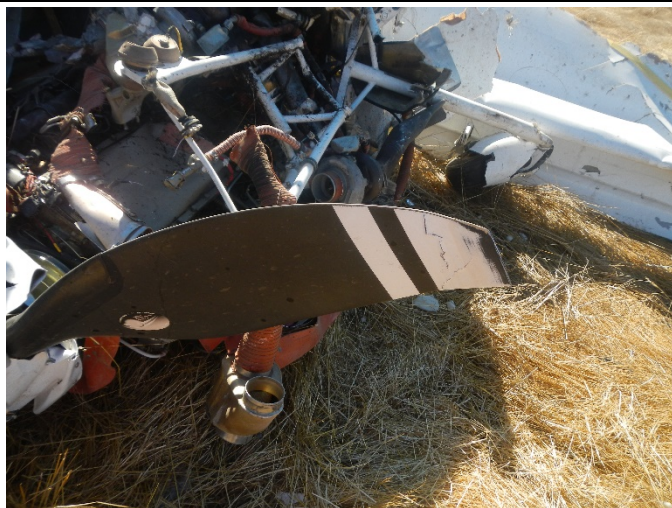
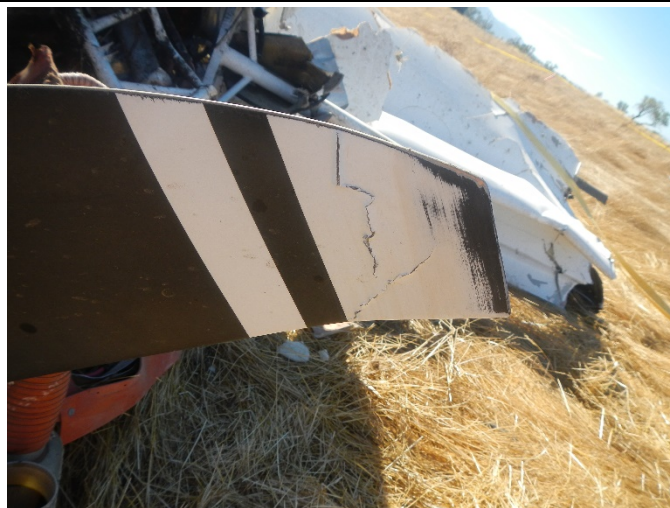
**PROPELLER**

The three-bladed composite propeller remained attached to the crankshaft and two of the blades were separated from the hub and were found near the initial impact area. One of the separated blades displayed leading edge and chord-wise paint erosion. The other separated blade displayed a split along the leading edge near the blade root, but otherwise remained relatively undamaged. The blade that remained attached to the hub was displaced forward at the tip and displayed light chord-wise paint erosion at the tip. The propeller spinner was crushed aft around the hub and was slightly displaced toward one side with the tip folded over the hub
