# **NATIONAL TRANSPORTATION SAFETY BOARD**

## **Aerial Imagery Factual Report**

### **A. ACCIDENT                      WPR17FA151**

Location:                      Marineland, Fl.  
Date:                              July 13, 2017  
Time:                              2258 Eastern Daylight Time (EDT)  
Event:                              N2173S, PA44-180, Inflight Breakup

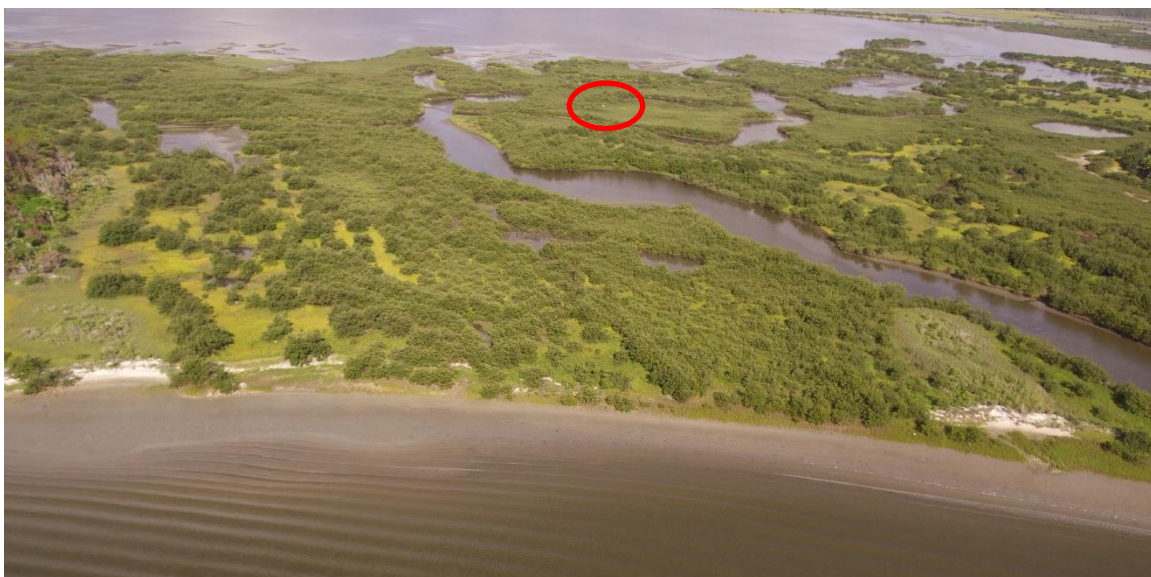
**Figure 1 – View of search area from east side of river. Circle indicates left wing.**

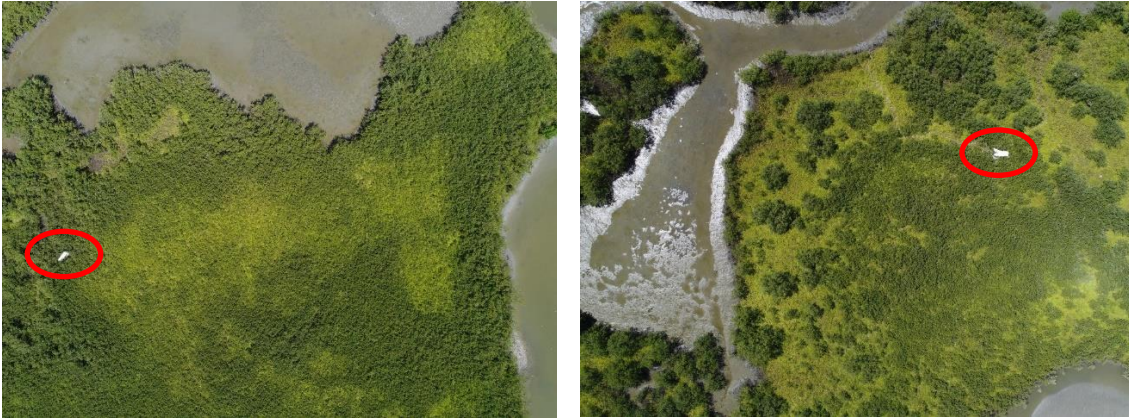
Approximately 330 still photographs were taken. Initially no processing was performed in the interest of time. The UAS pilot and NTSB airworthiness investigator reviewed raw imagery on a laptop screen in shade and quickly identified the wings. See Figures 3 and 4.

**Figures 3 and 4 – Left Wing and Right Wing in unprocessed photos.**

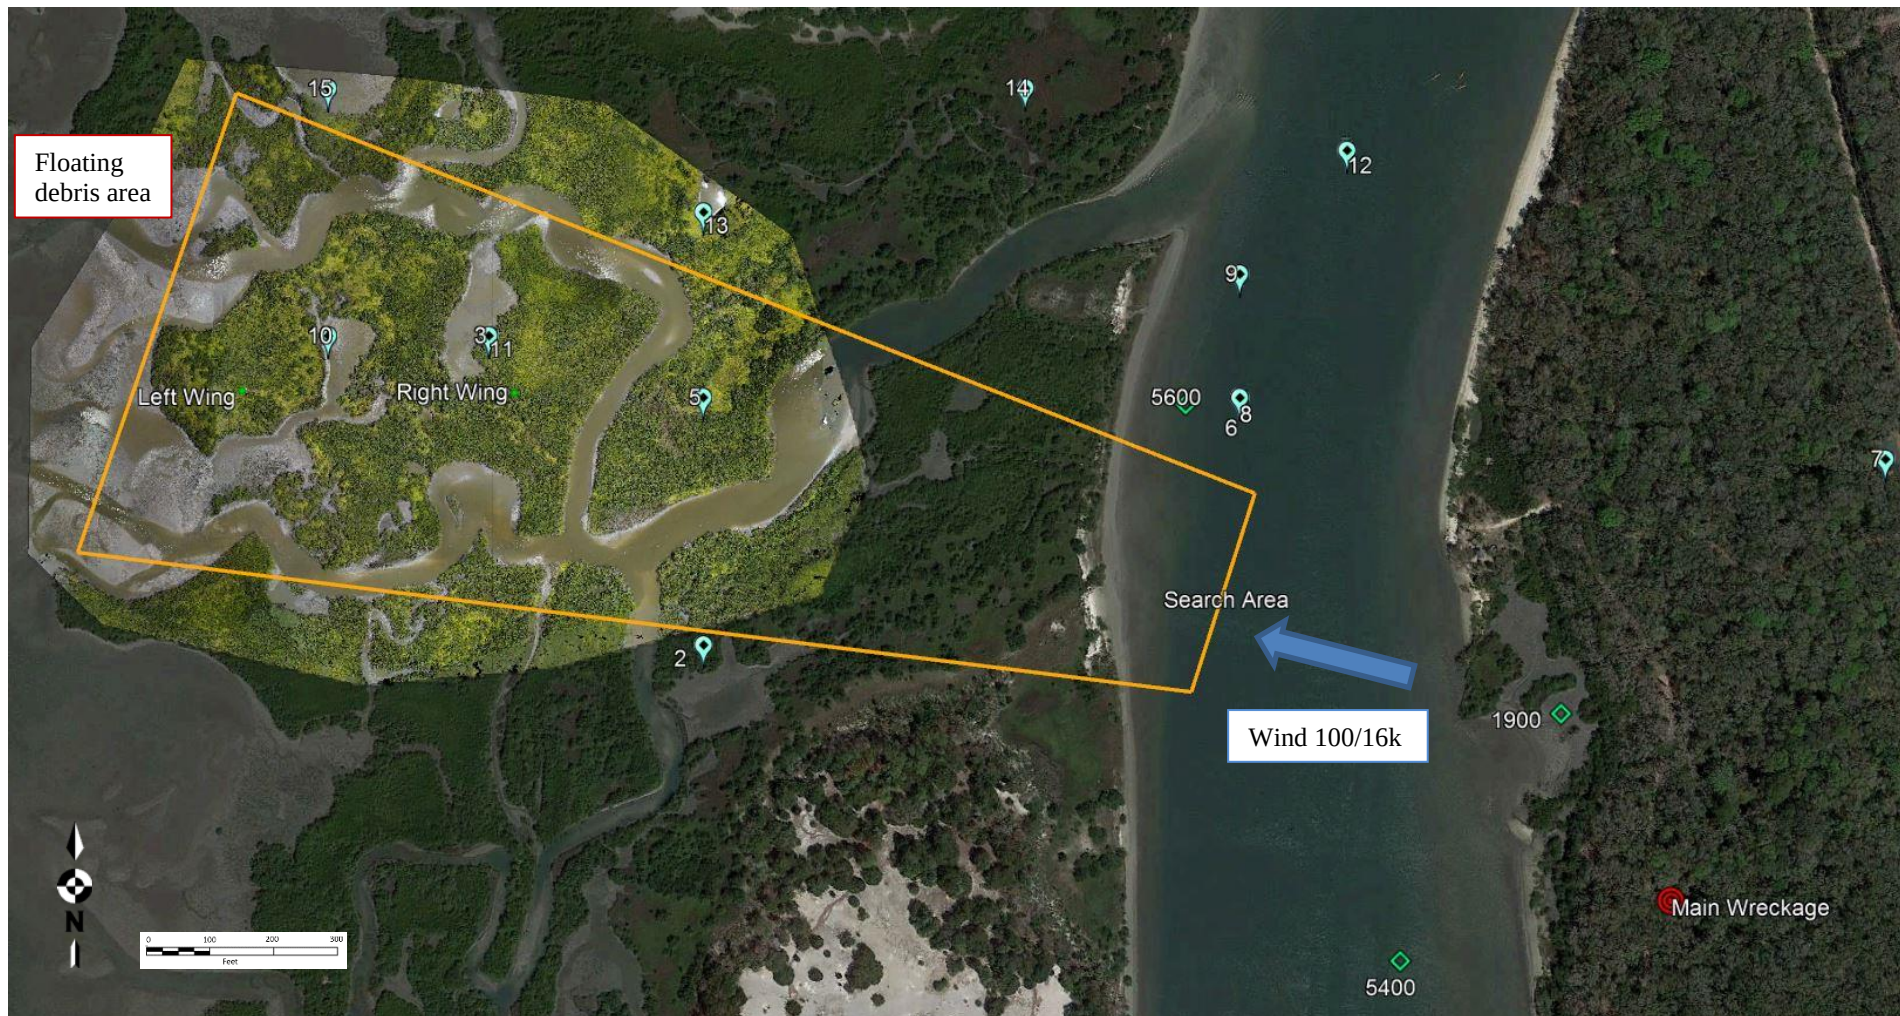
The wreckage location and significant radar returns were added to the orthomosaic to aid visualization of the breakup and flight path. See figure 5.

Figure 3 – Orthomosaic including wings, main wreckage, miscellaneous wreckage, radar targets, and search area.
