# **National Transportation Safety Board**

## **Performance Study**

### **Specialist Report**

| Airplane: | PIPER PA 44-180, N2173S |

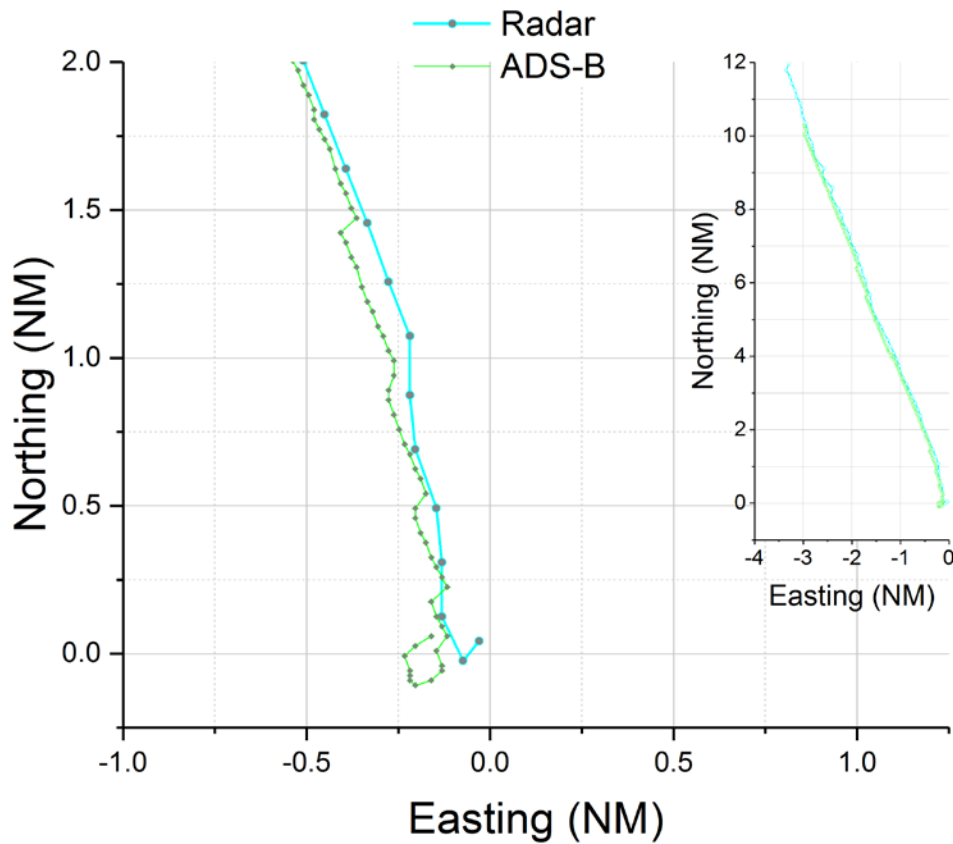
Figure 1 and Figure 2 show the radar and ADS-B flight paths for the accident airplane. The ADS-B recorded latitudes and longitudes showed stair-step-like irregularities compared to the smoother path of the radar.

**Figure 1.** ADS-B and radar flight path in Easting v Northing.

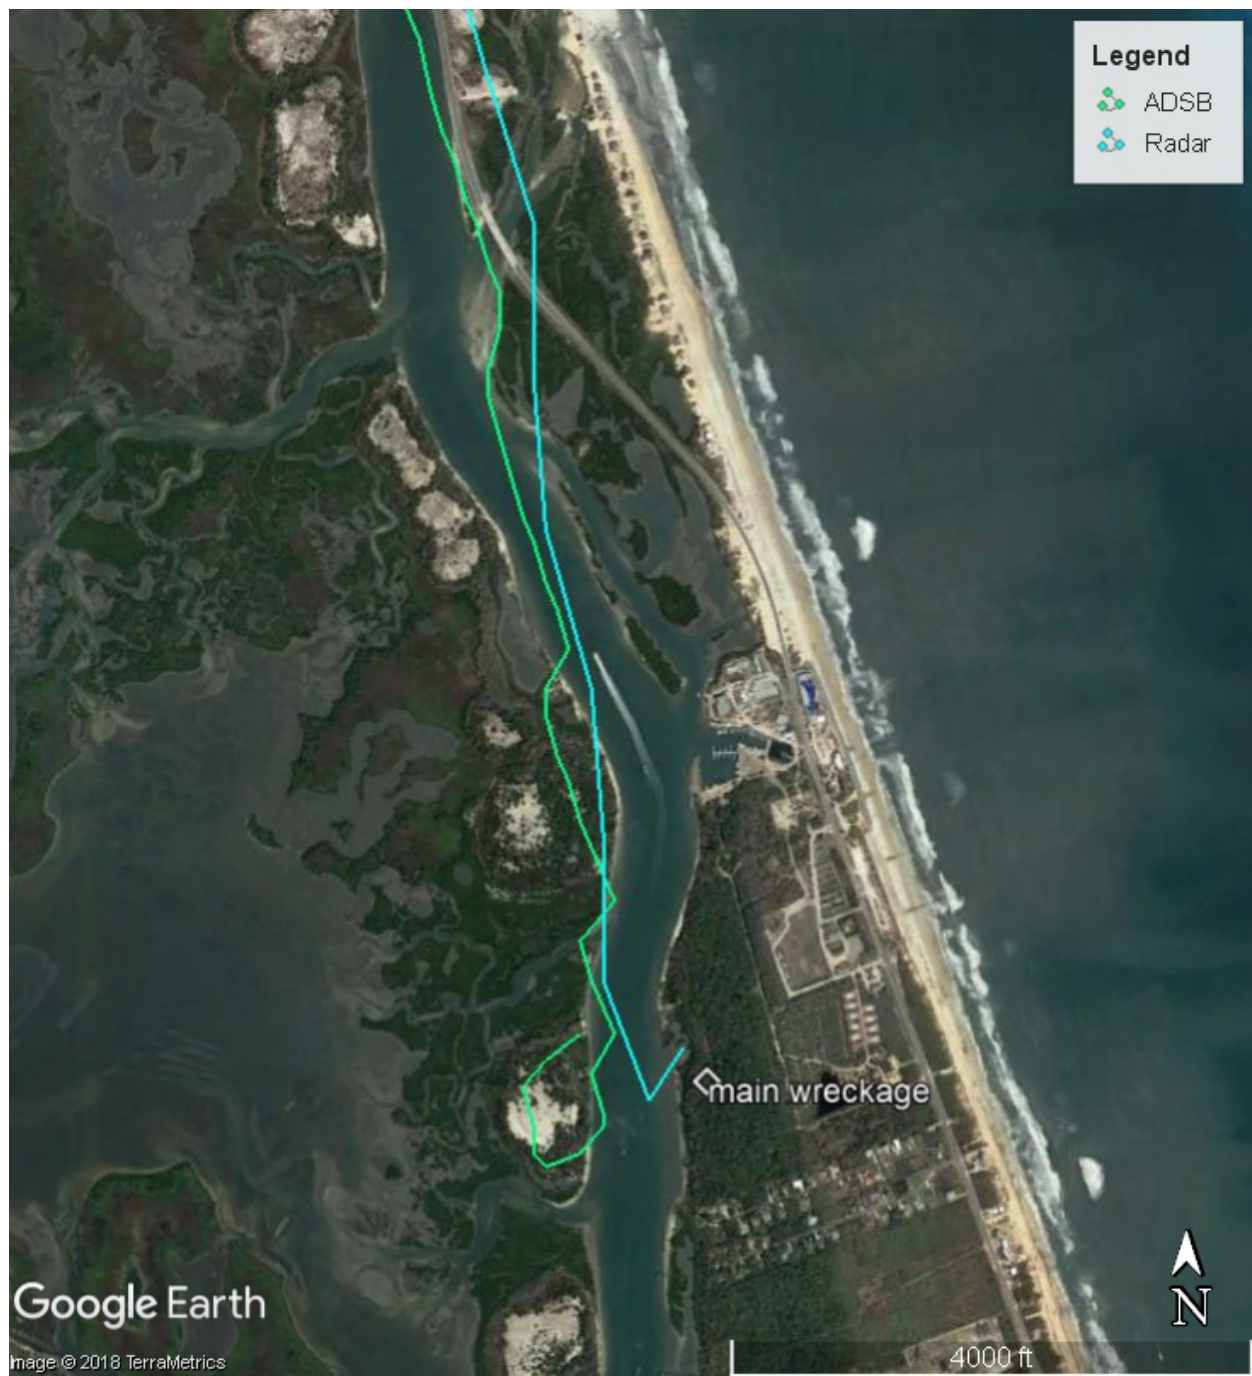
**Figure 2.** ADS-B and radar flight path in latitude and longitude in Google Earth.

As Figure 2 illustrated earlier, the end of flight radar and ADS-B paths show different flight paths. While the ADS-B latitude and longitude records were irregular, the flight path for the end of flight shows a right descending turn that appears consistent with the radar record. Figure 6 shows the descending right turn, the recorded debris field, and the location of the main wreckage. The rate of descent was more than 10,000 ft/min.

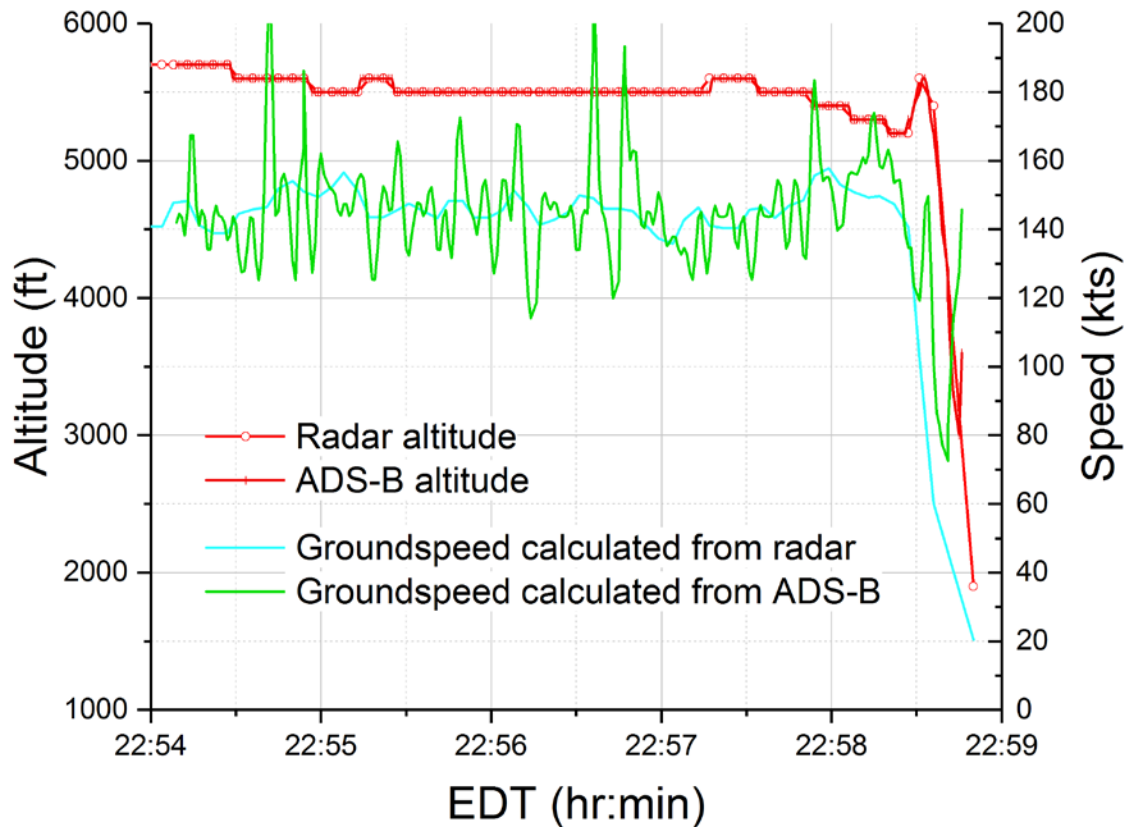
Groundspeed calculations from both the radar and ADS-B tracks are shown in Figure 3. Even smoothed, the ADS-B groundspeed calculations were considerably noisier than the radar calculations due to the irregularities in the ground track. Airspeed calculations, not shown, also varied considerably due to the changing track angle of the ADS-B ground track. For this reason, the radar ground track was used for the calculations throughout much of this report, unless otherwise specified.

**Figure 3.** ADS-B and radar altitudes and calculated groundspeeds. Both groundspeed calculations have been similarly smoothed.

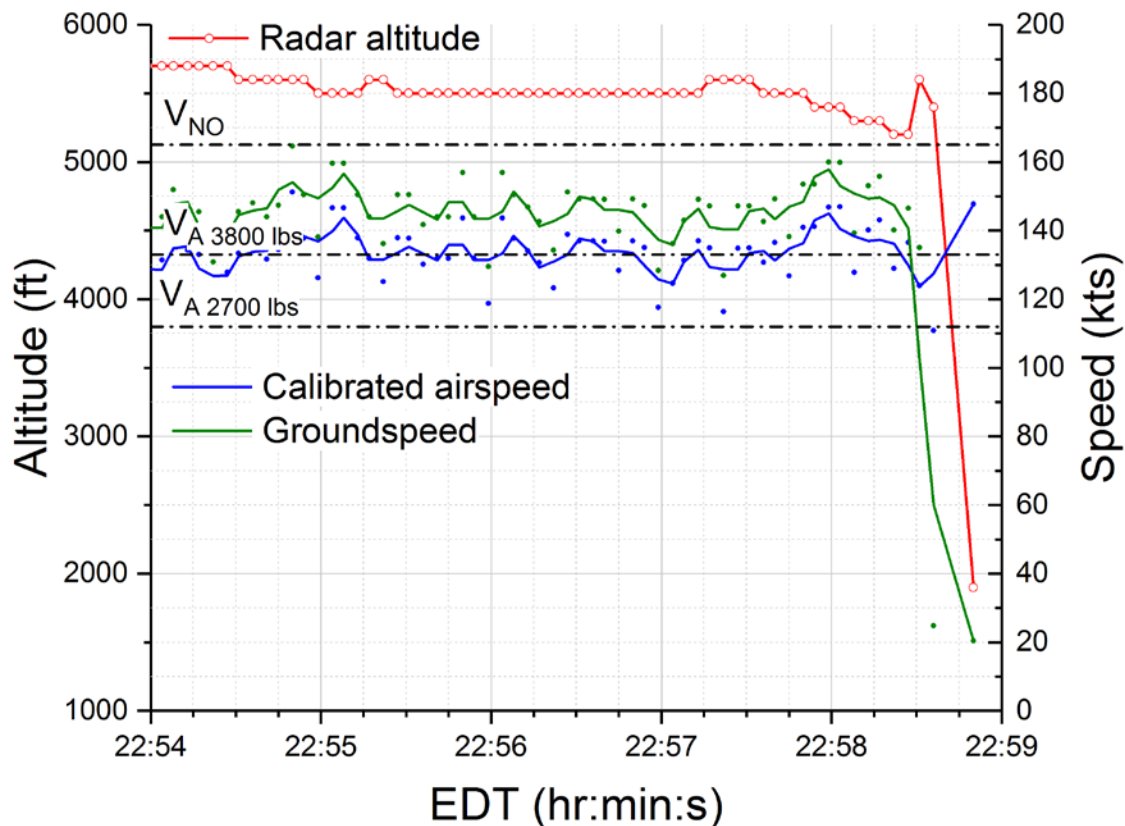
Figure 4 shows the airplane's groundspeed and calibrated airspeed for the last five minutes of flight. On the plot are the reported design maneuvering speeds ( $V_A$ ) of 133 kts for a heavy airplane (3,800 lbs) and 112 kts for a lighter case (2,700 lbs) [1]. The airplane was estimated to be between 3,250 – 3,350 lbs<sup>1</sup>, so the operational  $V_A$  would have been between these two values. Also shown is the maximum structural cruising speed of 165 kts ( $V_{NO}$ ).

**Figure 4.** Altitude and calculated ground and calibrated airspeed. Noted are  $V_{NO}$  and  $V_A$  in calibrated knots.

The airplane was flying at an altitude of about 5,500 ft and an airspeed just above 130 kts with some variation. At about 22:57:36 the airplane began to descend and increase speed to a maximum airspeed of 144 kts at 22:57:59 and an altitude of 5,200 ft by 22:58:22. At 22:58:27 the airplane began to rapidly gain altitude from 5,200 ft to 5,600 ft, for a rate of climb of 6,000 fpm. The Pilot Operating Handbook does not report rates of climb above 2,000 fpm.

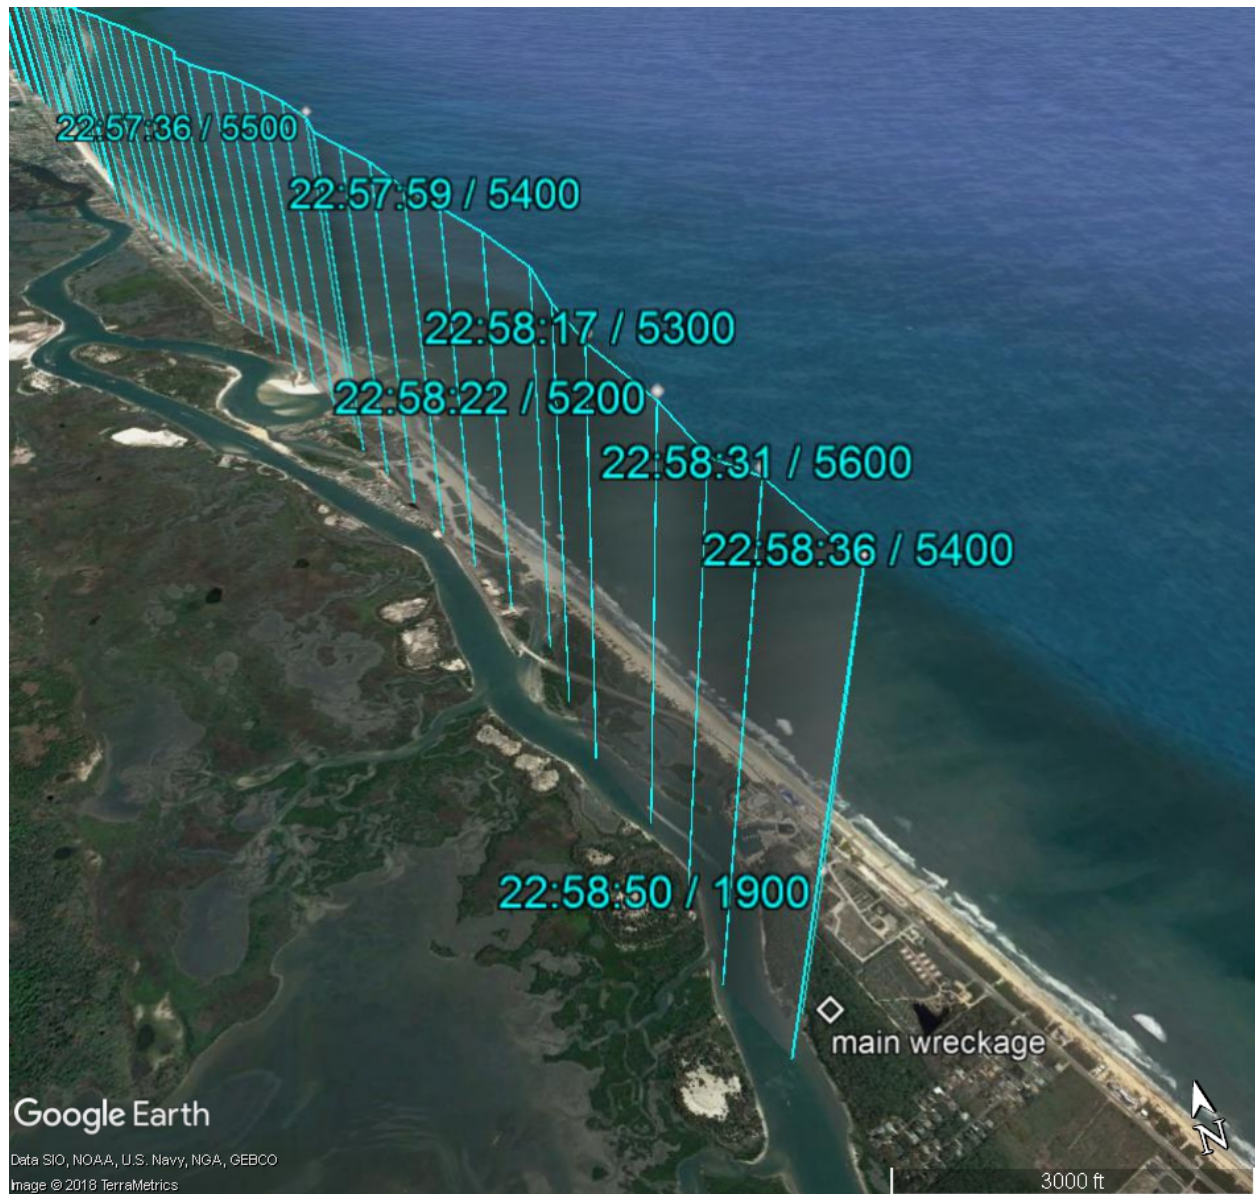
The airplane then began losing altitude rapidly. Figure 5 shows when the airplane began to first descend at 22:57:36, when it reached a maximum airspeed of 144 kts at 22:57:59, its local lowest altitude of 5,200 ft at 22:58:22, the climb to 5,600 ft and then subsequent beginning of its final descent.

**Figure 5.** Google Earth radar flight path.

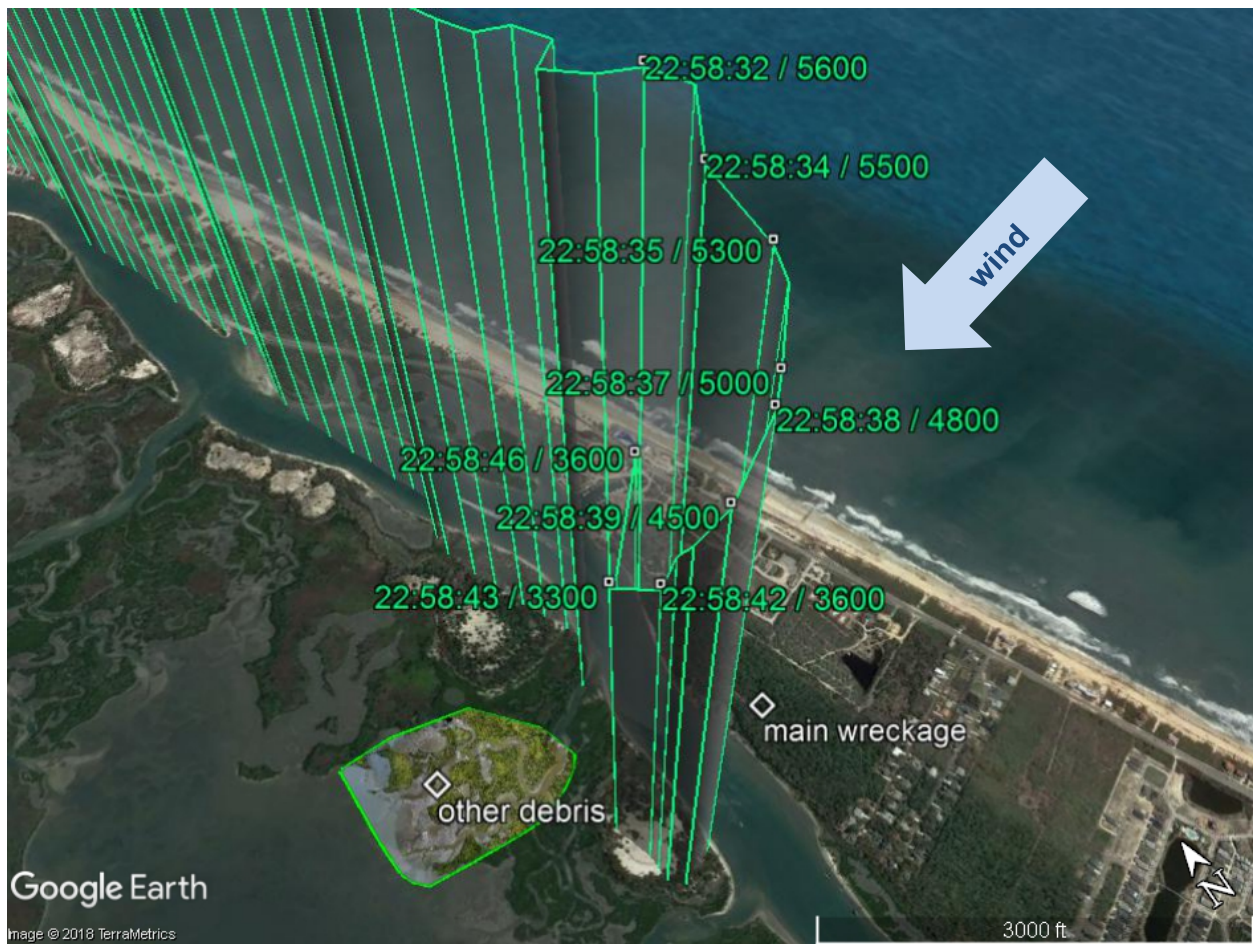
**Figure 6.** Google Earth ADS-B end of flight path. An arrow represents the 3 kts wind from 90°. The portion of the ground outlined in green and shown in a lighter color is the surveyed debris field. A diamond to the right of the flight path marks where the main fuselage wreckage was found.

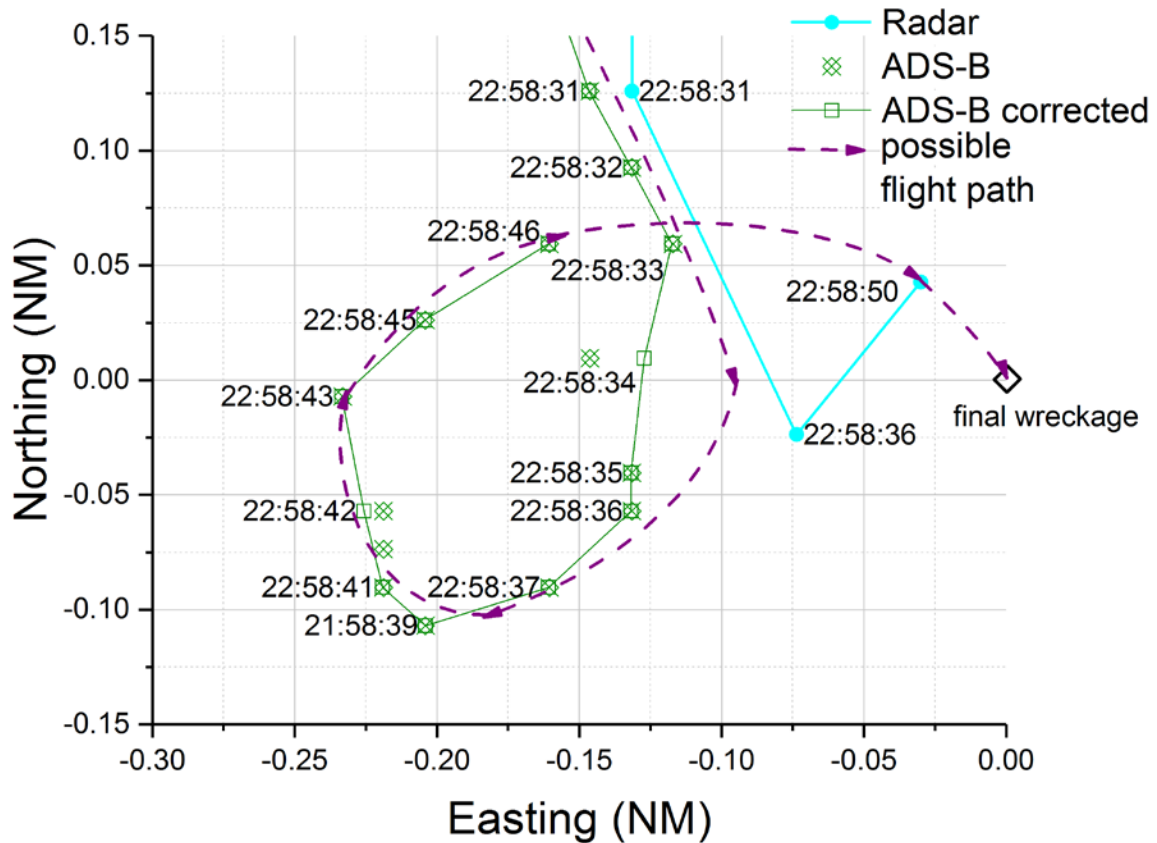
Figure 7 shows the ADS-B path, a slightly smoothed ADS-B path, and the radar path. The points for 22:58:31 show good agreement while 22:58:36 illustrate the easting offset that made the ADS-B data irregular. However, the last ADS-B data point at 22:58:46 and the last radar data point at 22:58:50 could show a consistent flight path if the airplane was following a descending right turn. A possible flight path from both radar and ADS-B data is shown.

**Figure 7.** The recorded ADS-B points and smoothed ADS-B path (both in green), radar flight (in blue), and the possible actual flight path (purple) for end of flight.

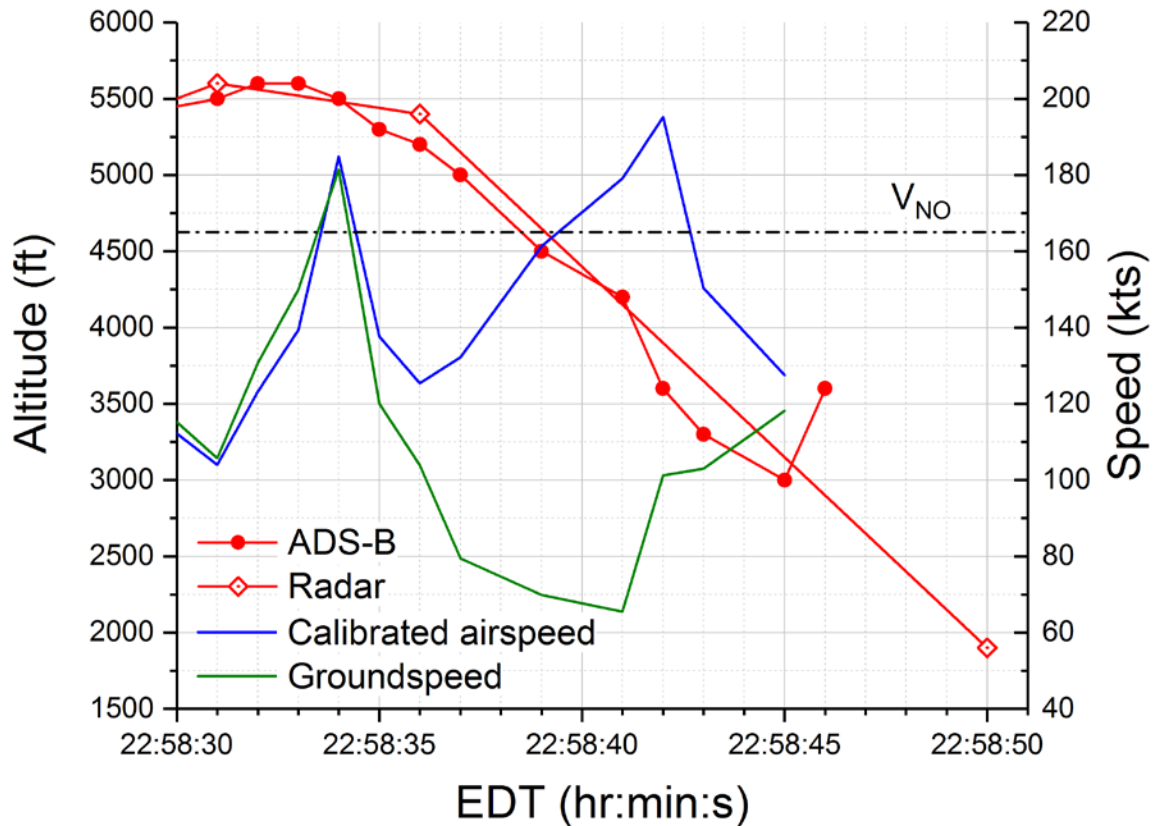
Figure 8 shows calibrated airspeed and groundspeed calculated from the smoothed ADS-B position data for the descending right turn at the end of flight. At 22:58:39 the airplane exceeded  $V_{NO}$  again. This time is shown on the flight path in Figure 6 and Figure 7. If an inflight break-up occurred after the point the airplane exceeded  $V_{NO}$  the second time, the combination of the airplane's momentum and the wind from the east would have carried shed pieces of airplane northwest of the flight path, which is consistent with the debris field.

**Figure 8.** ADS-B and radar altitude with speeds calculated from smoothed ADS-B locations (Figure 7).

The airplane then began losing altitude rapidly after 22:58:33. It gained airspeed while descending and at 22:58:39, exceeded the  $V_{NO}$  of 165 kts while at an altitude of 4,500 ft. The debris field, winds, and airplane direction near the time of exceeding  $V_{NO}$  are consistent with an in-flight breakup.
