**Date of Accident:** July 13, 2017

**NTSB File No.:** WPR17FA151

**Aircraft:** Piper PA-44-180 Seminole

**Written by:** Les Doud – Hartzell Propeller Air Safety Investigator

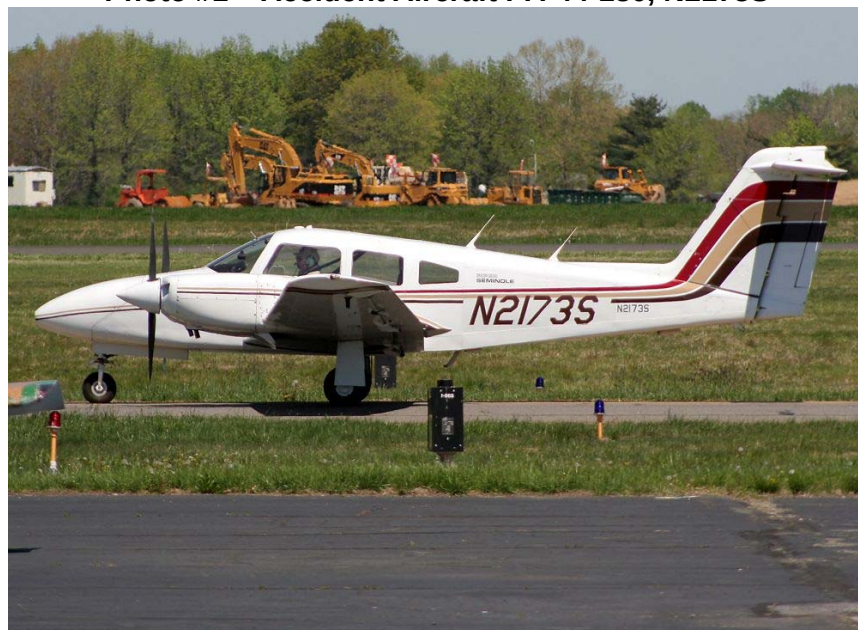
The following is an excerpt from the NTSB Preliminary Report. A picture of the accident aircraft is shown in Photo #1.

**Photo #1 – Accident Aircraft PA-44-180, N2173S**

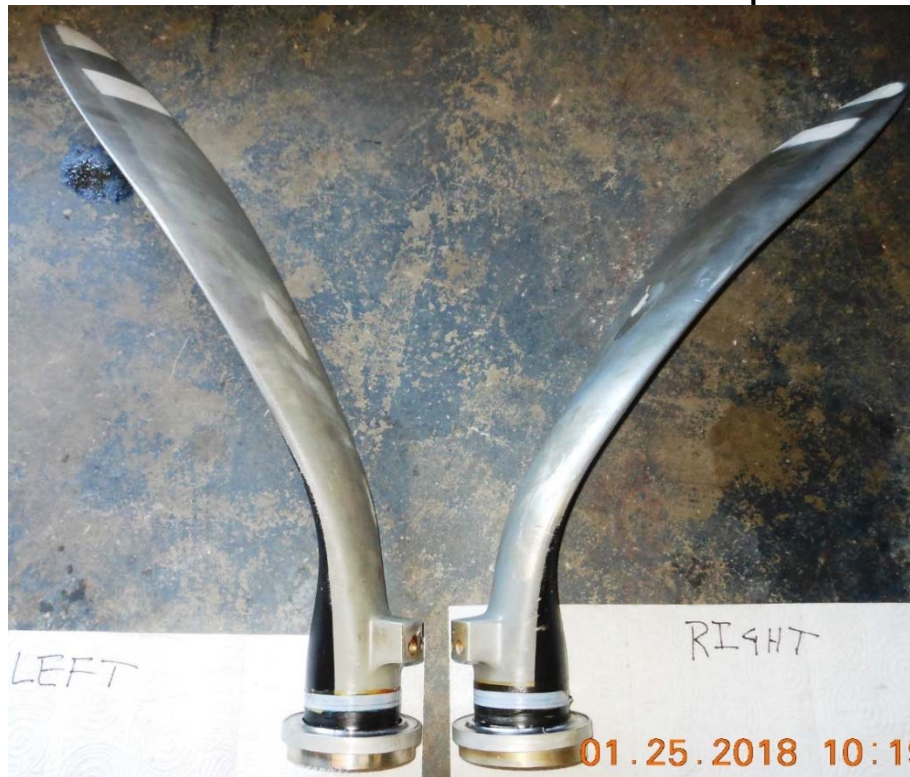
The left and right propellers had very similar damage indicating power symmetry at time of impact. Photo #2 shows the similarity in damage between left-right L1-R1 blades. Photo #3 shows the symmetry between the face side of the left and right blades. Both propellers also had fractured pitch change knobs on L1 and R1 blades as well as counterweight punctures in the spinner dome. Impact marks on the preload plates indicated blade angles in the low range of normal operation at or near the low pitch stop angle. Impact marks between the hub and blades, chordwise/rotational abrasion and blade bending all indicated rotation at impact.

**Photo #2 – Blades R1 and L1 bend and twist comparison**

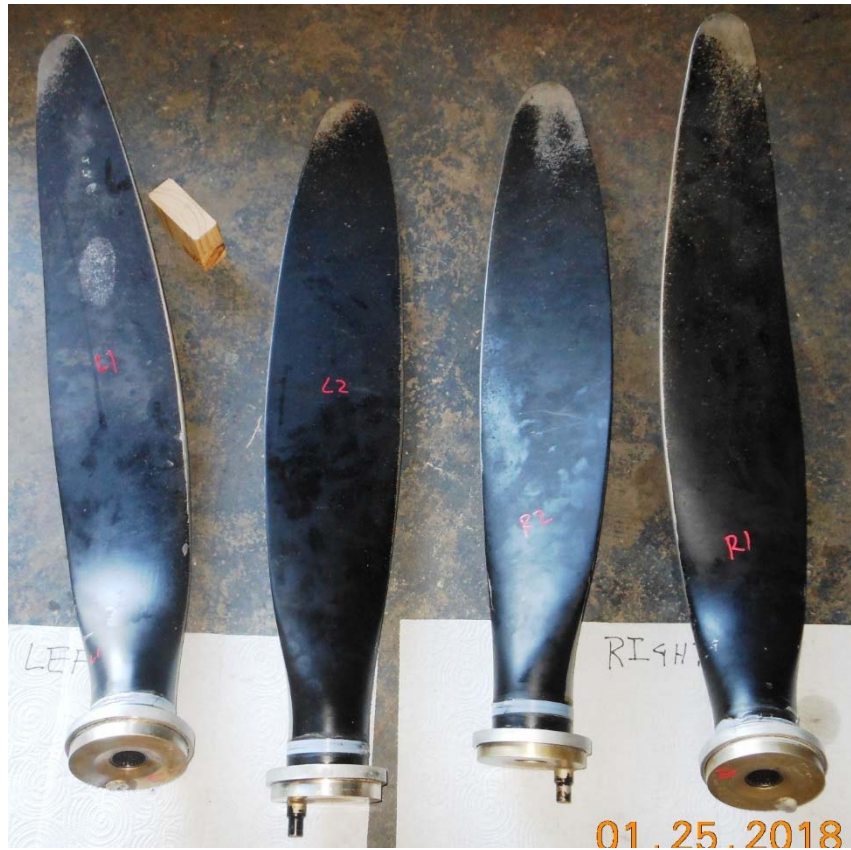
Photo #3 – Left vs. Right blade face side comparison

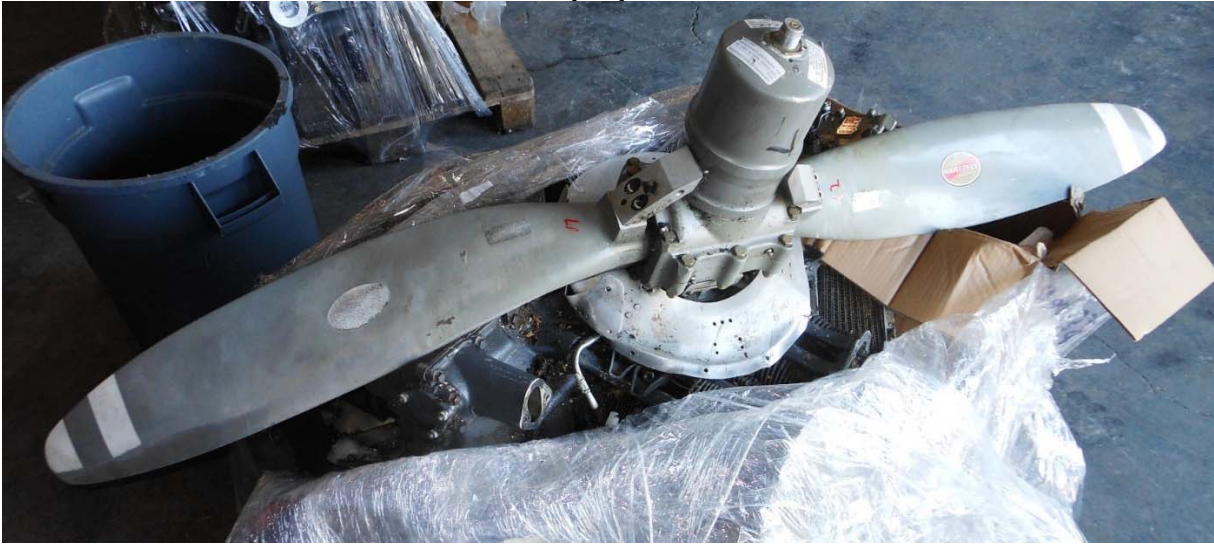
**As Received Condition:** The propeller was recovered to Florida Air Recovery in Jacksonville, FL and presented for examination in the condition shown in Photo #4. All six mounting studs were present with no apparent damage to the propeller mounting flange. Both blades were bent aft and twisted leading edge down in varying degrees. The propeller pitch change mechanism appeared to be on the start lock. Blade L1 was rotated beyond the low pitch stop angle and the counterweight punctured the cylinder. The air charge valve was fractured and all the air charge was released.

**Photo #4 – Left propeller as-received**

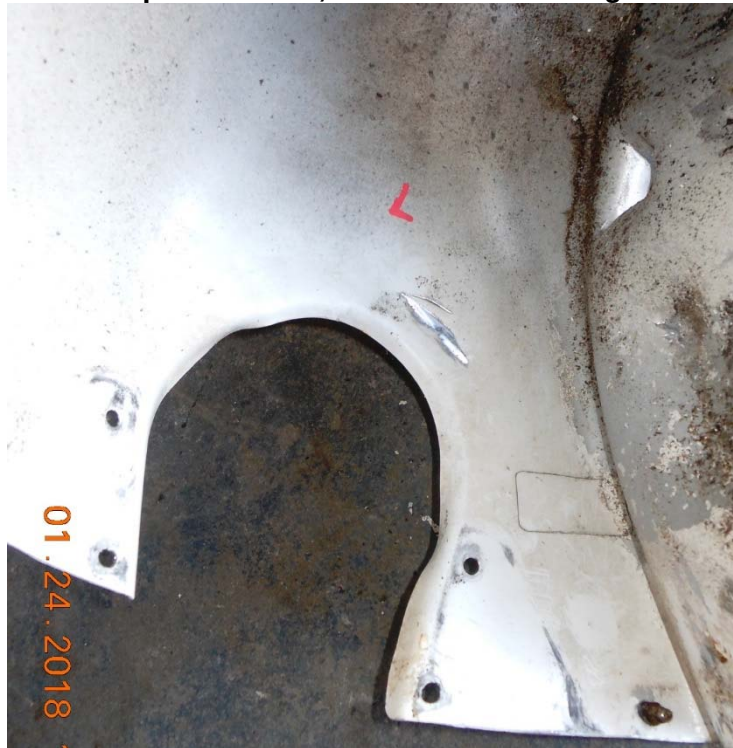
**Spinner Dome:** The spinner dome was crushed, punctured and torn. There was a counterweight puncture visible on the internal surface in the low pitch blade angle range (Photo #5).

**Photo #5 – Left spinner dome, internal counterweight contact mark**

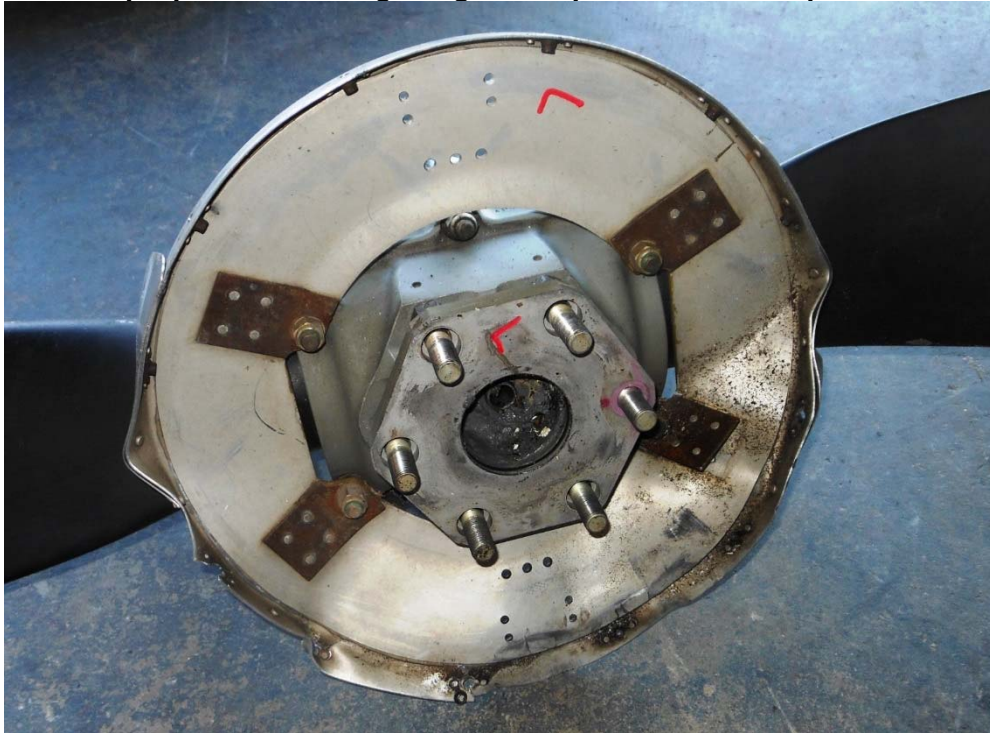
**Spinner Bulkhead:** The spinner bulkhead was intact with spinner dome mounting flanges bent (Photo #6).

**Engine/Propeller Mounting:** The propeller mounting flange and hardware appeared intact and undamaged (Photo #6).

Photo #6 – Left propeller mounting flange and spinner bulkhead prior to disassembly

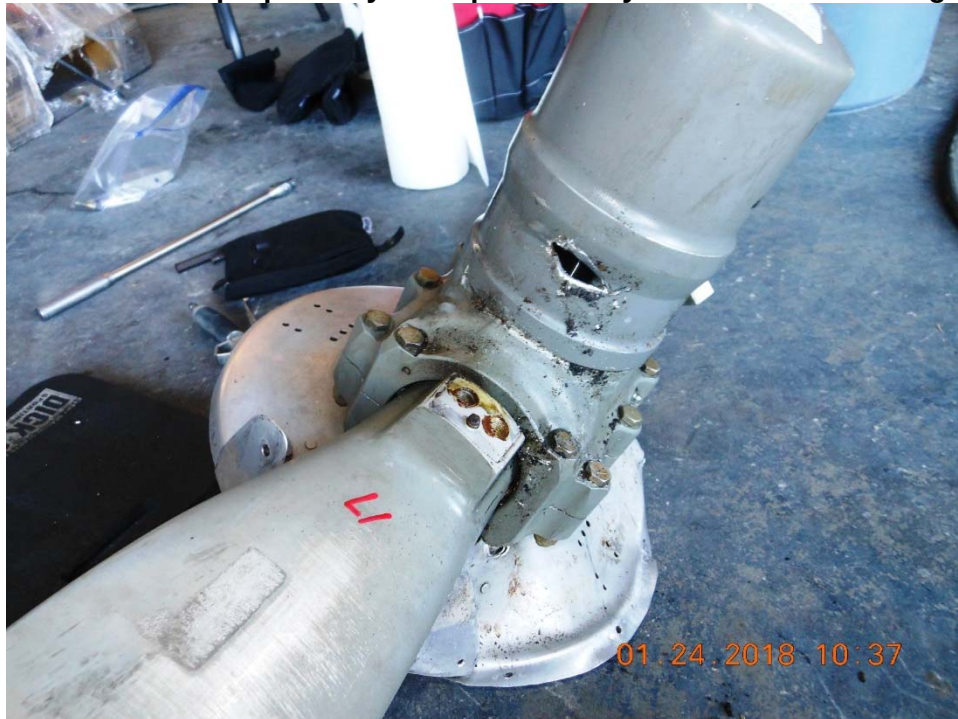
**Cylinder:** The cylinder remained attached to the hub. The cylinder was punctured by the blade L1 counterweight when the blade was forcefully rotated towards low pitch (Photo #7).

Photo #7 – Left propeller cylinder puncture by blade L1 counterweight

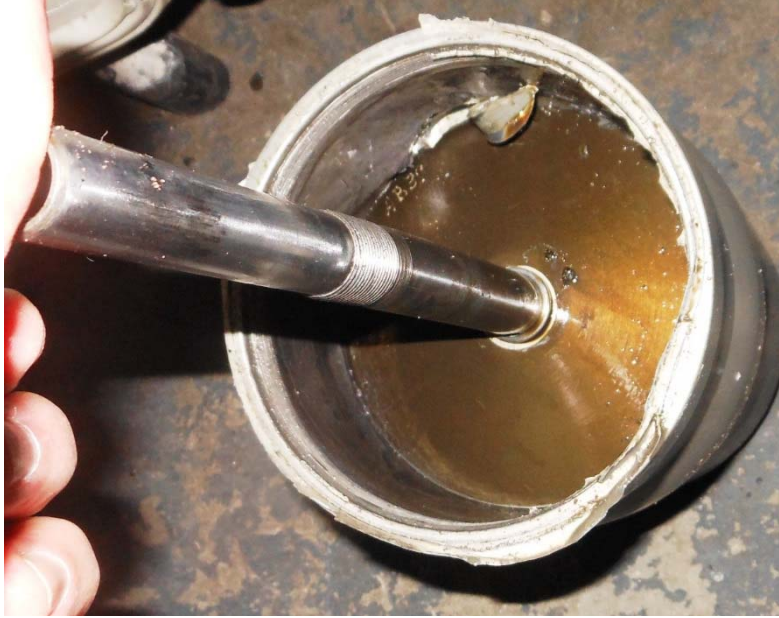
**Piston:** The piston appeared intact and undamaged but was trapped within the cylinder by the puncture/deformation caused by the L1 counterweight impact (Photo #8). No effort was made to remove the piston from the damaged cylinder.

**Pitch Change Rod:** The portion of the pitch change rod aft of the piston appeared intact and undamaged (Photo #8). There was no attempt to remove the piston and rod due to damage to the cylinder.

**Photo #8 – Left piston bottom and pitch change rod trapped in cylinder**

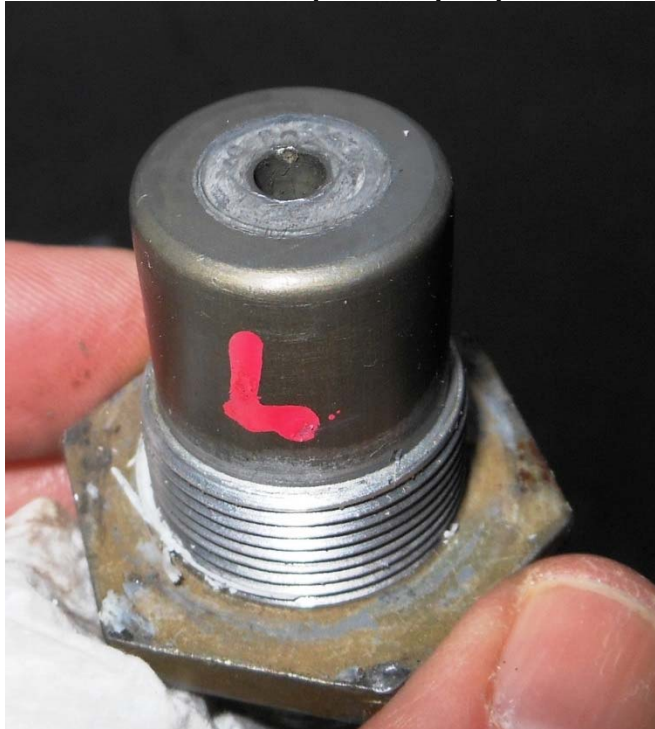
**Low Pitch Stop:** The low pitch stop had an impact mark from the cap screw (Photo #9) suggesting forcible contact with propeller at/near low pitch.

**Photo #9 – Left low pitch stop impact mark**

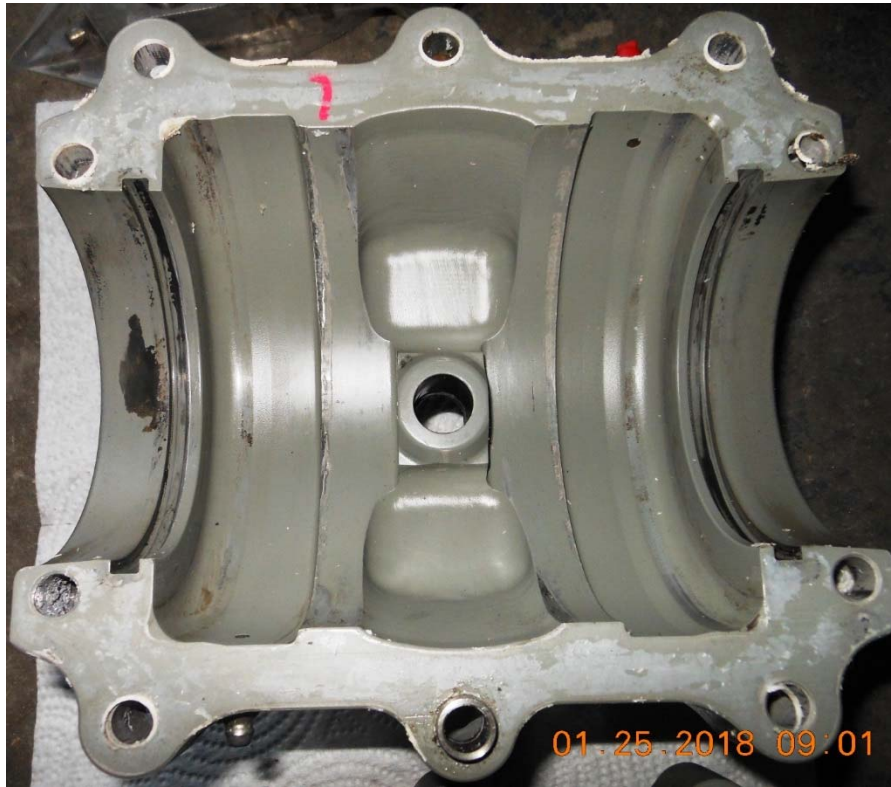
Photo #10 – Left aft hub half

**Hub Assembly:** The hub unit appeared intact with no visible cracks or fractures. There was visible preload plate shelf damage/deformation in the L1 and L2 blade pockets in the aft/trailing edge quadrant (Photo #10). There was one discernable blade impact mark on the aft hub half blade aperture corresponding to an impact mark on the blade in the trailing edge quadrant seen in Photo #13. The cylinder mounting boss appeared undamaged.

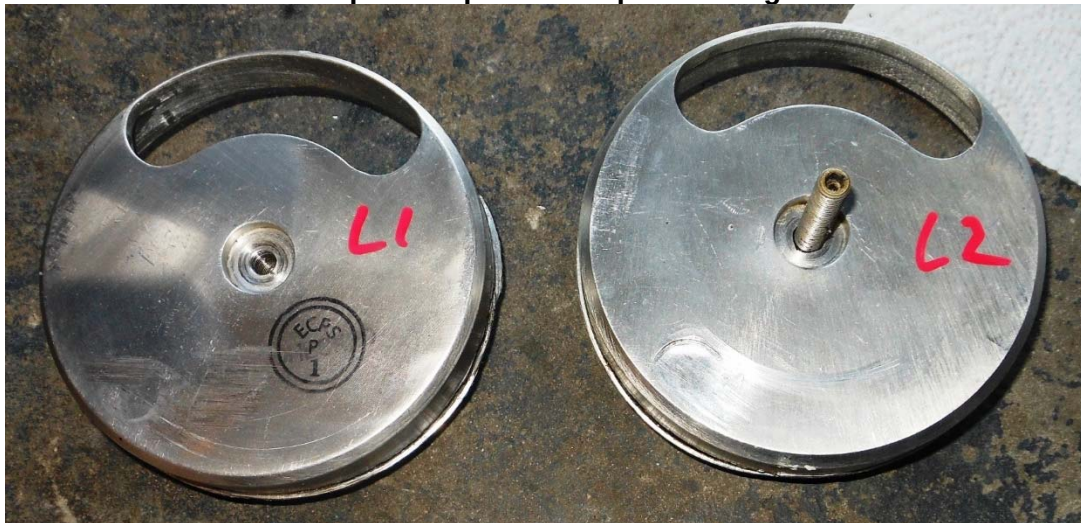
**Preload Plates:** Both preload plates exhibited knob block or block bumper contact marks in the low pitch range of normal operation (Photo #11).

| Preload Plate | Condition |
|---|---|
| L1 | Lip deformed, sheared/fractured in aft/trailing edge quadrant, knob block bumper marring in the low pitch range |

Photo #11 – Left preload plates and pitch change knobs/block

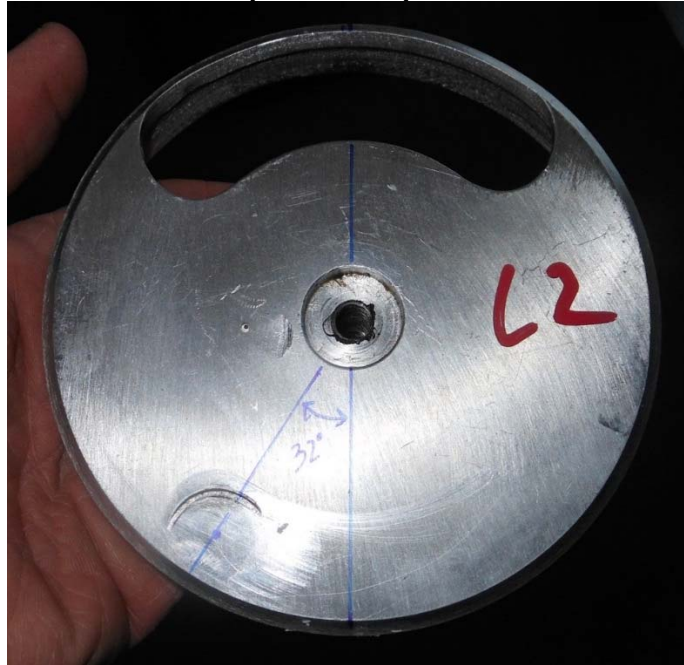
| Preload Plate | Condition |
|---|---|
| L2 | Lip deformed, sheared/fractured in aft/trailing edge quadrant. Knob block impact mark at approximately $32^{\circ}$ corresponding to a blade angle of $14^{\circ}$ (Photo #12) |

Photo #12 – Preload plate L2 impact mark measurement

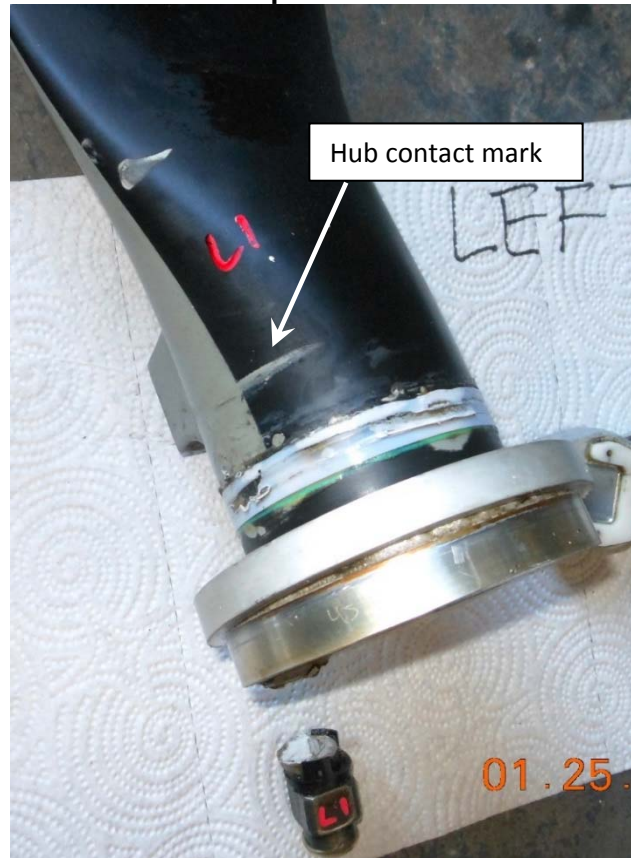
| Trail edge damage | Not remarkable, paint transfer mark where contacted hub aperture near shank (Photo #13) |
| Butt/shank impact marks | Contact mark with preload plate aft/trailing edge quadrant, the blade bearing lip sheared/fractured, smashed/torn seal rub strip |

Photo #13 – Blade L1 hub impact mark and seal rub strip damage

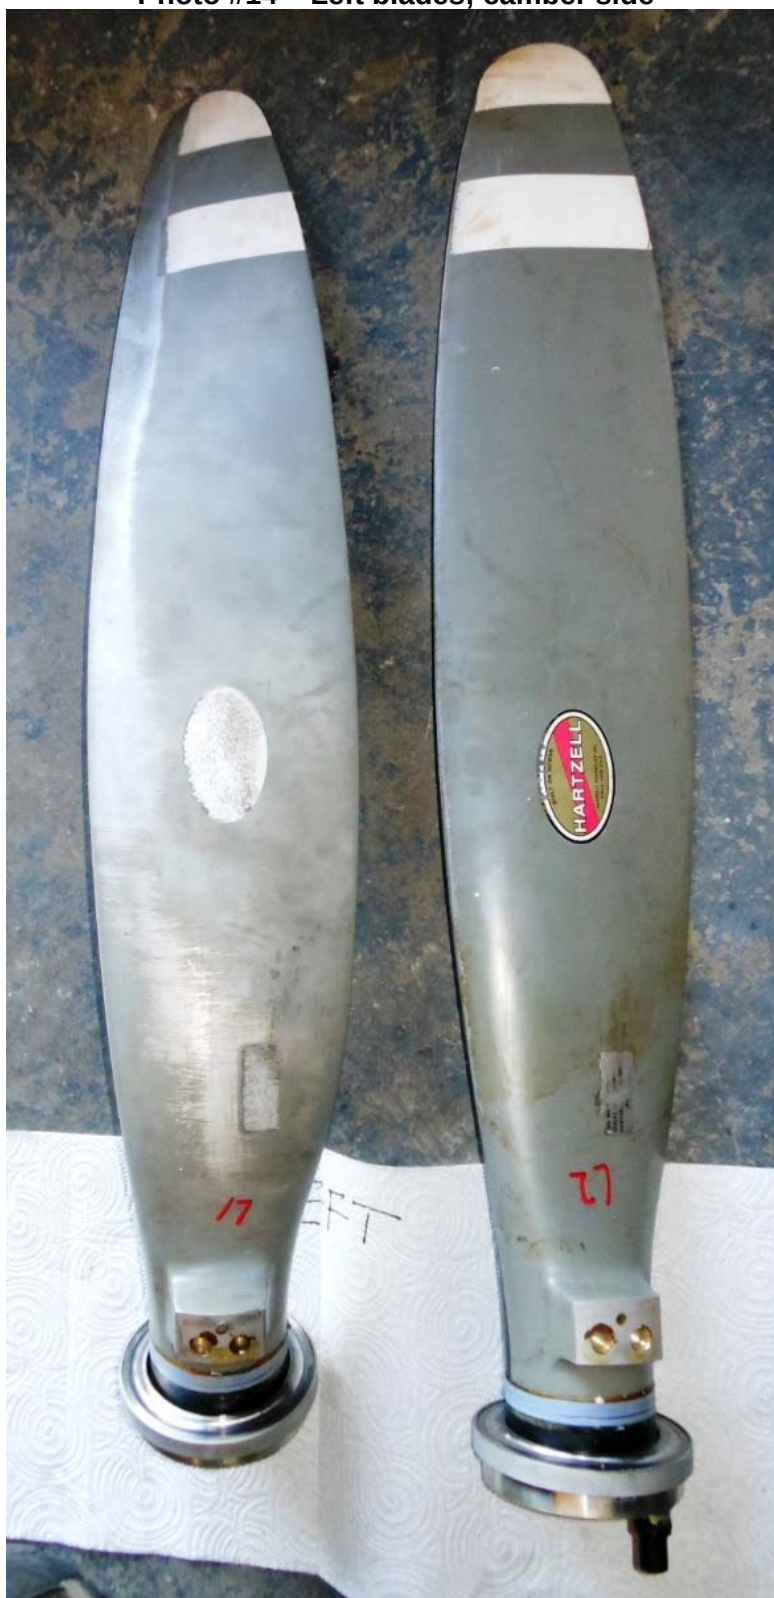
| Camber side | Chordwise/rotational paint abrasion concentrated along leading edge |
| Bend | Aft and opposite rotation |
| Twist | Leading edge down |

Photo #14 – Left blades; camber side

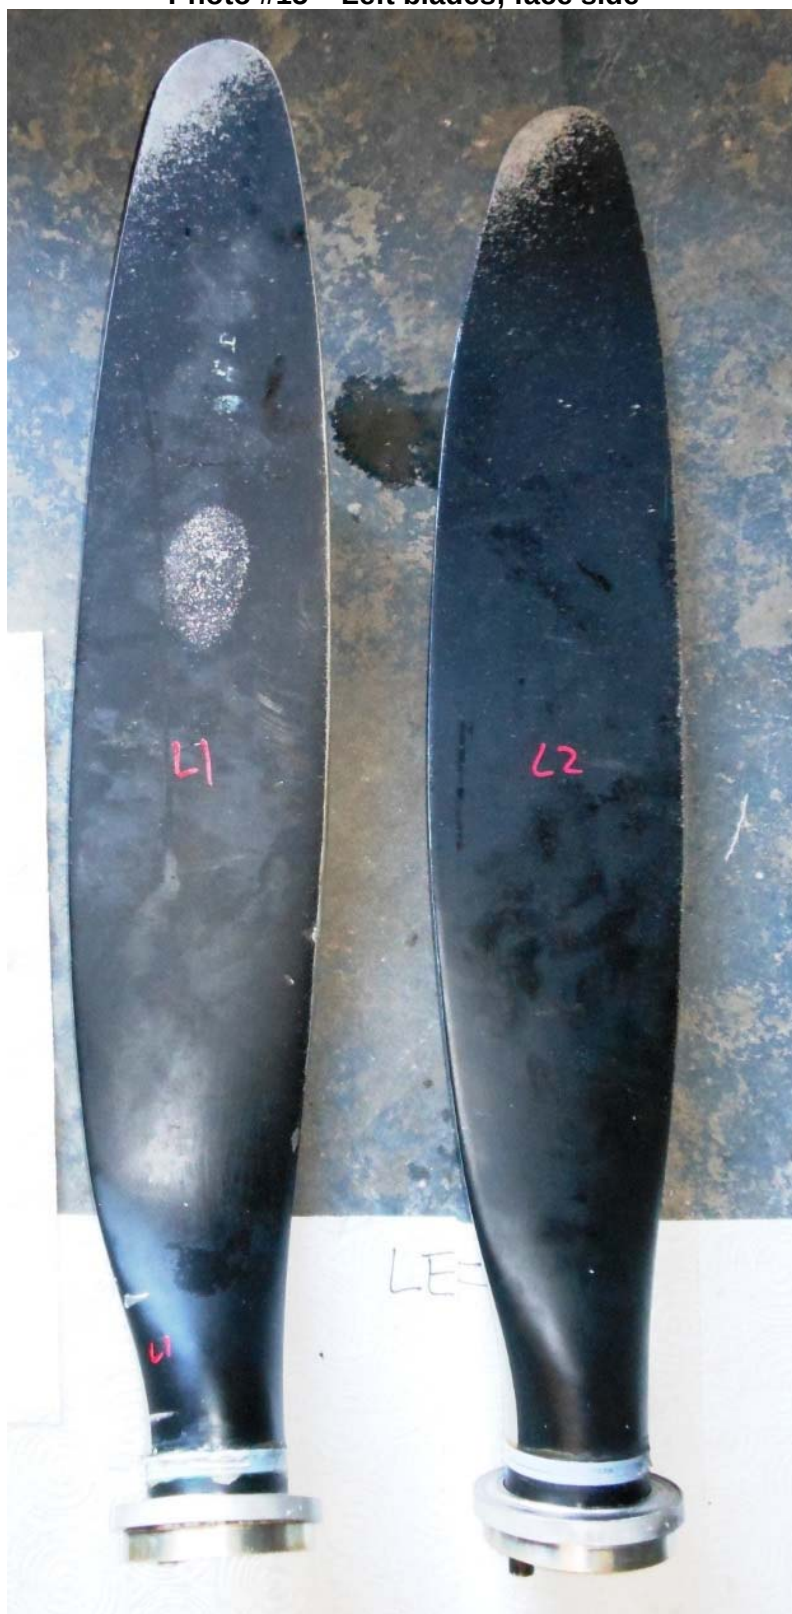
| Face side | Paint abrasion near tip/trailing edge area. An oval-shaped abraded area near mid-blade |

| Face side | Paint abrasion near tip/trailing edge area. |
| Bend | Approximately last 2" of tip bent aft |

Photo #15 – Left blades; face side

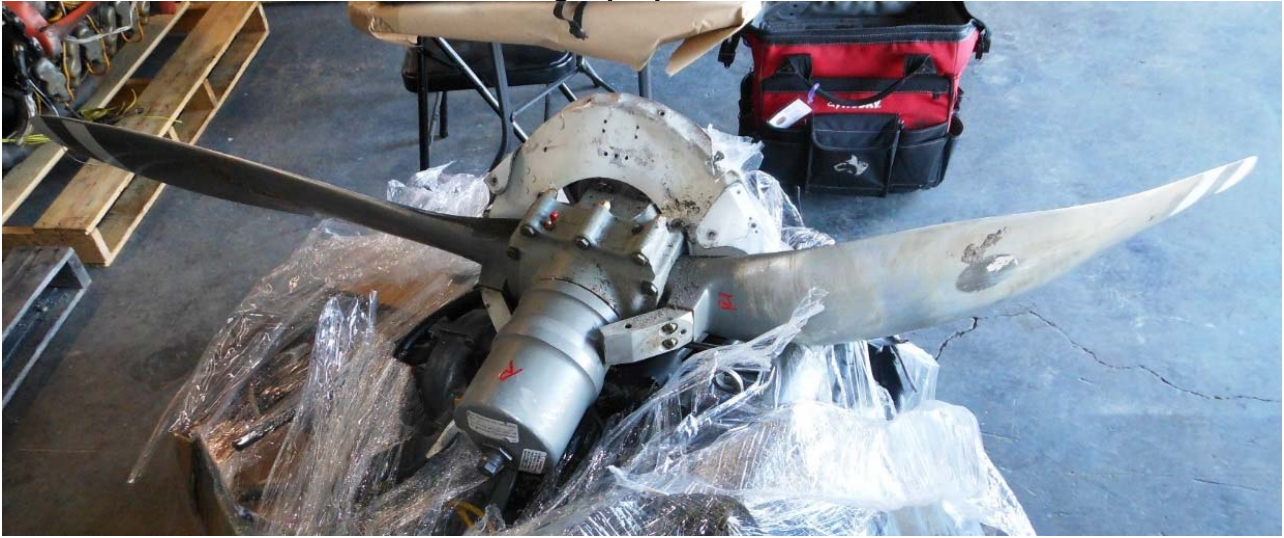
**As Received Condition:** The propeller was recovered to Florida Air Recovery in Jacksonville, FL and presented for examination in the condition shown in Photo #16. The propeller fractured from the engine aft of the crankshaft propeller mounting flange. The starter ring gear and crankshaft flange were still attached (Photo #17). All six mounting studs were present with no apparent damage to the propeller mounting flange. Blade R1 was bent aft and twisted leading edge. Blade R2 bend and twist was unremarkable. The propeller pitch change mechanism appeared to be on the start lock. Blade R1 was rotated beyond the low pitch stop angle and the counterweight punctured the cylinder. The cylinder base appeared partially separated from the hub mounting area adjacent to blade R1. The air charge valve was fractured and all the air charge was released.

**Photo #16 – Right propeller as-received**

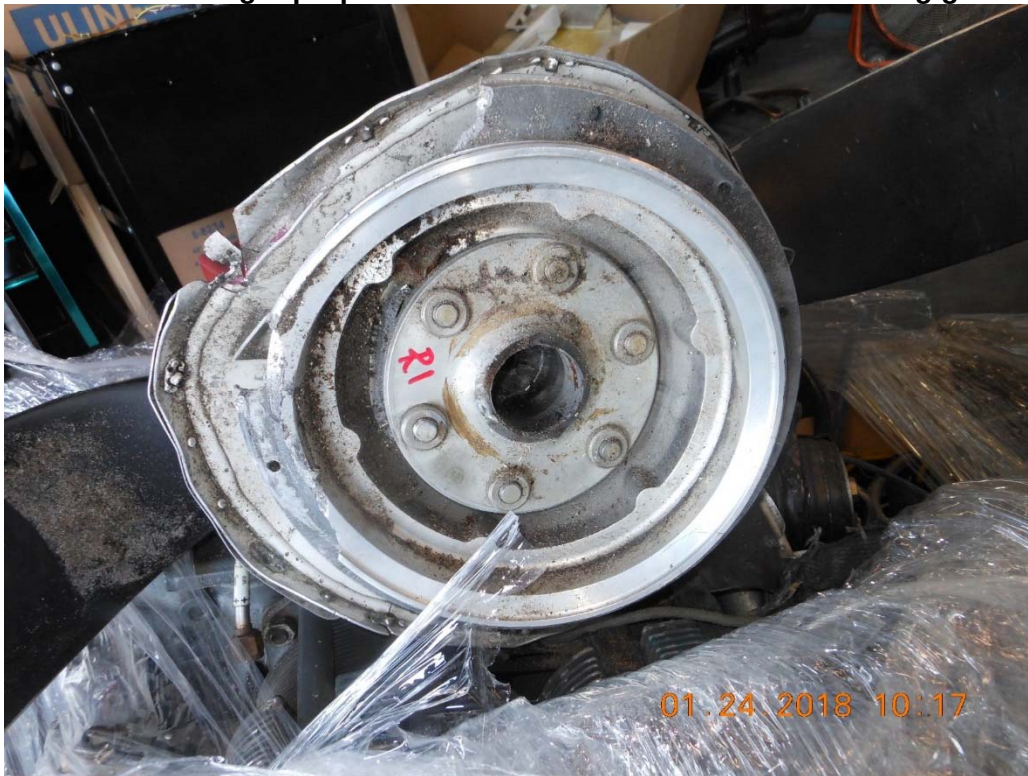
**Photo #17 – Right propeller fractured crankshaft and starter ring gear**

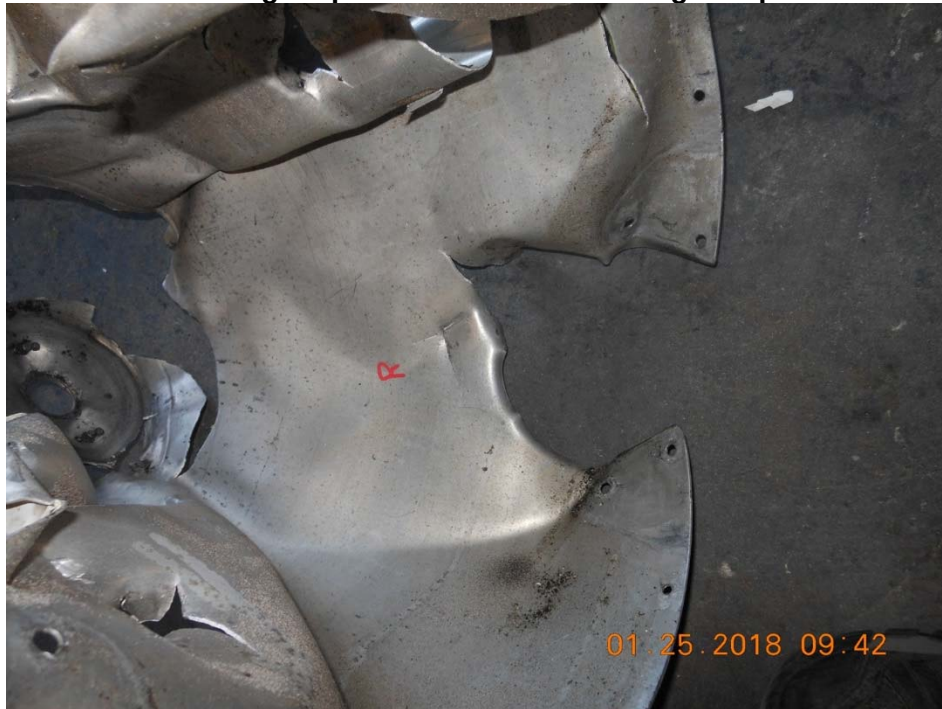
**Spinner Dome:** The spinner dome was crushed, punctured and torn. There was a counterweight puncture visible on the internal surface in the low pitch blade angle range (Photo #18).

**Photo #18 – Right spinner dome counterweight impact mark**

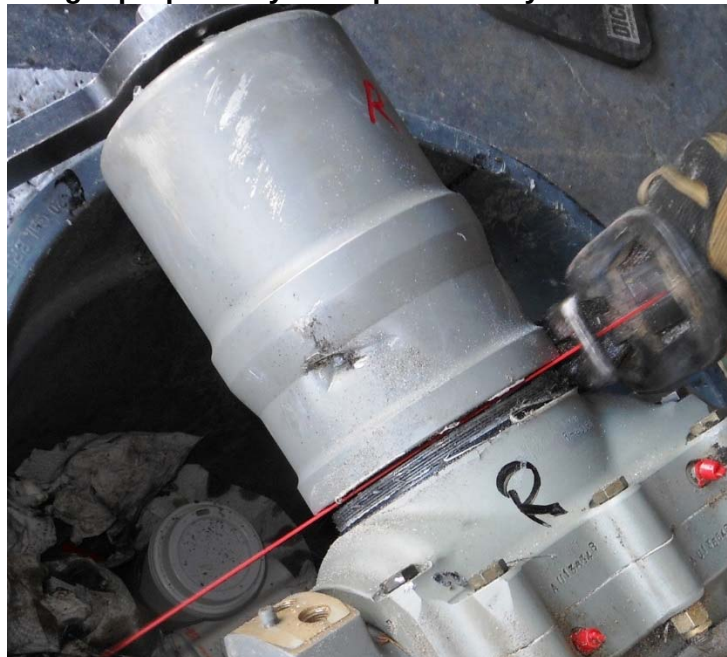
**Cylinder:** The cylinder was partially separated from the hub. The cylinder was punctured by the blade R1 counterweight when the blade was forcefully rotated towards low pitch. The cylinder unthreaded from the hub boss but the pitch change rod could not be removed from the propeller assembly so it was cut by a saw as shown in Photo #19.

**Photo #19 – Right propeller cylinder puncture by blade R1 counterweight**

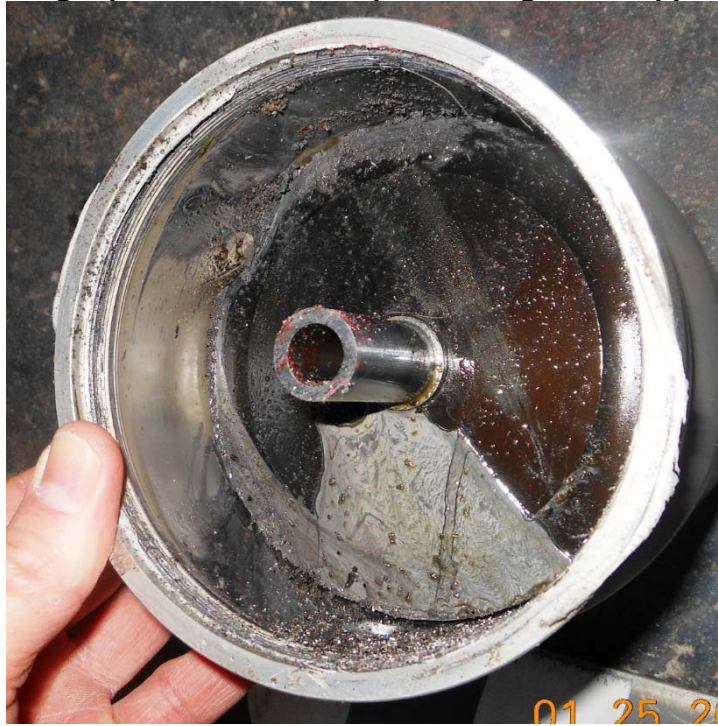
**Piston:** The piston appeared intact and undamaged but was trapped within the cylinder by the puncture/deformation caused by the R1 counterweight impact (Photo #20). No effort was made to remove the piston from the damaged cylinder.

Photo #20 – Right piston bottom and pitch change rod trapped in cylinder

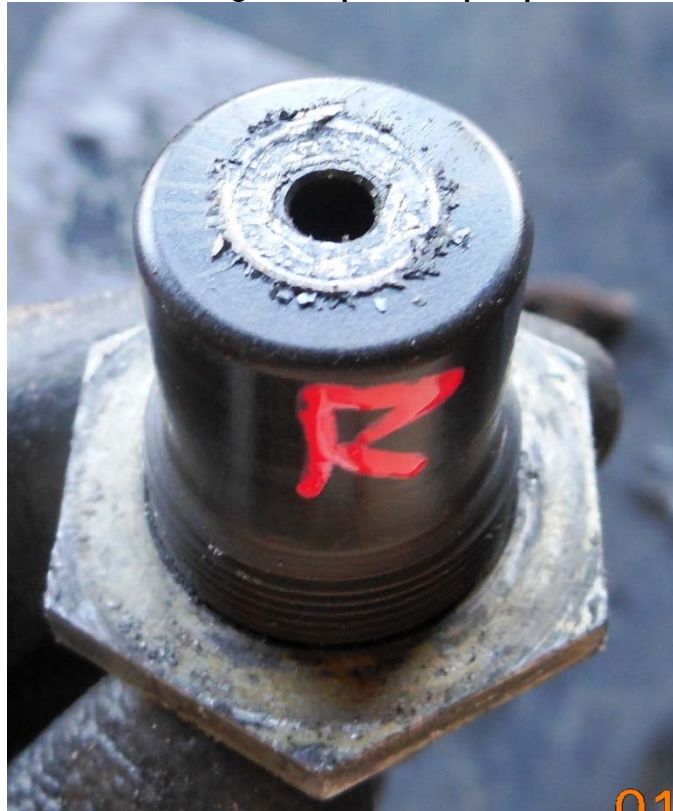
**Low Pitch Stop:** The low pitch stop had an impact mark from the cap screw (Photo #21) suggesting forcible contact with propeller at/near low pitch.

Photo #21 – Right low pitch stop impact mark

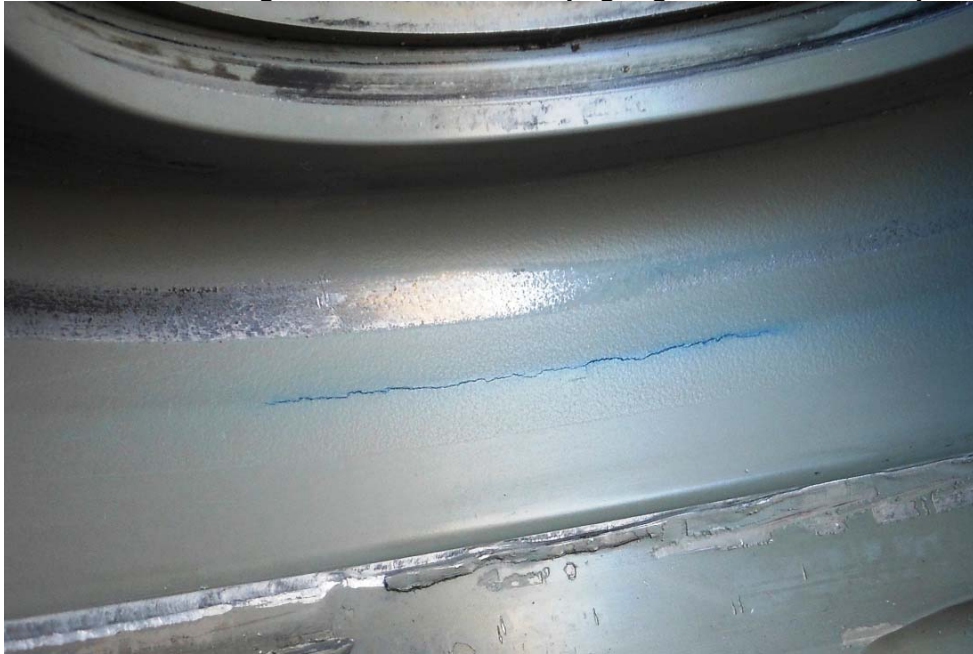
**Hub Assembly:** The hub unit appeared mostly intact. The hub cavity was mostly filled with black grease indicating it had been over-serviced. There was one visible crack in the R1 blade bearing pocket (Photo #22). There was visible preload plate shelf damage/deformation in the R1 and R2 blade pockets; predominantly in the aft/trailing edge quadrant on R1 and leading edge quadrant of R2 (Photos #23 and #24). There were discernable blade impact marks on the aft hub half blade apertures. The cylinder mounting boss was fractured adjacent to blade R1 as shown in Photo #25.

**Photo #22 – Right aft hub half crack (highlighted with blue ink)**

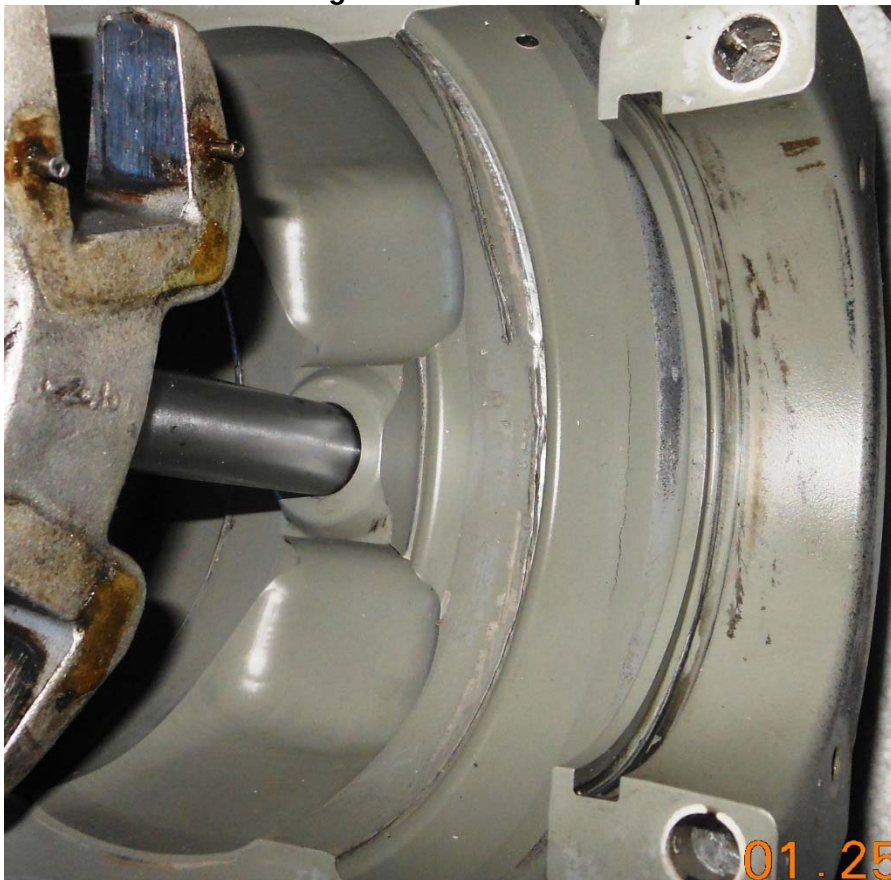
**Photo #23 – Right aft hub half blade pocket R1**

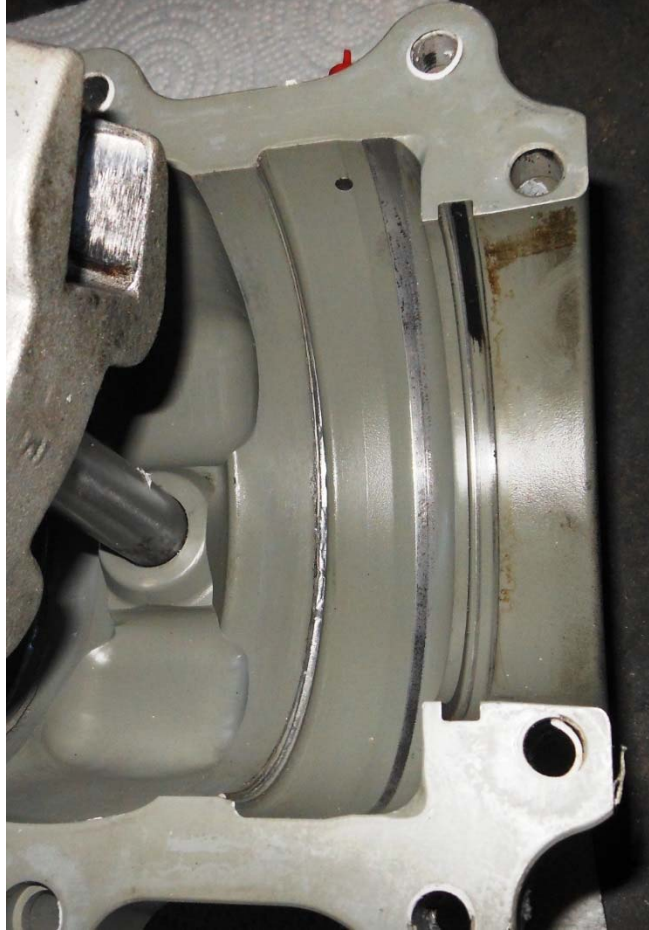
**Photo #24 – Right aft hub half blade pocket R2**

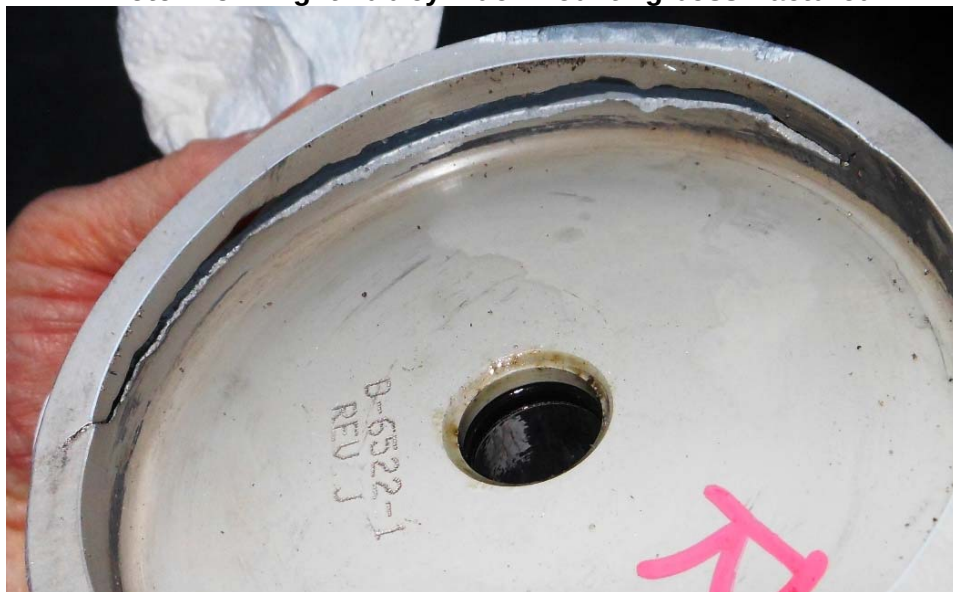
**Photo #25 – Right hub cylinder mounting boss fractured**

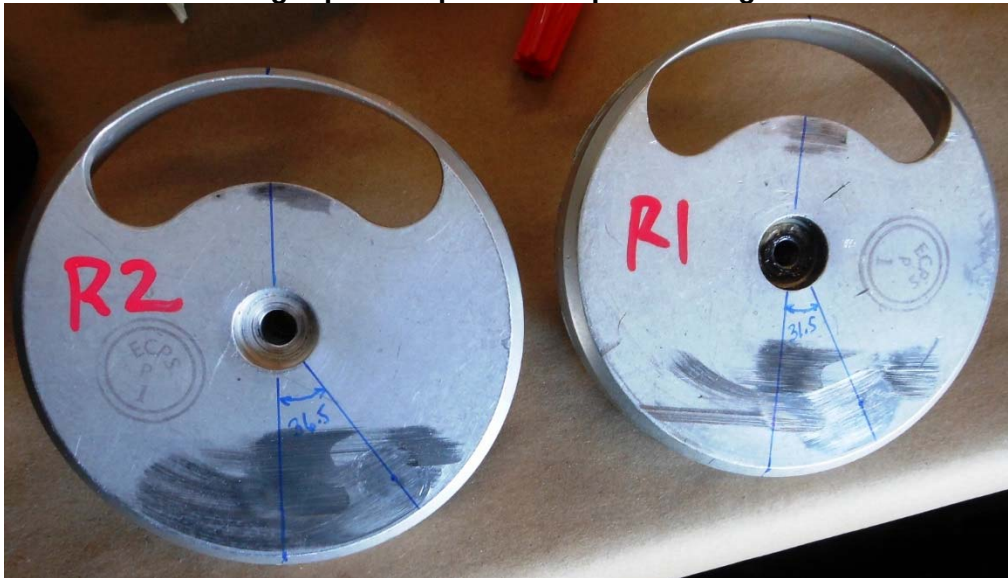
**Preload Plates:** Both preload plates exhibited knob block and/or block bumper contact marks in the low pitch range of normal operation (Photo #26).

| Preload Plate | Condition |
|---|---|
| R1 | Lip deformed, sheared/fractured in aft/trailing edge quadrant, knob block bumper marring in the low pitch range, knob block bumper mark at 31.5° corresponding to a blade angle of 14.8°. |
| R2 | Lip deformed. Knob block impact mark at approximately 36.5° corresponding to a blade angle of 9.5°. |

Photo #26 – Right preload plates and pitch change knobs/block

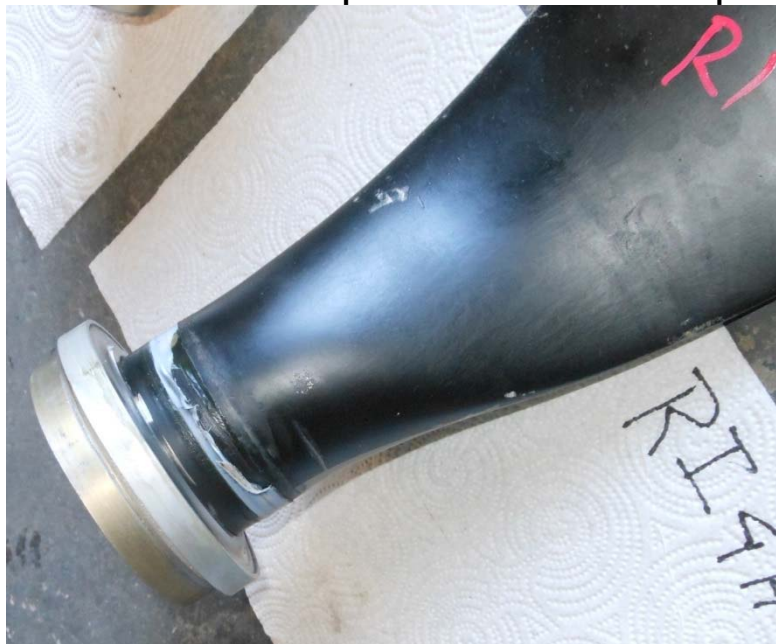
| Trail edge damage | Not remarkable, paint transfer mark where contacted hub aperture near shank (Photo #27) |
| Butt/shank impact marks | Contact mark with preload plate aft/trailing edge quadrant, the blade bearing lip sheared/fractured, smashed/torn seal rub strip |

Photo #27 – Blade R1 hub impact mark and seal rub strip damage

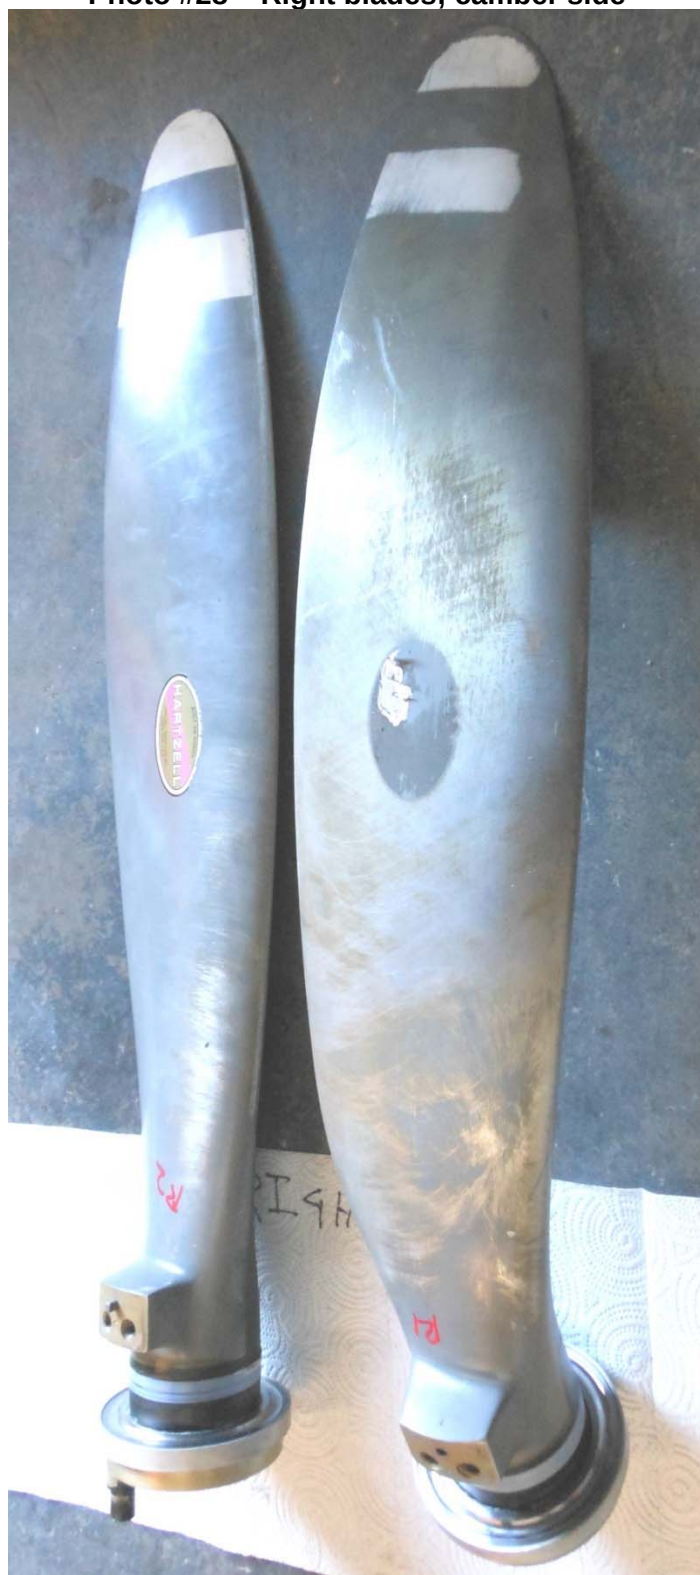
| Camber side | Chordwise/rotational paint abrasion |

| Camber side | Chordwise/rotational abrasion |

Photo #28 – Right blades; camber side

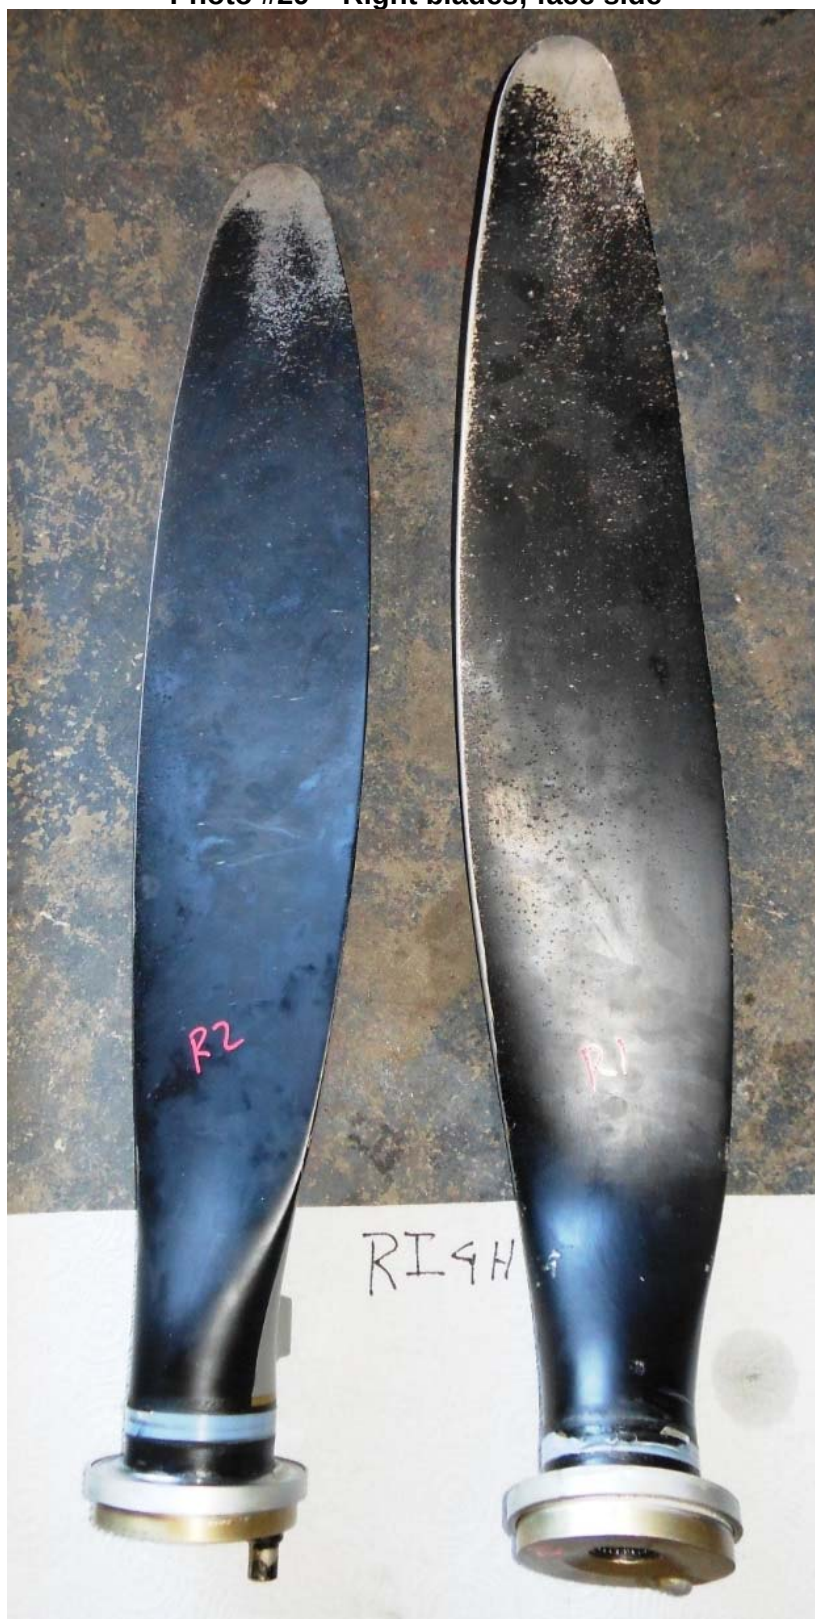
| Face side | Paint abrasion near tip/trailing edge area. |

| Face side | Paint abrasion near tip/trailing edge area. |

Photo #29 – Right blades; face side
