## **NATIONAL TRANSPORTATION SAFETY BOARD**

# **AIRFRAME AND ENGINE EXAMINATION**

**WPR17FA152**

Location: El Monte, CA  
Date: July 14, 2017  
Aircraft: Jansen Pazmany PL-1, Registration #186EJ, Serial #186  
NTSB IIC: Samantha Link

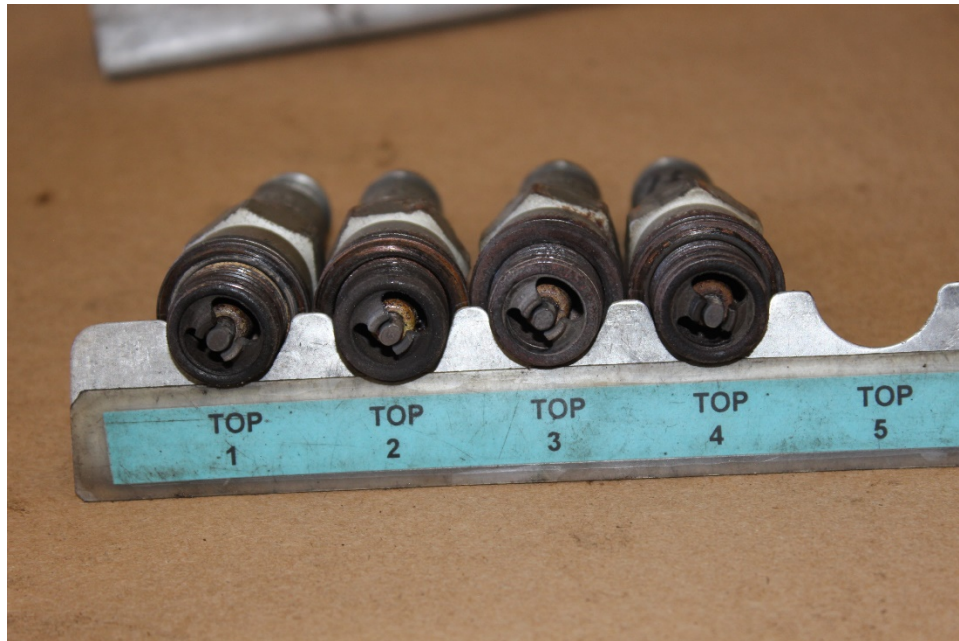
Figure 1: Top Spark Plugs

- The top spark plugs were removed
  - The electrodes were free of mechanical damage
  - Consistent with normal operations when compared to the Champion 'Check-a-plug' chart.

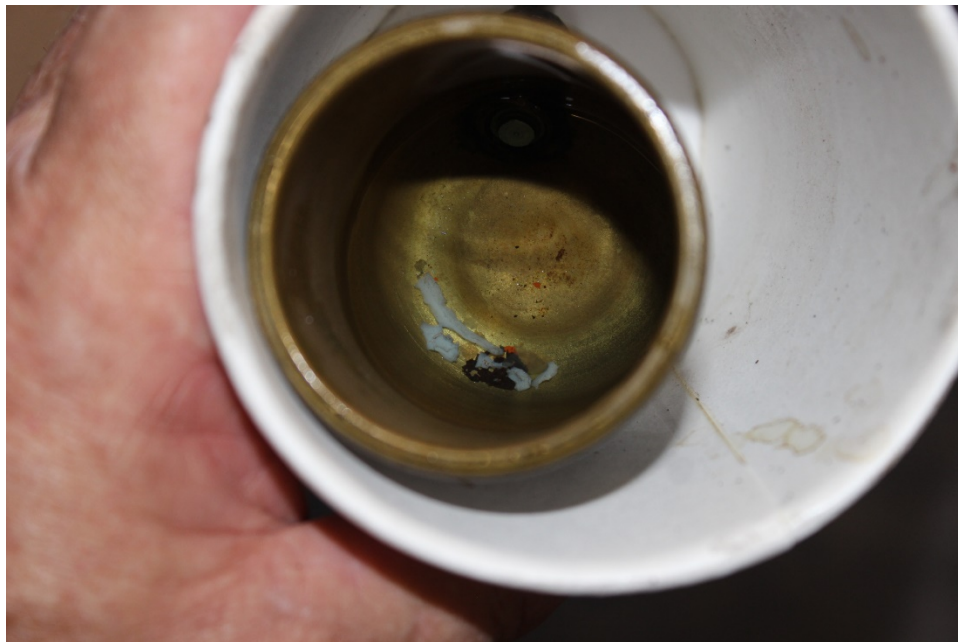
Figure 2: Gascolator Bowl

- Gascolator screen remained clear of debris
  - o The gascolator bowl was removed and had about one ounce of fuel remaining
  - o Small unidentified fragments were found at the bottom of the gascolator bowl

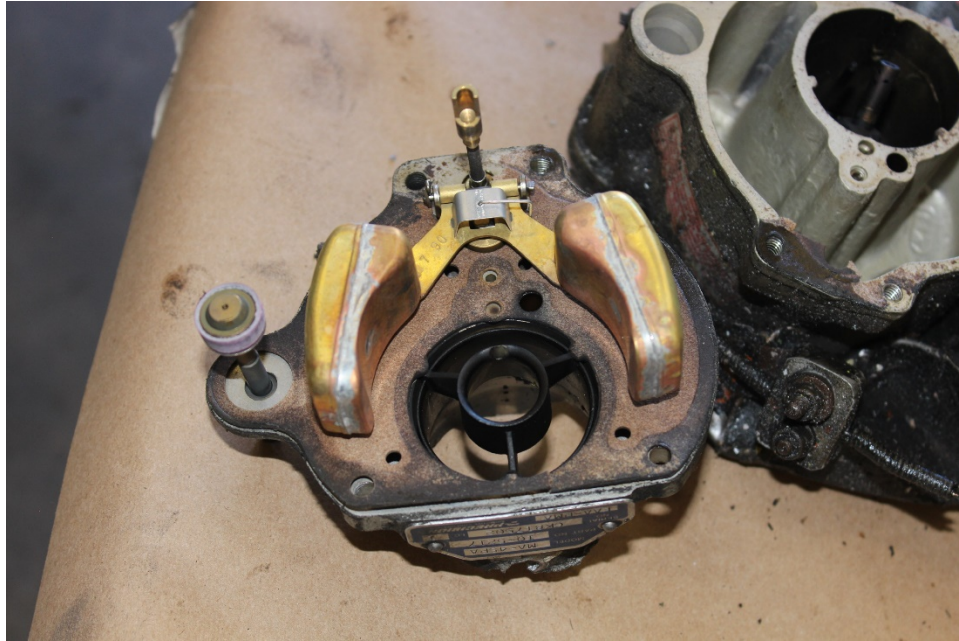
Figure 3: Carburetor Floats

- o The carburetor float pontoons remained intact and exhibited no evidence hydrodynamic crushing
- o Accelerator pump well was devoid of fuel
- o The fuel inlet screen was clear of debris

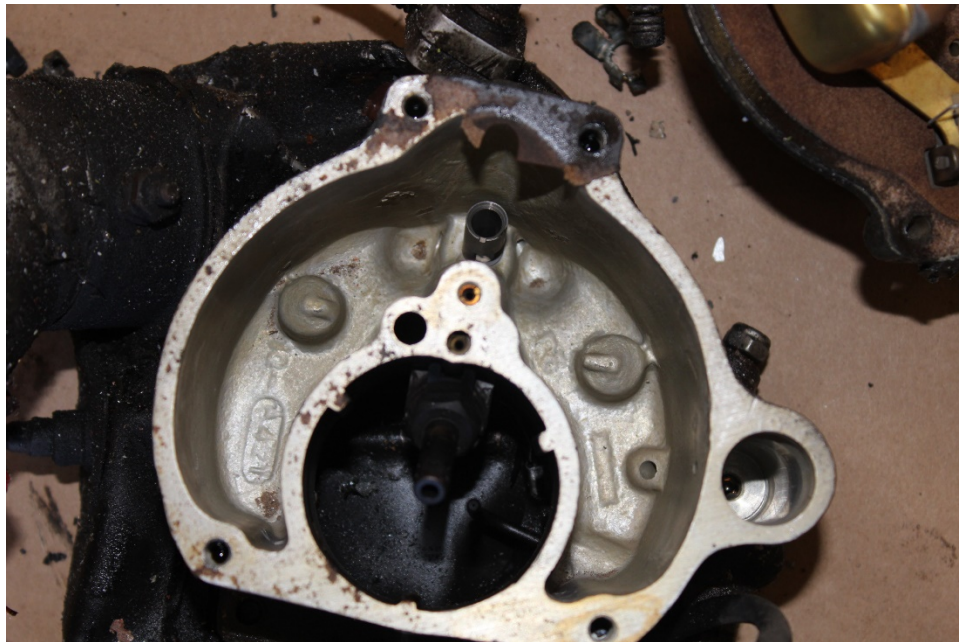
Figure 4: Carburetor Bowl and Accelerator Pump Well

- o Carburetor heat air box was crushed and clear of debris
- o The carburetor bowl was opened and the bowl remained free of visible contaminants
  - No fuel was present

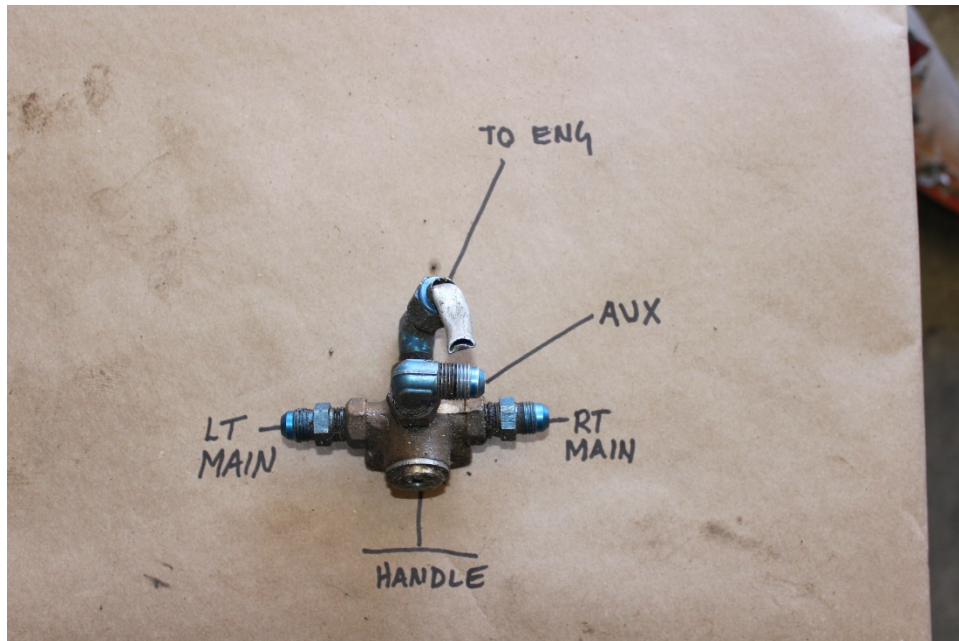
Figure 5: Fuel Selector

- The fuel pump was removed and disassembled
  - o Clear of debris
  - o No evidence of corrosion or water
  - o Diaphragm is intact and undamaged
- Fuel selector was removed and air was blown through it.

- o It was clear of debris
  - o The left fuel tank was selected
  - o The fuel selector had an unidentified fourth line. Further examination revealed a fourth fuel line along the sidewall which is capped behind the passenger seat. In addition, there is a fuel cap on the outside of the airframe in this area. It appeared that there was an auxiliary fuel tank installed at some point in time, but it has since been removed.

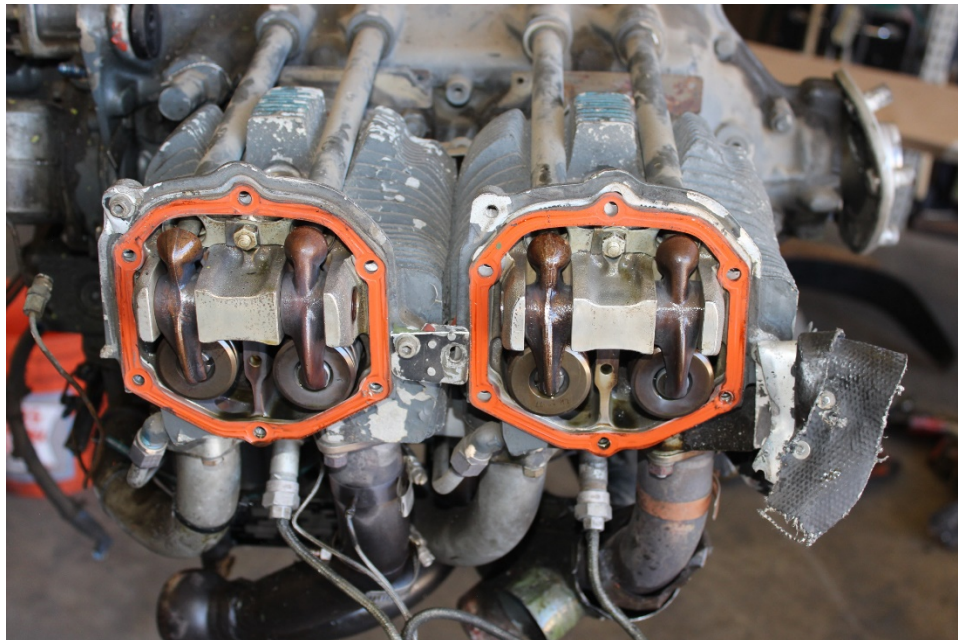
Figure 6: Right side of Engine

- The engine remained attached to the damaged engine mounts
- There was no evidence of catastrophic malfunction or preimpact fire
- The propeller was displaced from the crankshaft flange at its attachment point, consistent with impact energy
