**NATIONAL TRANSPORTATION SAFETY BOARD**  
Vehicle Recorder Division  
Washington, DC 20594

## **Onboard Image Recorder**

**Specialist's Factual Report**  
**By Sean Payne**

| NTSB Number: | WPR17FA161 |

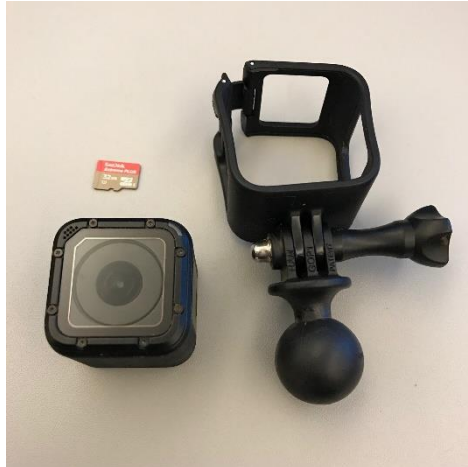
Upon arrival at the NTSB Vehicle Recorder Division, it was evident that the camera had not sustained any heat or structural damage and the information was extracted from the microSD card normally, without difficulty.

**Figure 1. The GoPro camera and microSD card that was received by the laboratory.**
