# NATIONAL TRANSPORTATION SAFETY BOARD

## MATERIALS LABORATORY FACTUAL REPORT

Report No. 18-069

Place : Apple Valley, CA  
Date : July 22, 2017  
Vehicle : Applegate Panzl S331E (N331ST)  
NTSB No. : WPR17FA161  
Investigator : Samantha Link (AS-WPR)

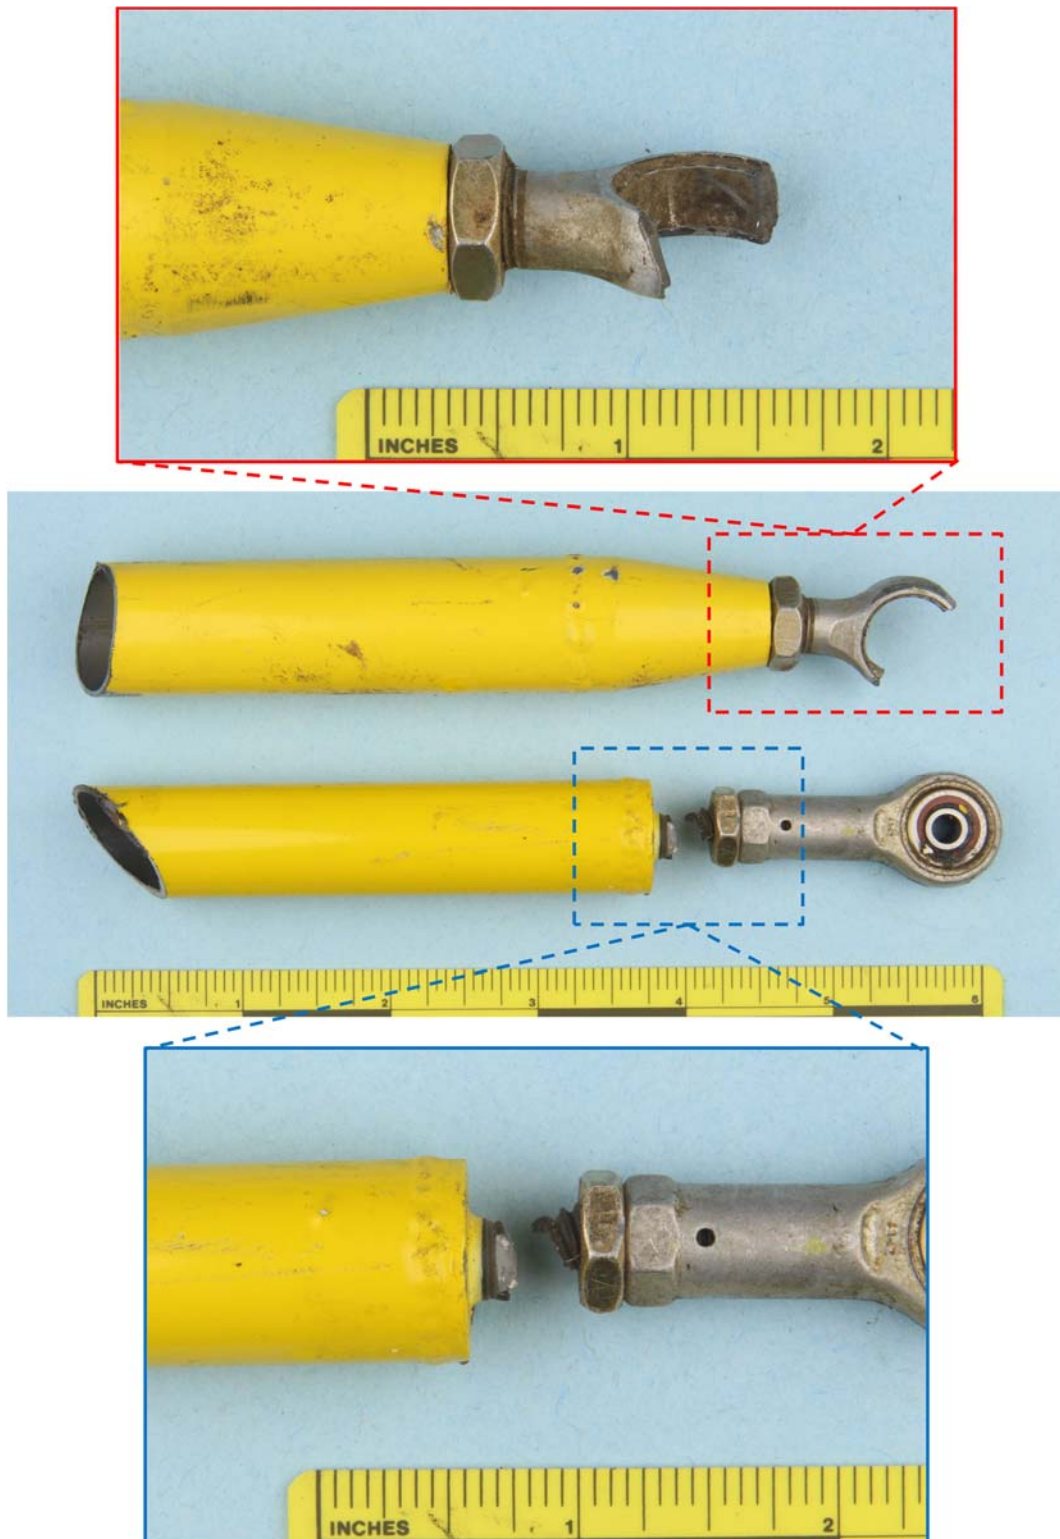
The rod ends of a control tube were submitted sectioned from the main body, as shown in Figure 1. The shaft end of one rod end was separated, while a portion of the outer ring of the other rod end was missing.

Figure 1: Overall (middle) and close-up (top and bottom) photos of the separations of the rod ends of the control tube.

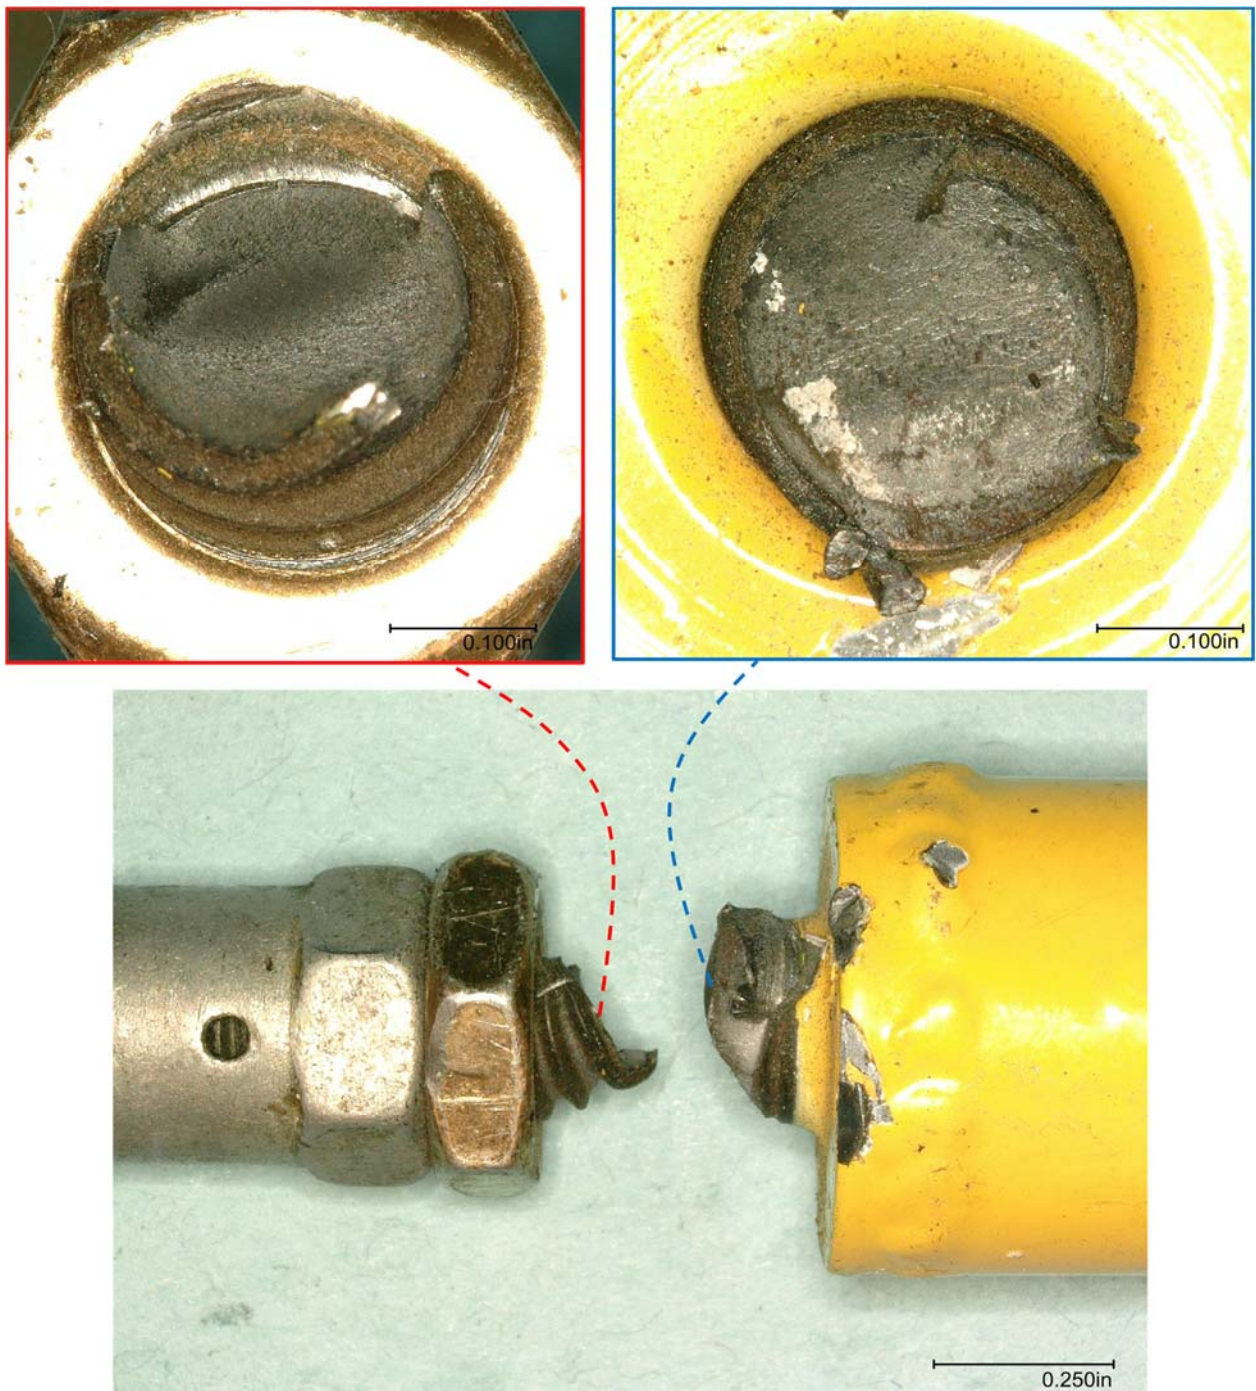
The fracture surfaces on the two rod ends were examined using a 5x to 50x digital zoom microscope. Figure 2 shows the separation through the shaft of the first rod end. The separation was through the threaded portion of the rod end shaft. The fracture surface on the shaft was at an approximately 45-degree angle to the longitudinal axis of the shaft. The fracture surface had features consistent with shear overstress.

Figure 2: Digital microscope images of the fracture surfaces of the separation through the threaded region of the first rod end.

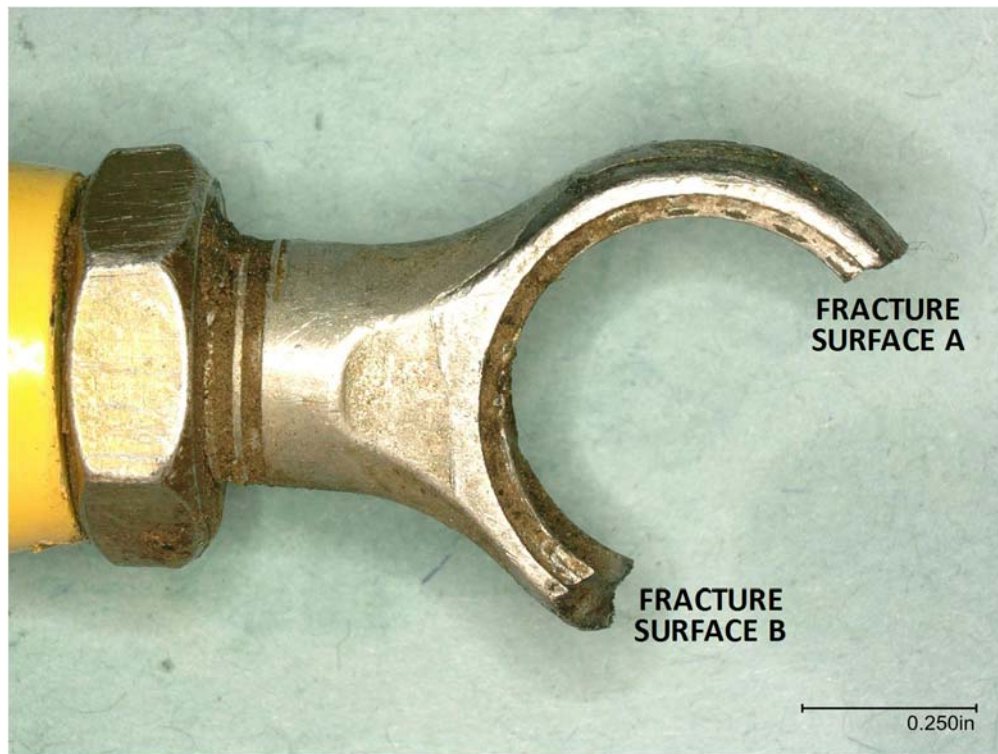
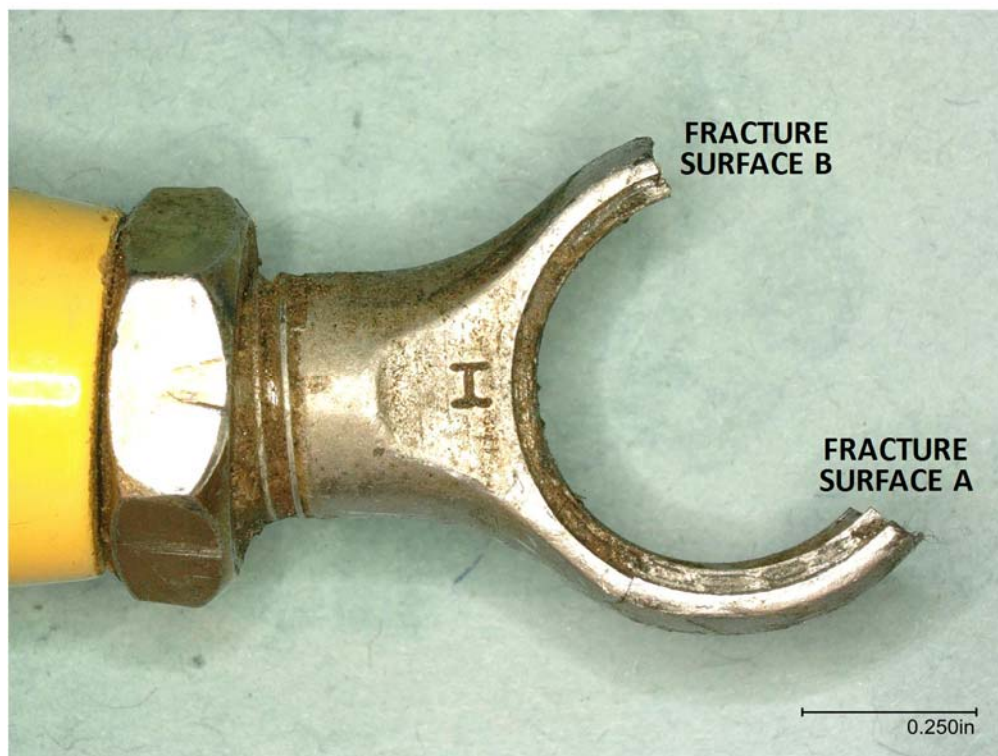
Figure 3 and Figure 4 show the fracture surfaces through the outer ring on the second rod end. The fracture surfaces were labeled A and B. Both fracture surfaces had relatively flat areas emanating from the inner diameter (ID) of the outer ring. Fracture surface A had smearing damage on much of its flat area. The fracture surfaces transitioned to angular planes adjacent to the outer diameter (OD), which is consistent with shear lips. The fracture surfaces of the separated outer ring were then examined using a Zeiss Auriga field emission (FE) scanning electron microscope (SEM), as shown in Figure 5 – Figure 8. The smearing damage on fracture surface A obscured most of the finer features. Fracture surface B had feathery features visible in the flat area that are consistent with fatigue cracking, as shown in Figure 7. The angular shear lip area had microvoid coalescence consistent with overstress, as shown in Figure 8.

Figure 3: Digital microscope images of the two faces of the second rod end showing the separation through the outer ring.

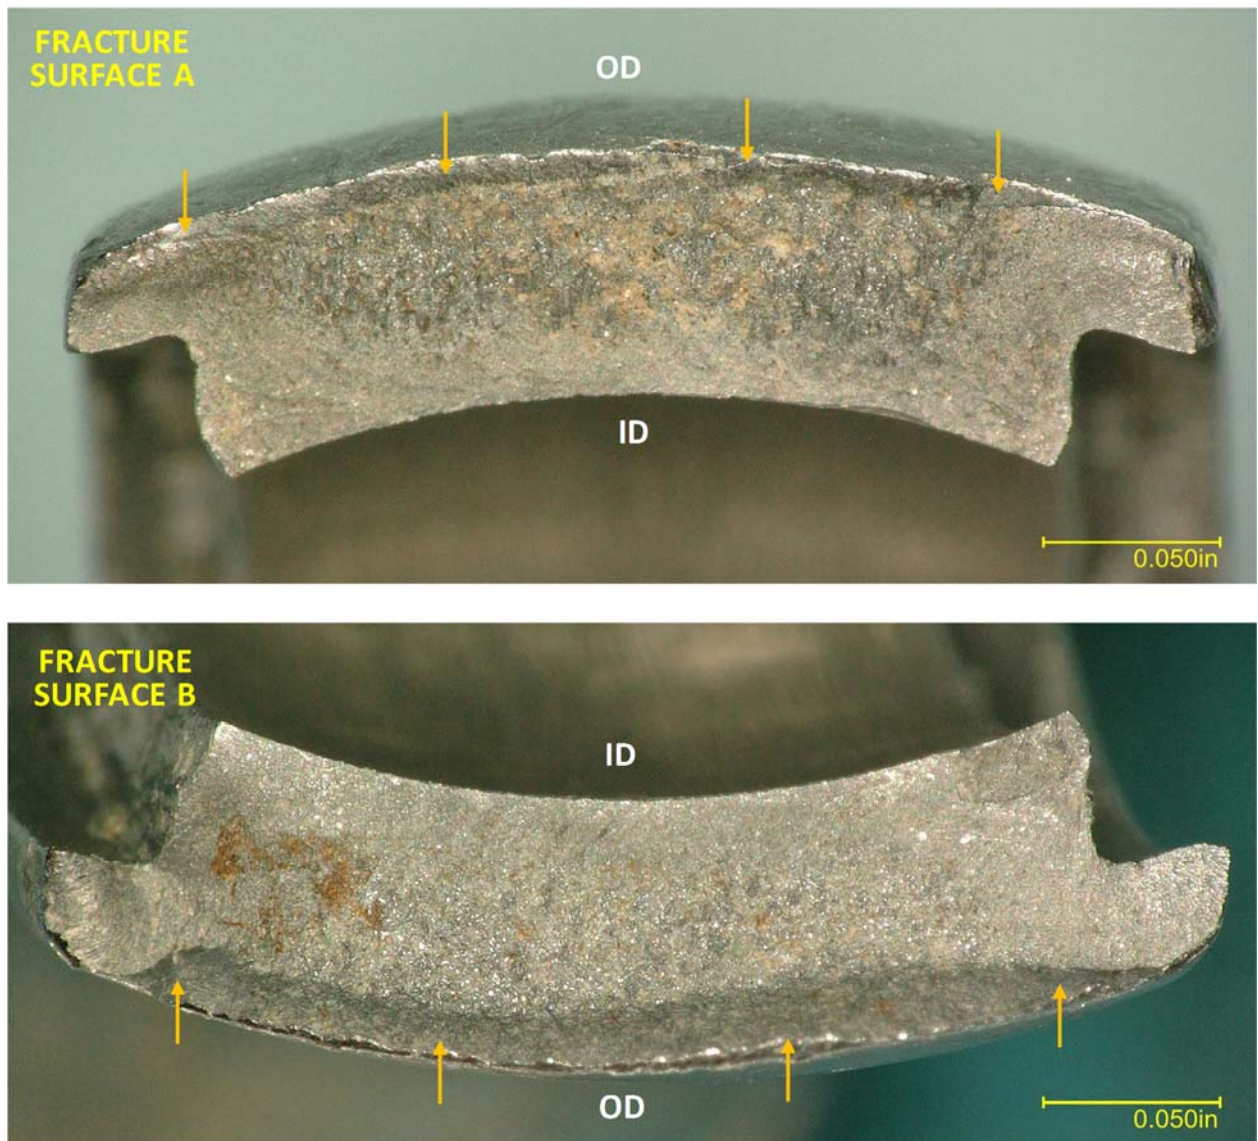
Figure 4: Digital microscope images of the fracture surfaces of the separations through the outer ring of the second rod end. The orange arrows point to the angled shear lips adjacent to the OD of the outer ring.

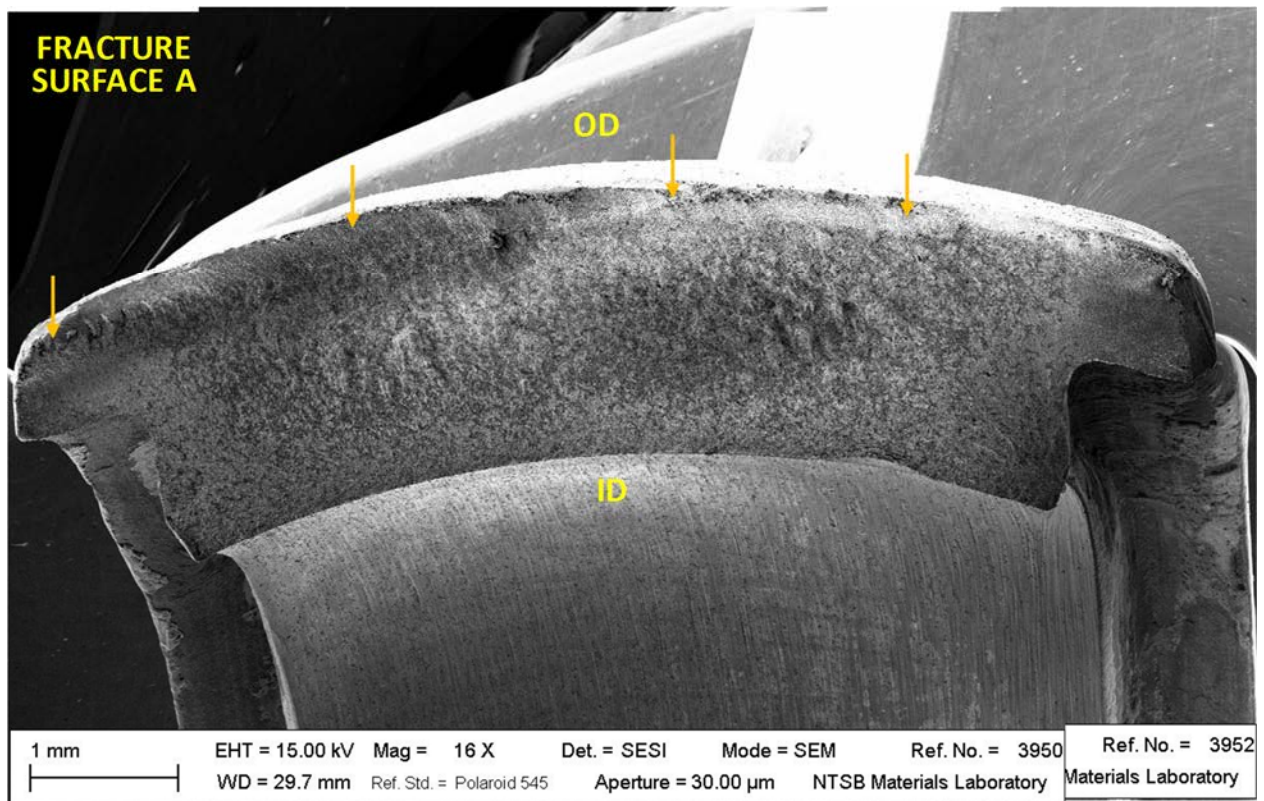
Figure 5: Secondary electron SEM images of fracture surface A on the outer ring of the second rod end. The orange arrows point to the angled shear lip adjacent to the OD of the outer ring.

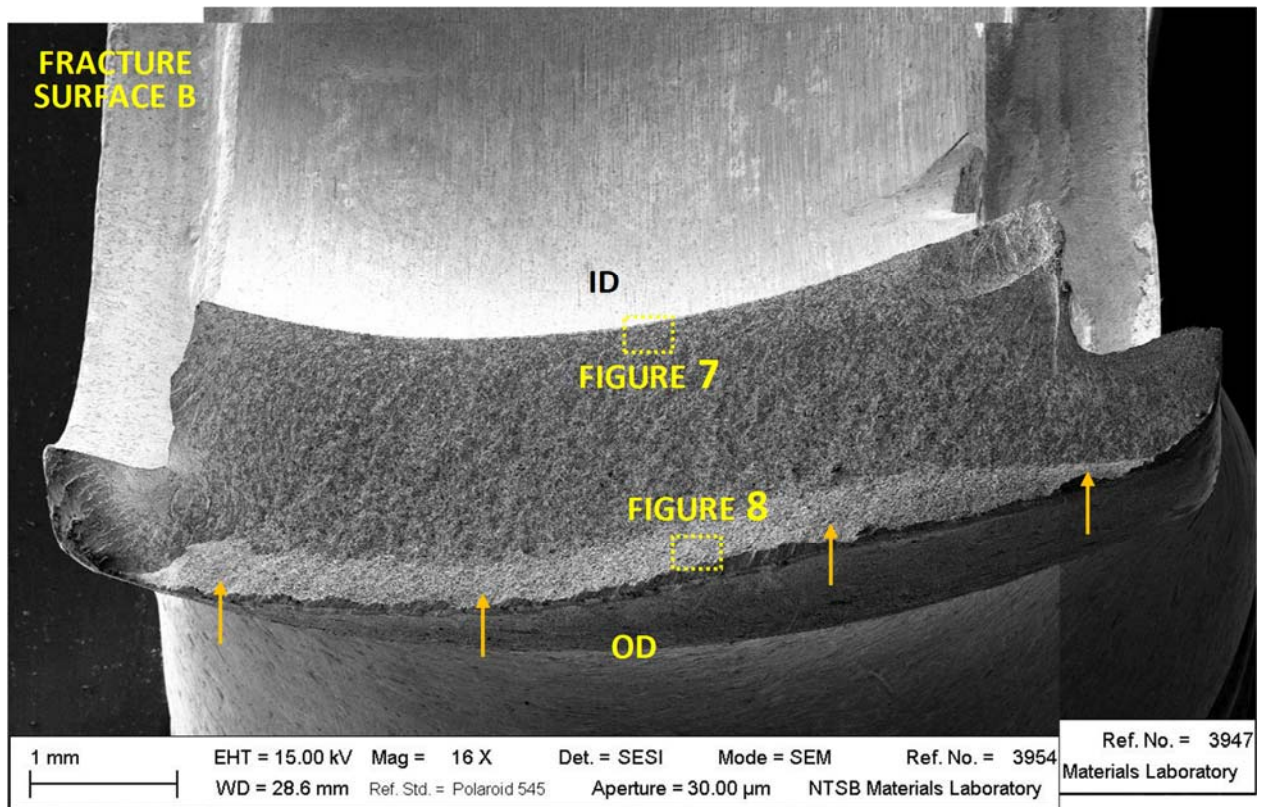
Figure 6: Secondary electron SEM images of fracture surface B on the outer ring of the second rod end. The orange arrows point to the angled shear lip adjacent to the OD of the outer ring.

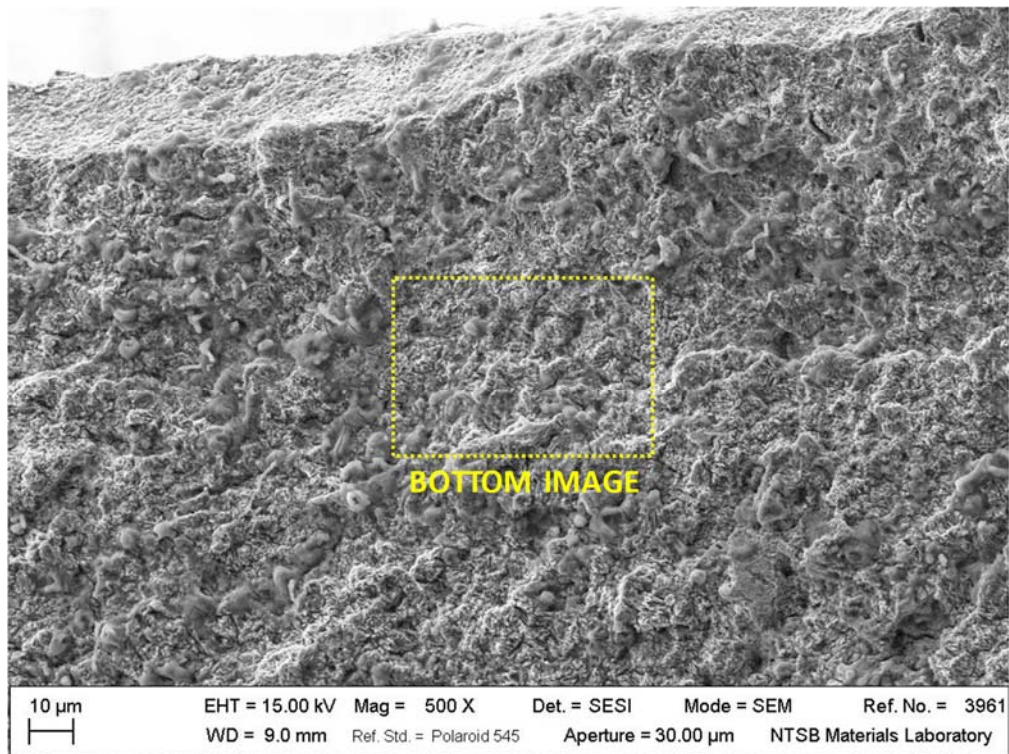
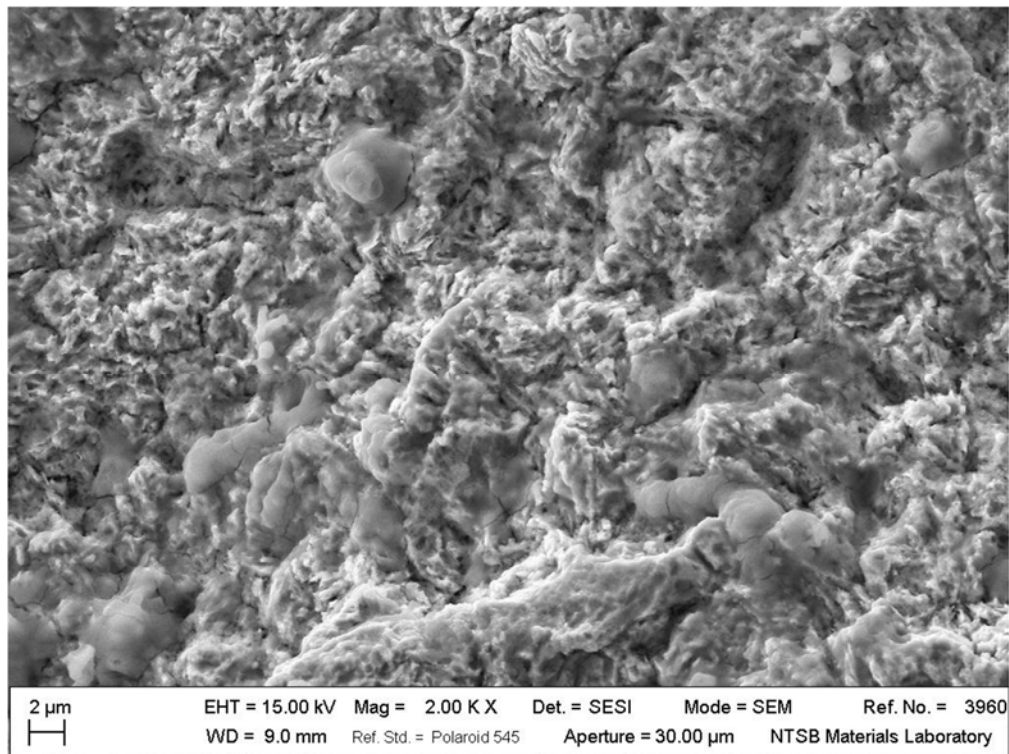
Figure 7: Secondary electron SEM images of the flat area on fracture surface B.

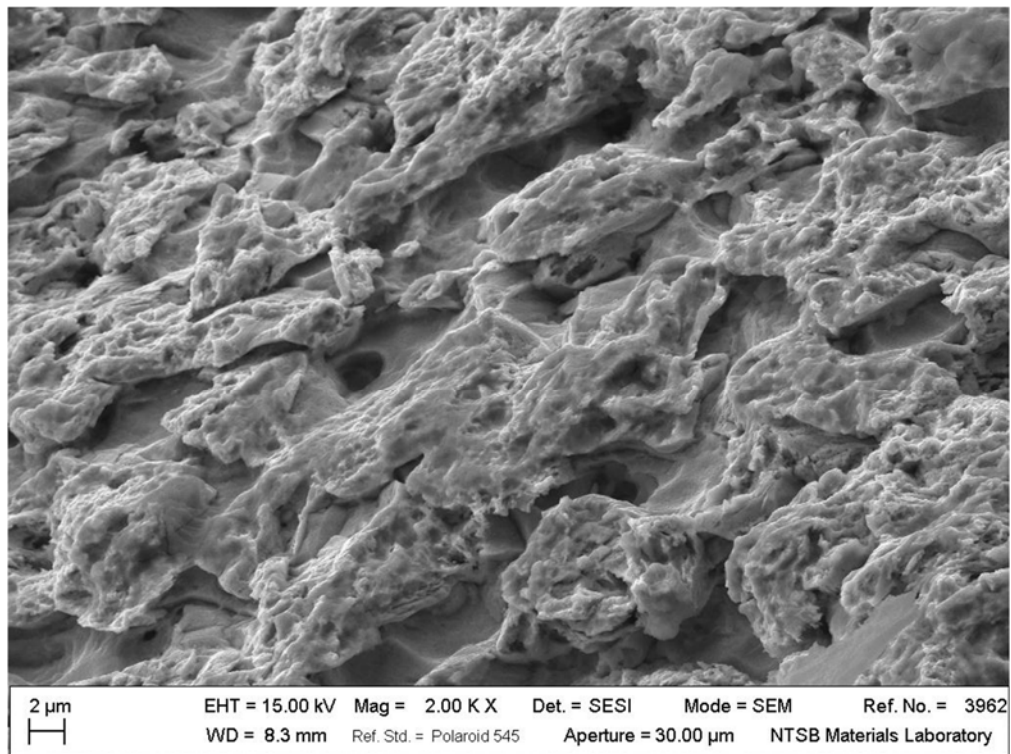
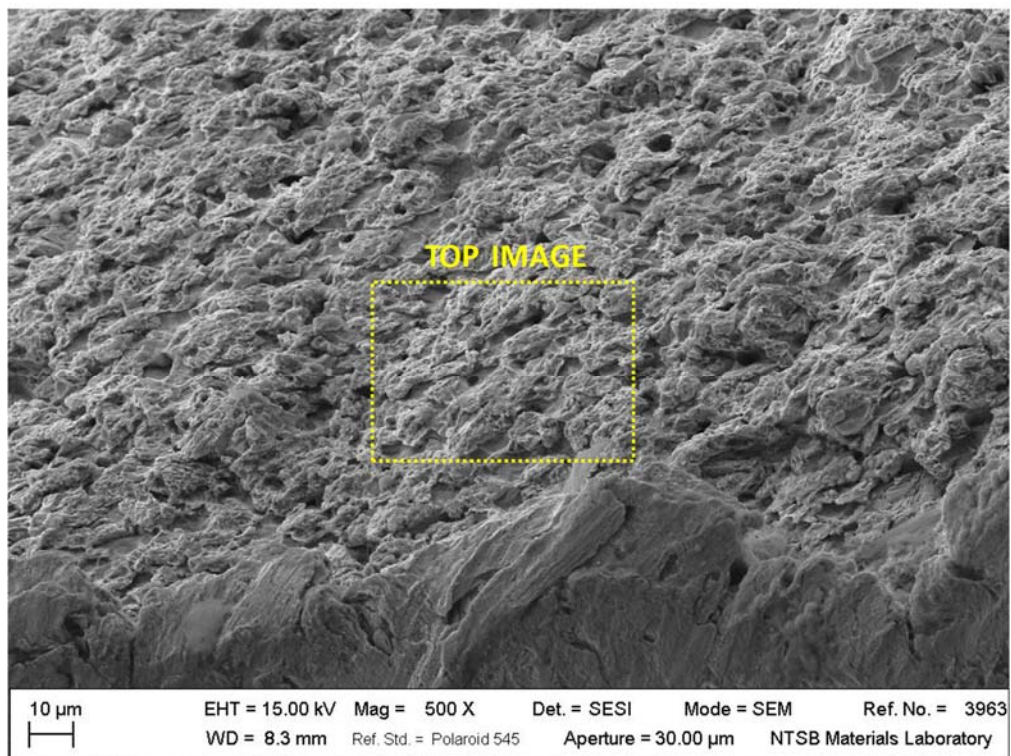
Figure 8: Secondary electron SEM images of the shear lip on fracture surface B.
