## **NATIONAL TRANSPORTATION SAFETY BOARD**

### **ON SCENE OBSERVATIONS**

**WPR17FA161**

Location: Apple Valley, California  
Date: July 22, 2017  
Aircraft: Applegate Penzl S331E, Registration #331ST, Serial #001  
NTSB IIC: Samantha Link

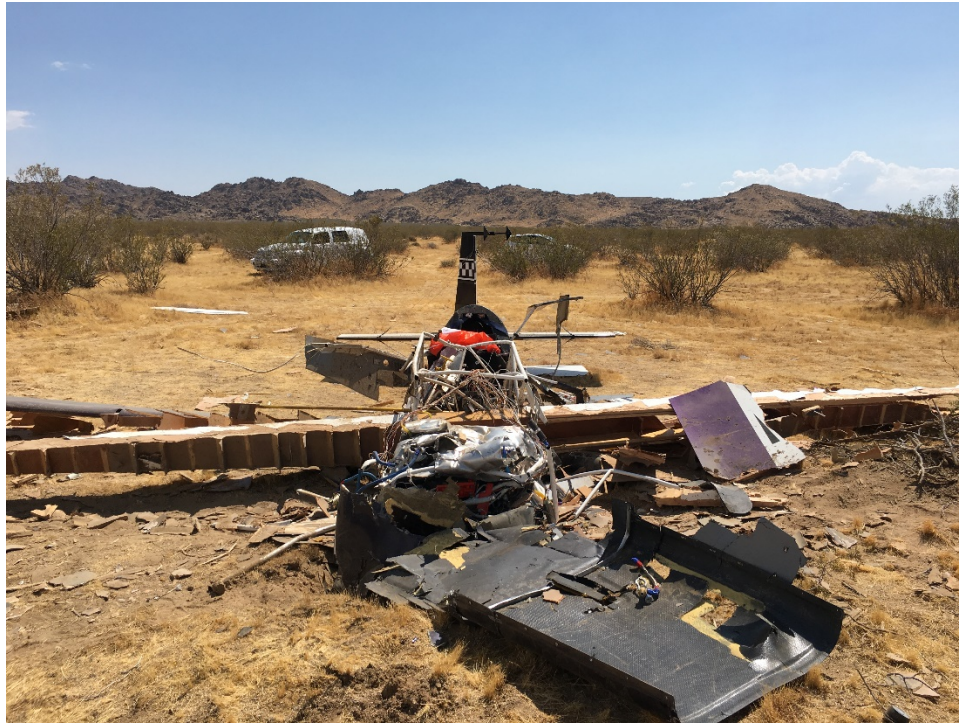
Figure 1: Front of Airplane

- The airplane crashed about 3 miles northeast of the airport
- The airplane impacted the ground upright at about a 45 degree angle.
  - The airplane maintained its general form.
  - Fragments of airplane skin, canopy, etc were spread around the main wreckage.
- The engine came to rest in a crater that was about 3 feet by 4 feet wide and about 2 feet deep.
  - When the engine was removed, wood and composite propeller fragments were noted at the bottom of the crater.
  - There were no obvious signs of catastrophic mechanical anomalies with the engine
- Both the right and left wing leading edges left impact marks in the sand.
  - The right wing impact mark was about the width of the leading edge
  - The left wing impact mark was on a small hill and about double the width of the leading edge
    - It appeared as if the left wing had about 10 degrees of rotation at the time of impact.

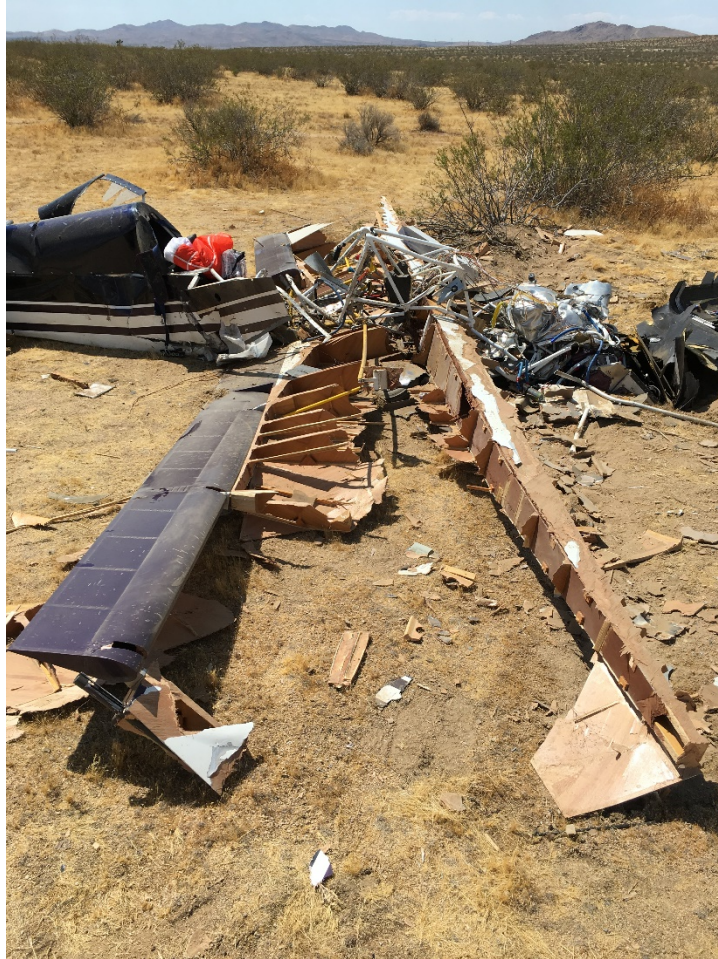
**Figure 2: Right Wing**

- The wings were heavily damaged.
  - The wood spar and ribs were heavily damaged but mostly intact. The skin for both wings was completely separated and fragmented throughout the main wreckage.

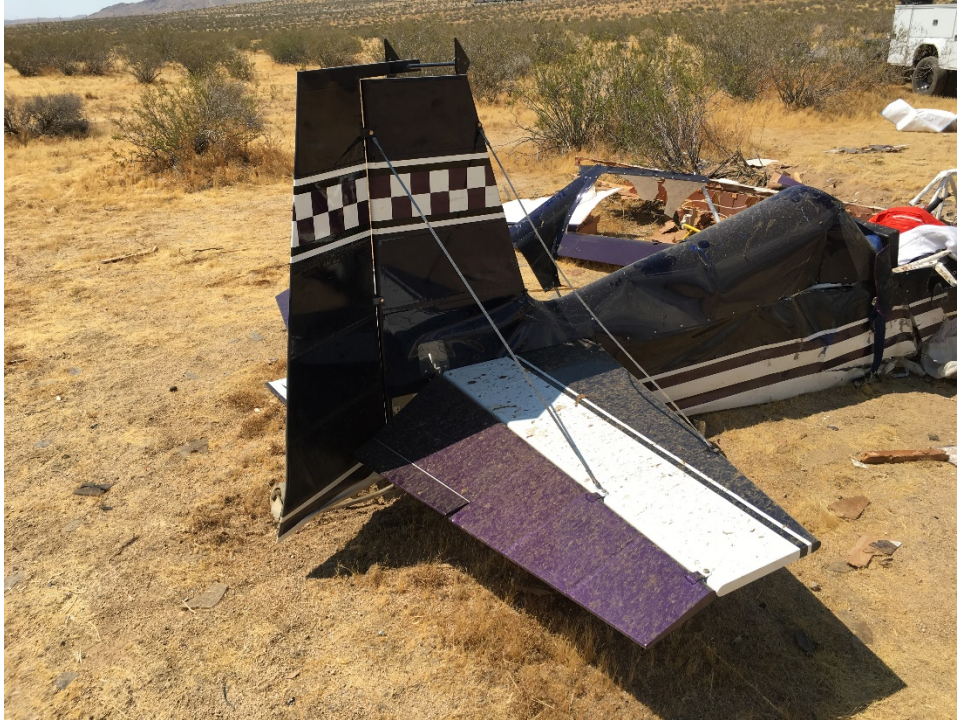
Figure 3: Empennage

- The empennage was mostly intact and sustained minimal damage. The elevator and rudder moved freely without binding.
- The flight controls were connected through push/pull tubes. Control continuity was established throughout the airplane.

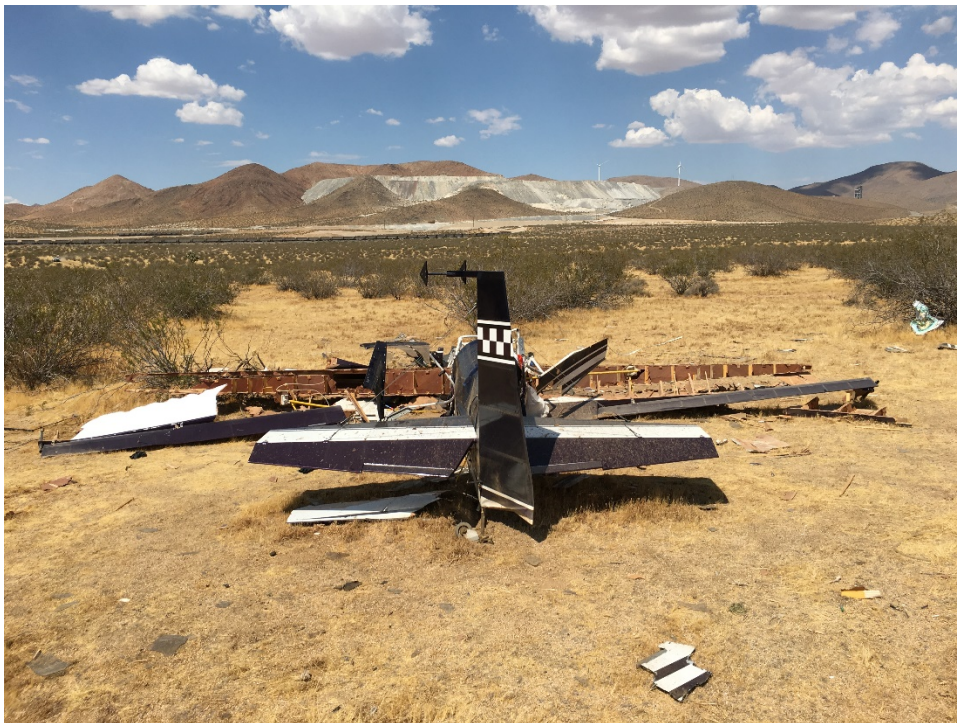
Figure 4: Empennage looking forward

- Although the wing broke away from the ailerons, they remained connected to their attachment points.
    - The spades remained attached
- The aft fuselage sustained heavy crush damage. The aft fuselage skin was still attached to the airplane, but evidence of heavy damage was noted throughout.

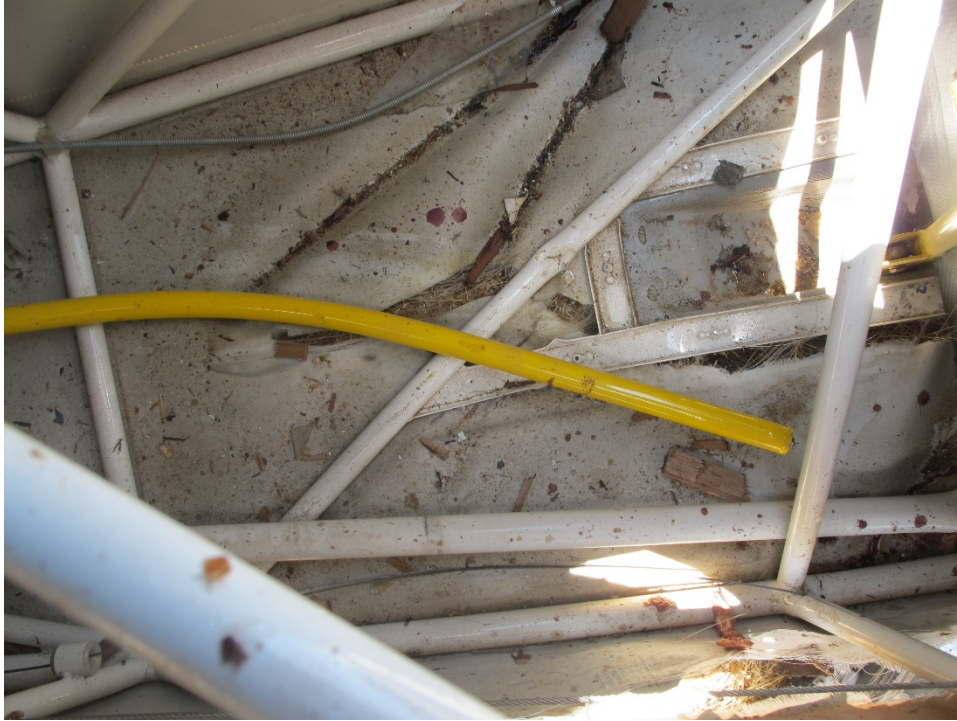
- The elevator torque tube was disconnected from underneath the seat. Given the positioning of the fracture and the wreckage, we could not see the exact location of the break. However, the aft portion of the tube (extending towards the elevator) was clearly visible. The tube was bent in an overall “moon” shape, and to the naked eye, the fracture surface appeared to be consistent with overload.

Figure 7: Fractured and Bent Elevator Control

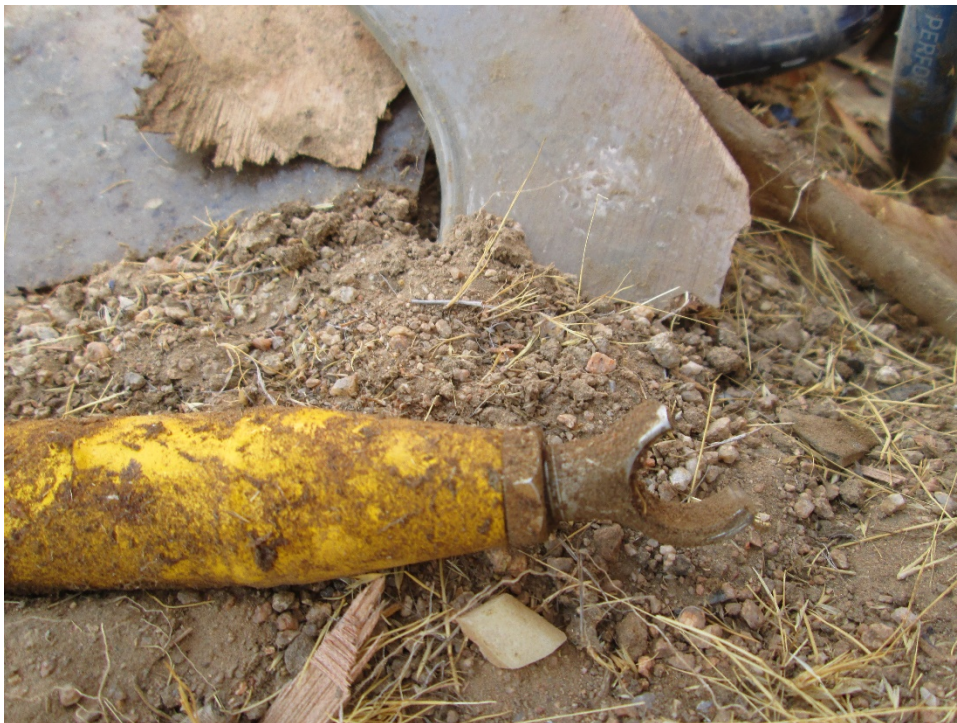
- The right aileron control and rudder controls were continuous and not damaged.
  - The connection for the ailerons are at the base of, and about two feet forward, of the control stick. The left aileron broke at eye bolt where it attaches to the control stick. The ball, and part of its surrounding attach point were still connected to the control stick attachment point. To the naked eye, the fracture appeared to be consistent with overload.

Figure 8: Fractured Left Aileron Control

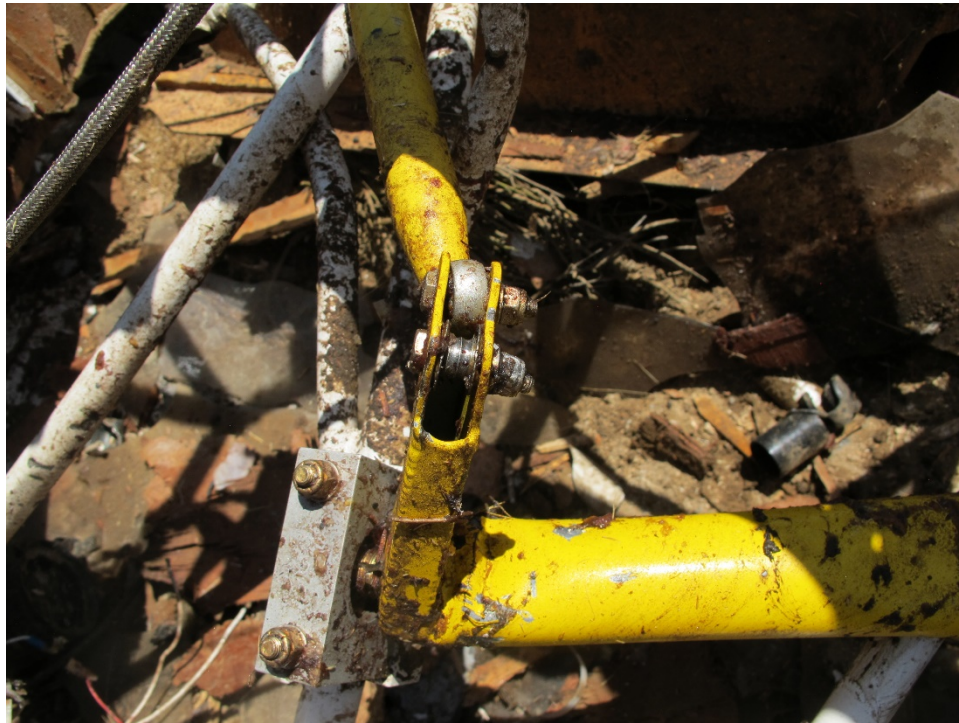
Figure 9: Aileron Attachment Point for Control Stick
