## **NATIONAL TRANSPORTATION SAFETY BOARD**

# **ENGINE EXAMINATION**

**WPR17FA161**

Location: Apple Valley, CA  
Date: July 22, 2017  
Aircraft: Applegate Panzl S331E, Registration #331ST, Serial #001  
NTSB IIC: Samantha Link

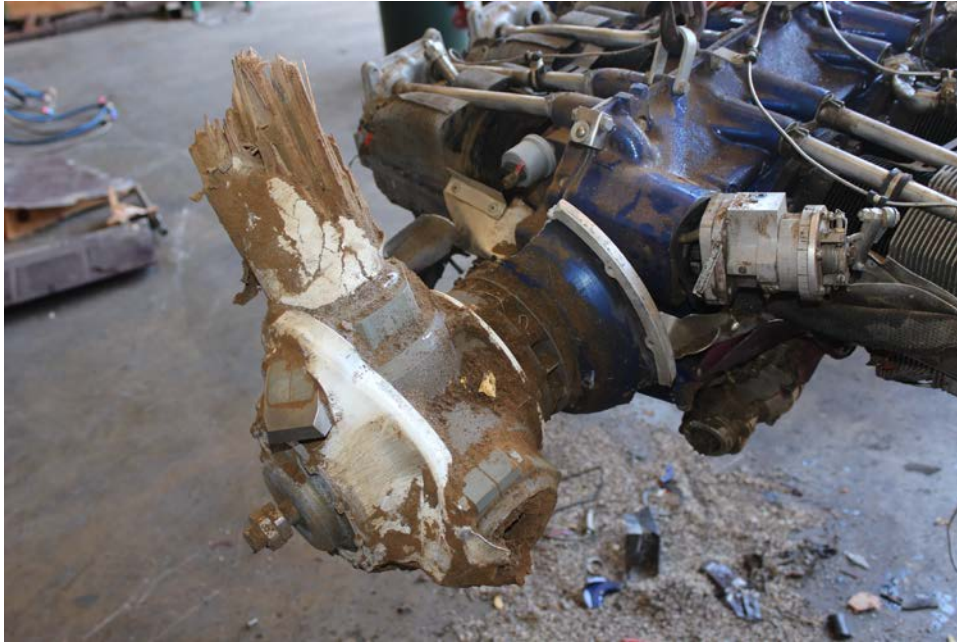
Figure 3: Propeller Assembly

- Propeller Assembly
  - The propeller governor was displaced from mounting bad, control remained securely attached at control arm
  - The propeller hub remained attached to the crankshaft flange

- The three wood/composite propeller blades were all destroyed, at or close to the propeller hub
    - Propeller hub serial: MTV-9-B-C/08302
- Engine driven fuel pump was displaced from accessory case

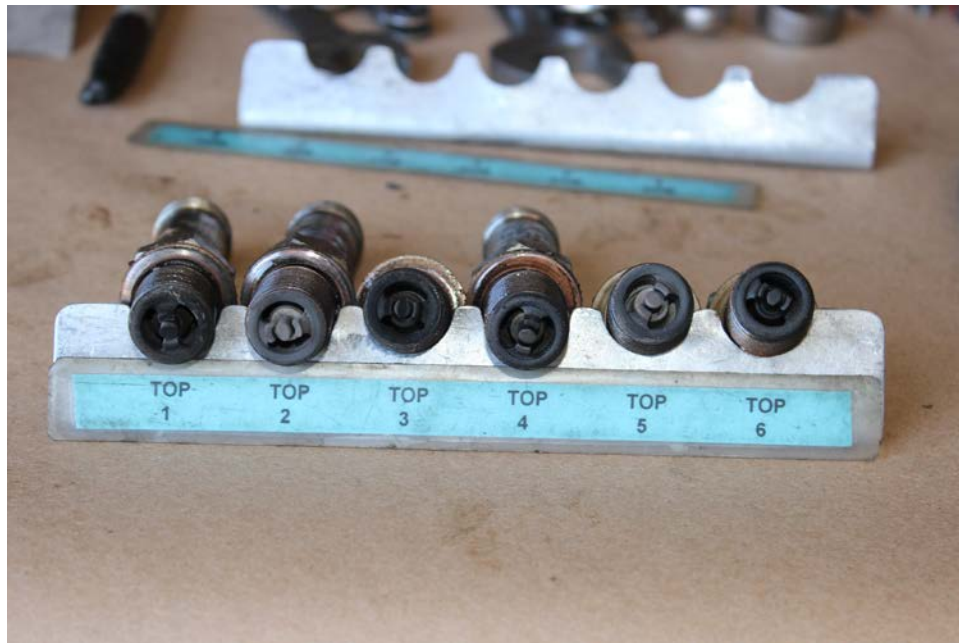
Figure 5: Top Spark Plugs

- All 6 fuel injection nozzles were clear of debris and were unobstructed
- Top spark plugs were removed. The electrodes remained mechanically undamaged and exhibited varying coloring

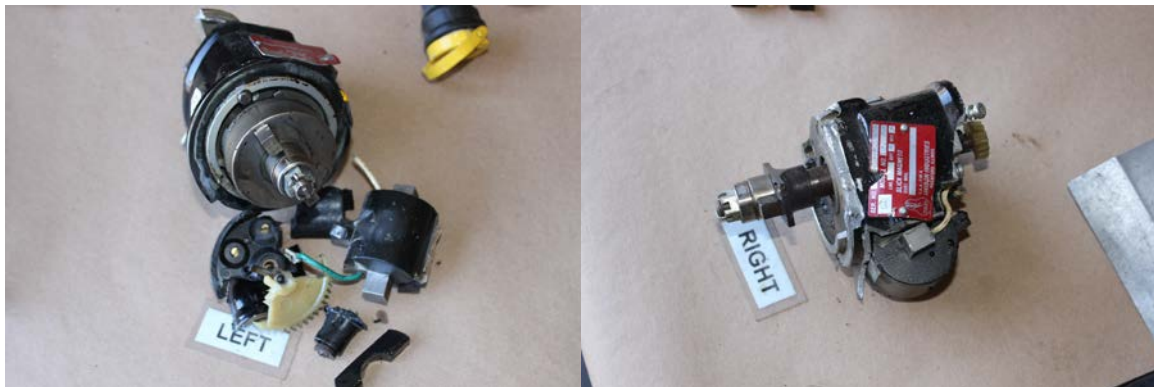
Figure 6: Magnetos

- Magnetos:
  - Right magneto was displaced from mounting pad
  - Left magneto remained securely clamped at its mounting pad
  - Both magnetos were fragmented and could not be functionally tested

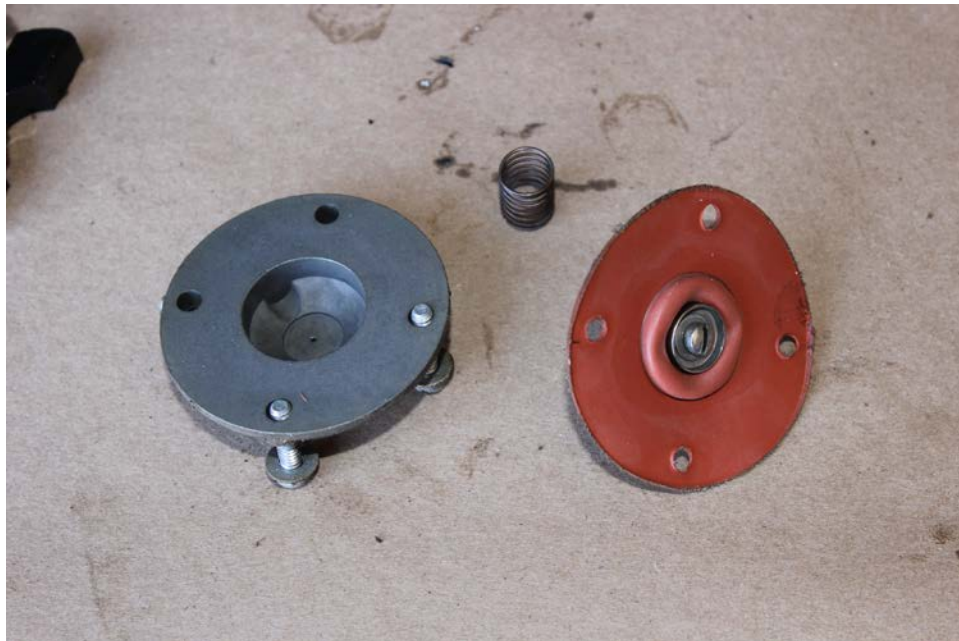
Figure 8: Fuel Flow Divider

- The fuel flow divider remained secured at its mounting bracket, the flow divider was disassembled
  - No visible contaminates
  - Diaphragm remained intact
