## **NATIONAL TRANSPORTATION SAFETY BOARD**

# **ACCIDENT SITE EXAMINATION SUMMARY**

**WPR17FA166**

Location: Ogden, Utah  
Date: July 26, 2017  
Aircraft: N60WB; Beech A36TC  
NTSB Investigator-in-Charge: Andrew Swick

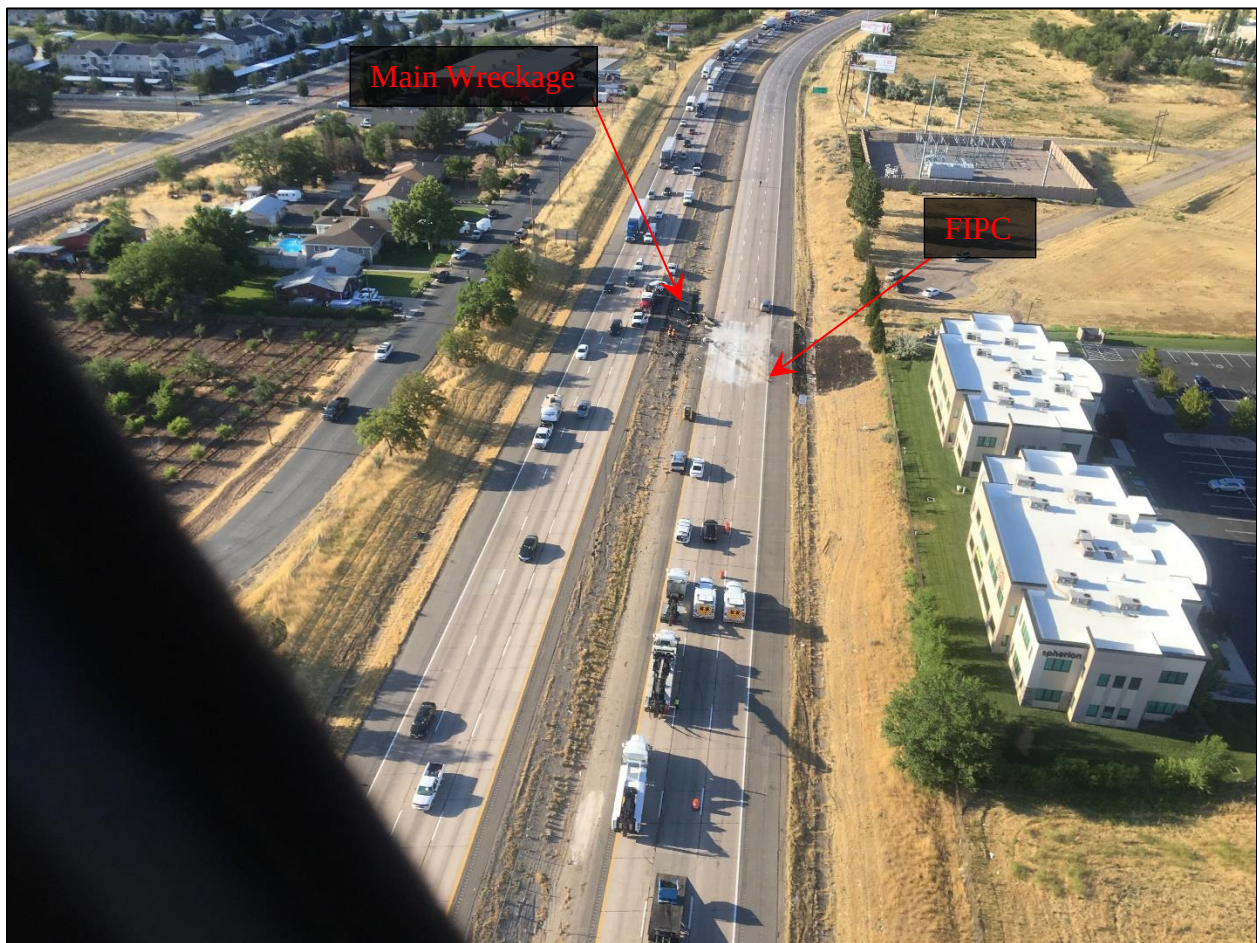
Figure 1-Aerial View of the Accident Site

Examination of the accident site was conducted on July 27, 2017, by the NTSB-IIC, FAA-IIC and Utah State Troopers. The accident site was located on Interstate 15, about one mile south of OGD. The wreckage debris field was spread diagonally across both the north and south-bound lanes. The main wreckage and most of the loose debris was in the north-bound lane. A small brush fire was extinguished on the east ditch.

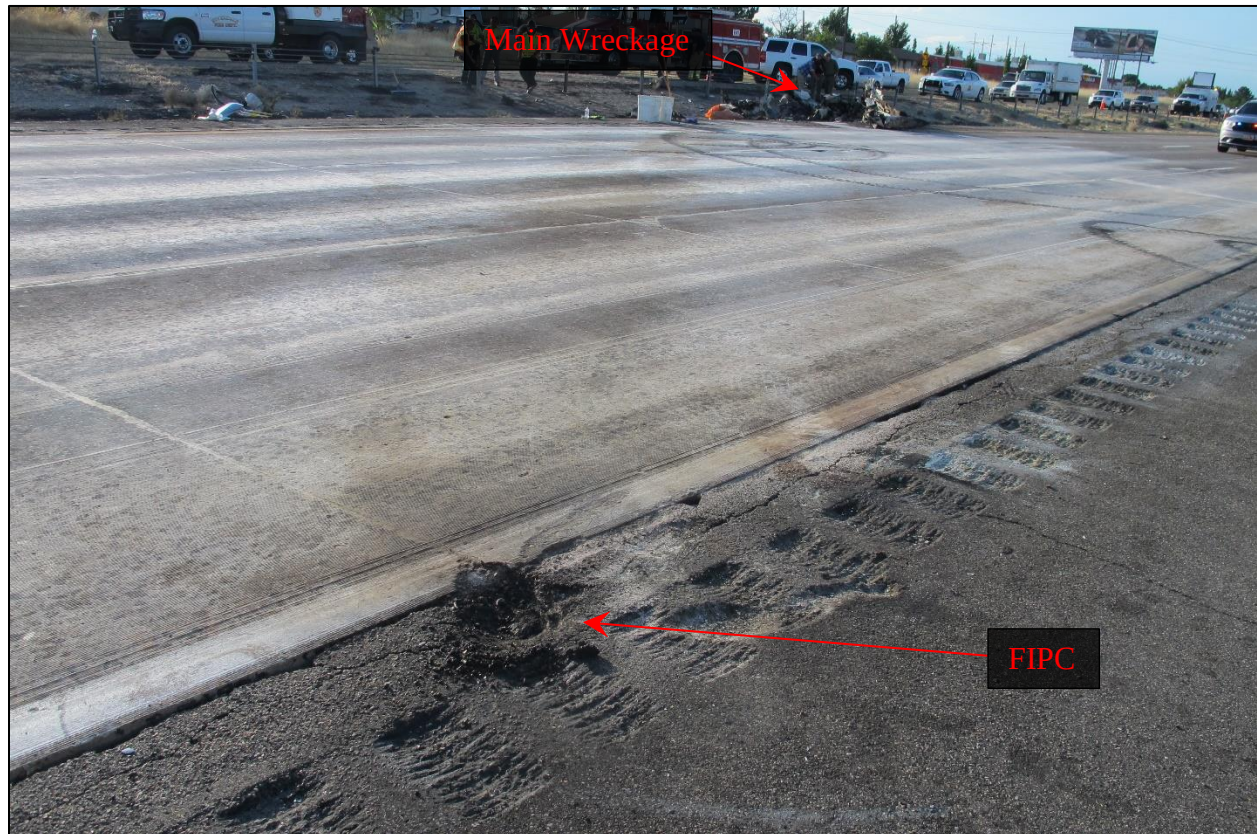
Figure 2-First Identified Point of Contact (view northwest)

The first identified point of contact (FIPC) was near the righthand white fog line and rumble strip of the northbound lanes. The debris field was about 150 feet long with debris in both north and southbound lanes.

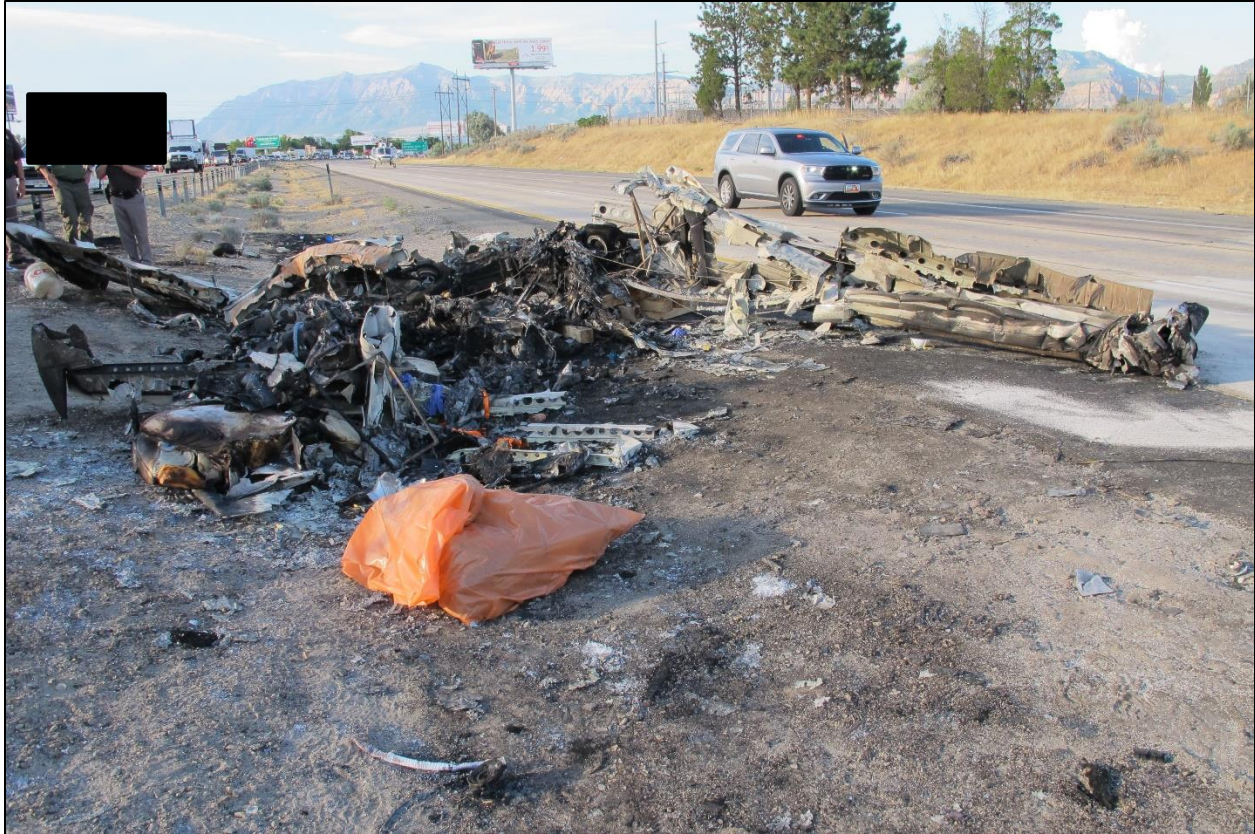
**Figure 3-Main Wreckage (view north)**

The main wreckage came to rest in the median, along the center guardrail. The main wreckage remained intact with post-crash fire damage. The wing tip tanks and the leading edge of the wings were crushed, consistent with vertical impact damage. All flight controls were accounted for and flight control continuity was attained.

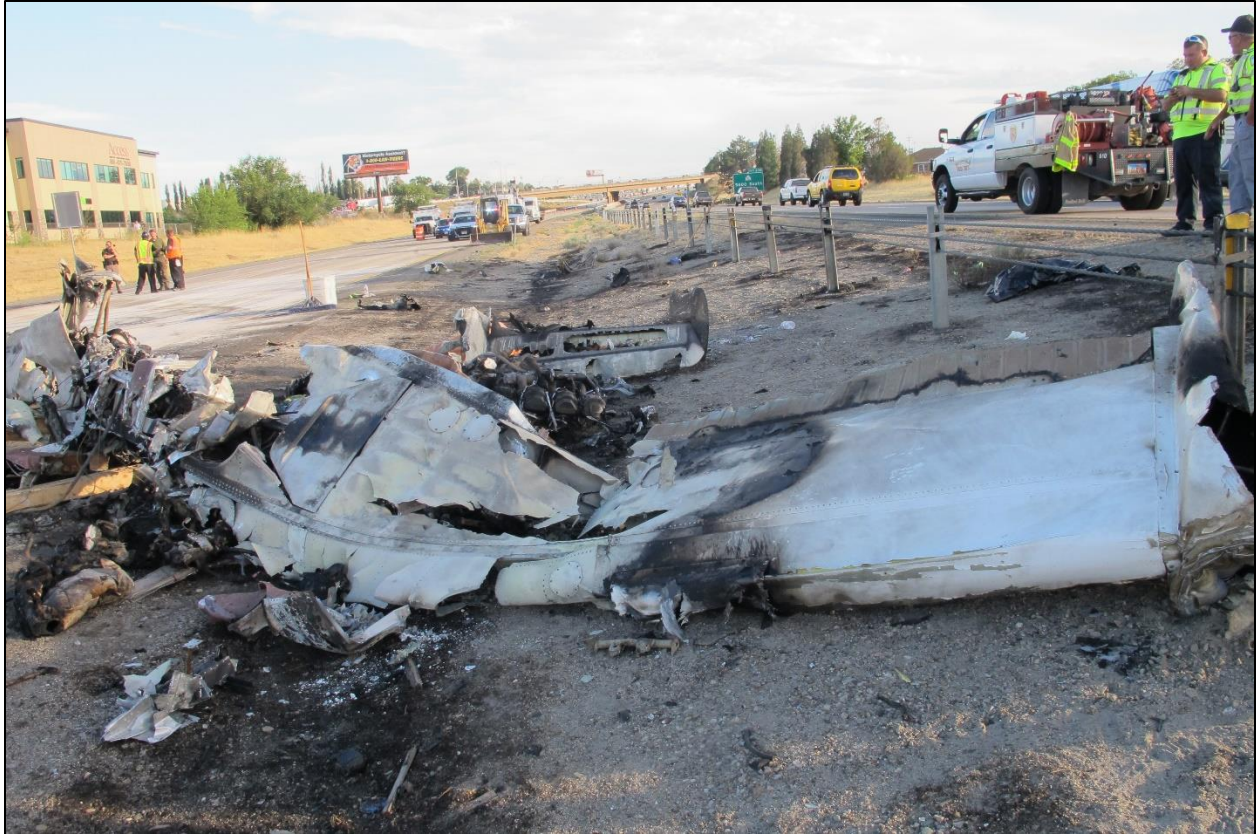
**Figure 4-Main Wreckage (south view)**

The wing tip tanks and the wing's leading edges had crush damage consistent with a nose down aircraft attitude and impact with terrain. Flap jack screws were identified and documented.

The photo shows the accident site and the main wreckage along side the road. The wreckage has impact and thermal damage.

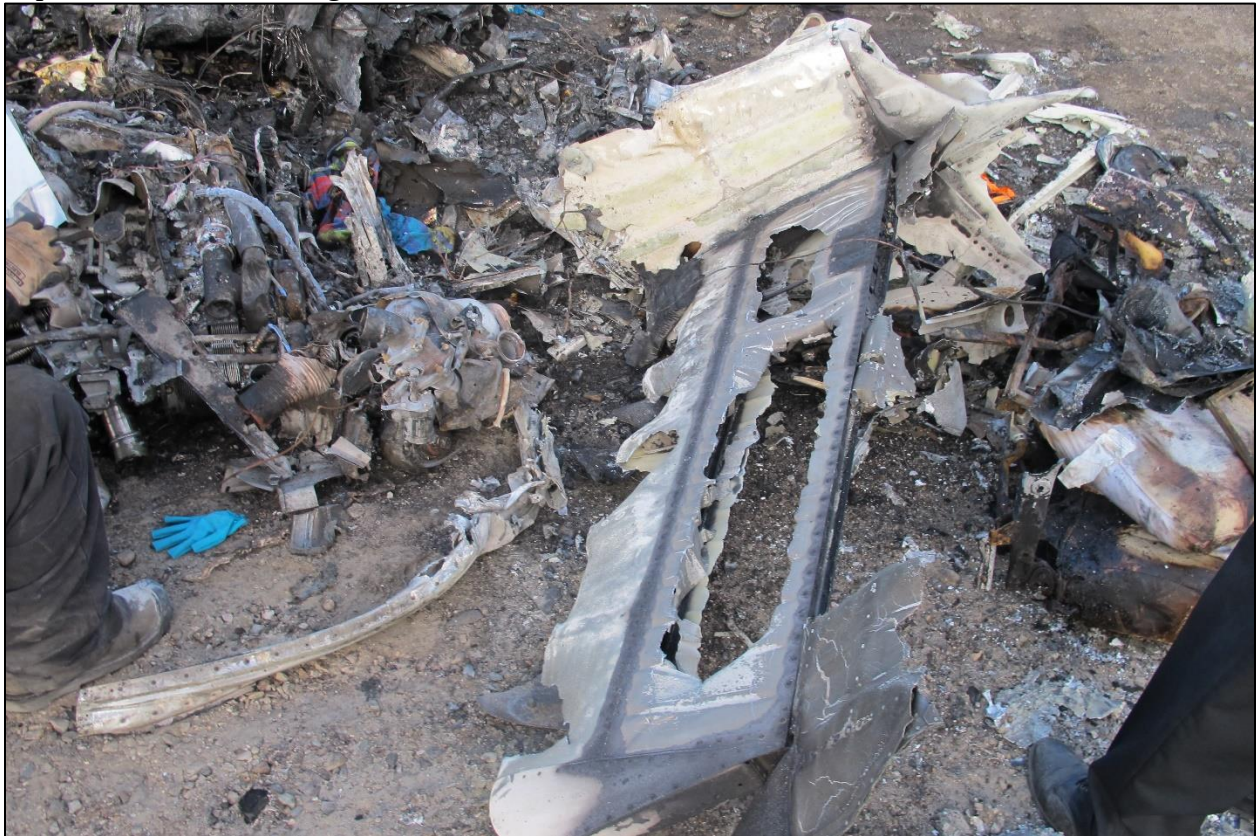
**Figure 5-Aft Fuselage and Empennage**

The aft fuselage and empennage had excessive thermal damage. The flight control surface mounts remained attached to their respective locations. The rudder control cables were cut during the removal of the bodies from the wreckage. The rudder cables remained attached to the rudder attach points and the remaining rudder moved freely on its lower hinge point. The elevator control tubes were melted and only sections remained. The tube sections moved the remaining elevators sections freely in both directions.

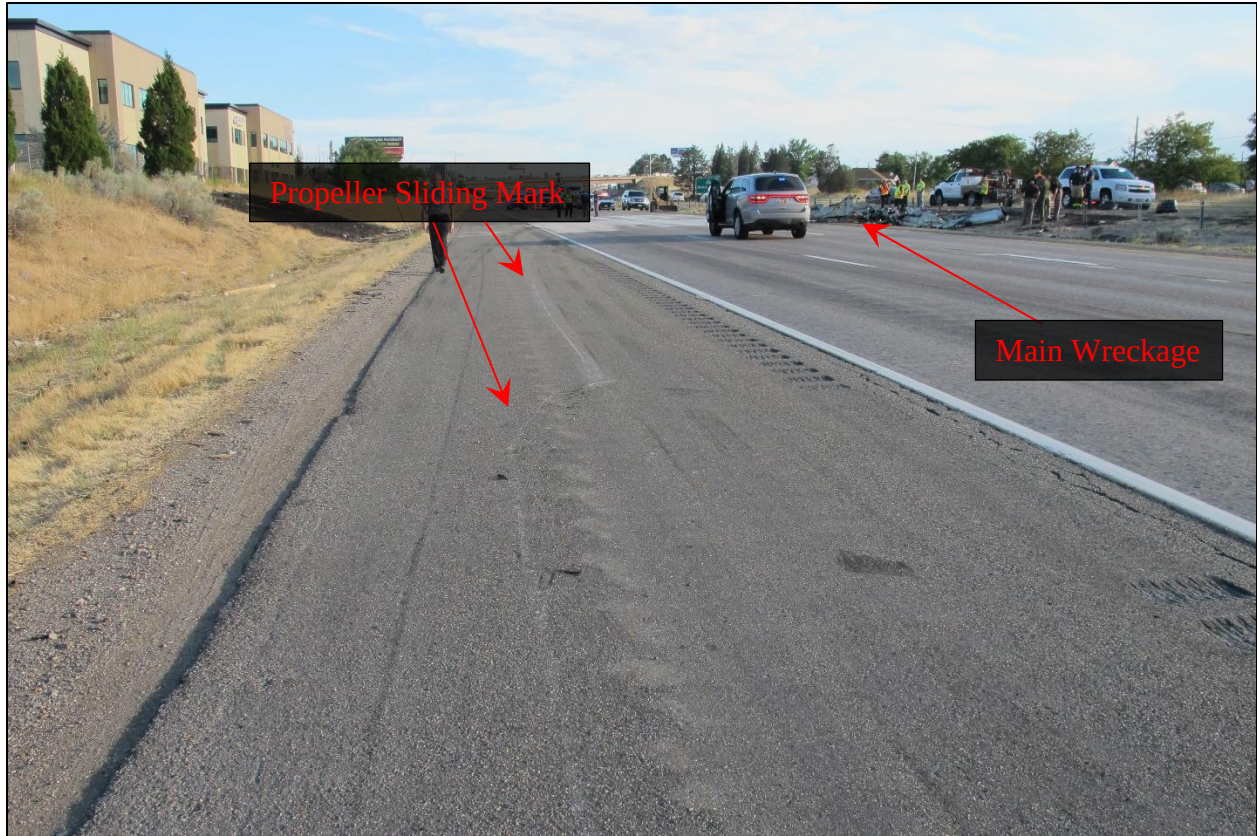
**Figure 6-Propeller Marks, (view south)**

The propeller assembly separated from the engine during the accident sequence and was subsequently relocated about 200 feet further up the lane from the debris field, after being impacted by a passing tractor trailer. No other vehicles were involved in the accident sequence. The propeller blades remained attached and the spinner separated. Sections of spinner material were found in the debris field. The blades had multidirectional scoring and slight bending to two blades. One blade had aft bending near its midsection and missing material at its tip.

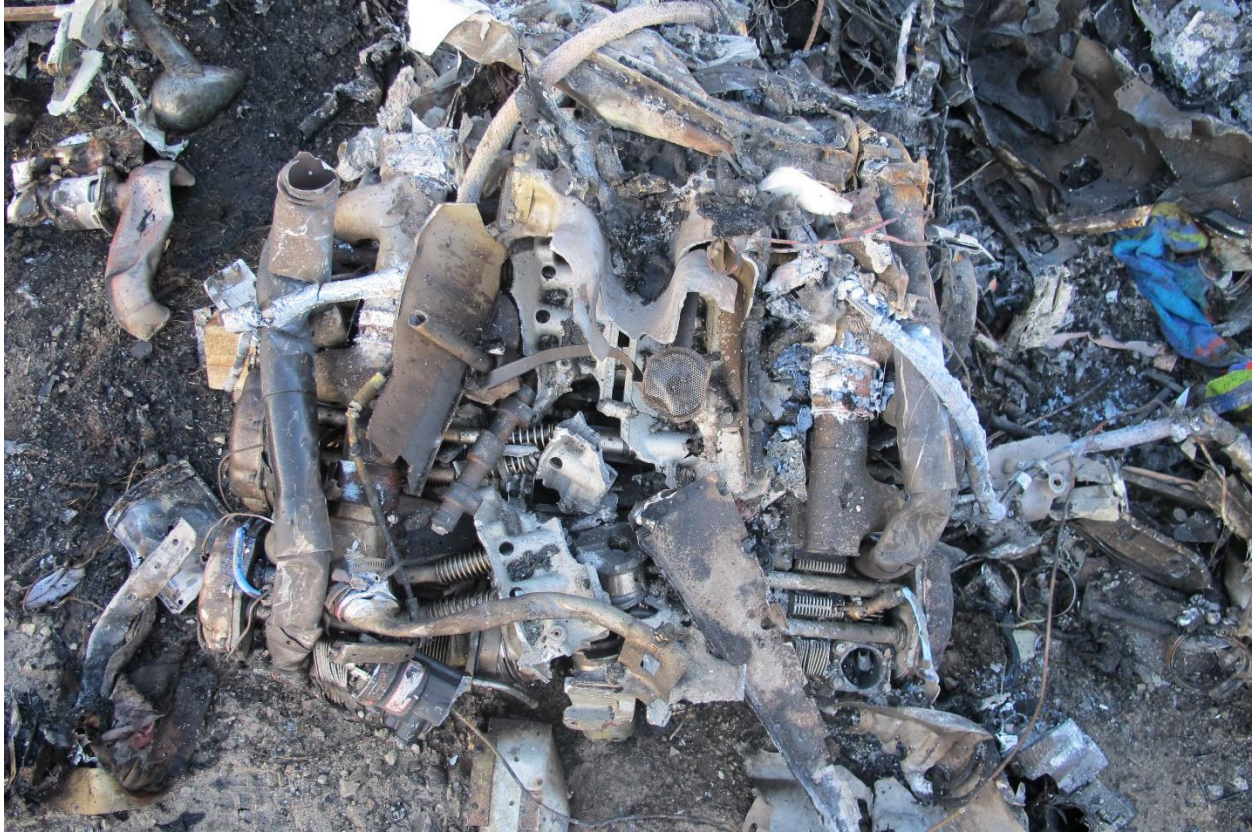
**Figure 7-Lower Side of Engine**

The engine was found inverted with impact damage to the forward crankcase and cylinders no. 5 and 6. Thermal discoloration was noted throughout the exterior surfaces and thermal damage was found on several components on and near the accessory section. A forward section of the crankshaft separated near the no. 6 connecting rod journal. A section of the cam shaft separated from the engine. The exhaust stacks had impact damage.

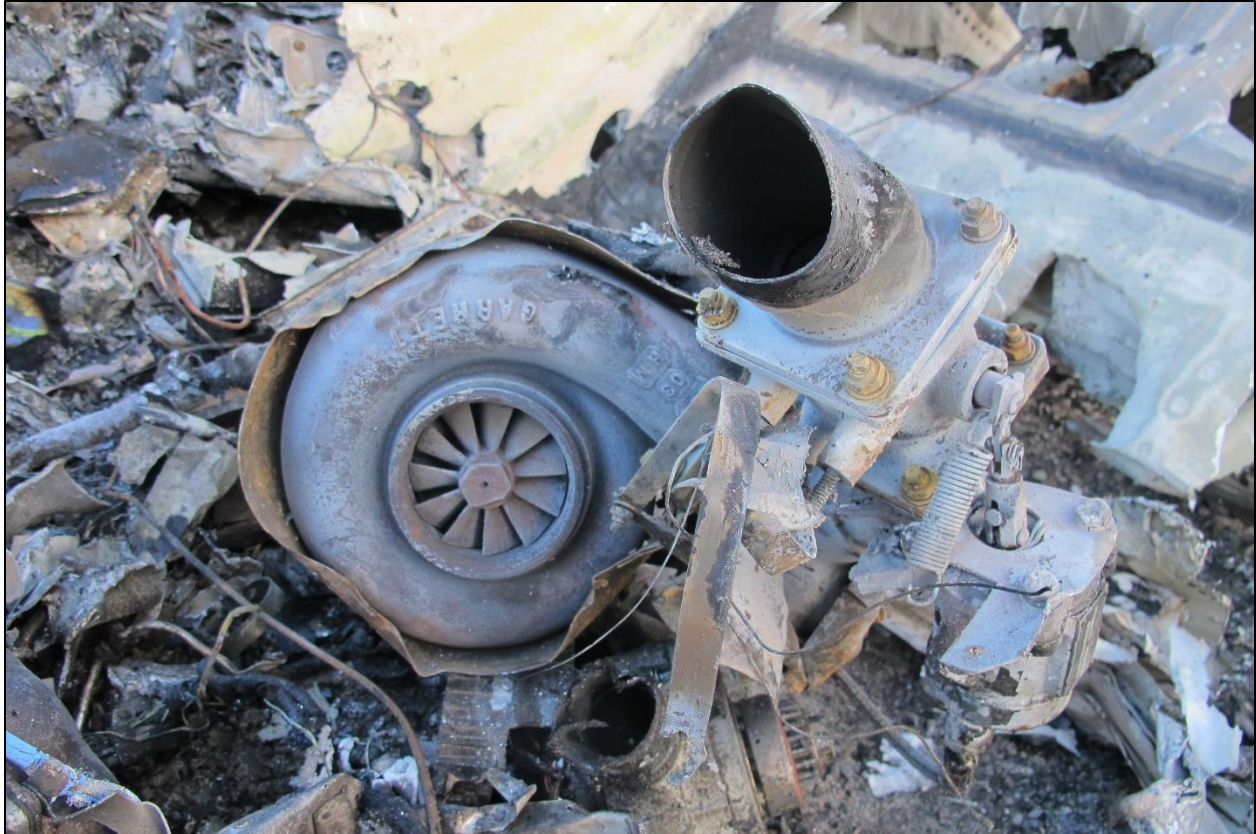
**Figure 8-Turbocharger and Wastegate Valve**

The turbocharger and associated parts separated from the engine and remained attached to one oil feed line. The exhaust pipe was found about 10 ft north of the main wreckage. The v-band clamp that connects the turbocharger and the exhaust pipe was found near the turbocharger. The v-band clamp had its bolt, was safety wired, and the clamp was damaged. The turbocharger turbine rotated freely by hand. The wastegate separated from its mount and was free to move by hand. The overboost valve remained attached to the induction tubing and had thermal damage.

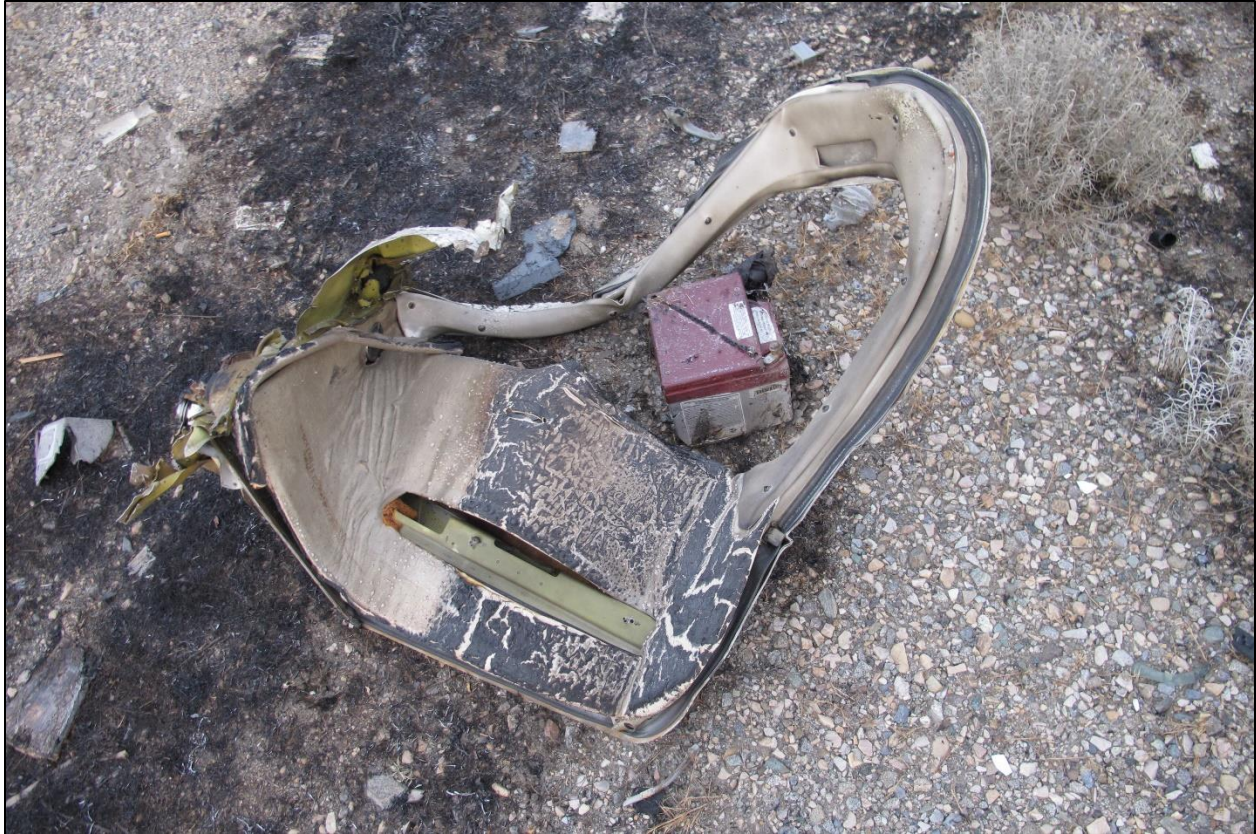
**Figure 9-Forward Entry Door**

The forward entry door separated from the main wreckage and had impact damage to the forward side. The window separated from the door. The interior surface had thermal damage. The door latches were found in the engaged [out] position. The door handle separated from the door and was found with the main wreckage.

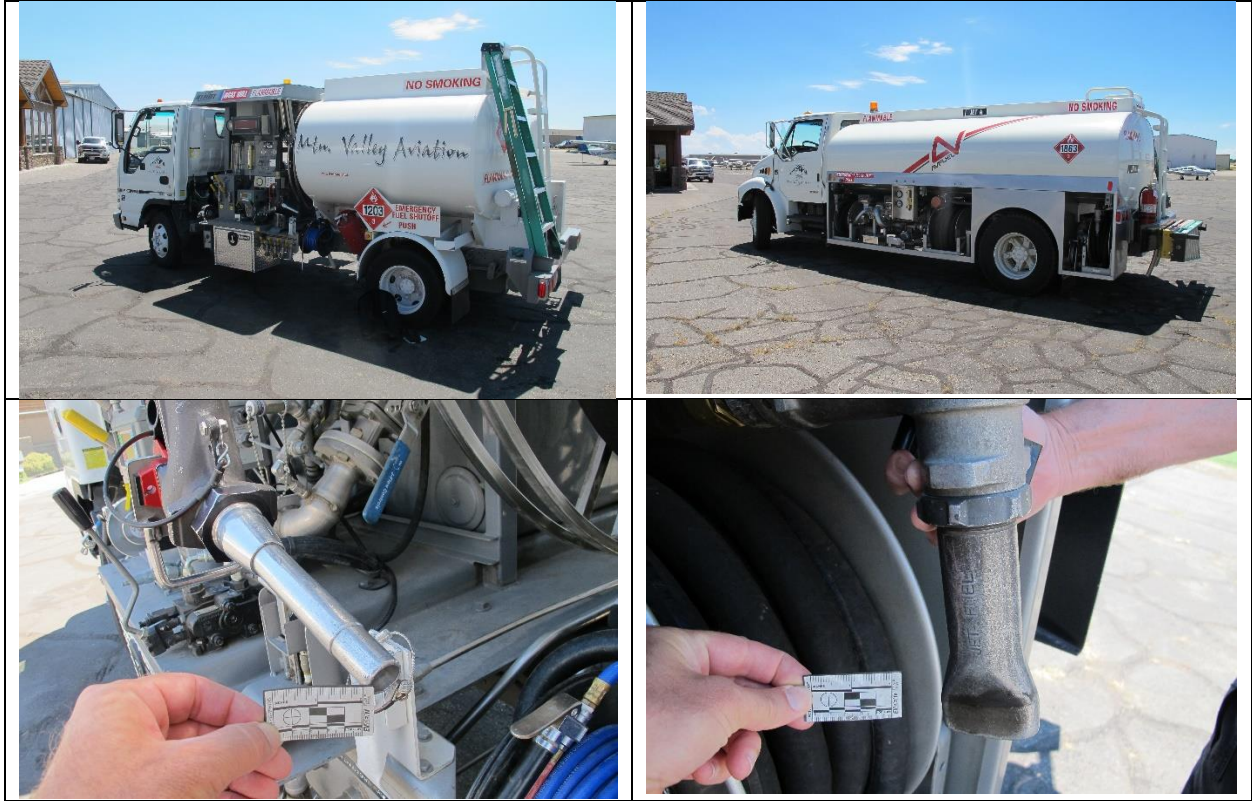
**Figure 10-Fuel Trucks and Nozzles at OGD**

Kemp Jet Services at OGD was the refueler of the accident airplane prior to the accident flight. The trucks and their fuel nozzles were examined. The paperwork associated with the refueling on the accident date was examined and recorded.

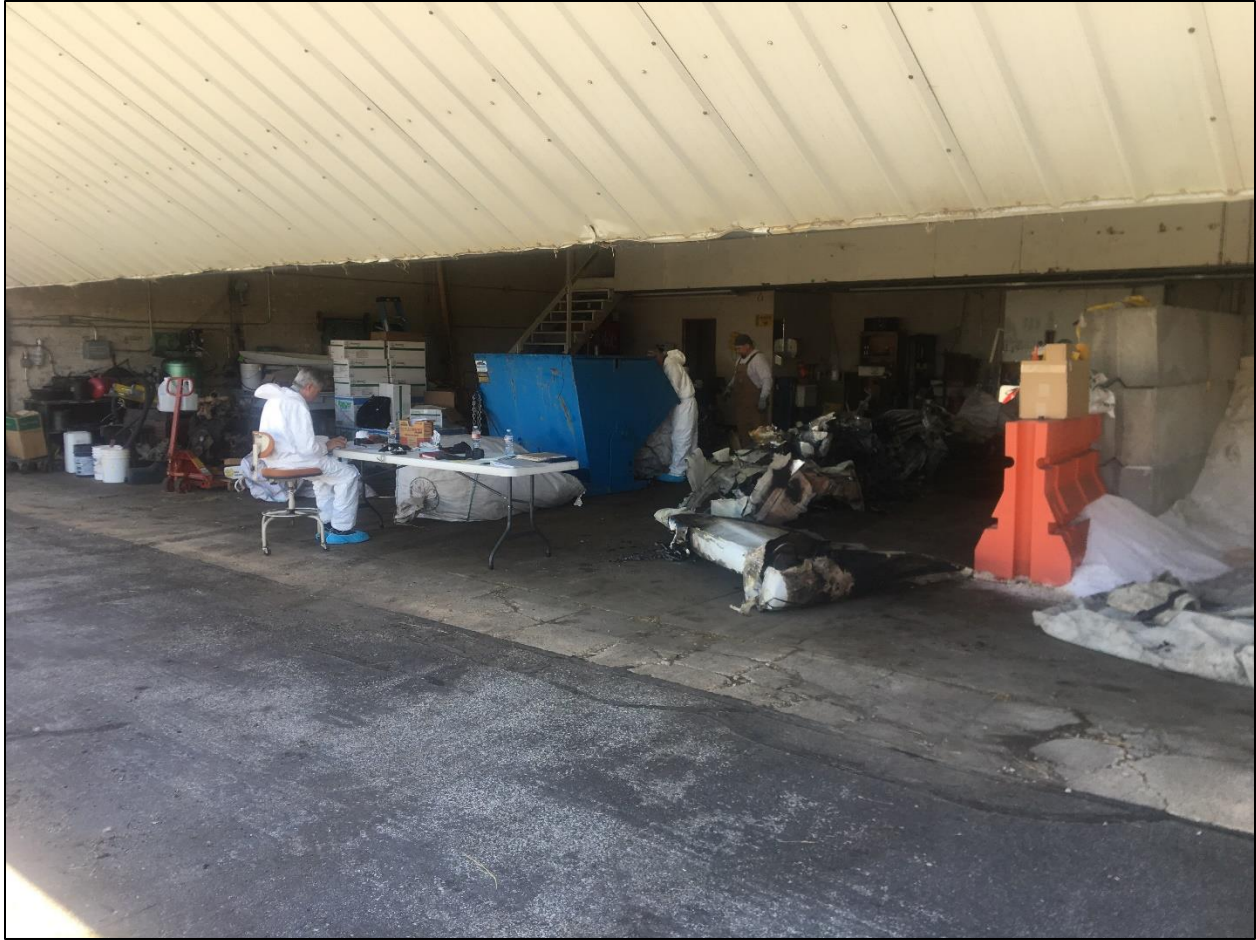
**Figure 10-Post-accident Examination**

The wreckage was relocated to a city owned hangar at OGD, where the post-accident examination took place on the July 27<sup>th</sup>, and 28<sup>th</sup> of 2017. The wing remained intact and the engine was placed on a pallet. Debris from a collection container was sifted through for aircraft parts.

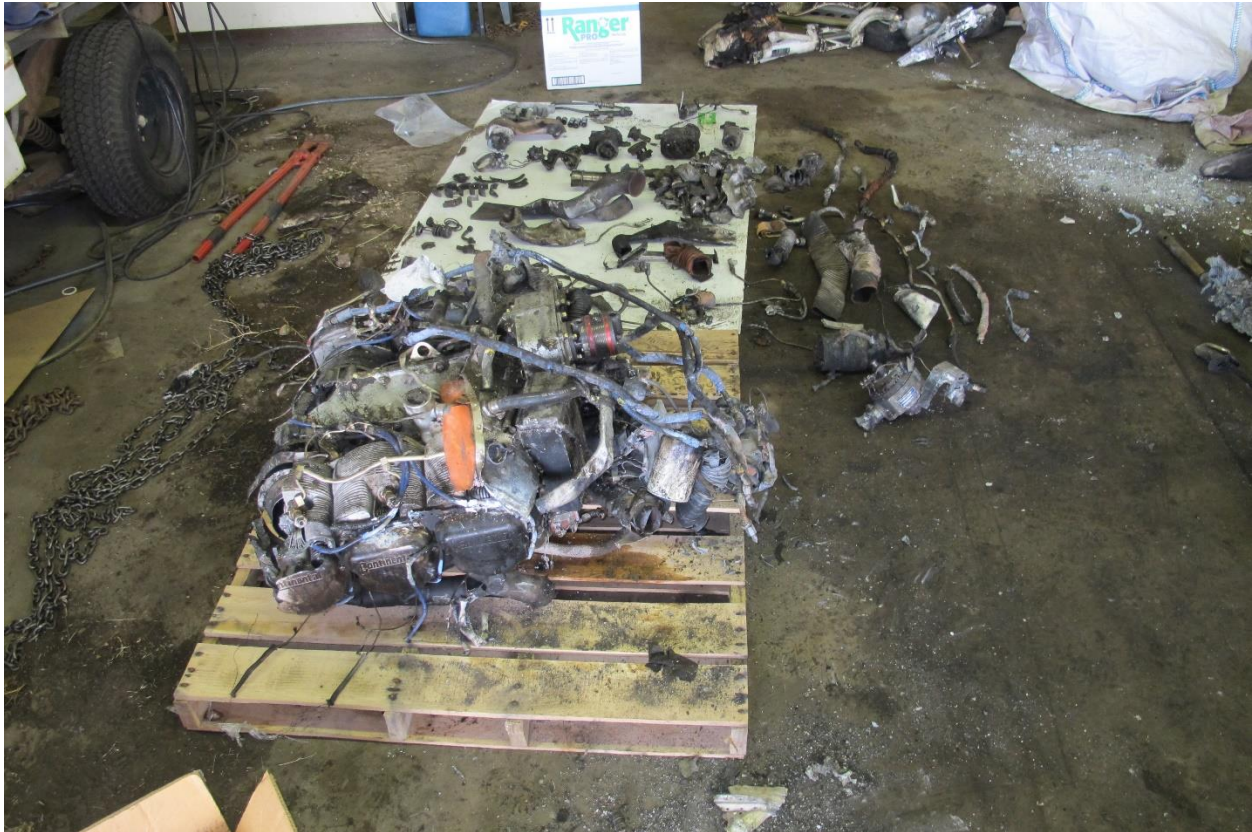
**Figure 11-Engine and Loose Engine Parts**

The engine and loose parts were photo documented and the loose parts were boxed in preparation for shipment.

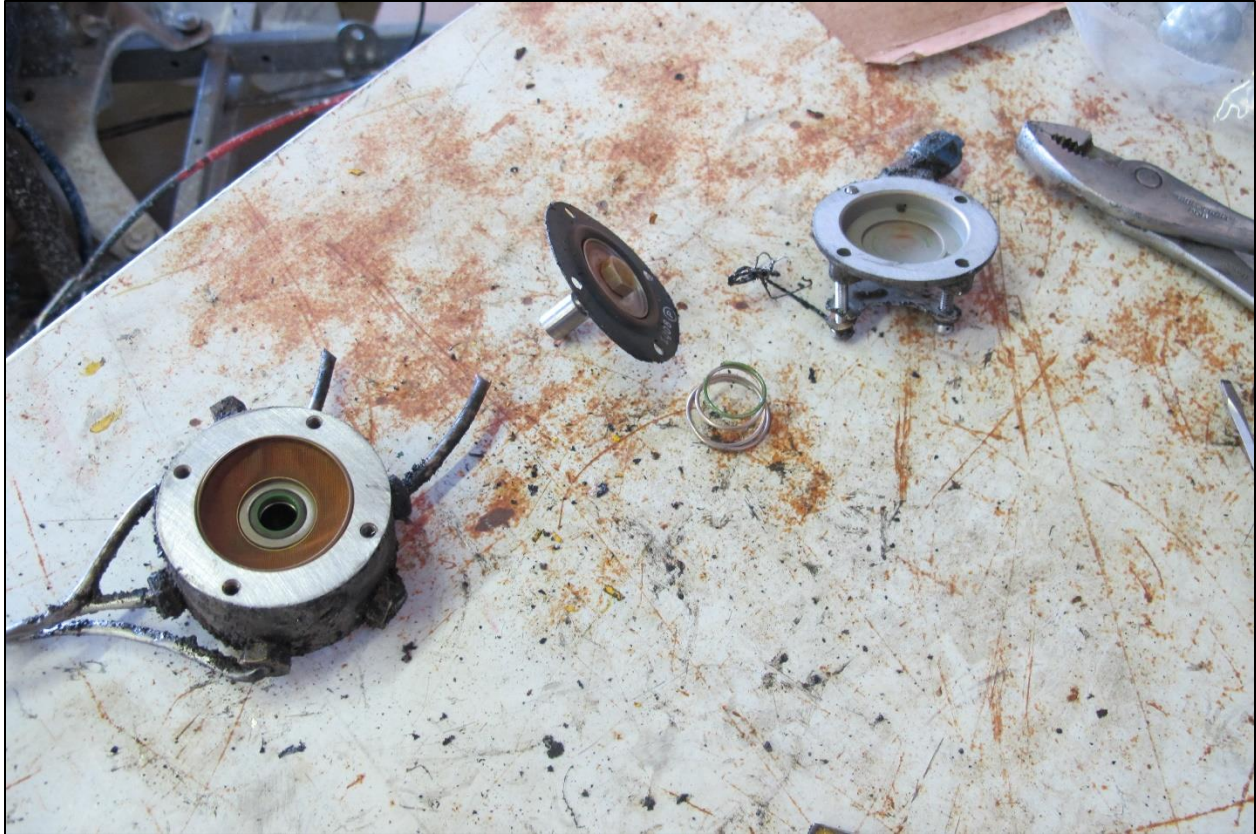
**Figure 12-Fuel Manifold Valve-Disassembled**

The fuel manifold valve was removed from the engine and disassembled. The diaphragm was intact and pliable and the screen was clear of debris. The fuel chamber was clear of fuel and debris.

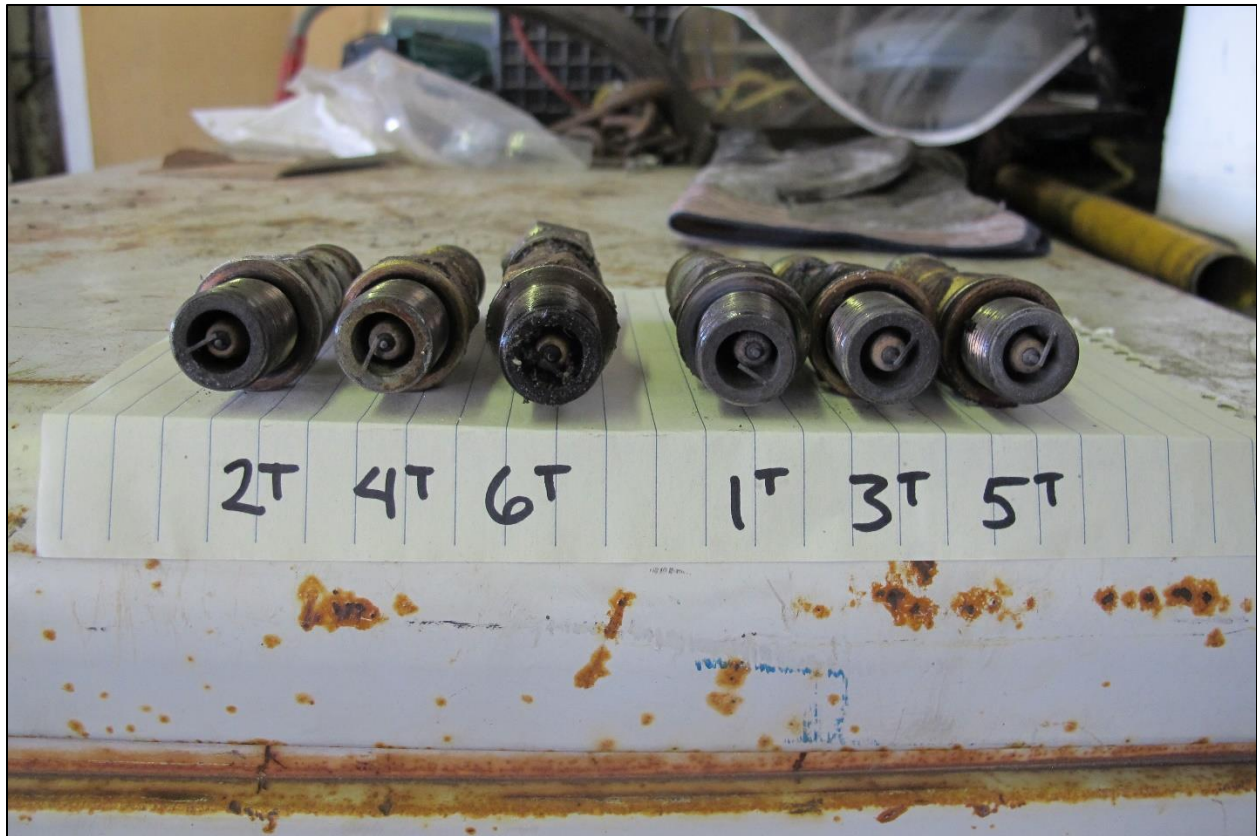
**Figure 13-Upper Sparkplugs**

The upper spark plugs were removed from the engine and examined. The electrode areas had (Normal-Worn Out) wear signatures, compared to an AV-27 Champion comparison chart. The electrode areas had light amounts of combustion deposits.
