**NATIONAL TRANSPORTATION SAFETY BOARD**  
Office of Research and Engineering  
Washington, D.C. 20594

## Video Study

**NTSB Case Number:  
WPR17FA171**

| Aircraft: | Cessna 172N |

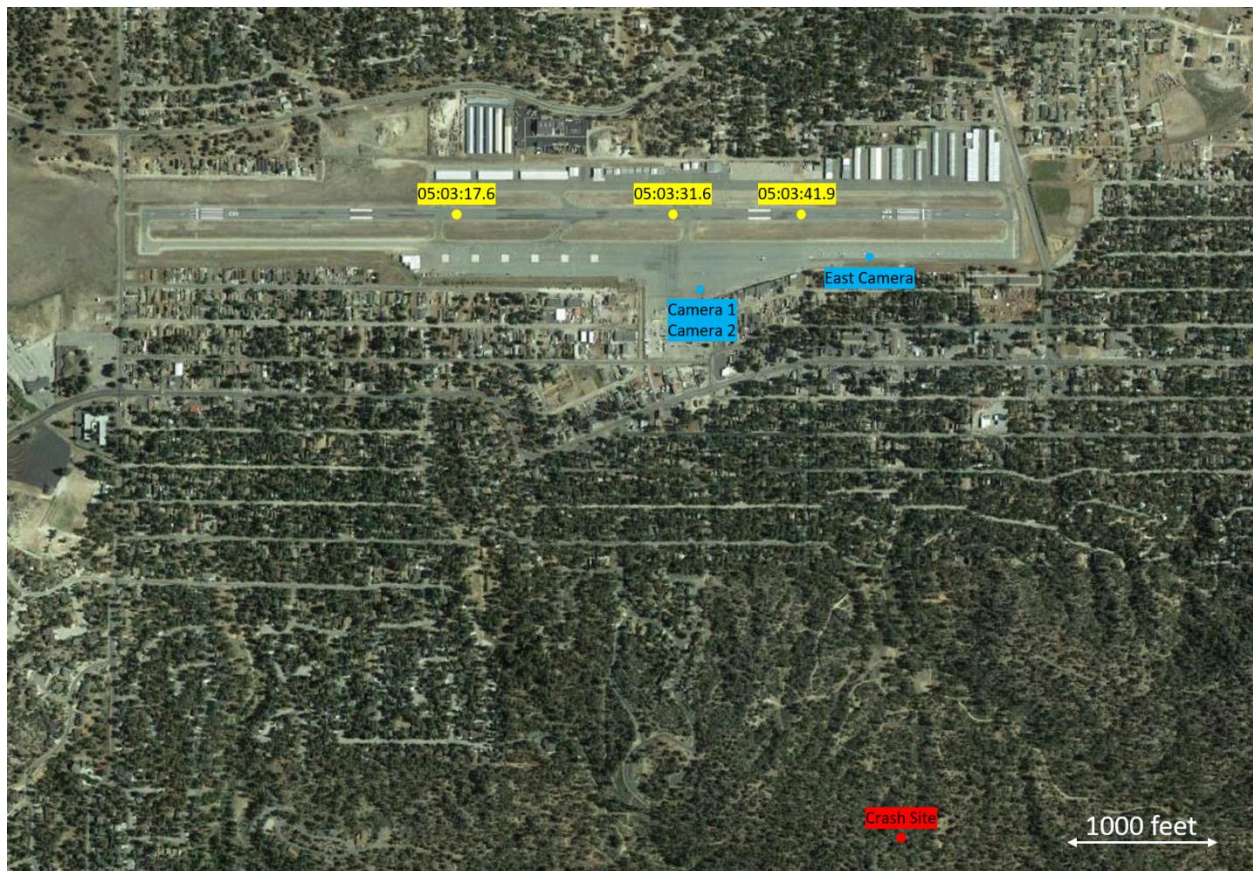
**Figure 1. Aerial View of the Airport with Marked Accident-Related Locations**

Figure 1 shows an aerial map of the airport area. The blue markers are the locations of the three cameras. They were mounted on light poles, with Camera 1 and Camera 2 mounted on the same pole. The red marker is at the crash site, located about 0.75 miles south of the runway. The yellow markers indicated airplane locations that will be explained below. The airplane was moving from left to right (west to east) during takeoff.

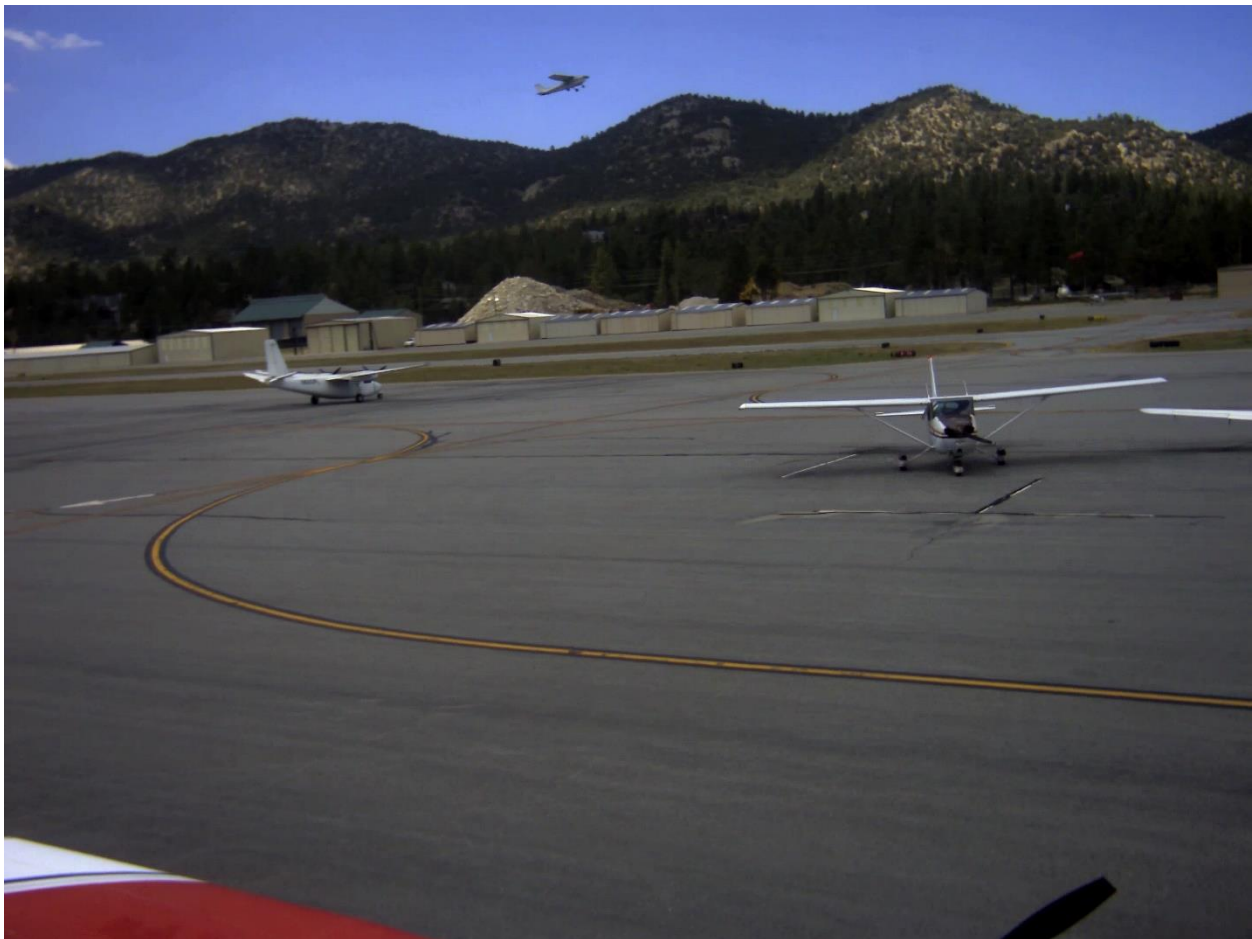
**Figure 2. Frame from Camera 2 Video Showing the Airborne Airplane**

A calibrated camera optics model made it possible to estimate the airplane locations on the runway during takeoff roll, and points on the ground track when the airplane was airborne and above the runway. Figure 2 is an example of a video frame that was used in analysis. It was recorded by Camera 2 and shows the airborne airplane at time 02:03:30.00. This frame and all other analyzed frames were used to estimate and plot the ground track distances of the airplane vs. time that are shown in Figure 3. The distance was set to zero at time 02:03:00.00.

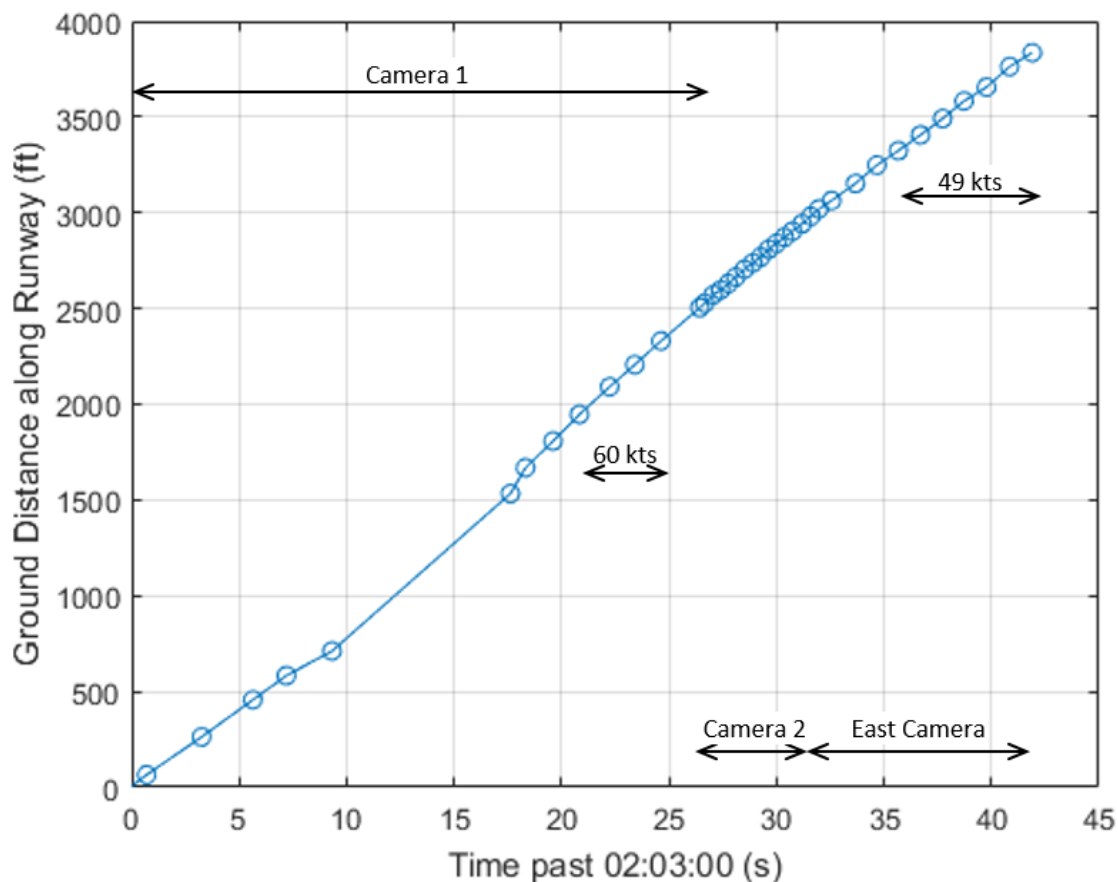
**Figure 3. Estimated Airplane Distance along Ground Track vs. Time**

Figure 3 also shows the time segments that correspond to the cameras that were used for ground track estimation. Note the gap from  $T=10$  s to  $T=17$  s where Camera 1 was not motion-activated. The first Camera 1 recorded video frame after this gap was at time 02:03:17.6. This is the first available frame after rotation. The airplane ground track location at the time this frame was recorded is marked in yellow in Figure 1. The second yellow marker in Figure 1, at time 02:03:31.6, corresponds to the last Camera 2 frame that recorded the full image of the airborne airplane. The nose of the airplane was out of the field of view of Camera 2 in the next frame. The third yellow ground track marker in Figure 1, recorded at time 02:03:41.9, corresponds to the last East Camera video frame that captured the airplane.

Two ground speed estimates are shown in the Figure 3. The first was estimated over 4 seconds shortly after rotation and is 60 kts. The airplane pitch angle in this time interval was estimated as  $8.5^\circ$ . The second ground speed was estimated during the last 6 seconds of data and is 49 kts. The airplane pitch angle in this time interval was estimated as  $5^\circ$ .

Since the ground speed was much higher than the vertical speed, the contribution of the vertical speed to the total speed (the vector sum of ground speed and vertical speed) was less than 0.5 knots. The accuracy of the ground speed estimates is  $\pm 2$  kts, much more than the contribution of the vertical speed to the total speed. Therefore, the speed estimates shown in Figure 3 can be viewed as both ground speed and total speed.

The information in Figures 3 and 4 shows that the airplane had reasonable speed, rate of climb and pitch angle shortly after takeoff and that about 10 seconds later, the speed, the rate of climb and the pitch angle were too low. The values started declining when the airplane altitude was about 90 feet above the runway.

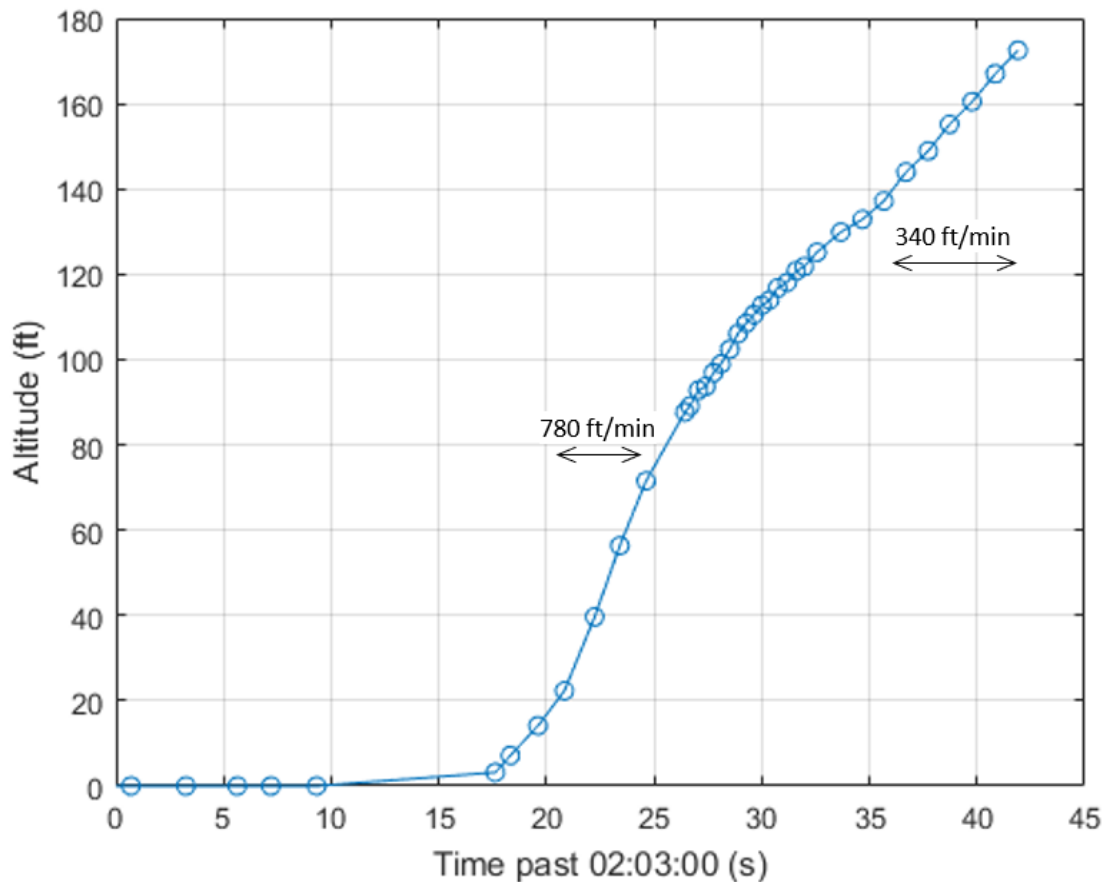
**Figure 4. Estimated Airplane Altitude above Runway vs. Time**

Figure 4 shows the estimated airplane altitude above runway vs. time. Two rates of climb estimates are shown in the figure. The rate estimate between times  $T=21$  s and  $T=24$  s is 780 ft/min. The rate estimate between times  $T=36$  s and  $T=41$  s is 340 ft/min. The tolerances of the rates of climb estimates are  $\pm 5\%$ , resulting in  $780 \pm 40$  ft/min and  $340 \pm 20$  ft/min, respectively.

Videos recorded by three surveillance cameras at an airport were used to estimate speed, altitude, rate of climb and pitch angle of an airplane that impacted ground shortly after takeoff. Shortly after rotation, the airplane had estimated air speed of  $60 \pm 2$  knots, rate of climb of  $780 \pm 40$  ft/min, and pitch angle of  $8.5^\circ$ .

These values started declining when the airplane was about 90 feet above the runway. After about 10 seconds, air speed estimate was down to  $49 \pm 2$  knots, rate of climb was down to  $340 \pm 20$  ft/min, and pitch angle was down to  $5^\circ$ .
