## FIELD NOTES

### HISTORY OF FLIGHT

On August 19, 2017, about 1352 Pacific daylight time, a Rich Wheeler Express CT, N246TM, impacted the wall of a canyon while on approach to land at the Madras Municipal Airport, Madras, Oregon. The pilot/owner was operating the airplane under the provisions of 14 Code of Federal Regulations Part 91. The private pilot, the sole occupant, sustained fatal injuries; the airplane was destroyed. The cross-country personal flight originated from San Carlos, California with a final destination of Madras. Visual meteorological conditions prevailed and no flight plan had been filed.

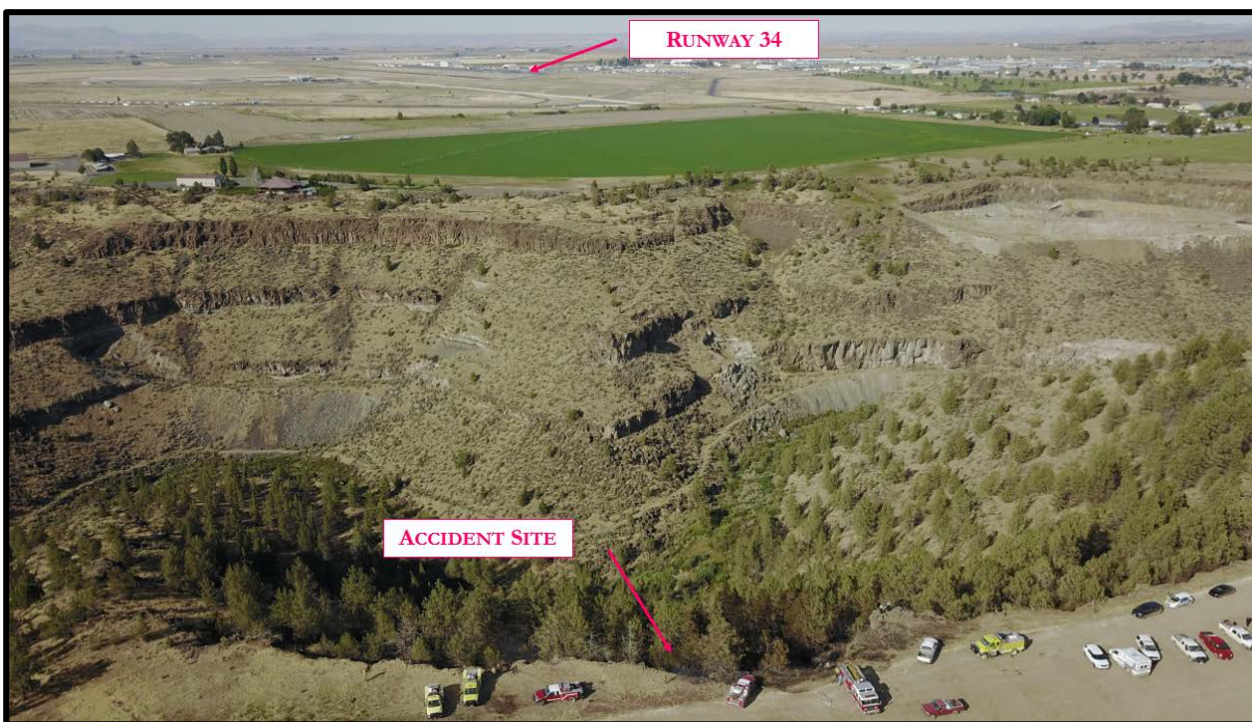
Figure 04: Accident Site Referencing Runway 34

The accident site was located on the north-facing slope of a canyon comprised of soft dirt and trees. The wreckage was about 1.1 nautical miles from the approach end of runway 34 on a bearing of 025°. The GPS coordinates for the crash site were 44.643112 north latitude and -121.164459 west longitude at an altitude of about 2,280 feet mean seal level (msl)

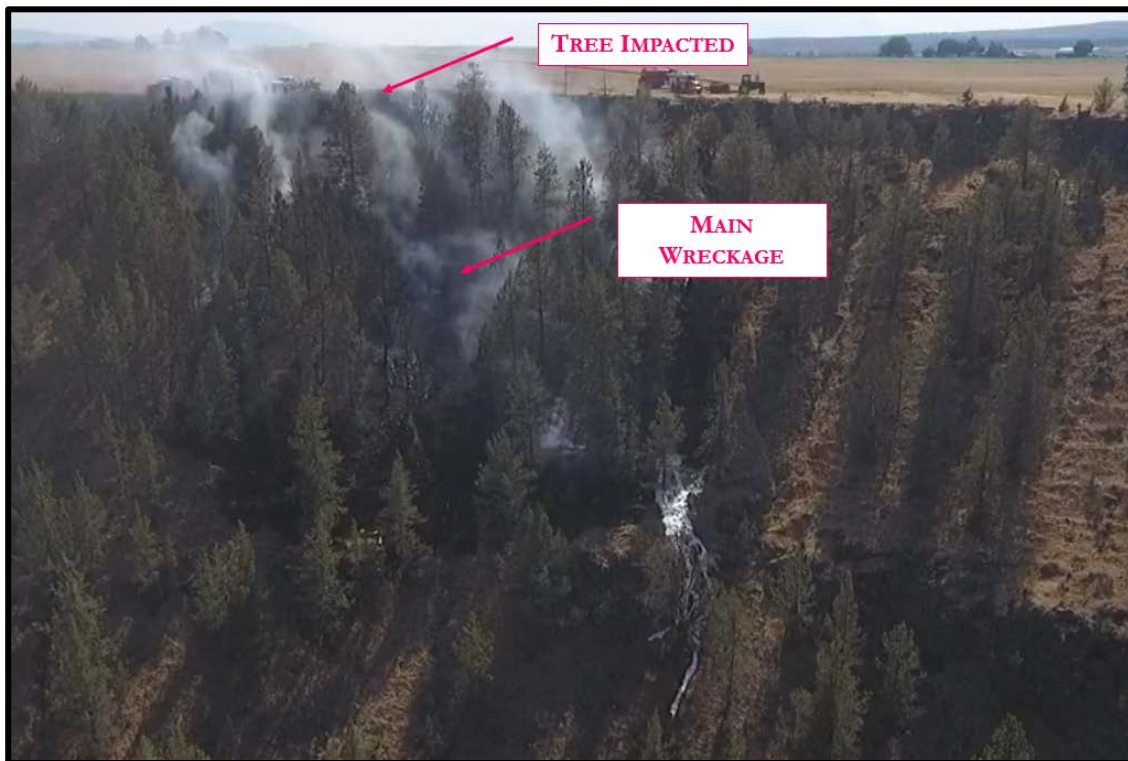
*Figure 07: Accident Site Referencing the Main Wreckage*

The first identified points of contact consisted of freshly severed tree limbs adjacent to the main wreckage. The debris field was primarily contained in the area of the main wreckage on a 60-70° slope comprised of loose dirt. The tree was located in a slight ravine in the ebb of the canyon wall.

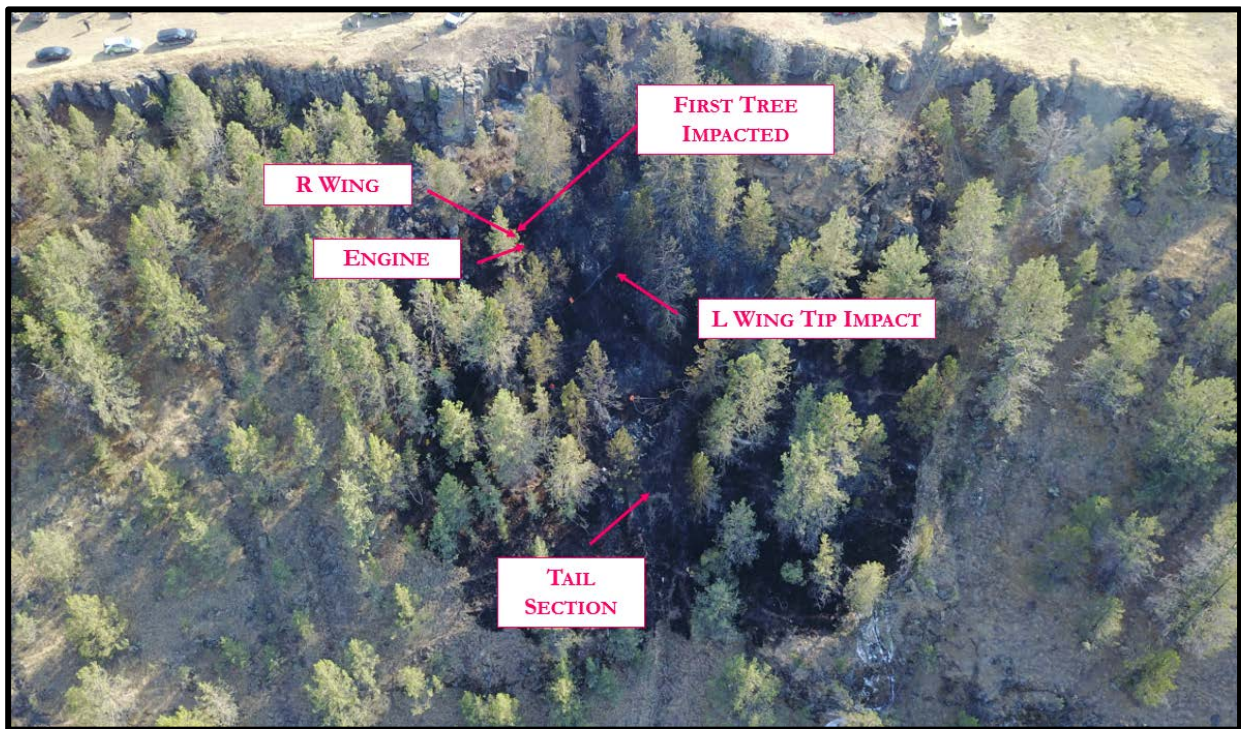
Figure 08: Main Wreckage

The main wreckage had been subjected to severe thermal damage and consisted of the outboard right wing, empennage, engine, and the mostly ashen remains of the fuselage. The cabin was completely consumed by fire.

The inboard right wing was located upslope of the engine and was identifiable by the shape of the wingtip and a small blue/green chard of material embedded in the navigation light area. The left wing was down slope of the engine toward the ravine. Under the wing were parts of the cockpit area and instrument panel, identifiable by the seat frames, rudders pedals, and burned remains of the radios.

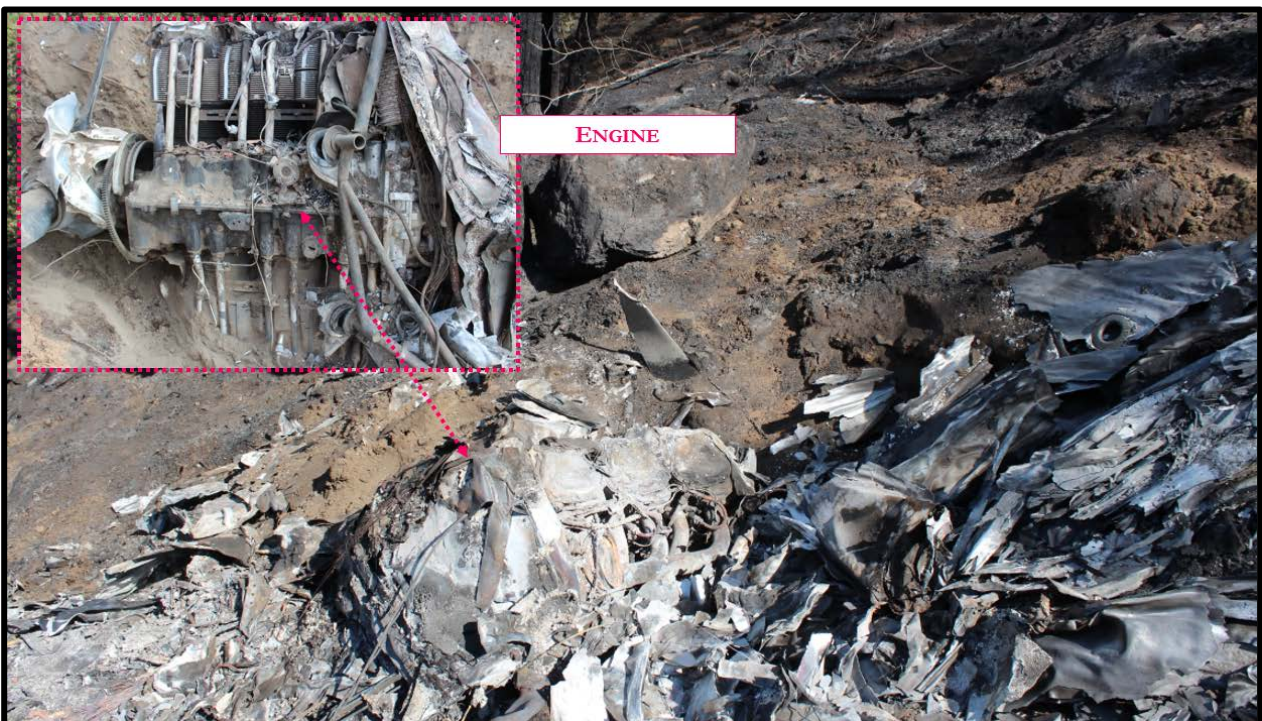
Figure 09: Engine

The engine came to rest on its left side, with the cylinders nos 2, 4, 6 completely imbedded in the dirt. A portion of one propeller blade was visible and the tip had melted. After unburying the engine and propeller, it was revealed that the propeller remained attached to the engine at the crankshaft flange. The spinner was bent around the hub and the bottom blade was broken free from the hub. All the blades were relatively straight aside from slight aft bends.

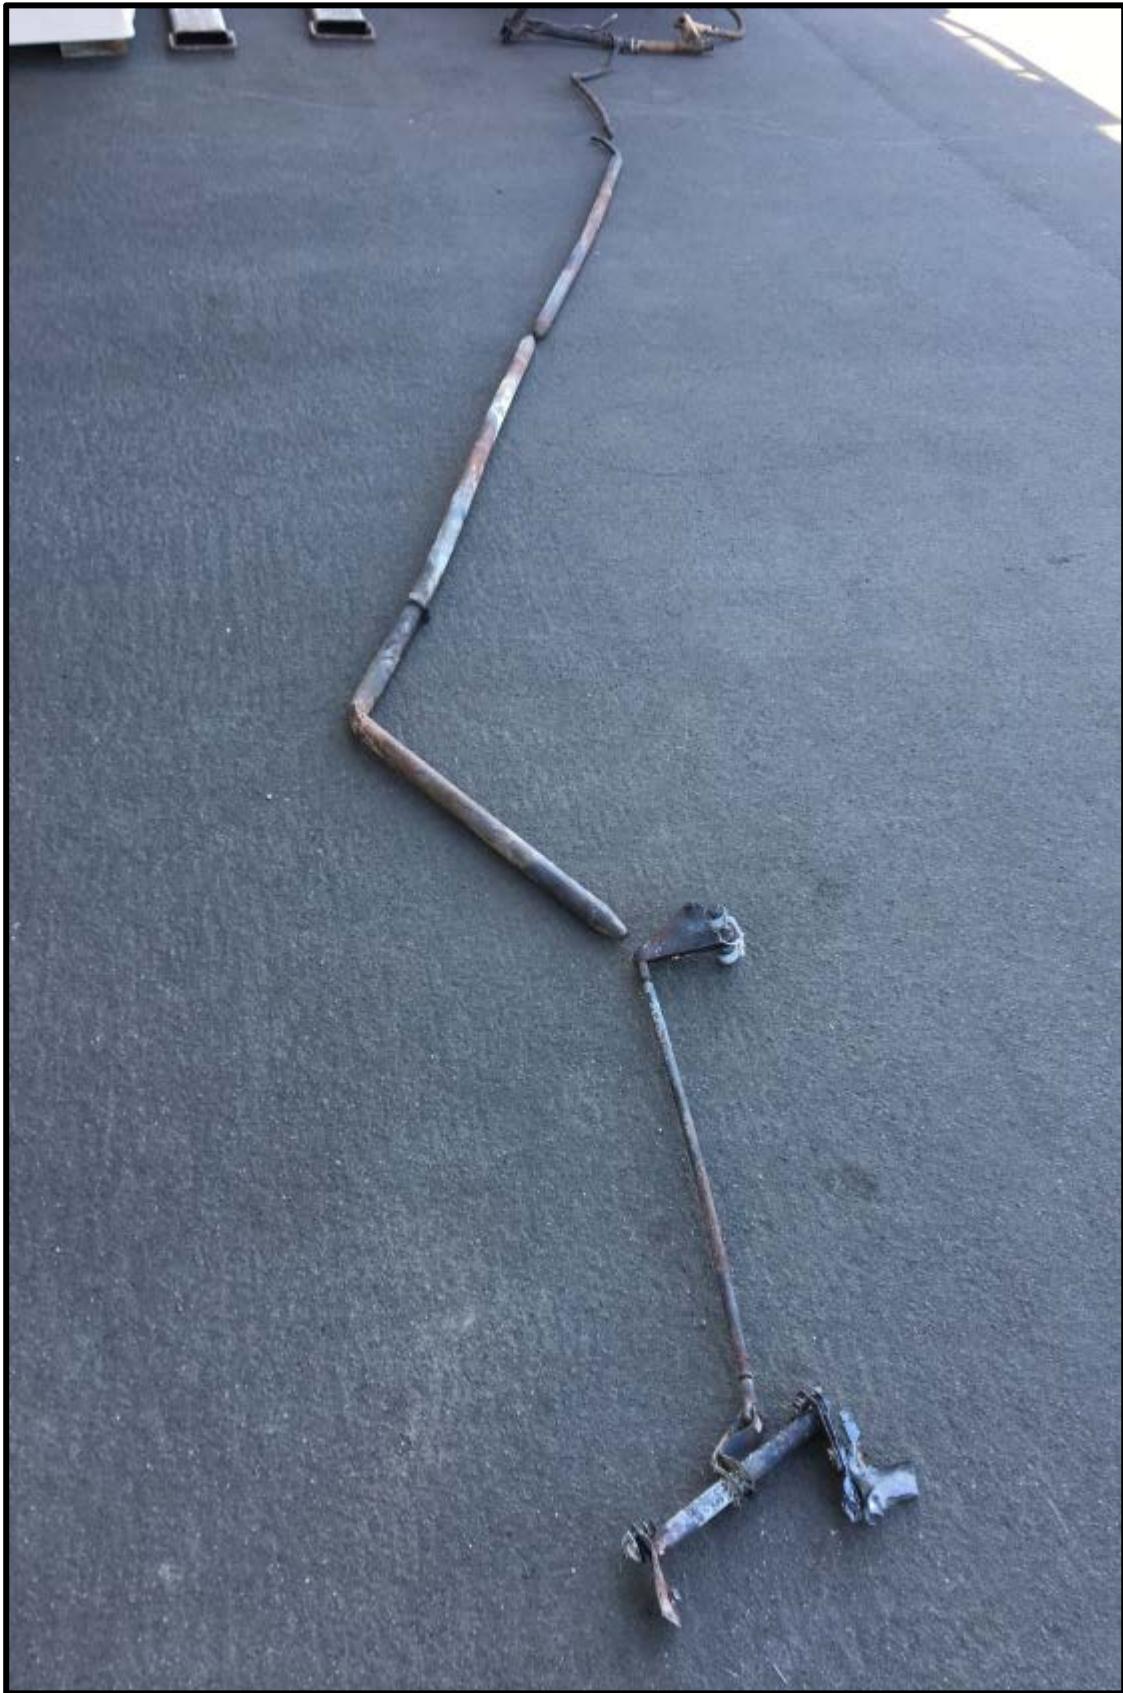
*Figure 10: Flight Control System*

Flight Controls. The airplane had dual flight controls consisting of various materials. Items made of steel were thermally damaged but generally intact. All items made of composite material or aluminum were consumed by fire.

Pitch. Pitch control was accomplished by one of two control sticks connecting to a mixing assembly, then via a series of two steel rods and two steel tubes running centerline to the elevators. This assembly used six rod end bearings to complete the connection. All but two rod end bearings demonstrated signs of damage from overload. Two rod end bearings, both of which connected to the same a steel bell crank, demonstrated no signs of overload, no signs of elongation, and were lacking attaching hardware. This bell crank was not recovered for inspection.

Roll axis. Roll was controlled by one of two control sticks connected to the mixing assembly, then to a series of aluminum tubes and bell cranks to the ailerons. The aluminum control tubes were consumed by fire. The ends of these control tubes were attached to rod end bearings and indicate they were connected to their respective steel bell cranks.

Yaw. Yaw was controlled by a pair of rudder pedals connecting to two steel cables running through pulleys to the rudder. The dual rudder pedal assemblies were made of steel and were thermally damaged. The two rudder control cables were found thermally damaged but generally intact to the connecting brackets that would have attached to the rudder.

Flaps. This airplane used an electric motor to manipulate the flaps. The electric motor was thermally damaged. The steel tubes used to manipulate the flaps were thermally damaged.
