WHEELER TECHNOLOGY INC.

March 15, 1991

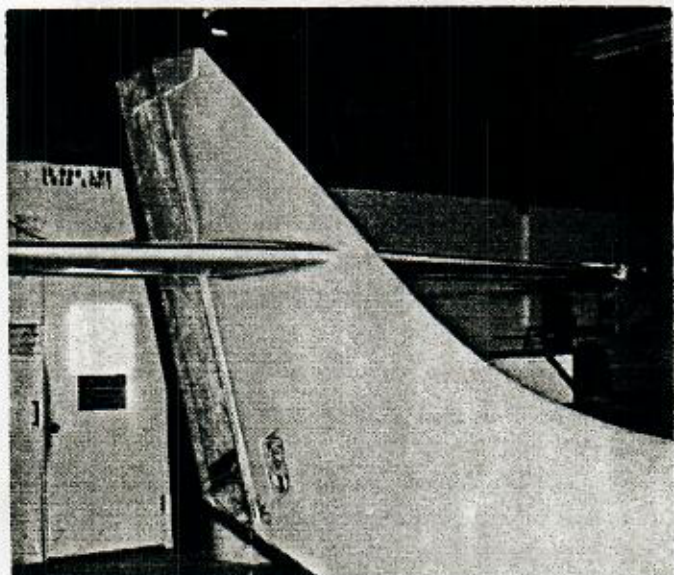
NEW FACTORY DEMO

Compare the angles of incidence of the horizontal stabilizers of C-GUPZ and the new factory demonstrator. These photos are nearly identical in size and perspective (GUPZ' rudder turned toward camera). The angle of C-GUPZ is clearly positive (leading edge rotated up) in comparison.

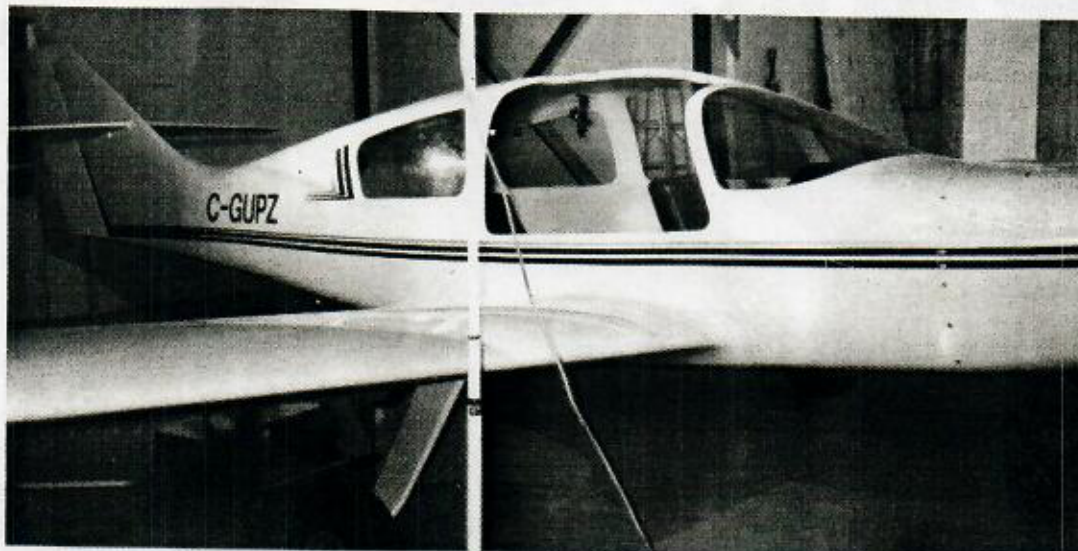
In this photo of GUPZ, the positive stab angle is also quite evident. For reference, the visible bottom of the fuselage is a waterline, which of course means that it is at zero degrees. The door sill also makes an easy and known reference.
