# NATIONAL TRANSPORTATION SAFETY BOARD

## Electronic Devices

**Specialist's Factual Report**  
**by Sean Payne**

Location: Benecia, California  
Date: September 09, 2017  
Aircraft: Raytheon G36  
Registration: N7215J  
Operator: Private  
NTSB Number: WPR17FA200

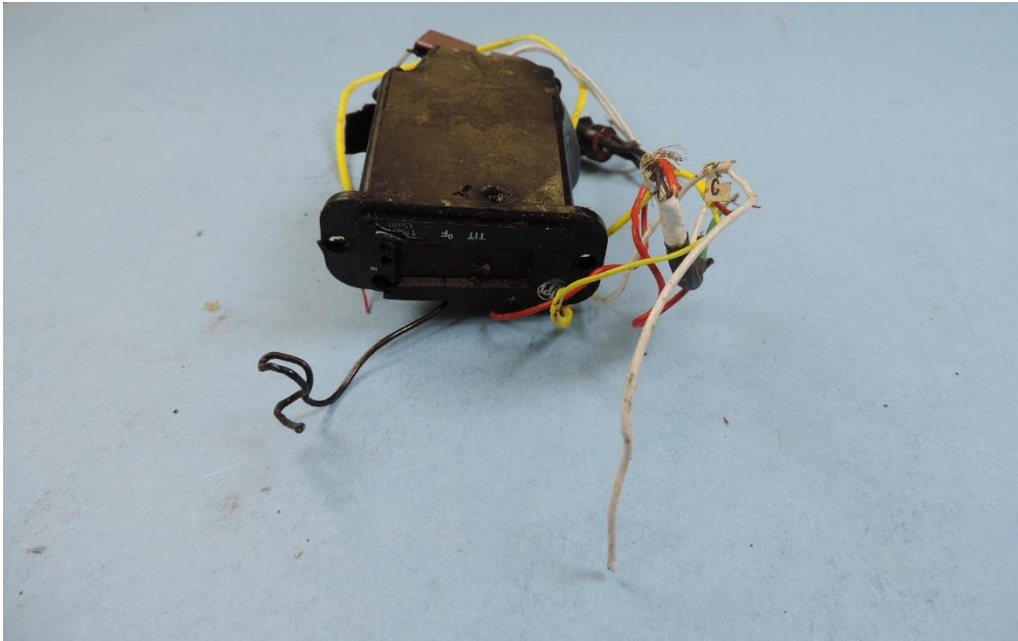
The device is pictured in figure 1. This device was configured to display Turbine Inlet Temperature (TIT). The device is not capable of recording data.

Figure 1. The JPI Slim-Line TIT probe.

No data was recovered from the device.

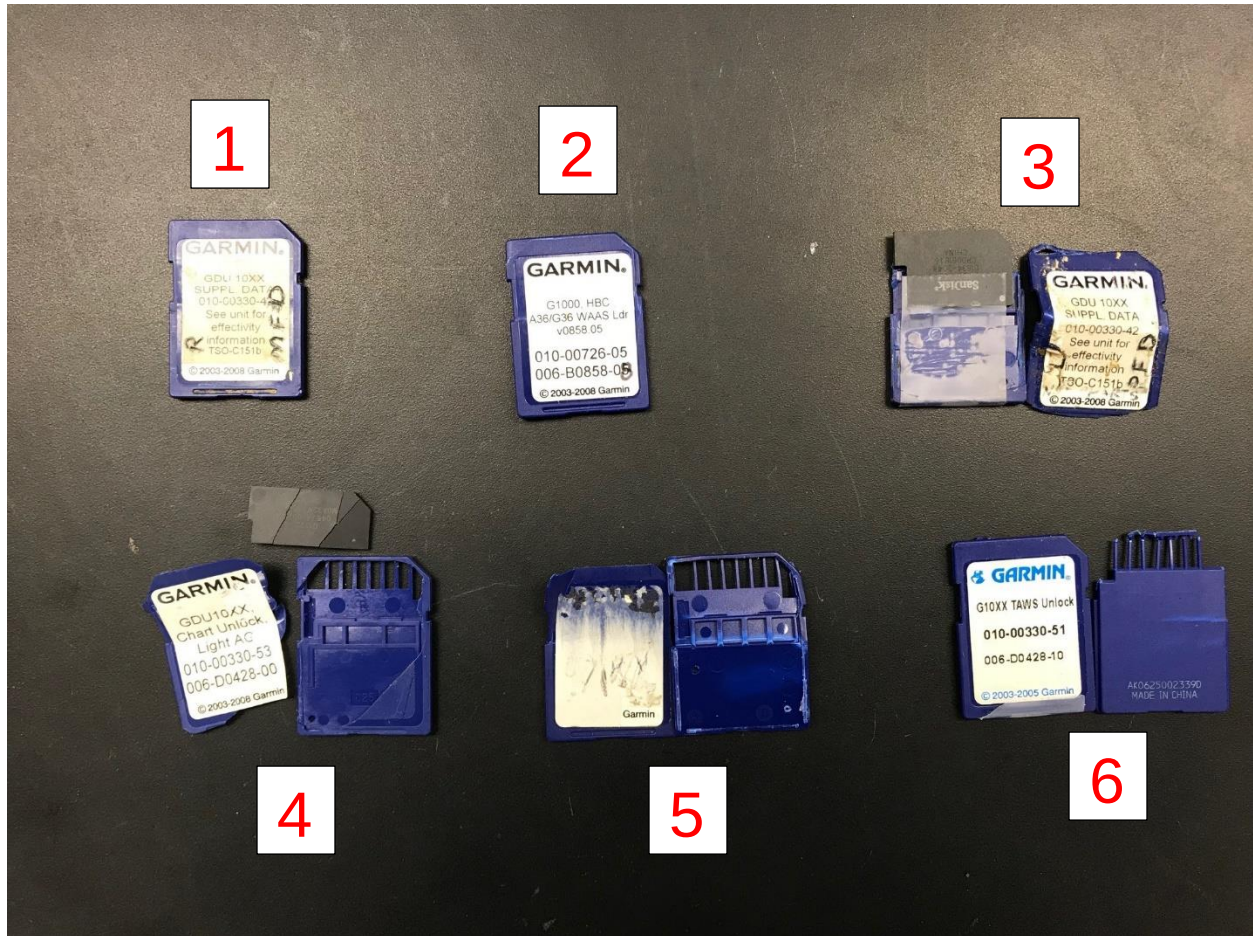
Figure 2. SD cards associated with the accident aircraft.

Card 1 was undamaged and was read normally. Card 1 contained chart databases.

Card 2's plastic packaging was cracked. When opened, the silicon memory chip was cracked. The card could not be read.

Card 3's silicon memory chip was broken free its plastic packaging. The silicon memory chip was reinserted in the plastic packaging. The card read but contained only chart databases.

Card 4's silicon memory chip was broken free from its plastic packaging. The silicon memory chip was cracked in multiple areas. The card could not be read.

Card 5 only consisted of plastic packaging. The silicon memory chip associated with the plastic packaging was missing.

Card 6's plastic packaging was cracked and the silicon memory chip was loose from the card. The silicon memory chip was reinserted in the plastic packaging. The card was read but contained only chart databases.

No flight data was recovered from any of the functioning SD cards.
