## **NATIONAL TRANSPORTATION SAFETY BOARD**

### **ONSITE EXAMINATION NOTES**

**WPR17FA200**

Location: Benicia, CA  
Date: September 9, 2017  
Aircraft: Registration Number: N7215J, Raytheon Aircraft Company G36,  
NTSB IIC: Albert Nixon

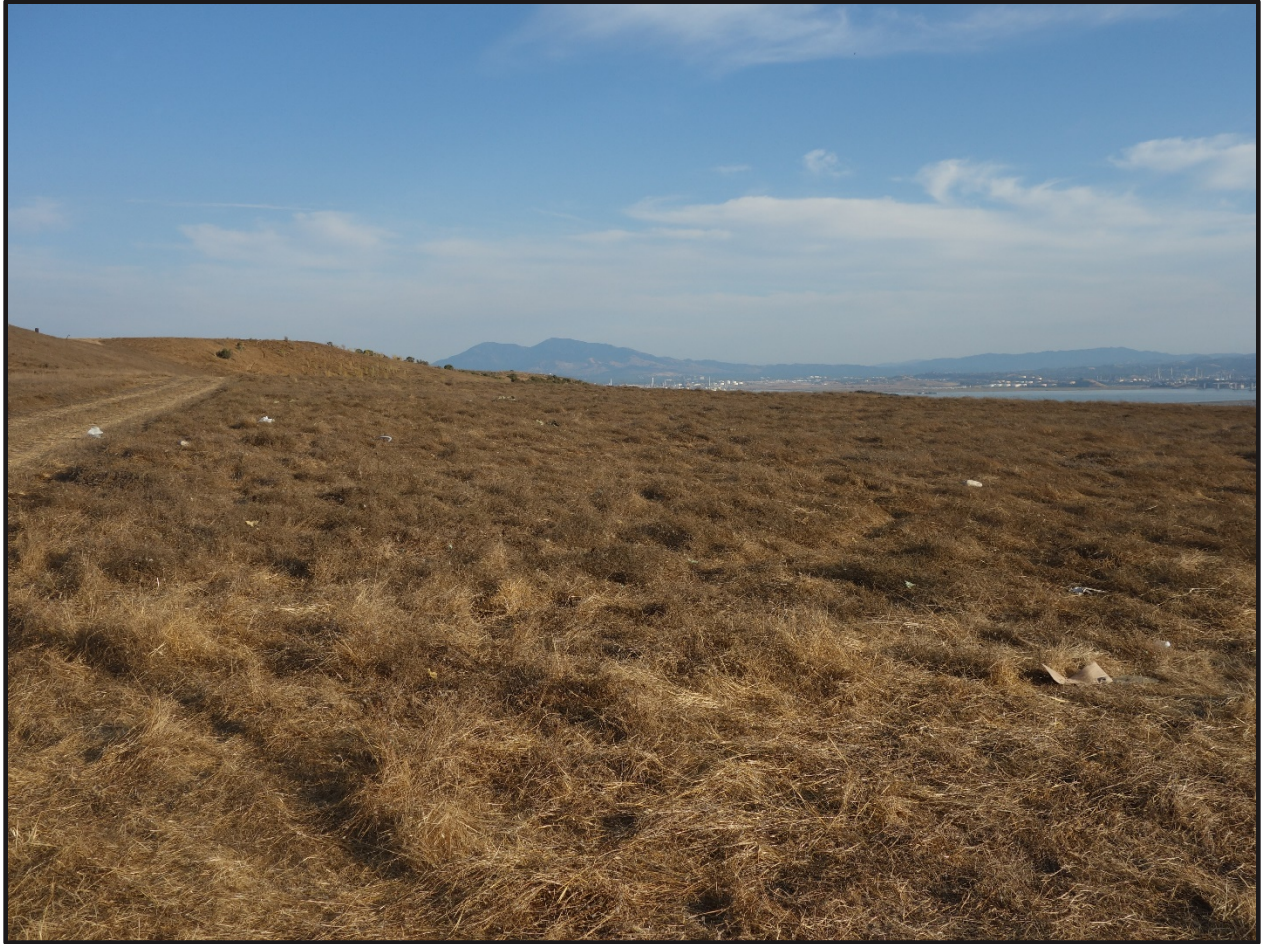
Examination of the accident site by the National Transportation Safety Board investigator-in-charge revealed the airplane's wreckage came to rest on top of a mesa on flat terrain with dense vegetation at an elevation of about 587 ft mean sea level. The fuselage came to rest upright on a magnetic heading of about 125°. A ground disturbance that measured about 8 ft long, 4 ft wide, and 1 ft deep, contained the majority of the fuselage and engine. The engine was observed partially buried in the ground disturbance. All major structural components of the airplane were located within the wreckage debris area. The airplane damage and ground signatures were consistent with a wing level, nose down, high angle impact, with terrain. There was no post impact fire.

**Figure 1: Airplane Wreckage Site terrain.**

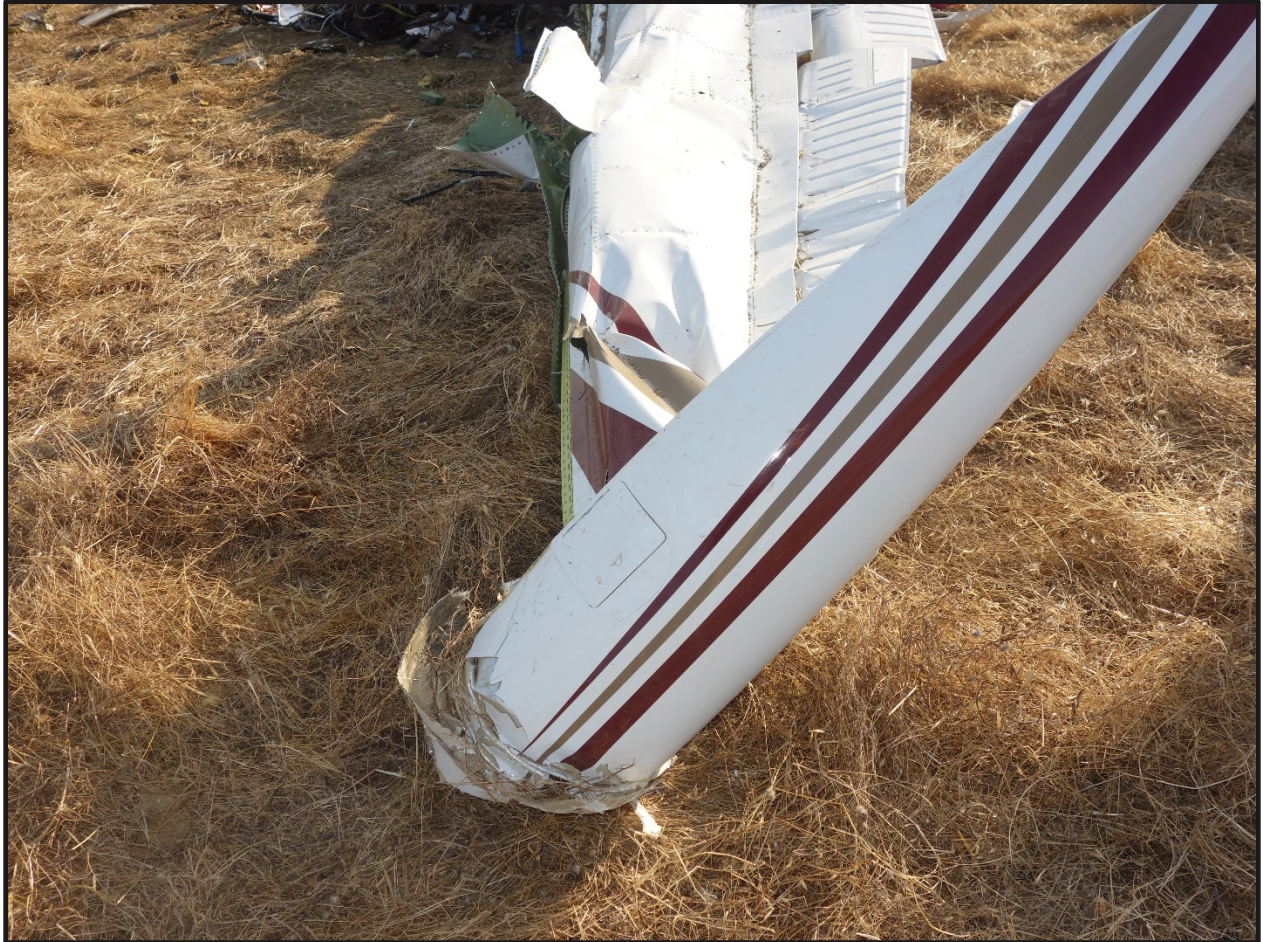
The airplane's wings were attached to the fuselage and sustained significant compression damage. The leading edges of both wings were crushed aft to the spar. The left and right leading-edge skins, and the main fuel bladders, were ruptured and their fragments were scattered about 170 ft in front of the airplane. Both wing's flaps and ailerons were attached. The front and bottom portions of the wing tip tanks sustained compression damage corresponding to about a 60° nose down impact angle. The landing gear and flaps were retracted.

Figure 2: Left wing as viewed from the left.
