## **NATIONAL TRANSPORTATION SAFETY BOARD**

# **AIRFRAME AND ENGINE EXAMINATION**

**WPR17FA200**

Location: Benicia, CA  
Date: September 9, 2017  
Aircraft: Registration Number: N7215J, Raytheon Aircraft Company G36,  
NTSB IIC: Albert Nixon

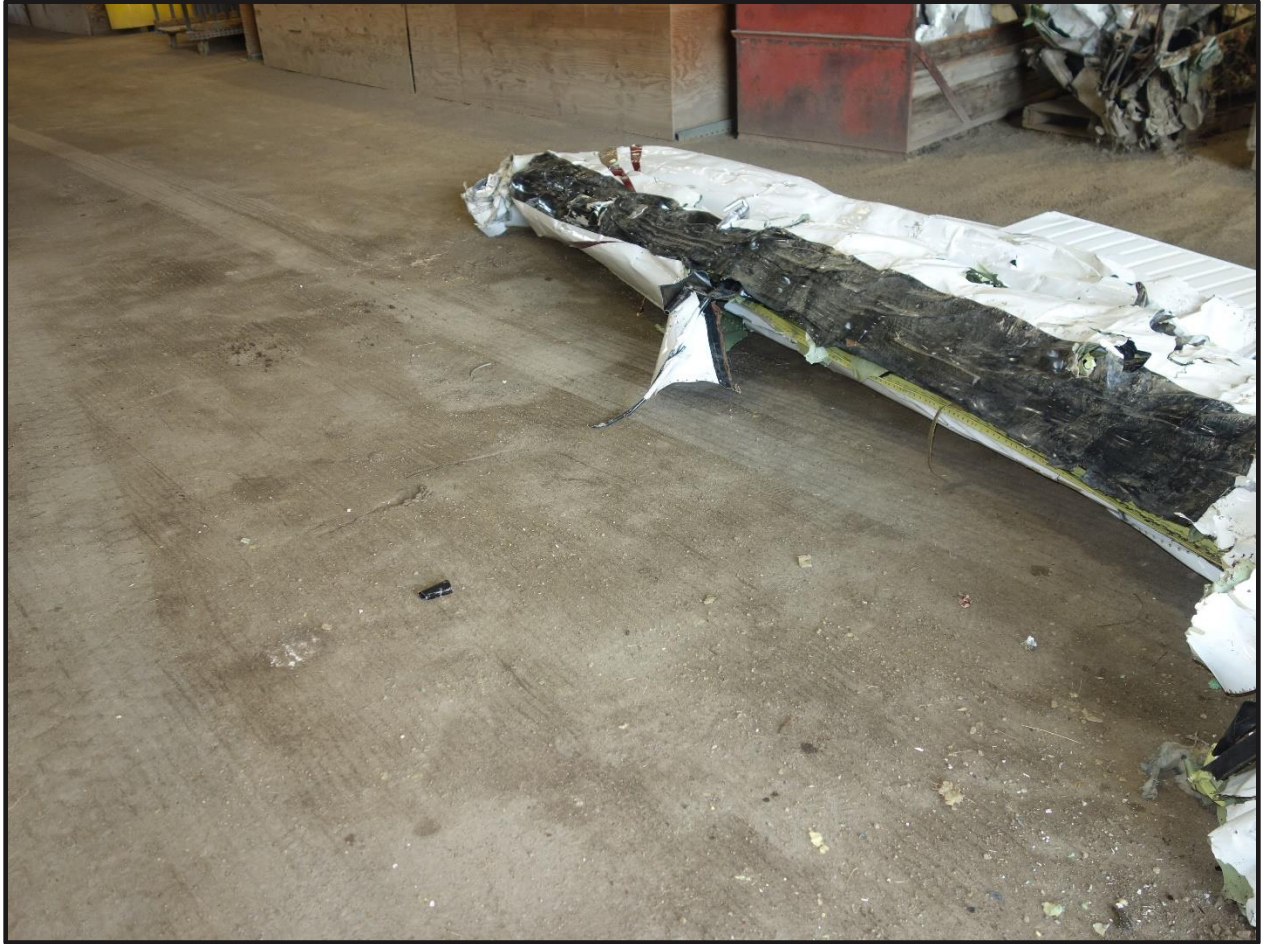
The wings sustained leading edge impact damage for the entire span. The leading-edge wing skins had separated.

Figure 1: Right wing as viewed from the front.

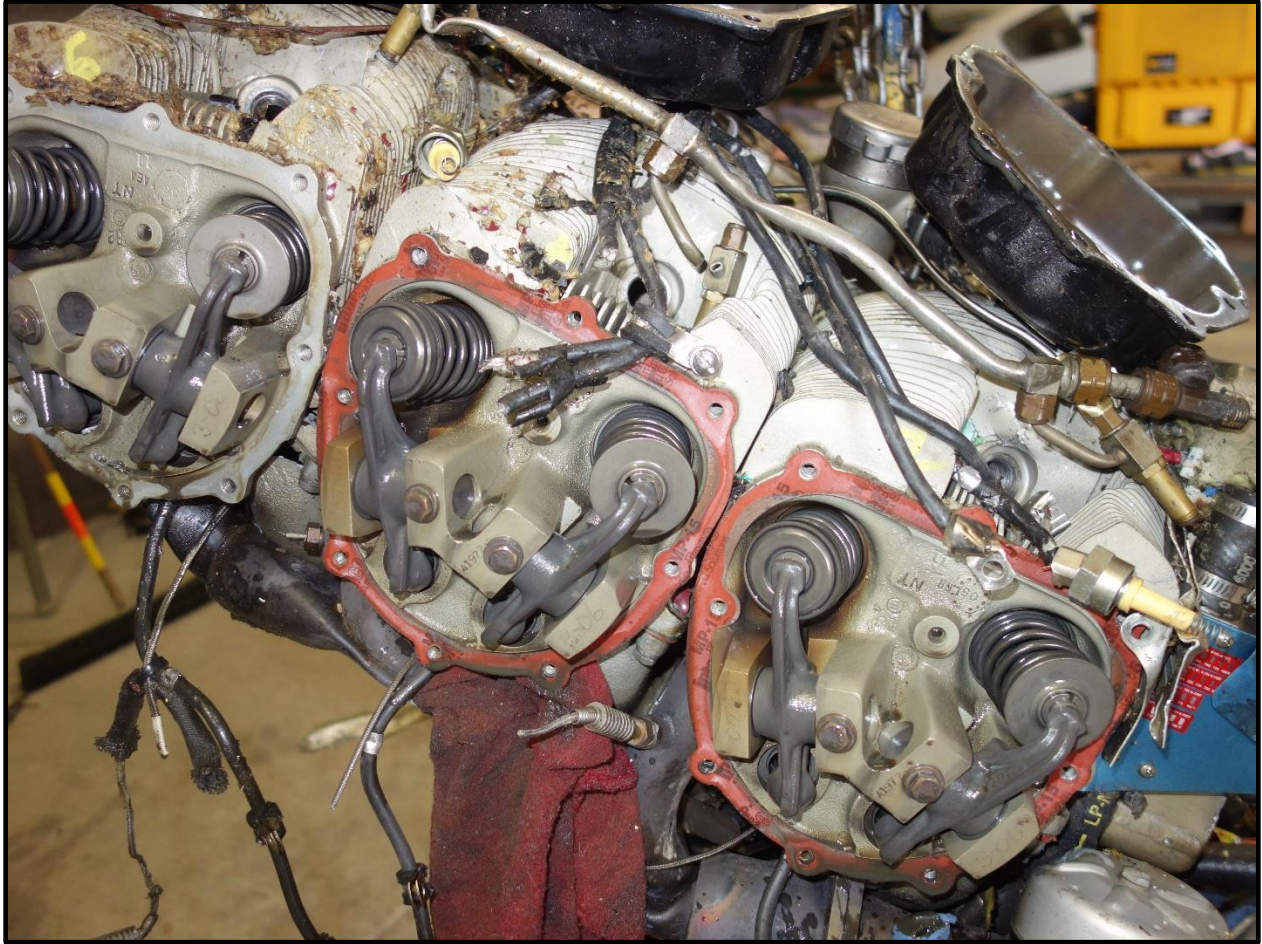
Examination of the Continental IO-550B-39B engine, that was modified by an aftermarket installation of a Tornado Alley Turbo Inc., turbonormalizing system covered under STC SA5223NM, revealed that the engine sustained impact damage that fractured all the engine mounts. The forward crankcase material sustained impact damage and large portions were separated. A large hole in the top portion of the right crankcase was observed between cylinders nos. 1 and 3. Inside the opening, crankcase material could be observed, and the crankshaft rotating components including connecting rods and counterweights were intact. The top aft portion of the crankcase had separated below the magneto mounts. Additionally, cylinders nos. 1 and 3 sustained substantial impact damage to their cooling fins and cylinder no. 1 valve rocker cover had separated.

Figure 2: Engine as viewed from the right side.
