## **NATIONAL TRANSPORTATION SAFETY BOARD**

# **AIRFRAME AND ENGINE EXAMINATION**

**WPR17FA213**

Location: Perkinsville, Arizona  
Date: September 22, 2017  
Aircraft: Cessna 172L, N7070Q, SN: 17260370  
NTSB IIC: Elliott Simpson

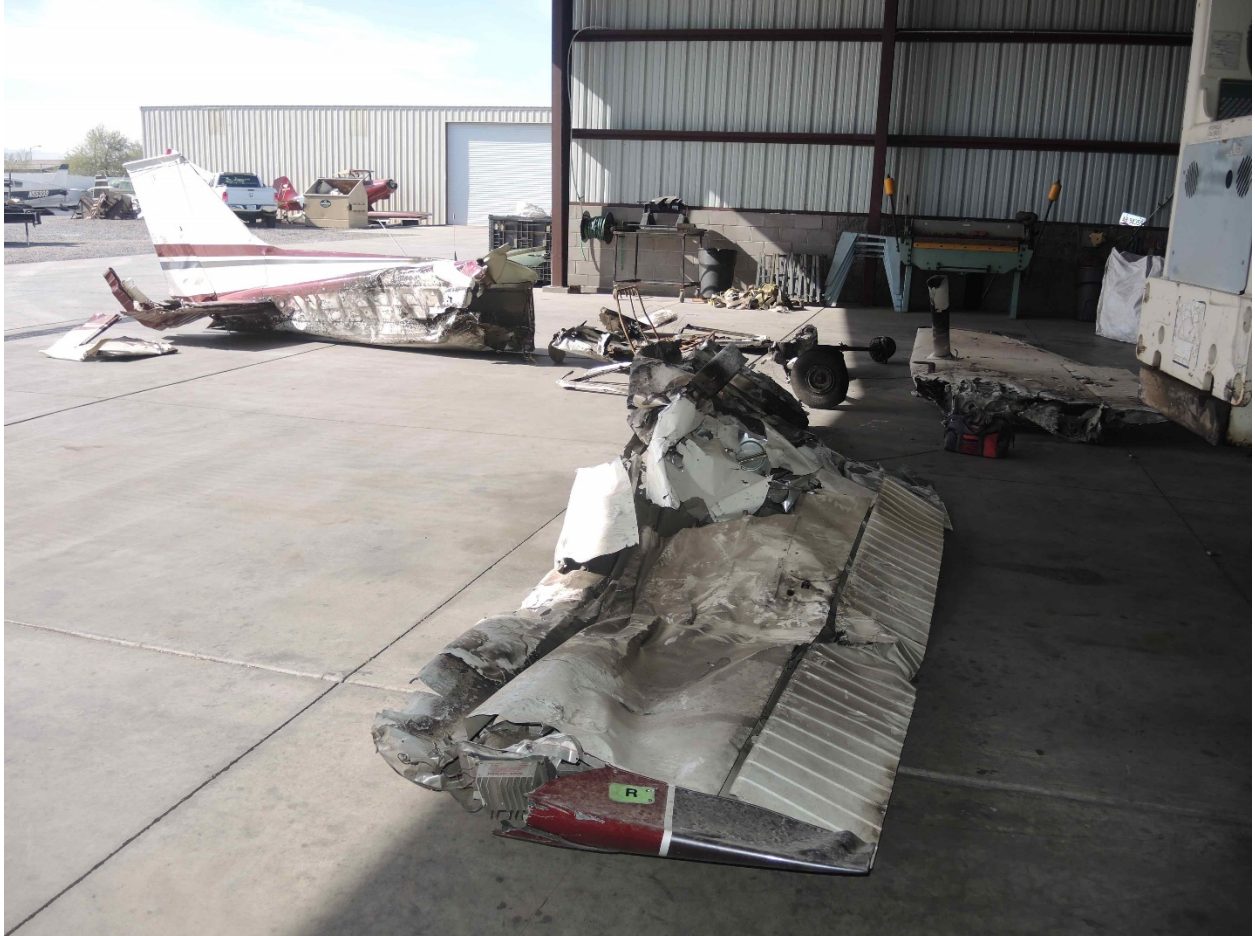
Photo 1 – Airframe Remnants

The fuselage, from the tailcone at the baggage door frame, through to the firewall, was consumed by fire (Photo 1). Remaining remnants included a 3 ft square section of the lower fuselage floor assembly, and the main landing gear, which remained attached to the lower box assembly. The left door had detached from the airframe, the right door had been consumed with only the window frame remaining.

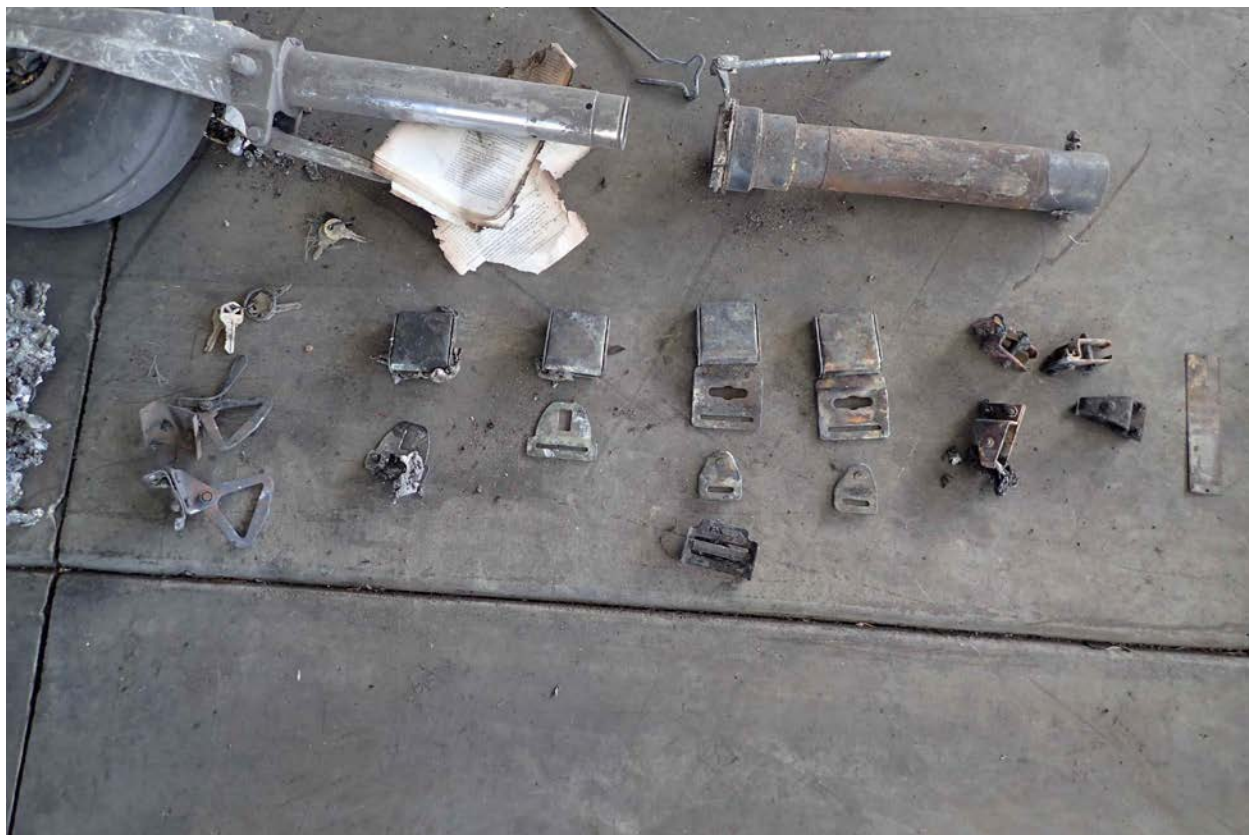
Photo 2 – Seat Belt Latches

The rear seat frame was intact and undamaged. The forward seats, with the exception of the steel seat adjustment members were consumed. Four of the seat rollers were located. The front

seat lap buckles were located latched, the belts were consumed by fire. The rear seat buckles were unlatched, and the belts were also consumed (Photo 2).

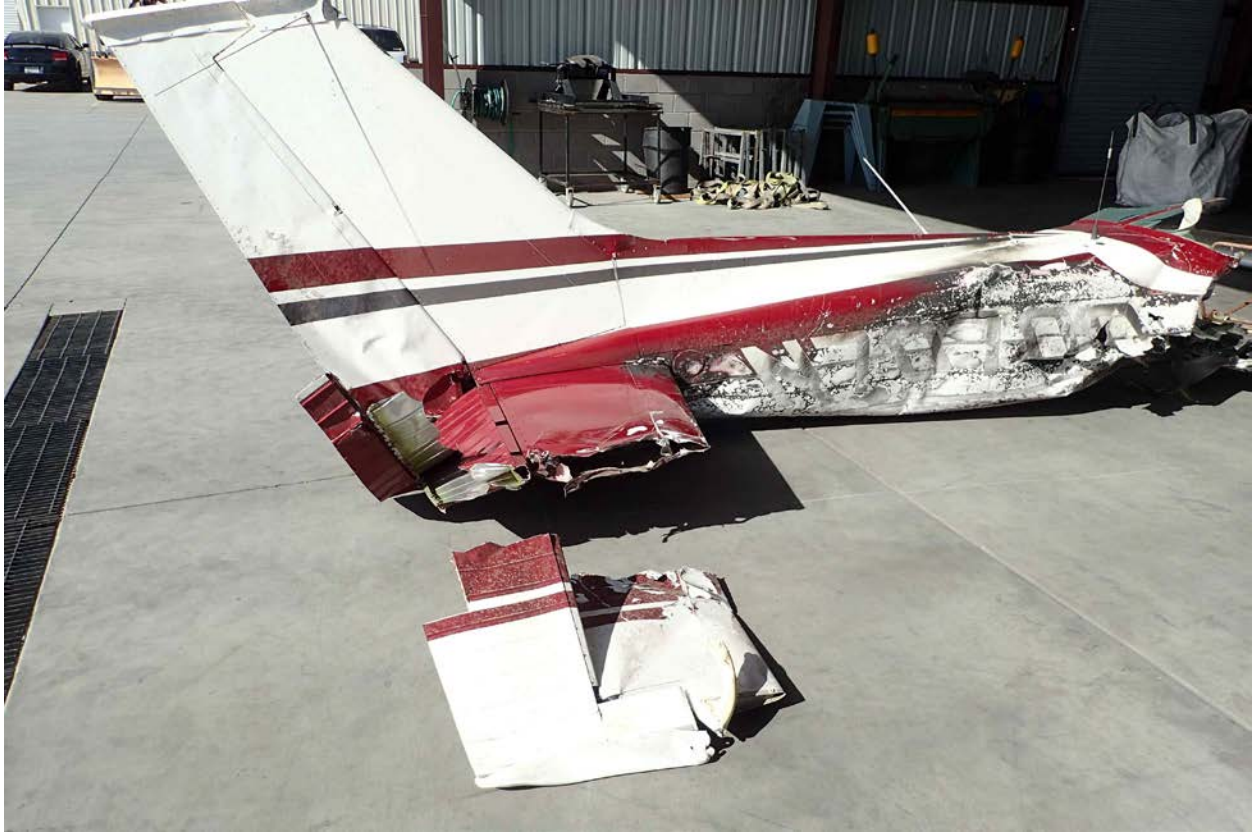
Photo 3 - Tail

The vertical and horizontal stabilizers remained attached to the tailcone. The left side of the tailcone was largely undamaged, and the right side sustained thermal damage along its entire length, and had been cut off during recovery (Photo 3).

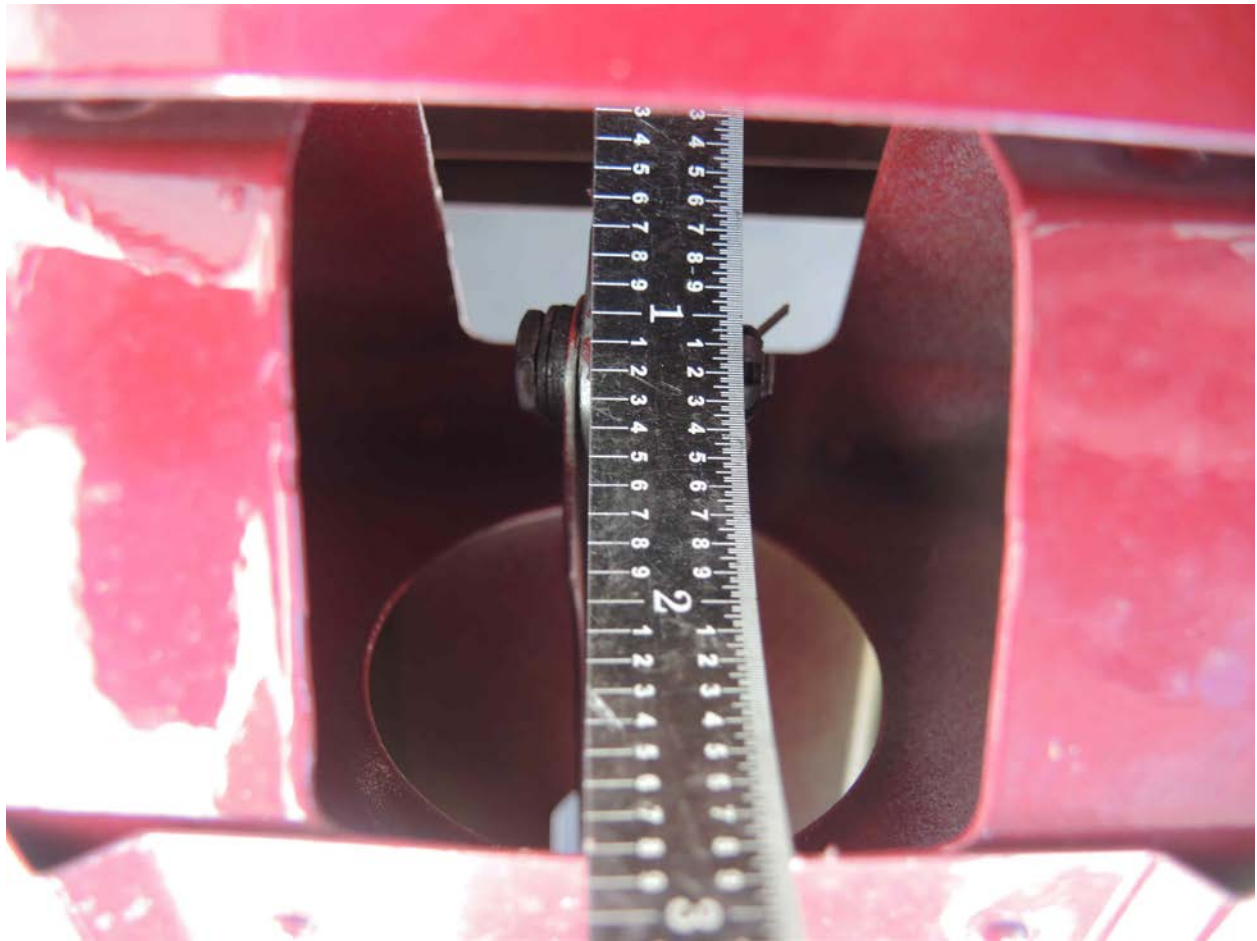
Photo 4 – Elevator Trim Actuator

The elevator remained attached to the horizontal stabilizer by its hinges; the trim tab was in place and its control rod had extended 1.25 inches out of the actuator (Photo 4), which according to Cessna documentation was consistent with a 5° tab down position. The underside of the right stabilizer and elevator sustained thermal damage, bubbling the paint. The control cables remained attached to the rudder horn, and were continuous to the aft cabin, where they had been cut by recovery personnel.

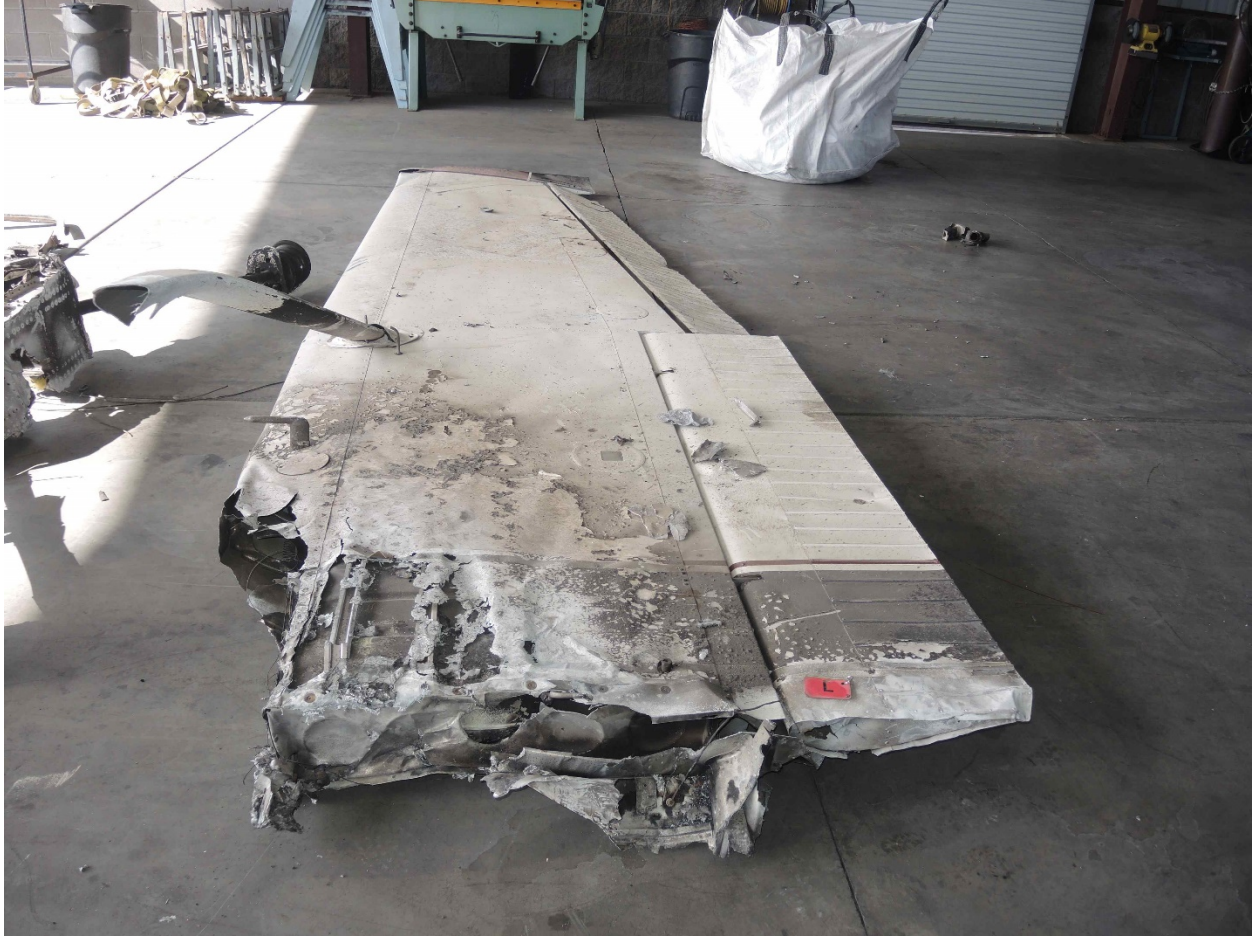
Photo 5 – Left Wing

The left wing was intact and largely undamaged, except for thermal damage to the inboard leading edge at the fuel tank (Photo 5). The main and aft spars had melted away. The lift strut remained attached to the spar, and had separated about 3 ft inboard from the fuselage.

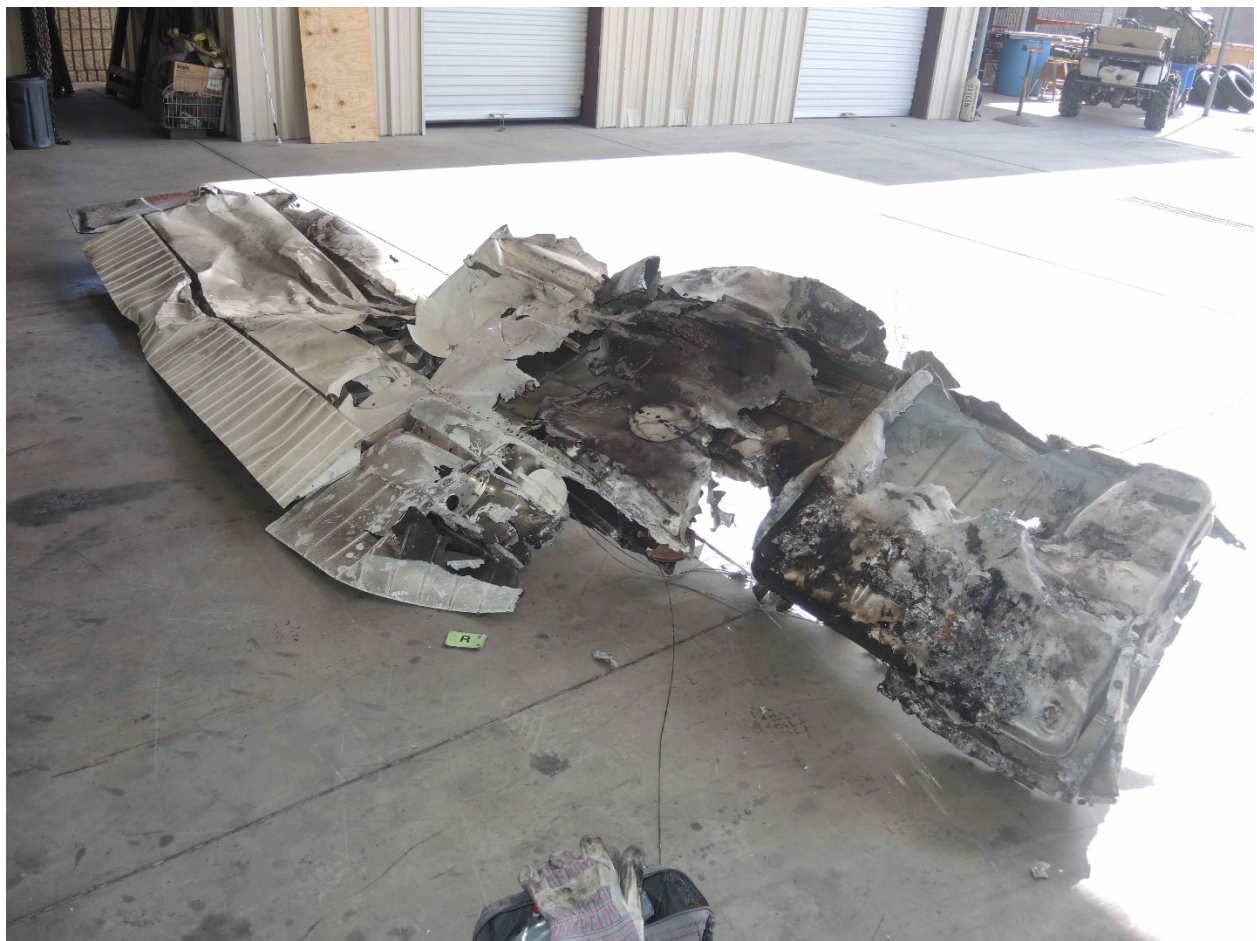
Photo 6 – Right Wing

The inboard section of the wing was consumed by fire, with only remnants of the fuel tank, flap actuator assembly, outboard flap and rail, and wing spar remaining (Photo 6). Outboard, the wing had sustained accordion-like crush damage to the underside, outboard of the lift strut attach point. The aileron remained attached at its hinges, and exhibited a crease midspan. The aileron control rod had separated in the area of crush damage. The bellcrank was intact, and the control cables were continuous to the wing root, where they appeared to have been cut during recovery.

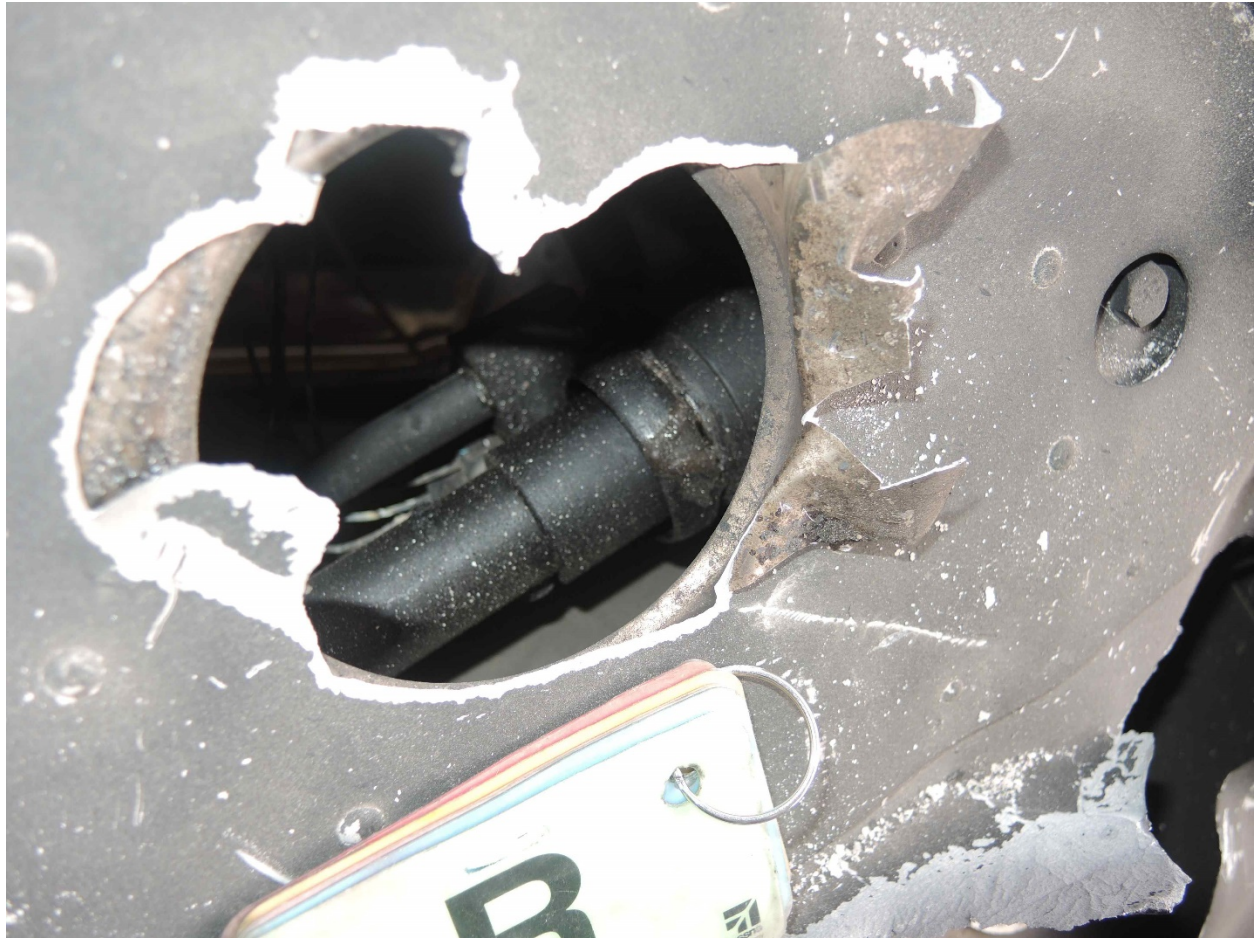
Photo 7 – Flap Actuator

The flap actuator jack screw exhibited an extension of about 1/8 inch (Photo 7), which according to Cessna documentation was consistent with fully retracted flaps.

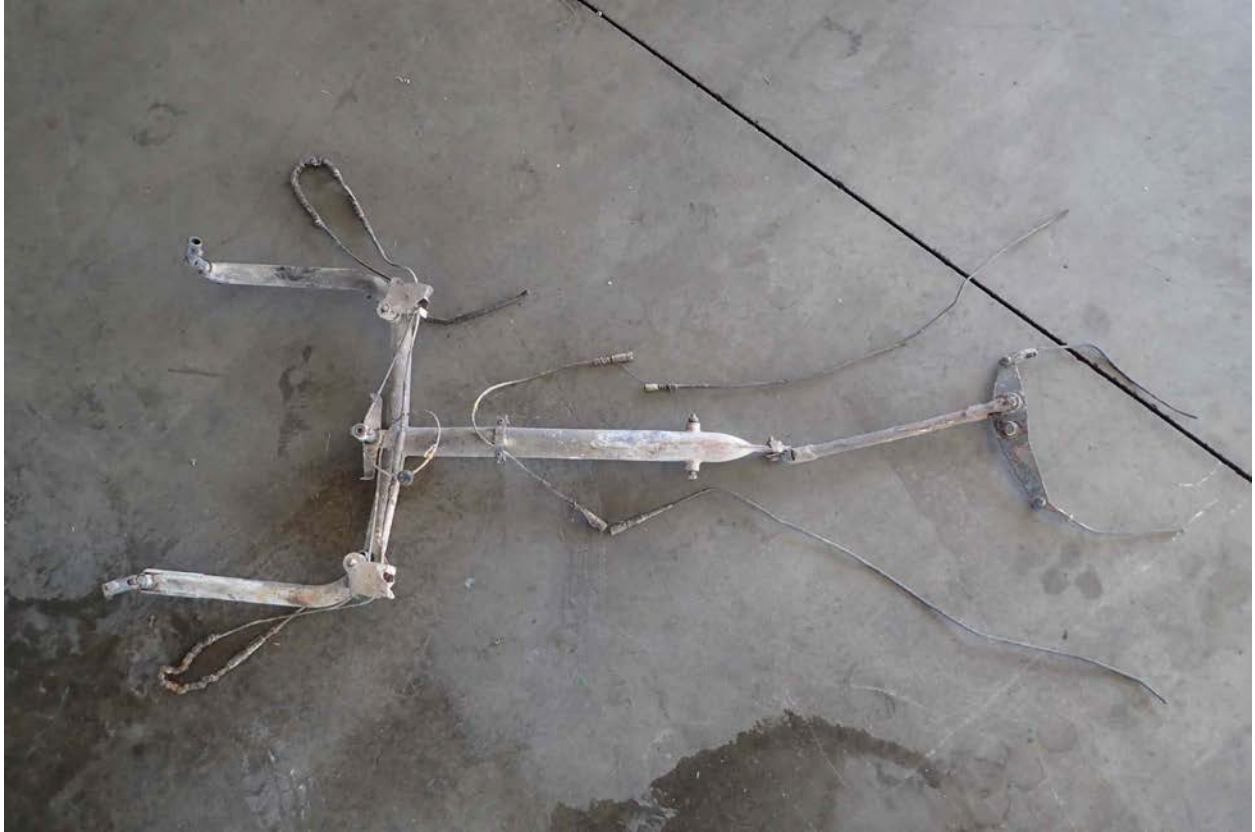
Photo 8 – Control Column

The steel sections of the control column were intact and had detached and burnt away from fuselage. Both yoke universal joints were intact and undamaged, and the yokes appeared to have melted away. The aileron interconnect chains were intact and appeared undamaged and still attached to the interconnect cable. The elevator push-pull tube remained attached at base of the control column. The tube was still attached to the elevator bellcrank and control cables (Photo 8).

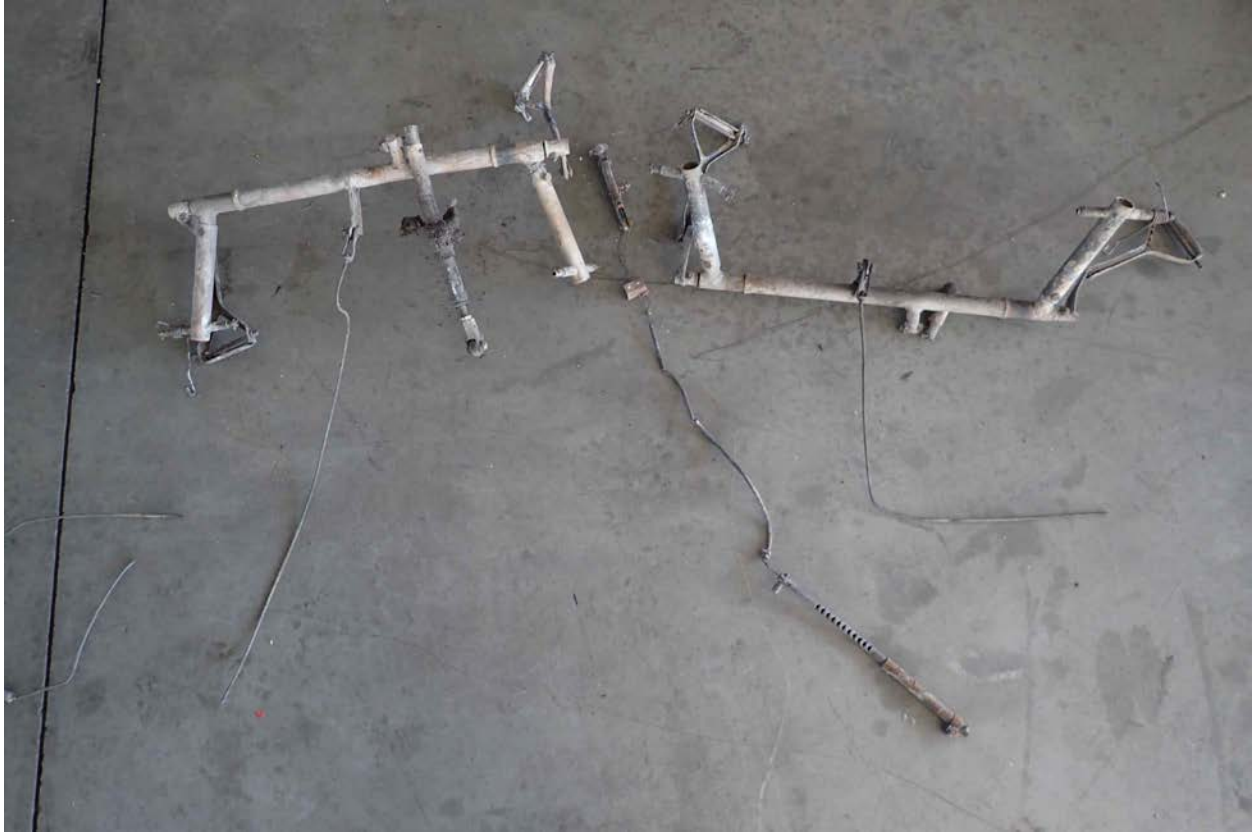
Photo 9 – Foot Pedal Assembly

The foot pedal and brake assembly were intact, and remained attached to both steering links, the parking brake assembly, and the rudder cables (Photo 9).

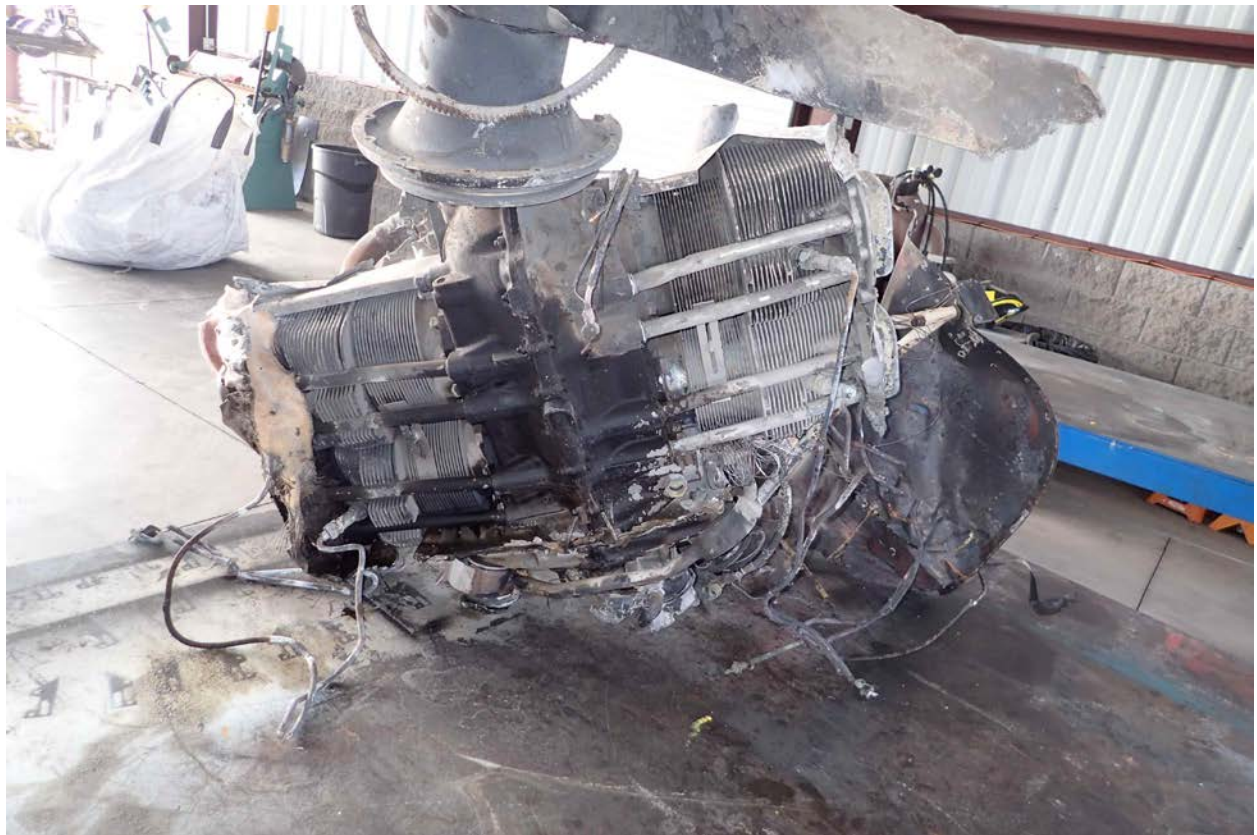
Photo 10 - Engine

The engine remained attached to its mount, which was still attached to the crushed firewall. The engine sustained thermal damage, consuming the right magneto, the spark plug harness, oil sump, alternator, and the right side of the accessory case. The crankcase did not exhibit any breaches indicative of internal catastrophic failure (Photo 10).

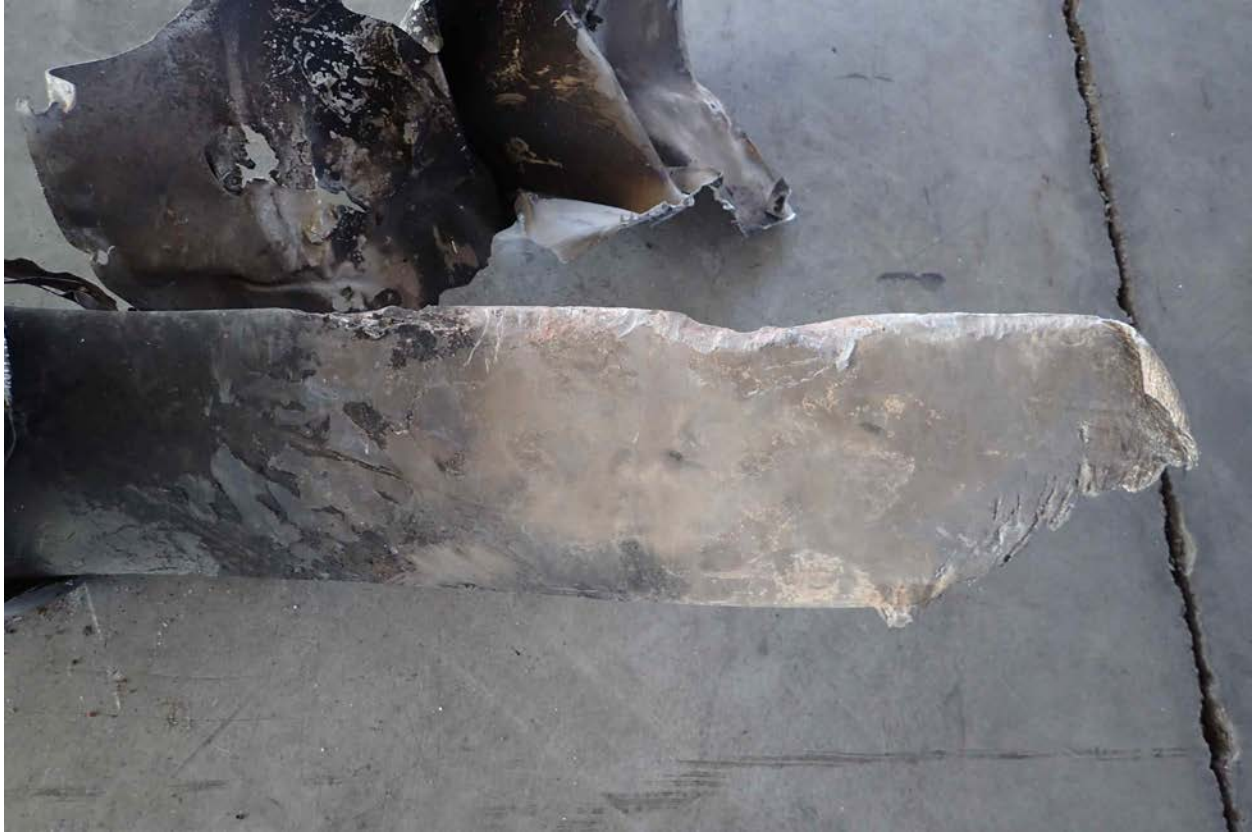
Photo 11 – Propeller Blade

The propeller remained attached at the crankshaft flange; and the ring gear had detached from the flywheel. The tip of one blade had melted off, about 24 inches from the root, the remaining section of the blade exhibited one-inch-deep leading edge gouges midspan (Photo 11). The tip of the second blade had separated about 28 inches from the root, and the blade had bent about 15° aft midspan (Photo 12).

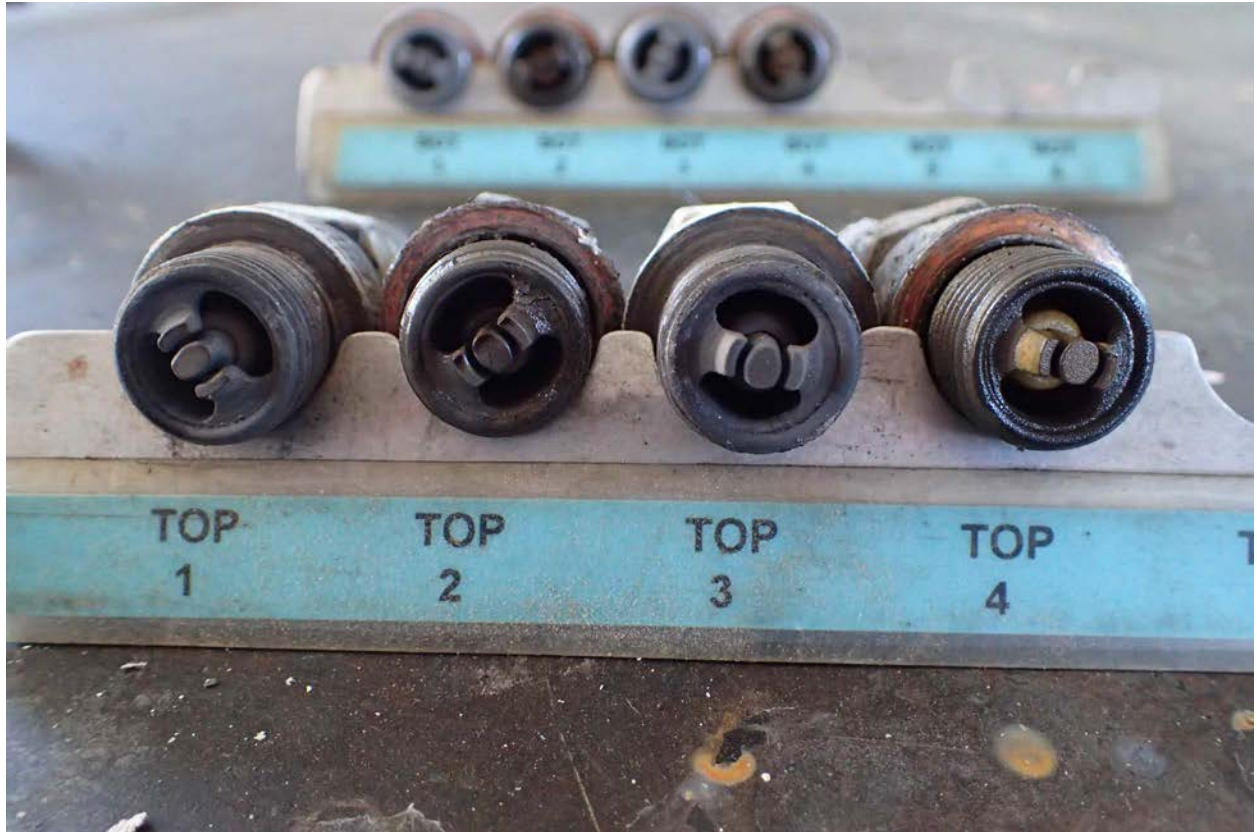
Photo 13 – Top Spark Plugs

The top and bottom spark plugs were removed and examined. Their electrodes remained mechanically undamaged, and coated in dark grey deposits. The top plugs displayed normal short service life wear signatures, and the bottom plugs displayed worn out-normal wear signatures when compared with the Champion Spark Plugs AV-27 Check-A-Plug chart (Photo 13,14).
