## **NATIONAL TRANSPORTATION SAFETY BOARD**

### **SITE and ON-SCENE INFORMATION**

**NTSB Accident: WPR17FA215  
Accident Date: September 29, 2017**

Location: Brinnon, Washington  
Date: September 29, 2017  
Aircraft: Piper PA28-140, N9549W, Serial # 28-22981  
NTSB IIC: Michael Huhn

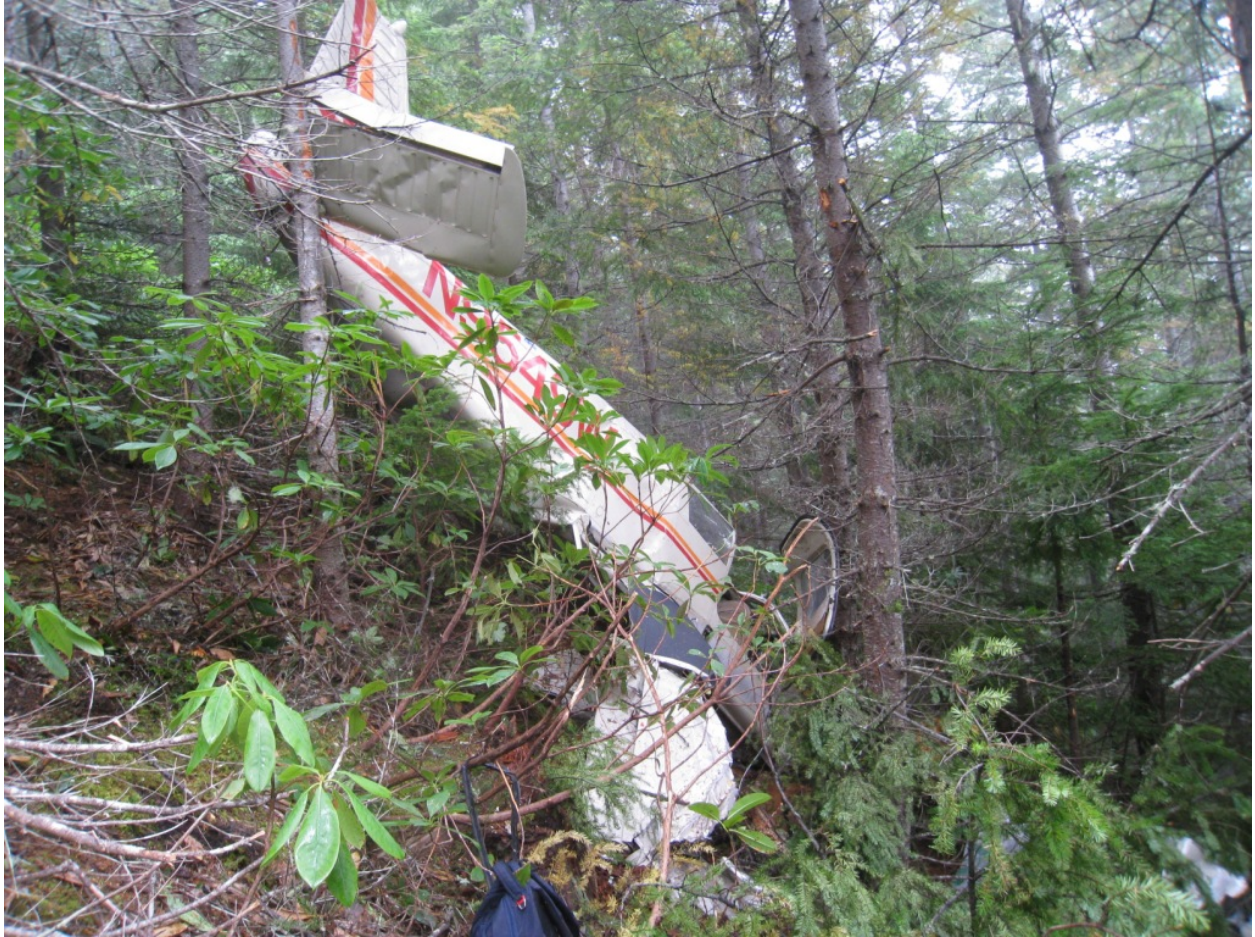
**Figure 1 - Fuselage**

- The main wreckage consisted of the fuselage, engine, wings, and most of the empennage
- The fuselage was upright, but partly suspended by vegetation, such that it was in an approximate 30° airplane nose down attitude

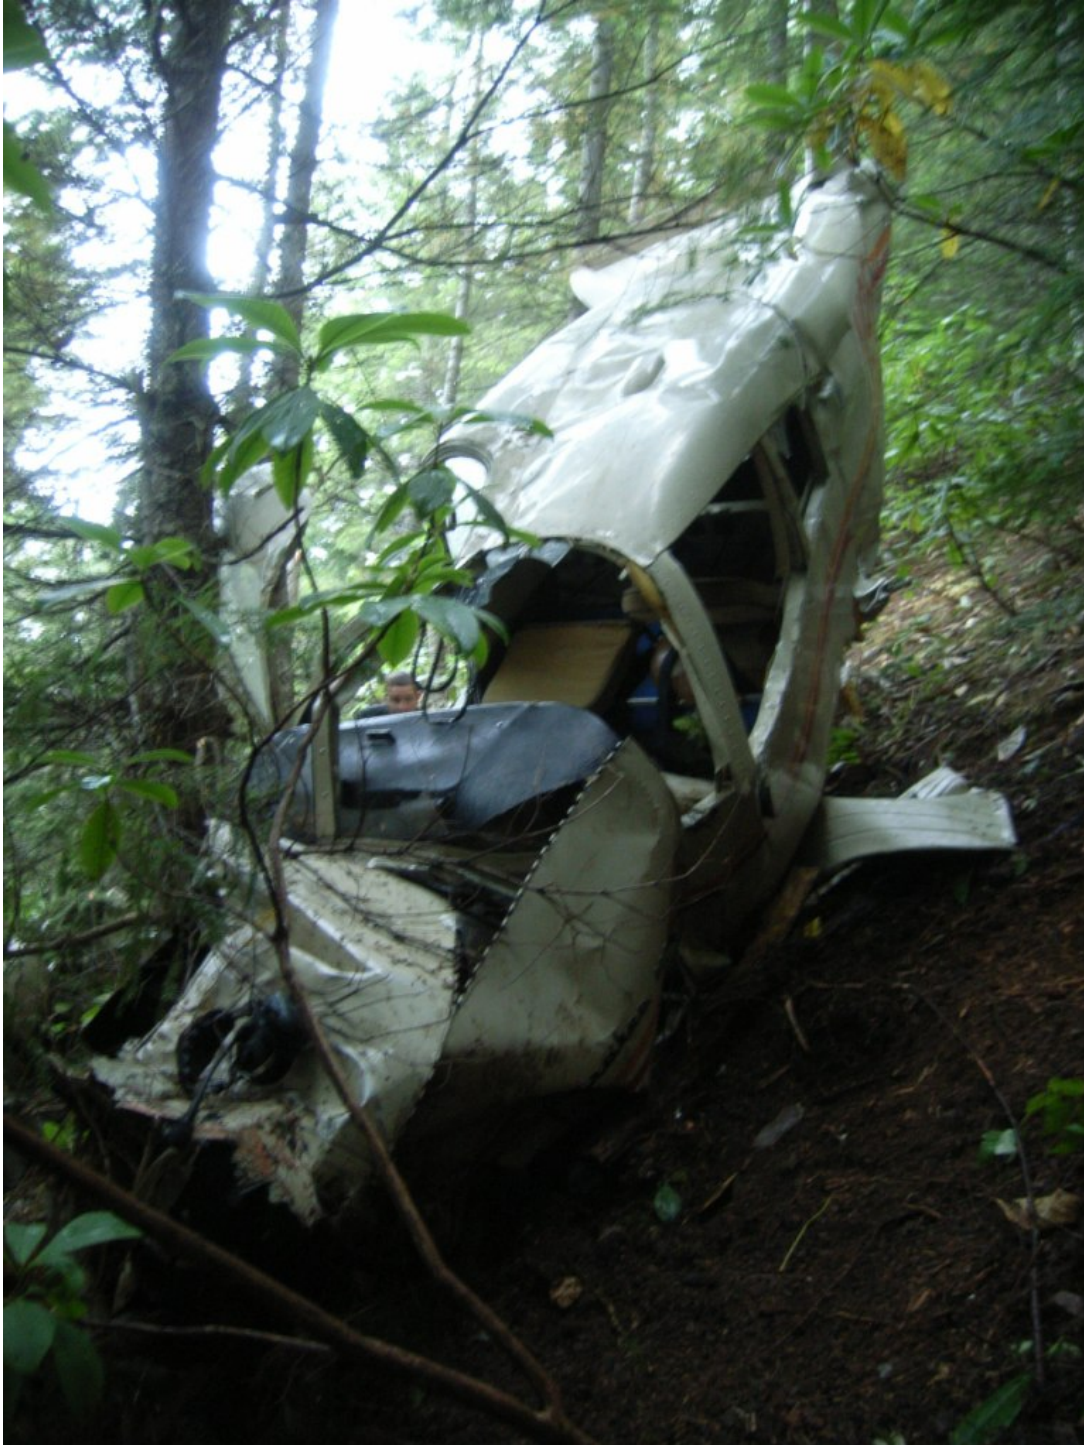
**Figure 2 - Front Fuselage**

- The fuselage heading was approximately south, and pointed approximately downslope
- The forward portion of the fuselage was significantly crushed and disrupted

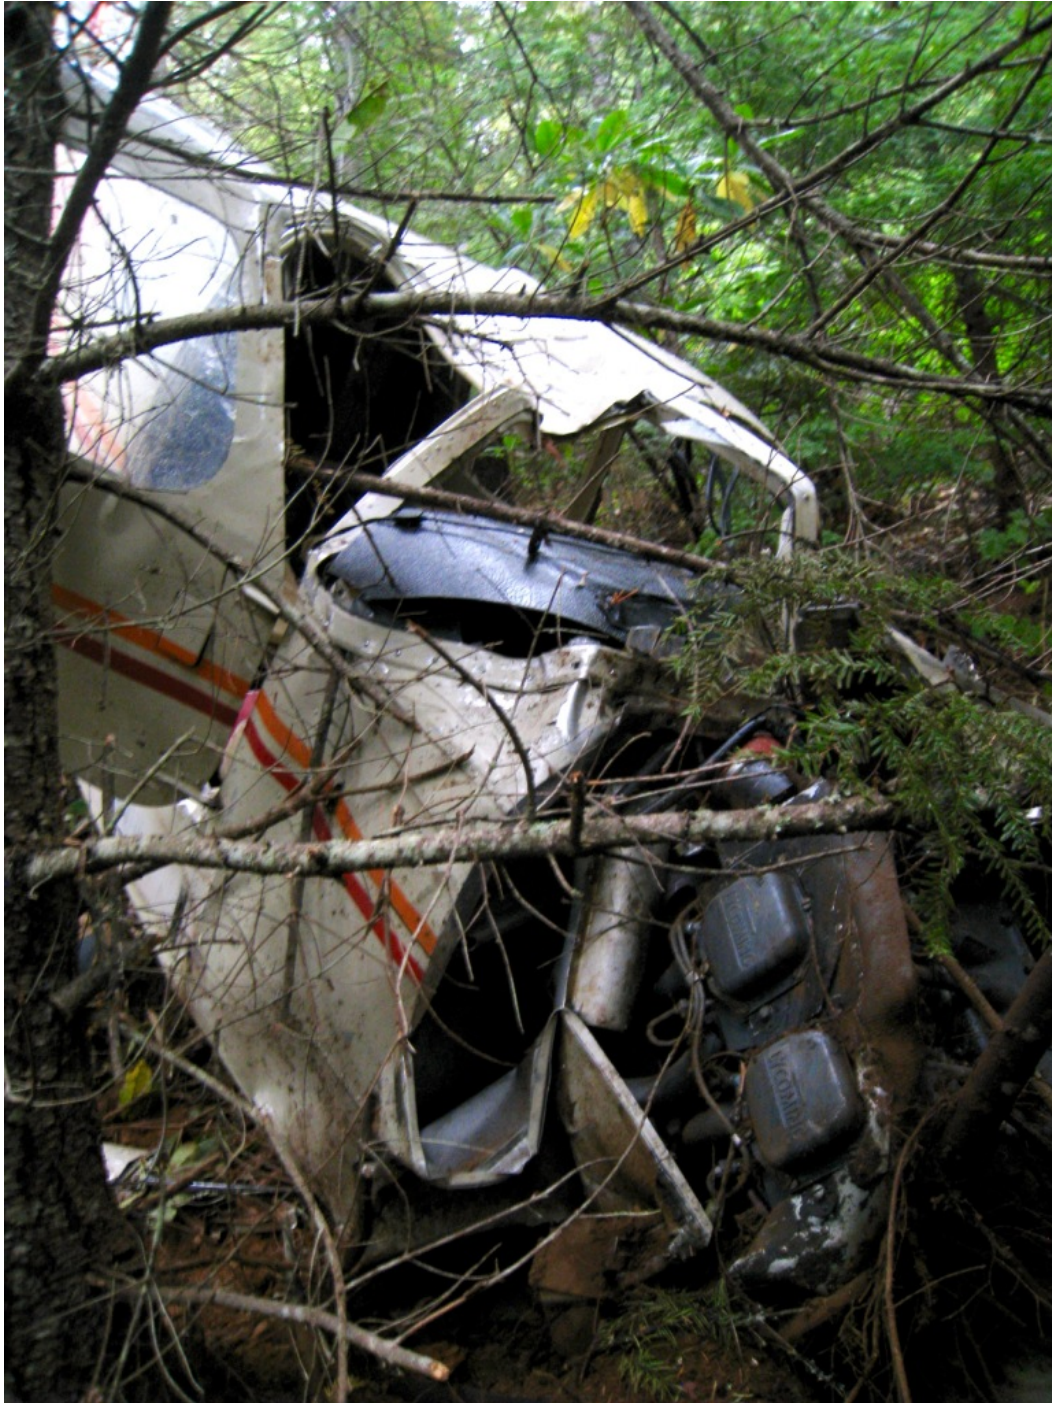
**Figure 3 - Front Right Fuselage**

- The cockpit volume was compromised by crushing in the aft direction
- The left wing was fracture-separated from the fuselage at the wing root
- The right wing was crushed in the aft direction, torn, and canted aft

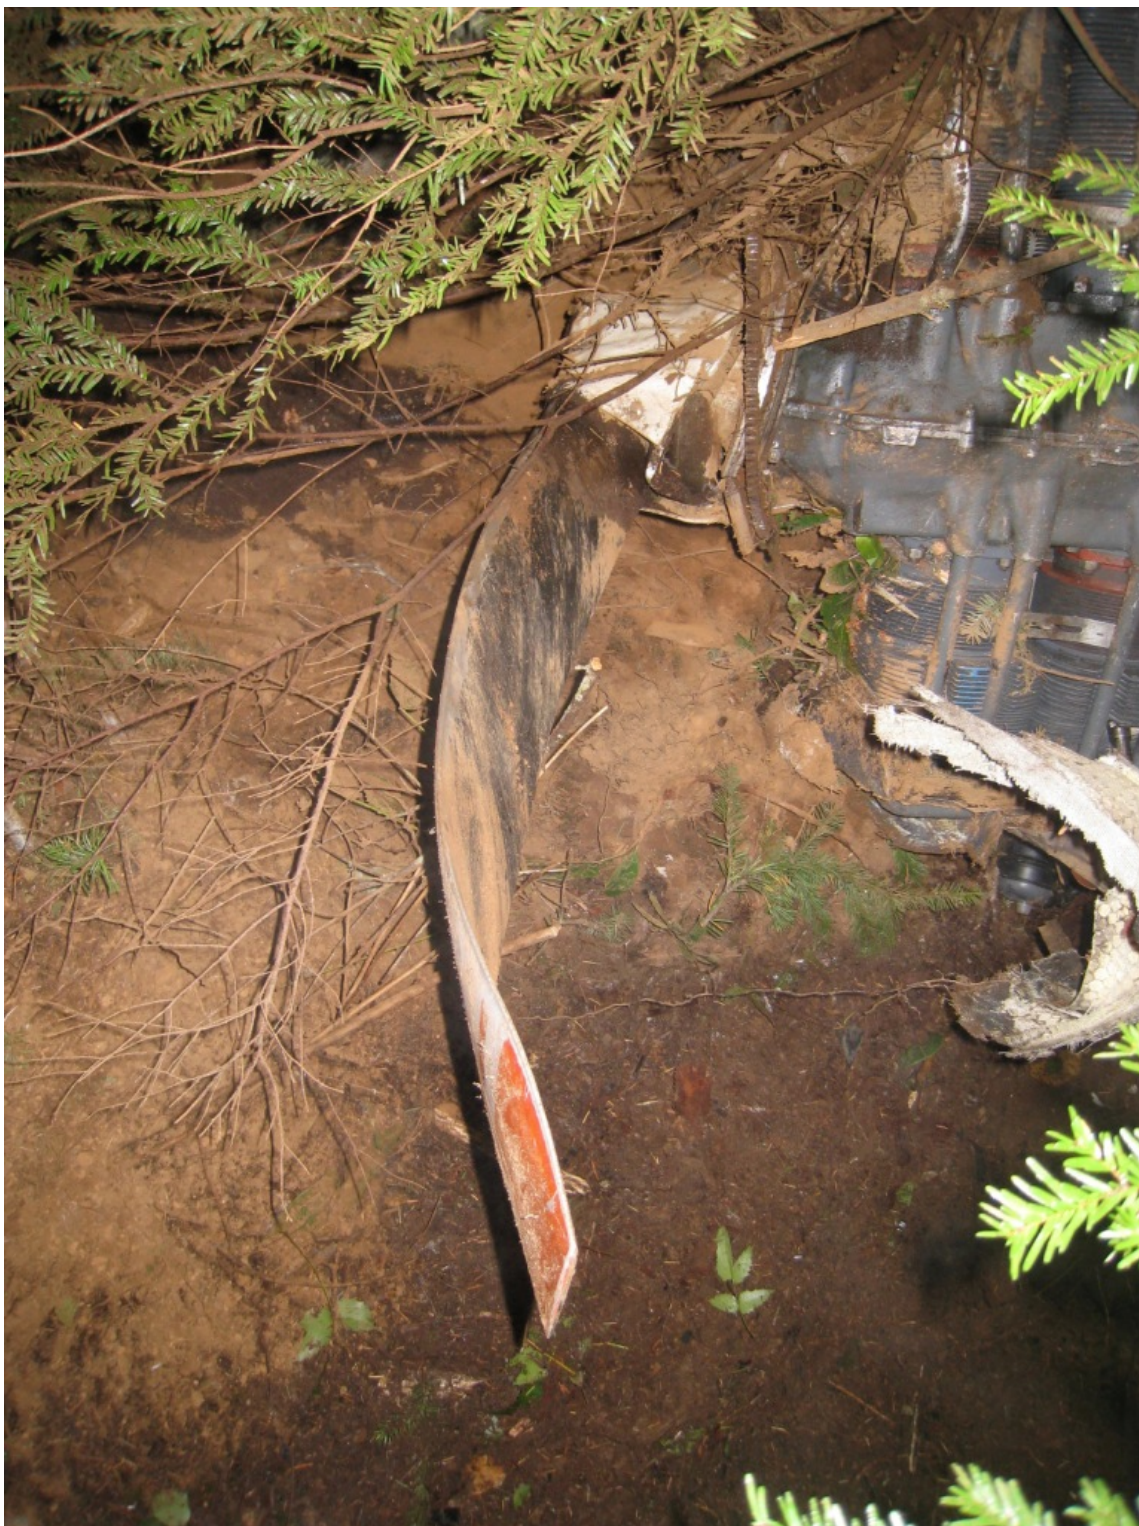
**Figure 5 - Propeller**

- The engine remained attached to the fuselage
- The propeller remained attached to the engine, and both were partially embedded in the soil
- The key remained in the ignition switch, which was set to the "BOTH" position

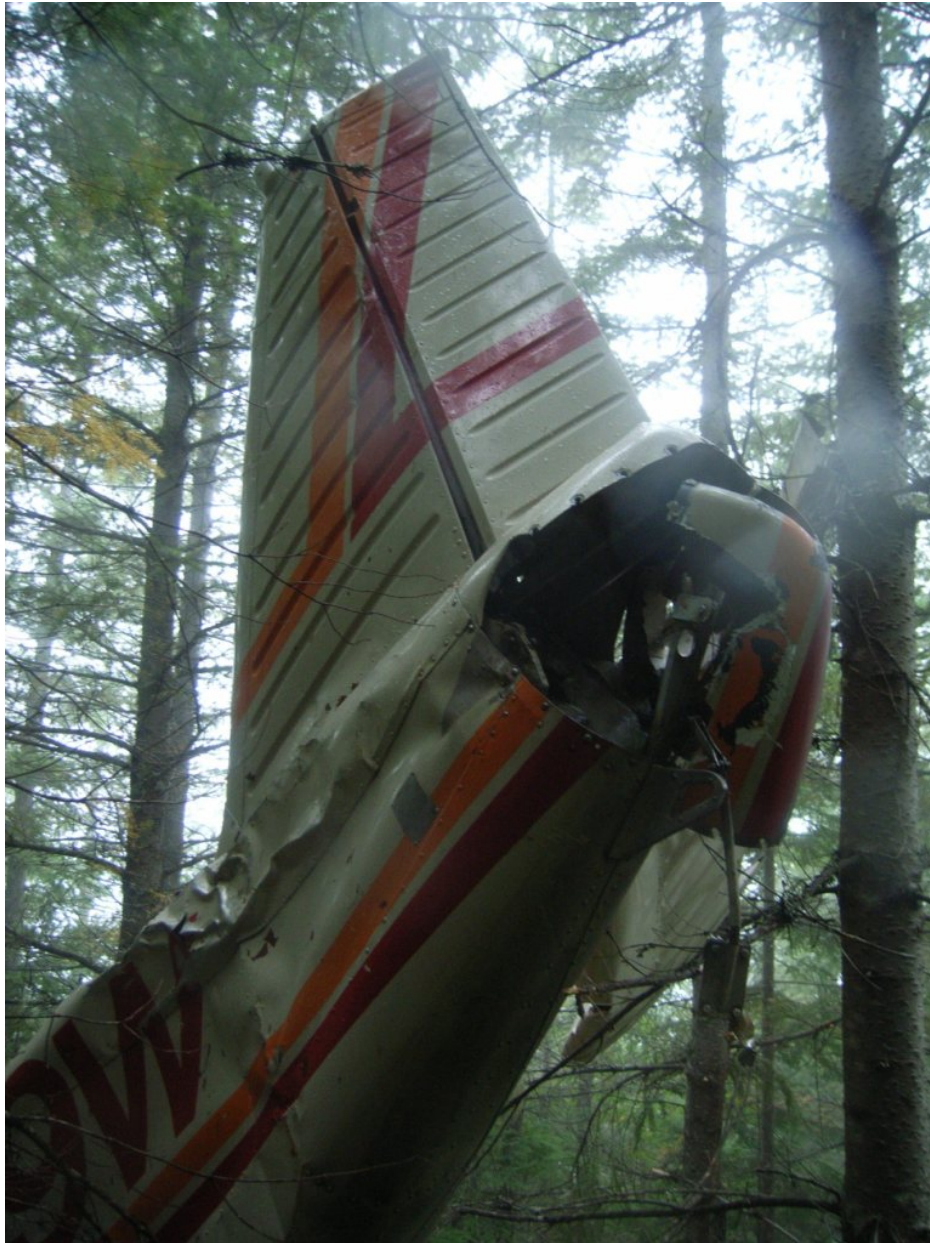
**Figure 7 - Aft Fuselage**

- The left horizontal stabilizer and elevator were fracture separated from the fuselage, and located about 100 feet back along the tree cut swath
- All aerodynamic and flight control surfaces appeared to be present at the accident site

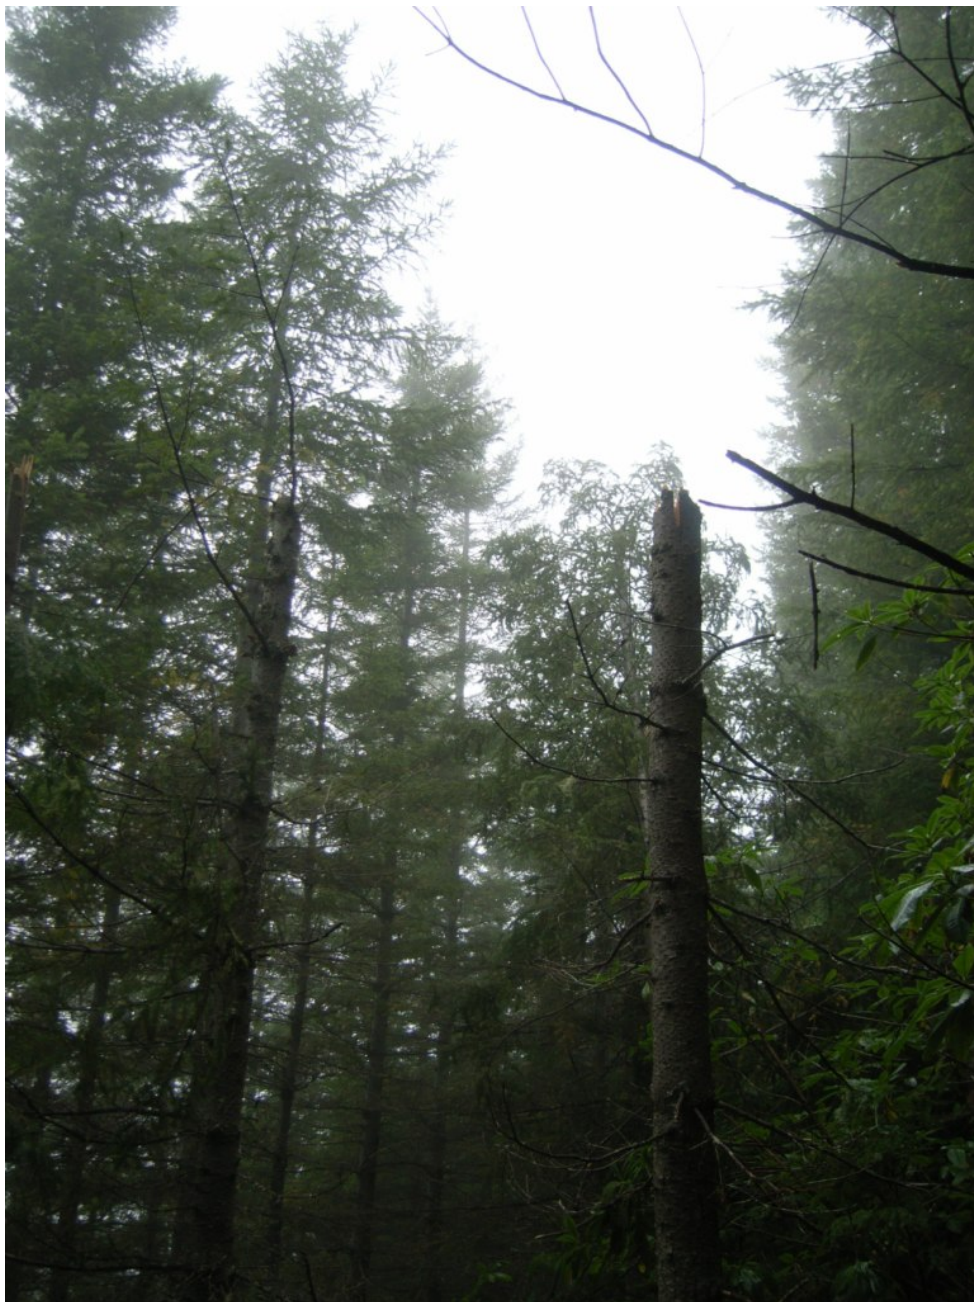
**Figure 8 - Damaged Trees**

- A cut tree swath was aligned on an approximate heading of 110° magnetic
- All wreckage was contained within a relatively small area; the furthest component found was located about 200 ft from the main wreckage

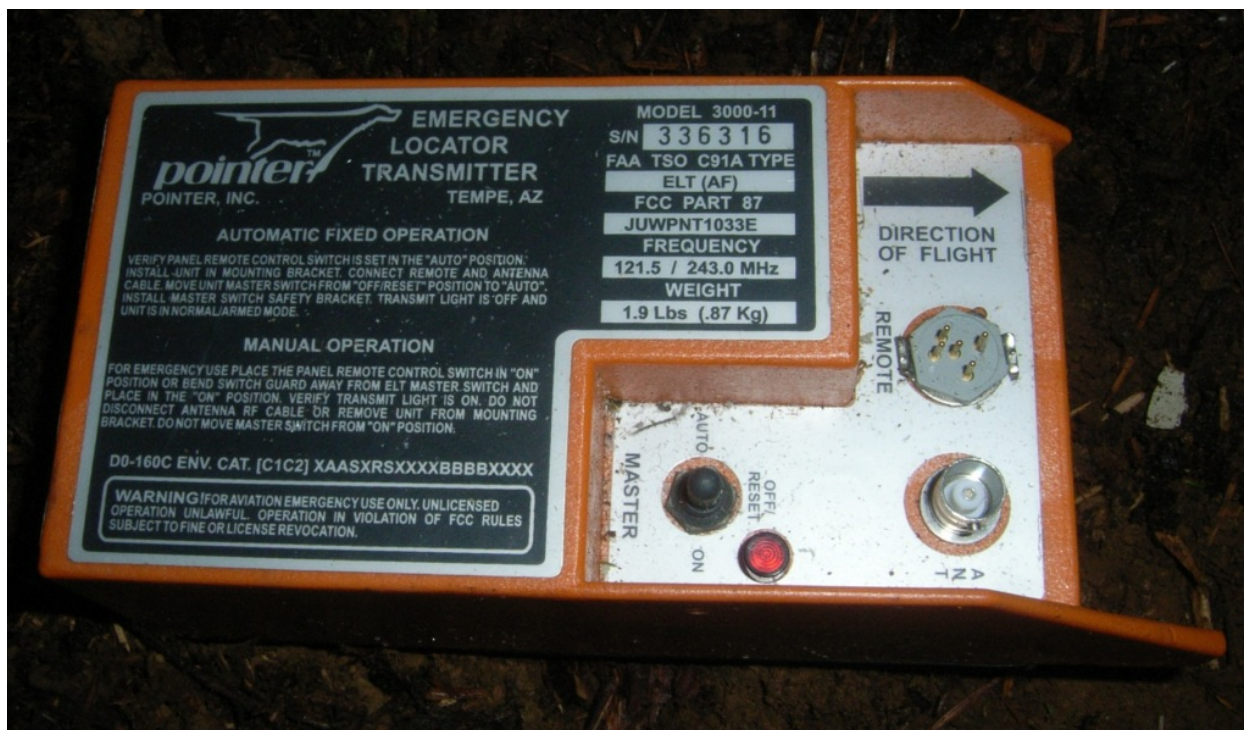
Figure 12 - ELT

- The cockpit fuel selector valve handle was found set to the right fuel tank
- The tachometer registered 5,495.38 hours
- The 121.5 Mhz emergency locator transmitter (ELT) was found still attached to its antenna cable, and the switch was found in the "AUTO" (armed) position
