## **NATIONAL TRANSPORTATION SAFETY BOARD**

### **AIRFRAME and ENGINE EXAMINATION**

**NTSB Accident: WPR17FA215  
Accident Date: September 29, 2017**

Location: Brinnon, Washington  
Date: September 29, 2017  
Aircraft: Piper PA28-140, N9549W, Serial # 28-22981  
NTSB IIC: Michael Huhn

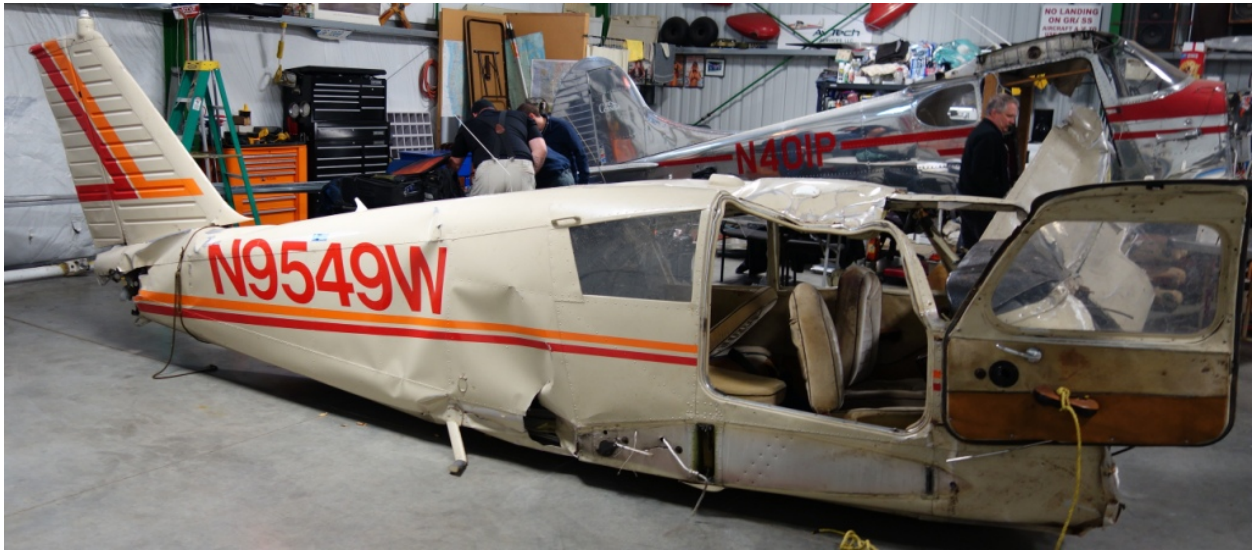
**Figure 1 - Fuselage**

The fuselage sustained impact damage but remained mostly intact. The upper cabin top skin around the door frame was crushed downward. The center and right windshield post were bent in a downward direction.

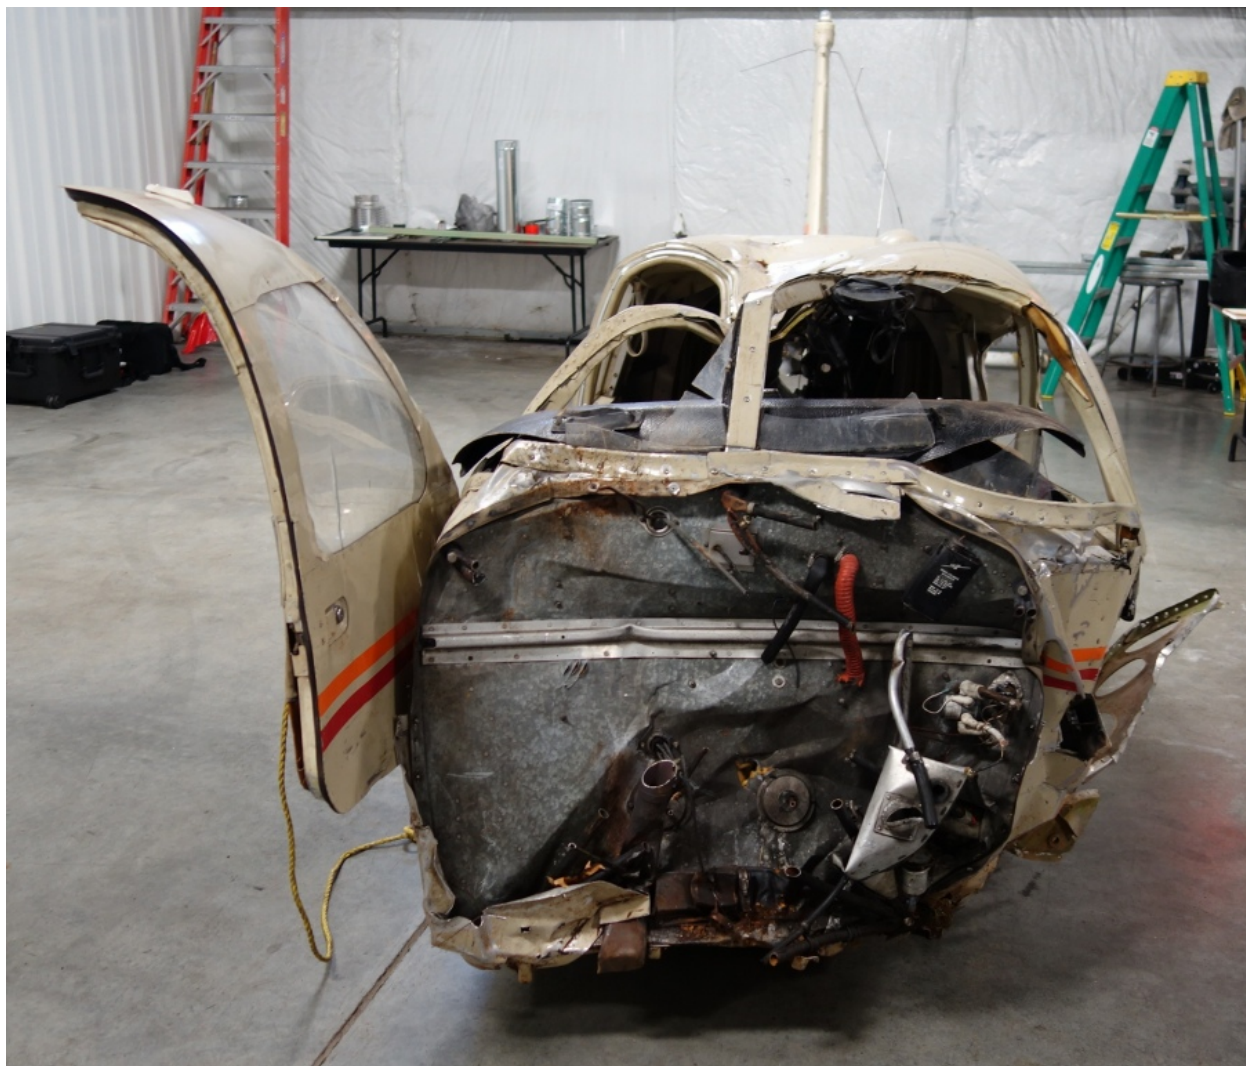
**Figure 3 - Firewall**

The lower left side of the fuselage in the area of the wing root going forward to the firewall sustained impact damage. The firewall sustained impact damage along its left side and bottom. The upper nose landing gear strut remained attached to the engine mount. The lower strut (with the nose wheel) separated from upper strut. The engine mount assembly had been cut off the firewall by recovery personnel.

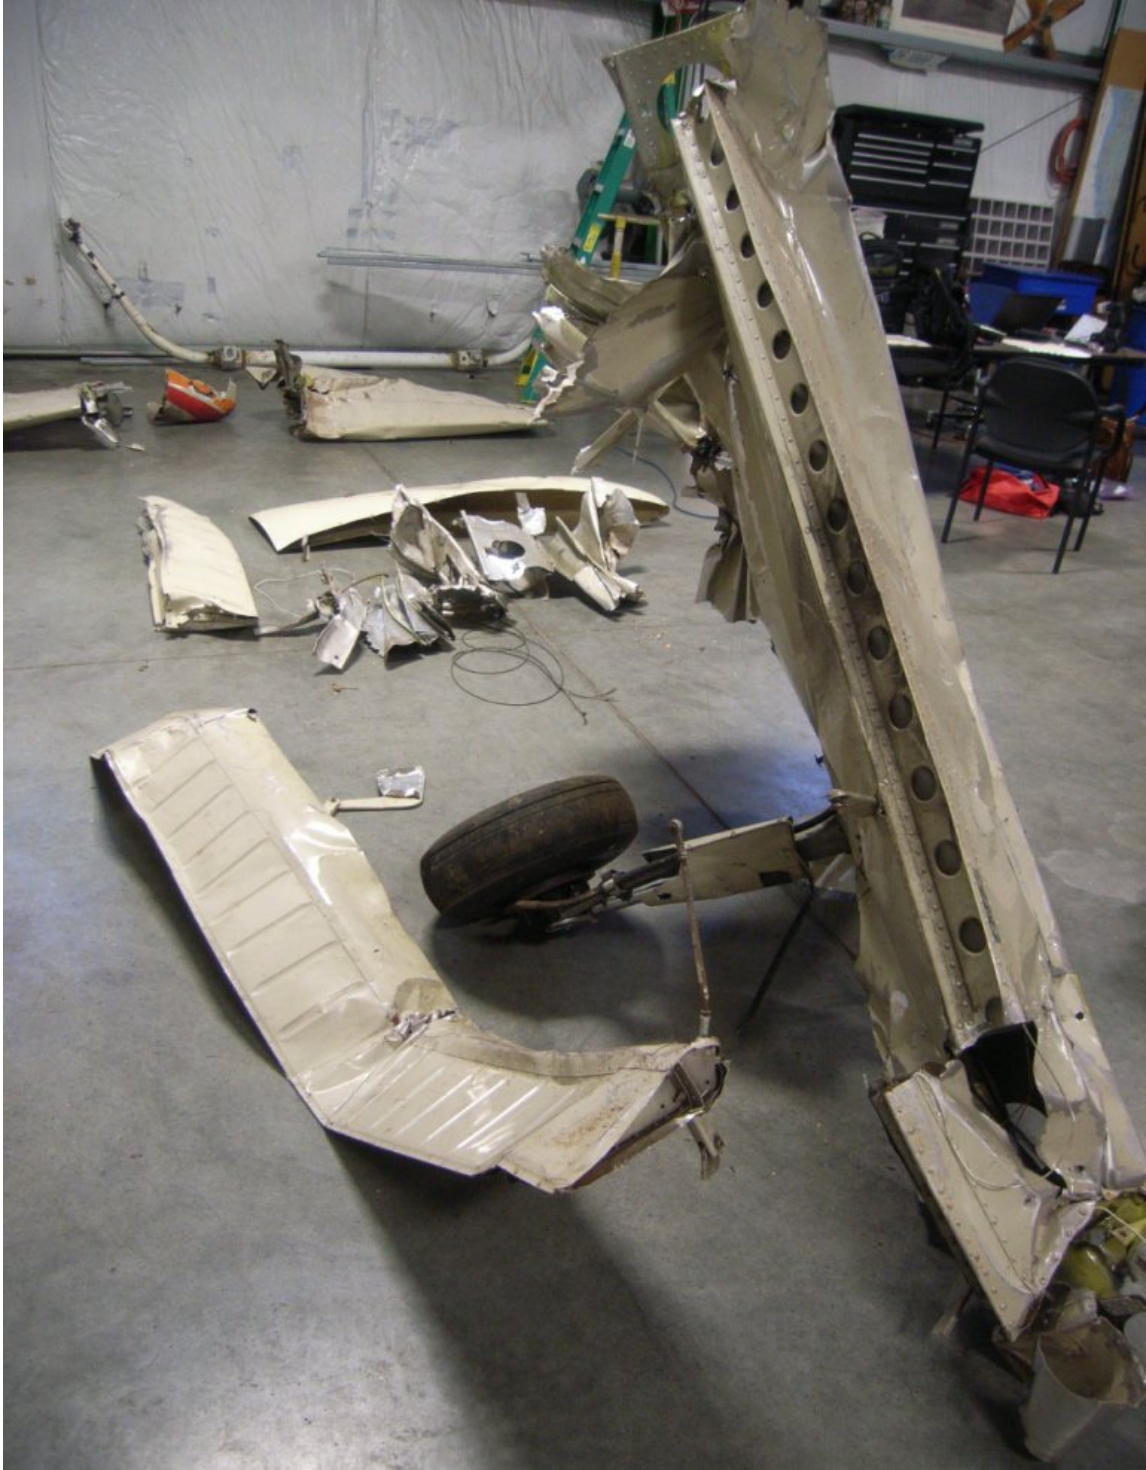
**Figure 6 - Left Inboard Wing**

The left wing sustained significant tree and ground impact damage. The wing had separated from the fuselage and was fragmented into several sections. The inboard section outboard of the fuel tank exhibited aft crushing signatures consistent with tree impact. The outboard wing section was highly fragmented. Most of the leading edge skins had separated from the wing. The landing gear remained attached to the wing. The wing tip assembly separated from the wing and was recovered at the accident site.

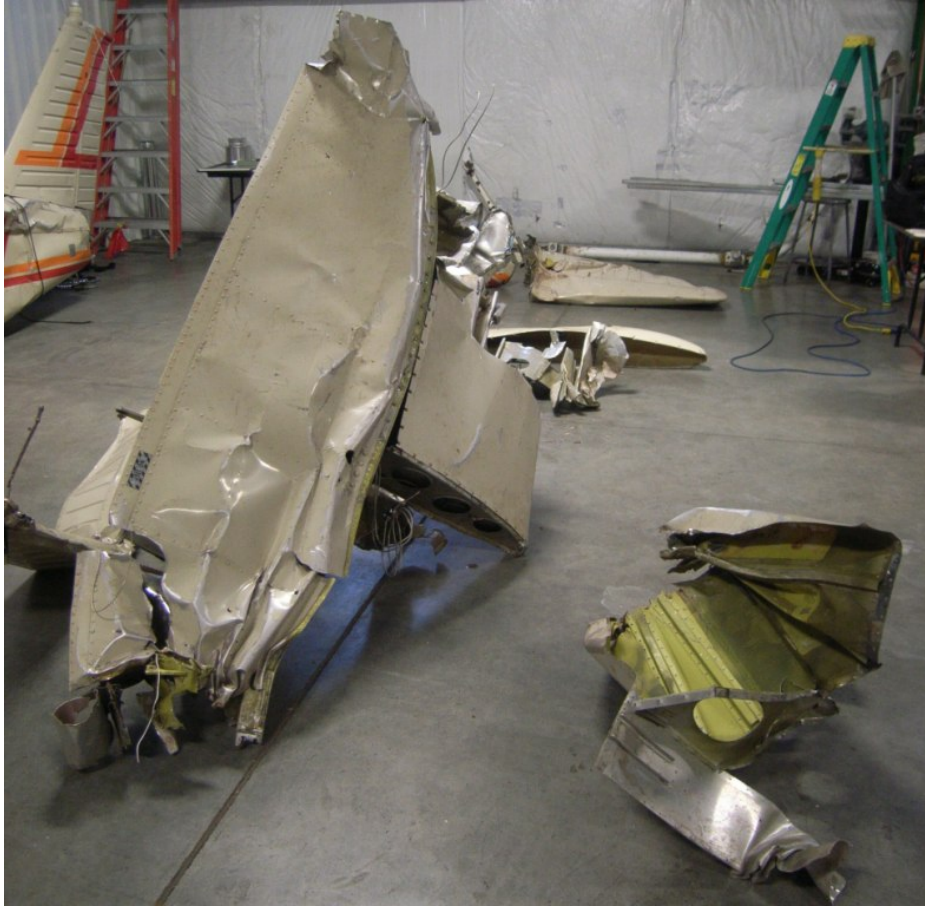
**Figure 7 - Left Wing**

The flap separated from the wing. The flap push/pull rod assembly remained attached to the flap but had separated from the flap torque tube assembly. The aileron separated from the wing and was fractured in two at about mid-span. Both aileron primary and balance cables remained attached to the aileron bellcrank assembly. The cables exhibited tension separation in the area of the wing root.

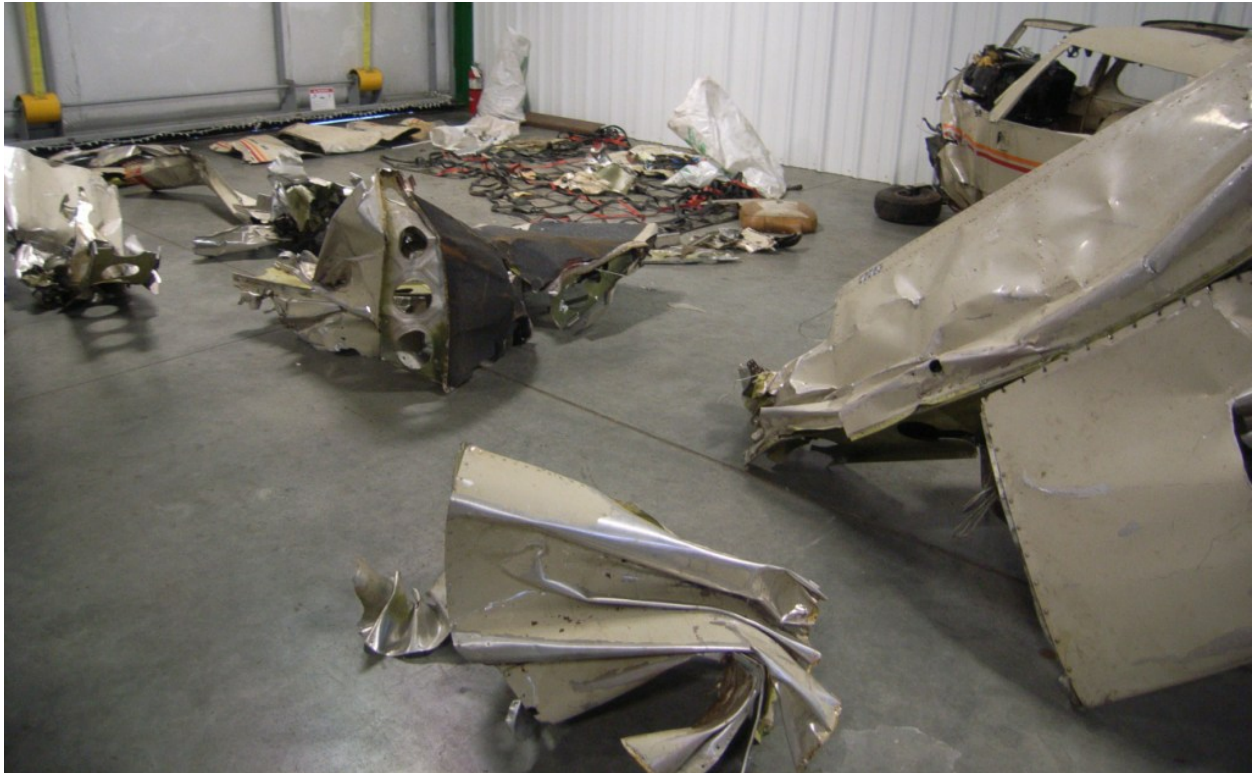
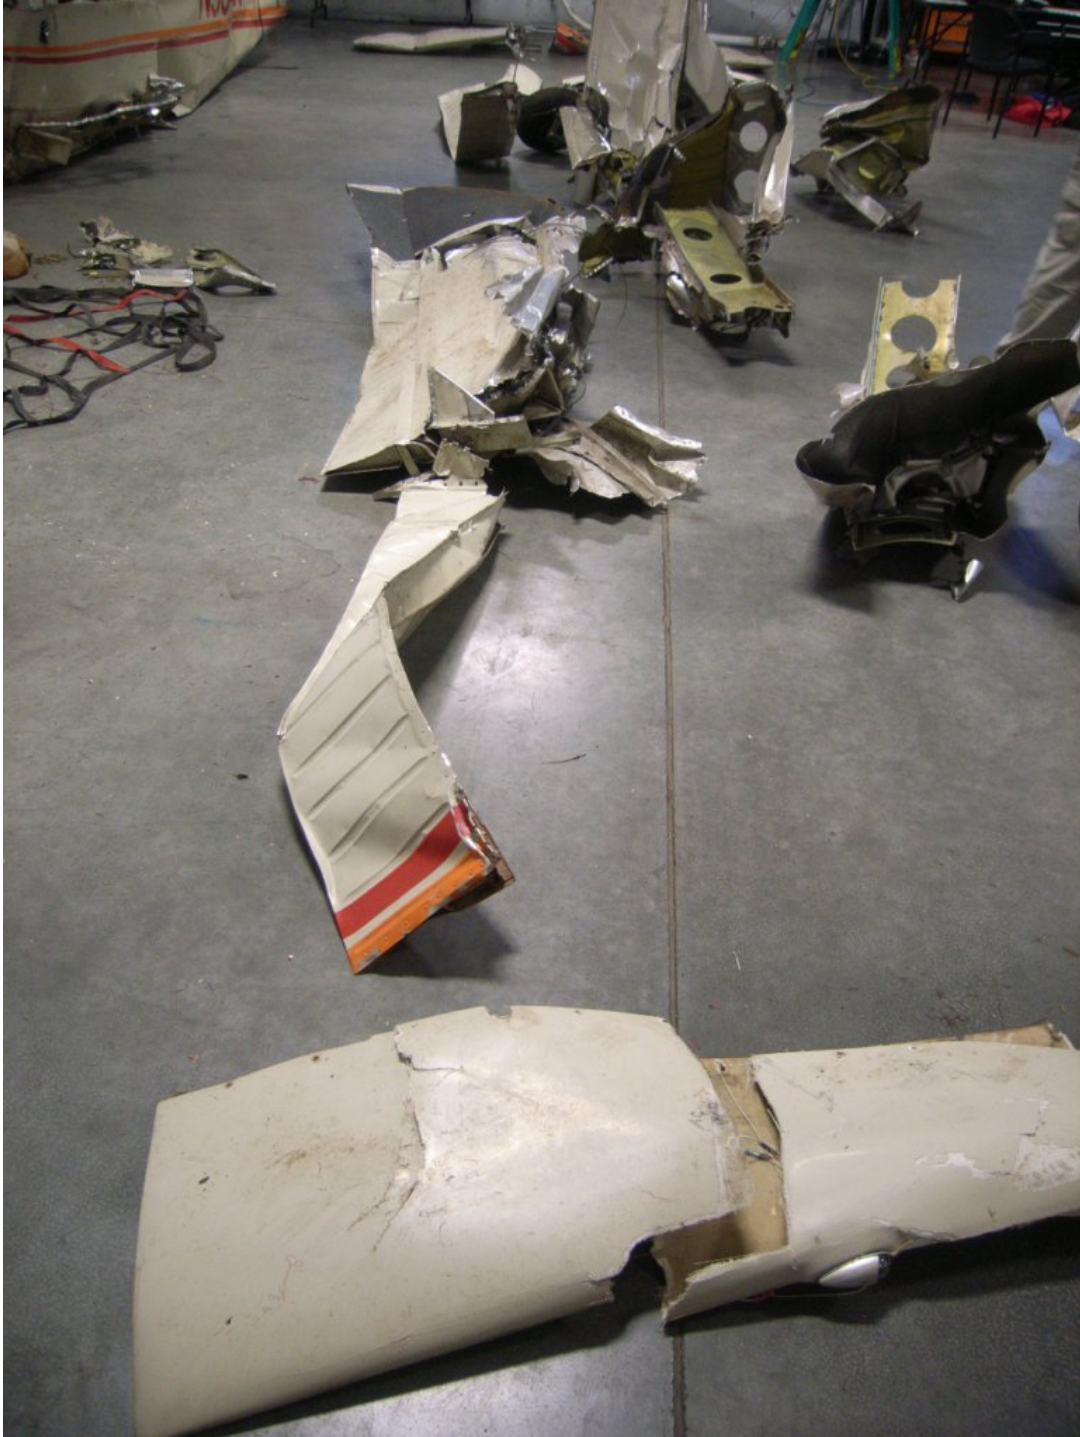
Figure 9 - Right Wing Fragments

The right wing sustained significant tree and ground impact damage. The wing had separated from the fuselage and was fragmented into several sections. The main spar was broken into several sections and separated from the wing. Most of the forward leading edge skins had separated from the wing. The landing gear assembly separated from the wing. The fuel tank was destroyed by impact.

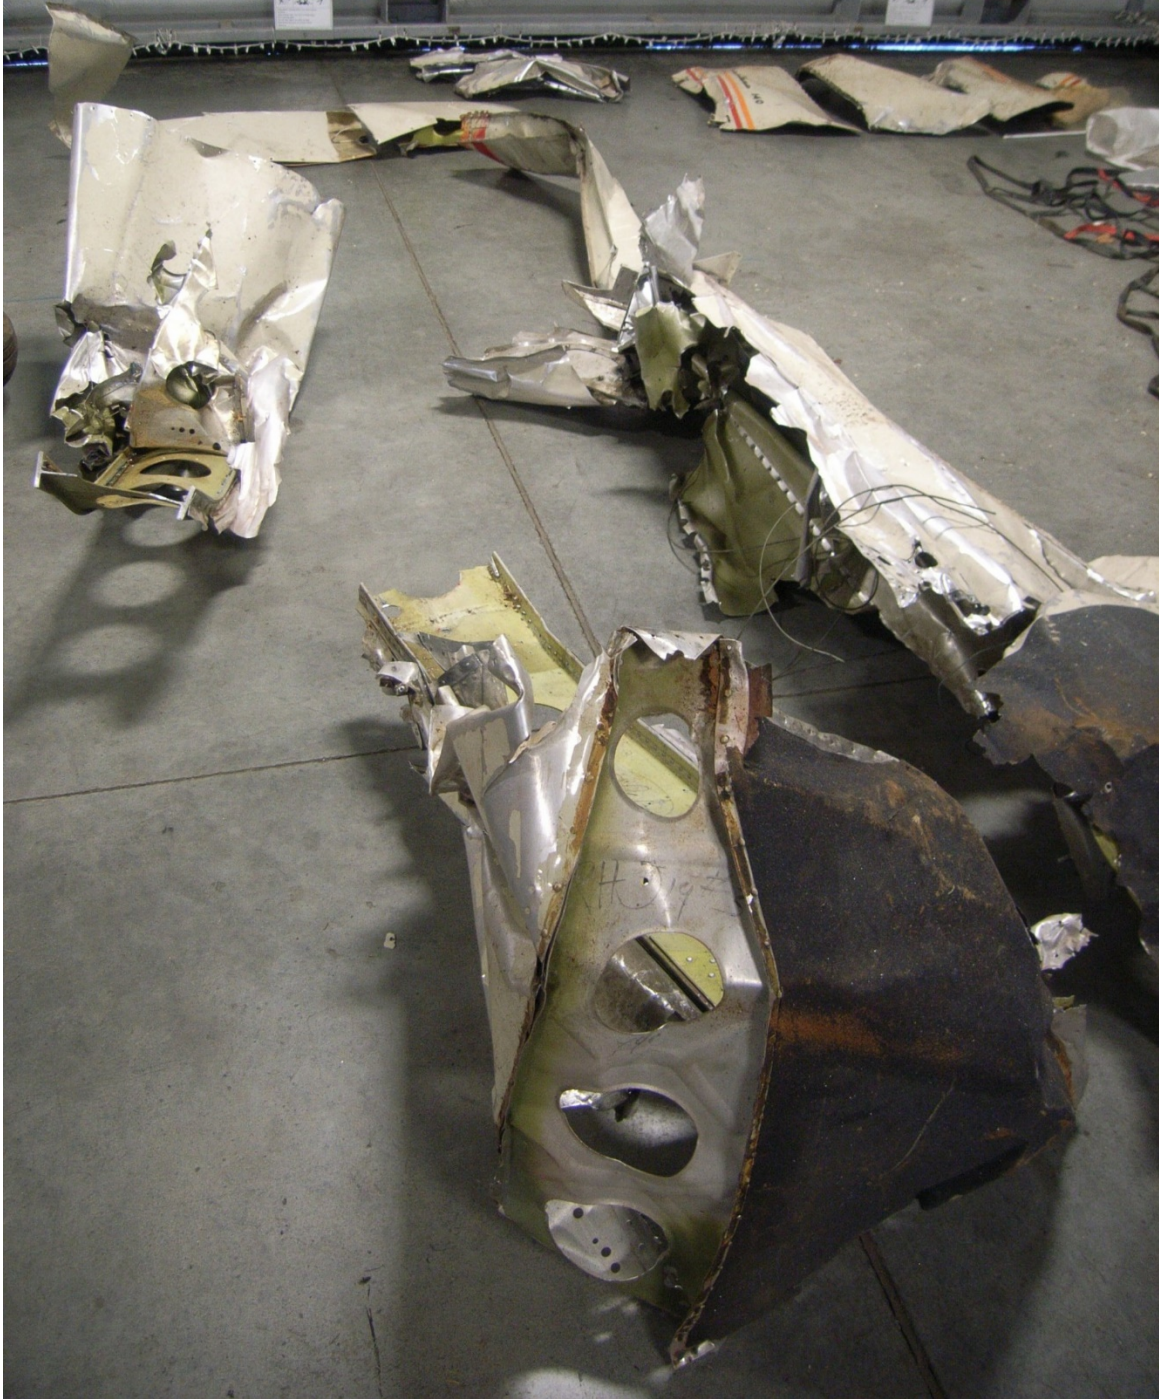
**Figure 11 - Right Wing**

The wing tip separated from the wing and was broken into several pieces. The right flap sustained impact damage but remained attached to the wing. The flap push/pull rod assembly separated from the flap, but remained attached to the flap torque tube assembly.

The aileron was found separated from the wing and exhibited impact damage. The aileron counterweight mounting plate remained attached to the aileron. The arm was broken and the counterweight had separated, and was not present during the exam. The aileron inboard hinge with the push/pull attach fitting separated from the aileron. The push/pull rod remained attached to both the fitting and the aileron bellcrank assembly. Both the aileron primary and balance cables remained attached to the aileron bellcrank assembly. The cables had been cut near the wing root by the retriever during the recovery process.

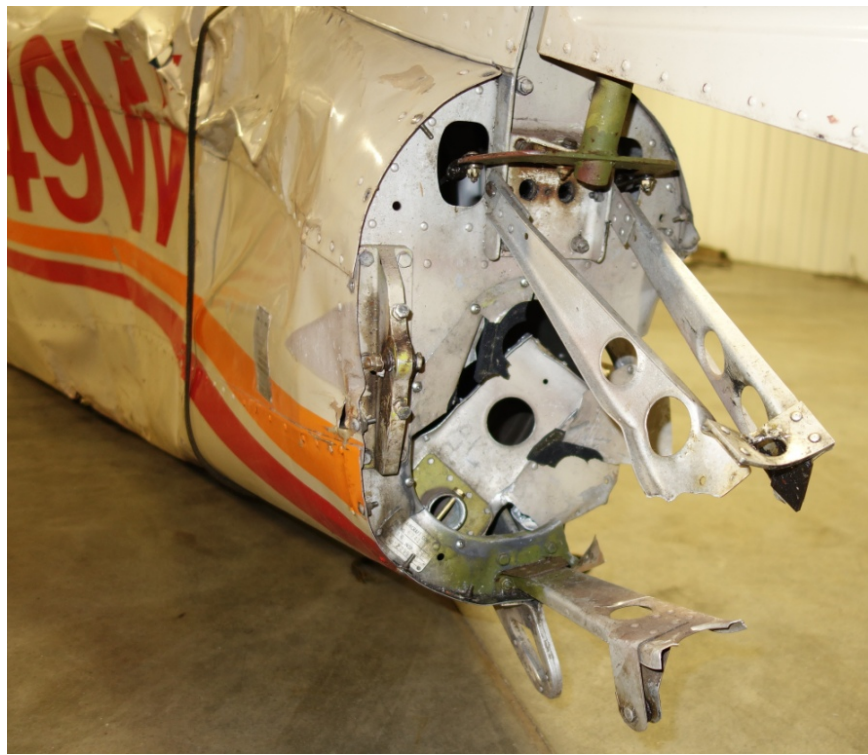
Figure 12 - Aft Fuselage Stabilator Attach Location

The horizontal stabilator is operated directly by the yokes, and its trim tab is operated by the pitch trim drum and jackscrew assembly. The stabilators had separated from the fuselage, and the trim drum had separated from the fuselage and stabilators. The left stabilator attach hinge assembly remained attached to the bulkhead but had separated from the stabilator. The right stabilator attach hinge assembly separated from the bulkhead but remained attached to the stabilator.

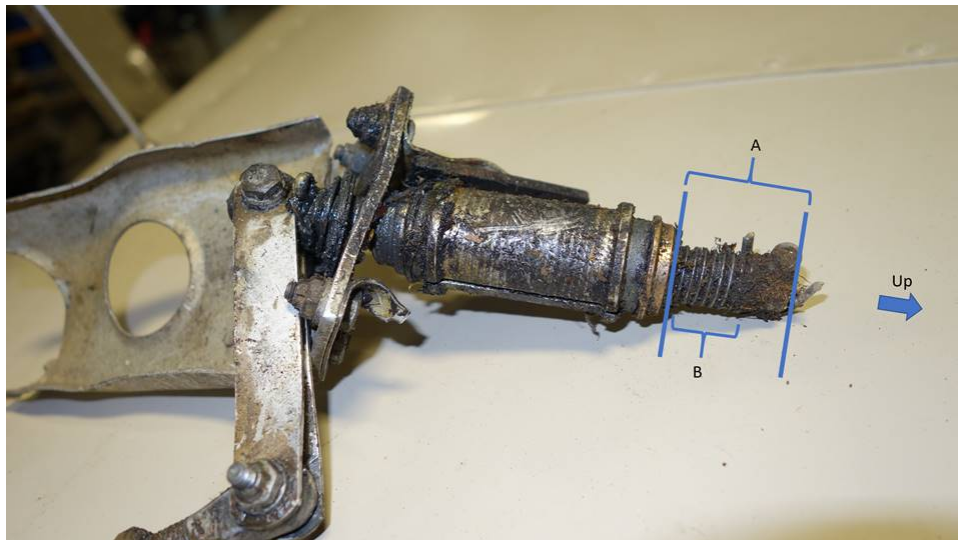
Figure 13 - Pitch Trim Drum Assembly

The stabilator trim drum (barrel) and jackscrew assembly separated from its supporting rib structure due to impact. Pitch trim setting is normally determined by the amount of trim screw exposure beyond the barrel, which is determined by measuring screw extension and also by counting threads. In Figure 13, 'A' denotes the extension distance, and 'B' denotes the threaded area; these values are compared to the chart (Figure 14) to determine stabilator setting. Based on the observed thread count (7 threads), the trim setting was neutral to slightly nose up. However, because the stabilator and trim assembly had both been torn from the aircraft, and the trim cable was absent, the setting could have been altered during impact and/or recovery, and therefore the actual stabilator trim setting could not be positively determined.

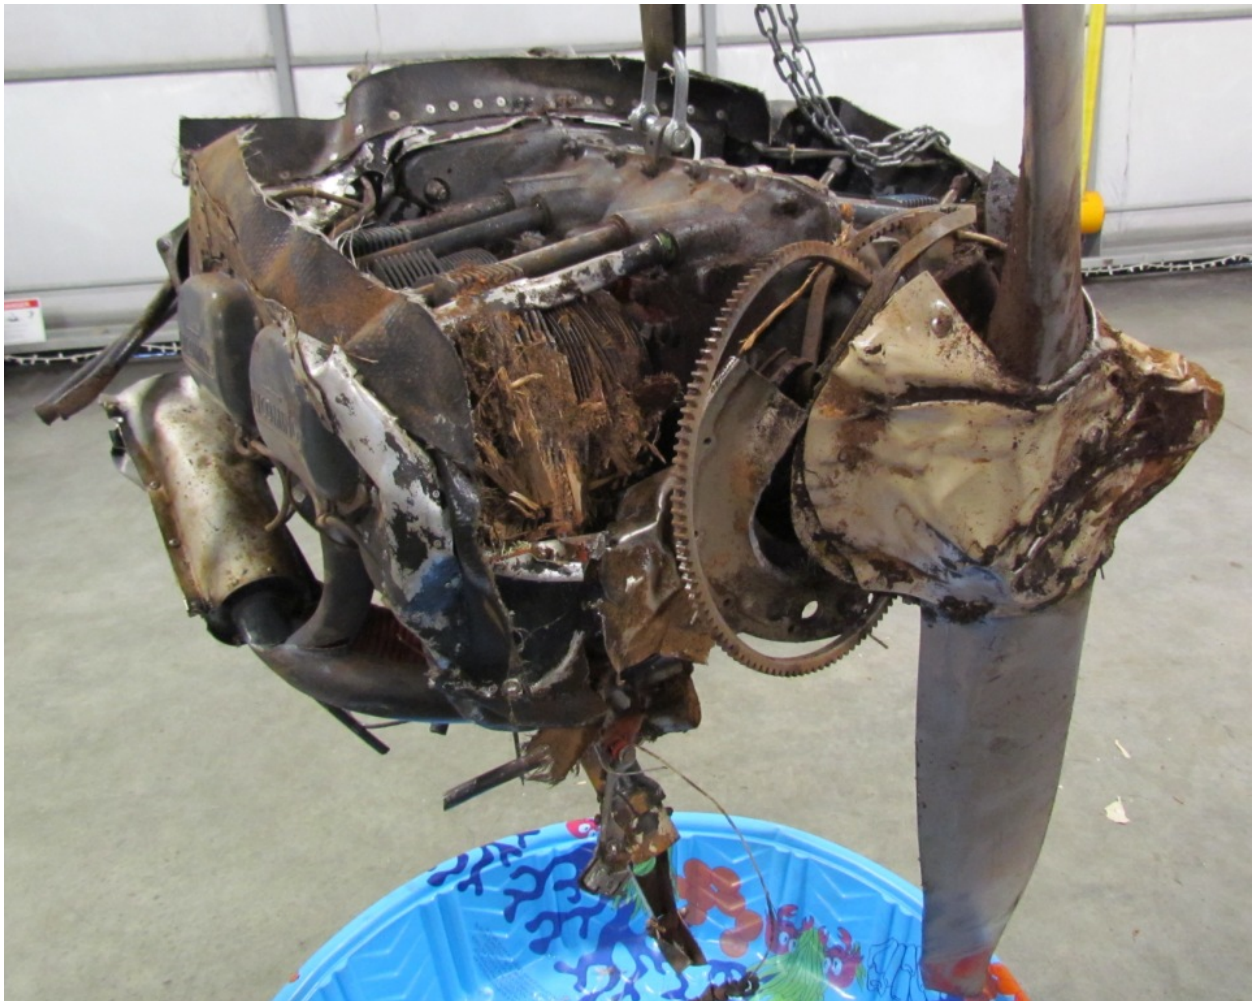
**Figure 16 - Engine**

The engine had separated from the firewall during the accident and recovery, and was hanging from a hoist when examined. The propeller remained attached to the crankshaft. Both blades were bent aft slightly. Twisting and chordwise scarring was observed. The exhaust was crushed aft, and the No. 1 exhaust pushrod was impact damaged.

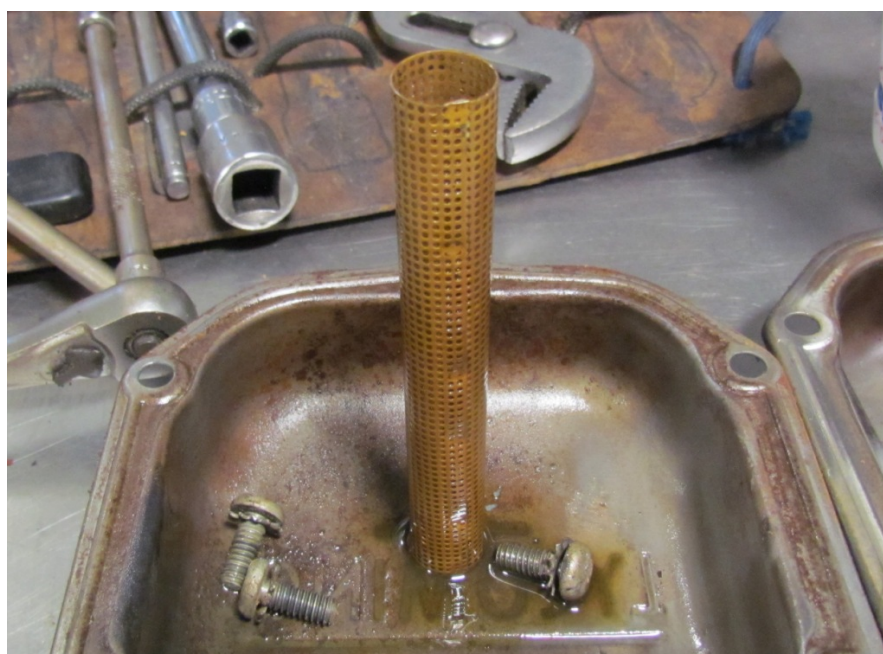
**Figure 19 - Oil Pickup Screen**

The cylinders were borescope inspected and no anomalies were noted. The crankshaft was rotated via the propeller, and thumb compression was obtained at all cylinders. Engine drive train continuity was established throughout. The oil pickup screen was found free of debris.

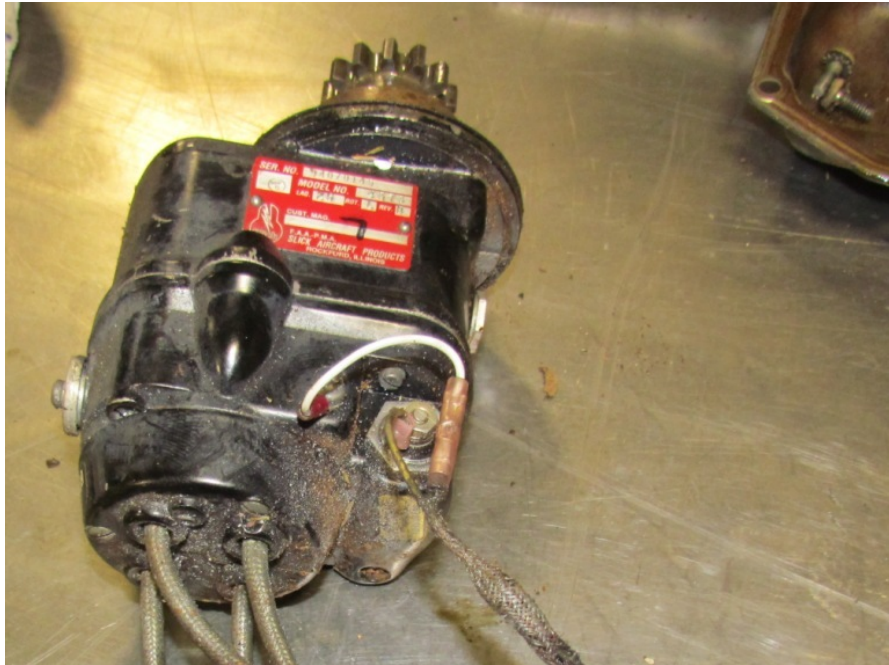
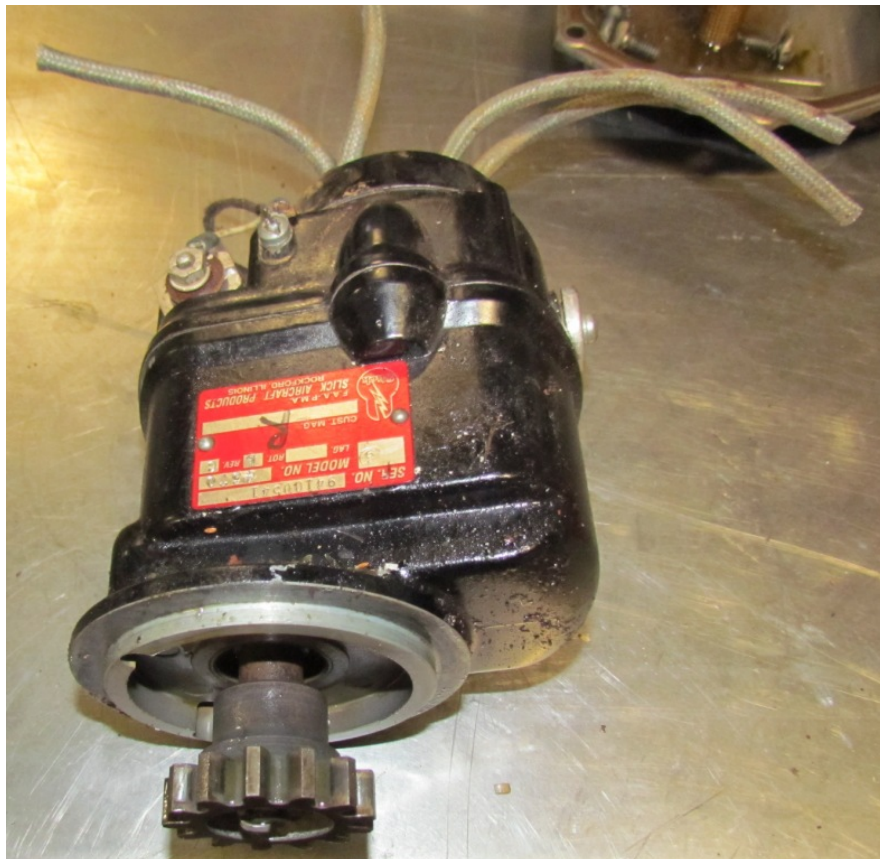
Both magnetos were found intact with no damage visible. Both magnetos produced spark at all leads when rotated by hand.

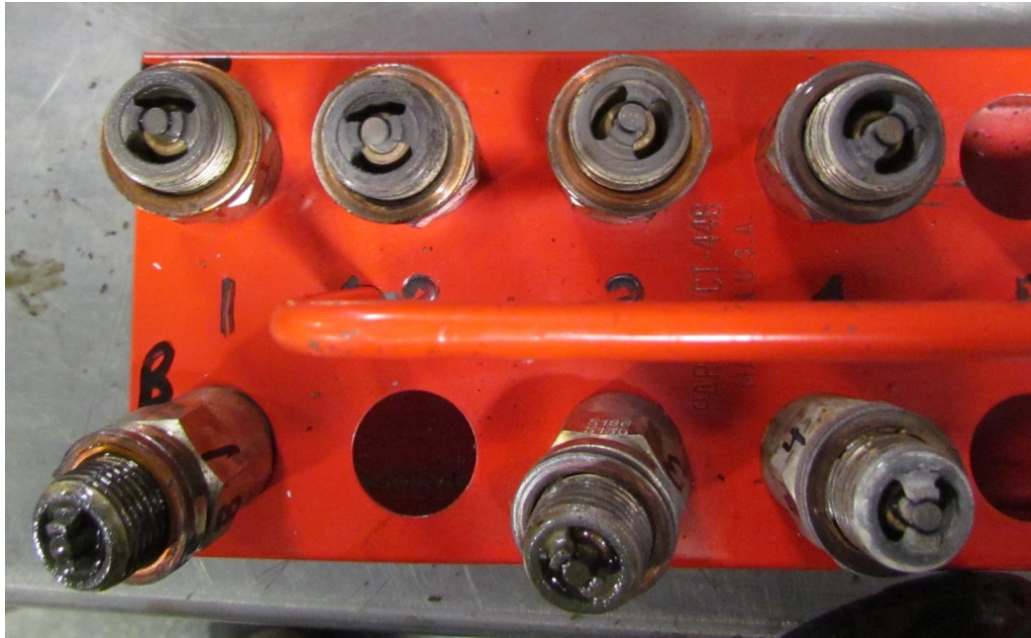
**Figure 22 -- Spark Plugs**

The valve covers, accessories and top spark plugs were removed for the examination. The spark plugs appeared normal as compared to the Champion Aviation Check-a-Plug Chart AV-27. Except for the No. 2 bottom spark plug which was impact damaged and the bottom No. 1 and No. 3 plugs were oil wetted.

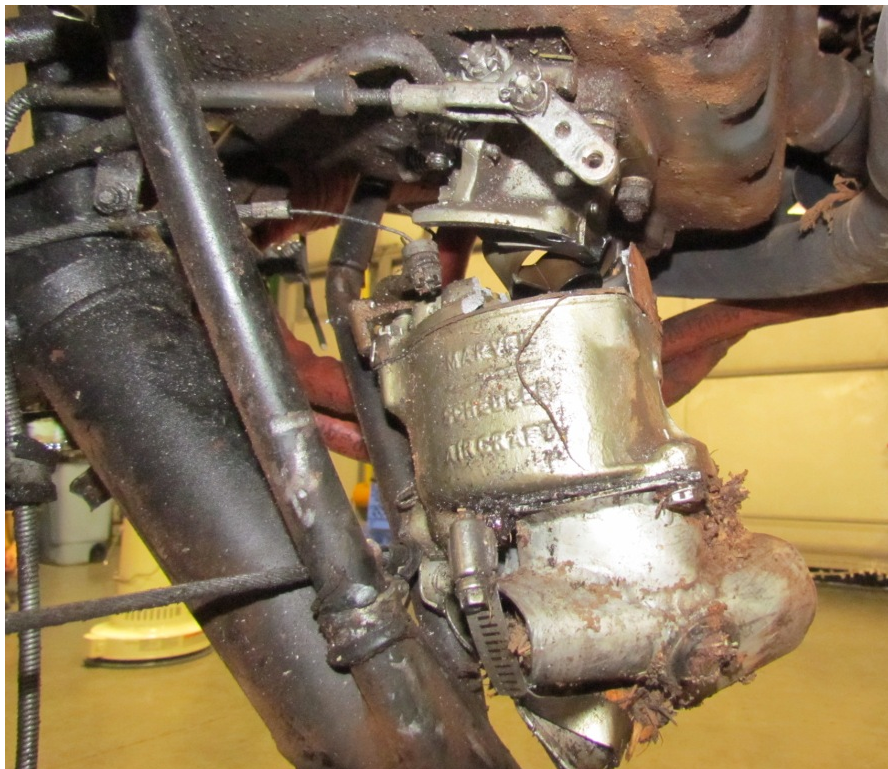
**Figure 23 - Carburetor**

The carburetor was found broken apart and hanging below its mounting position. Both the throttle and mixture controls remained attached. The carburetor was disassembled, and the metal floats exhibited hydraulic crushing on their outboard sides. The fuel inlet screen was found free of debris. The engine driven fuel pump produced pressure when operated by hand. The vacuum pump was disassembled, the rotor and vanes were found intact. No evidence of pre-impact mechanical anomalies or malfunction was observed with the engine.
