Shorts  
SD360  
Sherpa

# INFORMATION LETTER

Number SD360 Sherpa-IL-23

Title: SERVICING/PAINTING - REMOVAL OF MASKING MATERIAL/PAINT  
FROM NOSE LANDING GEAR DOWNLOCK ACTUATOR PISTON AFTER  
CLEANING/PAINTING OPERATIONS

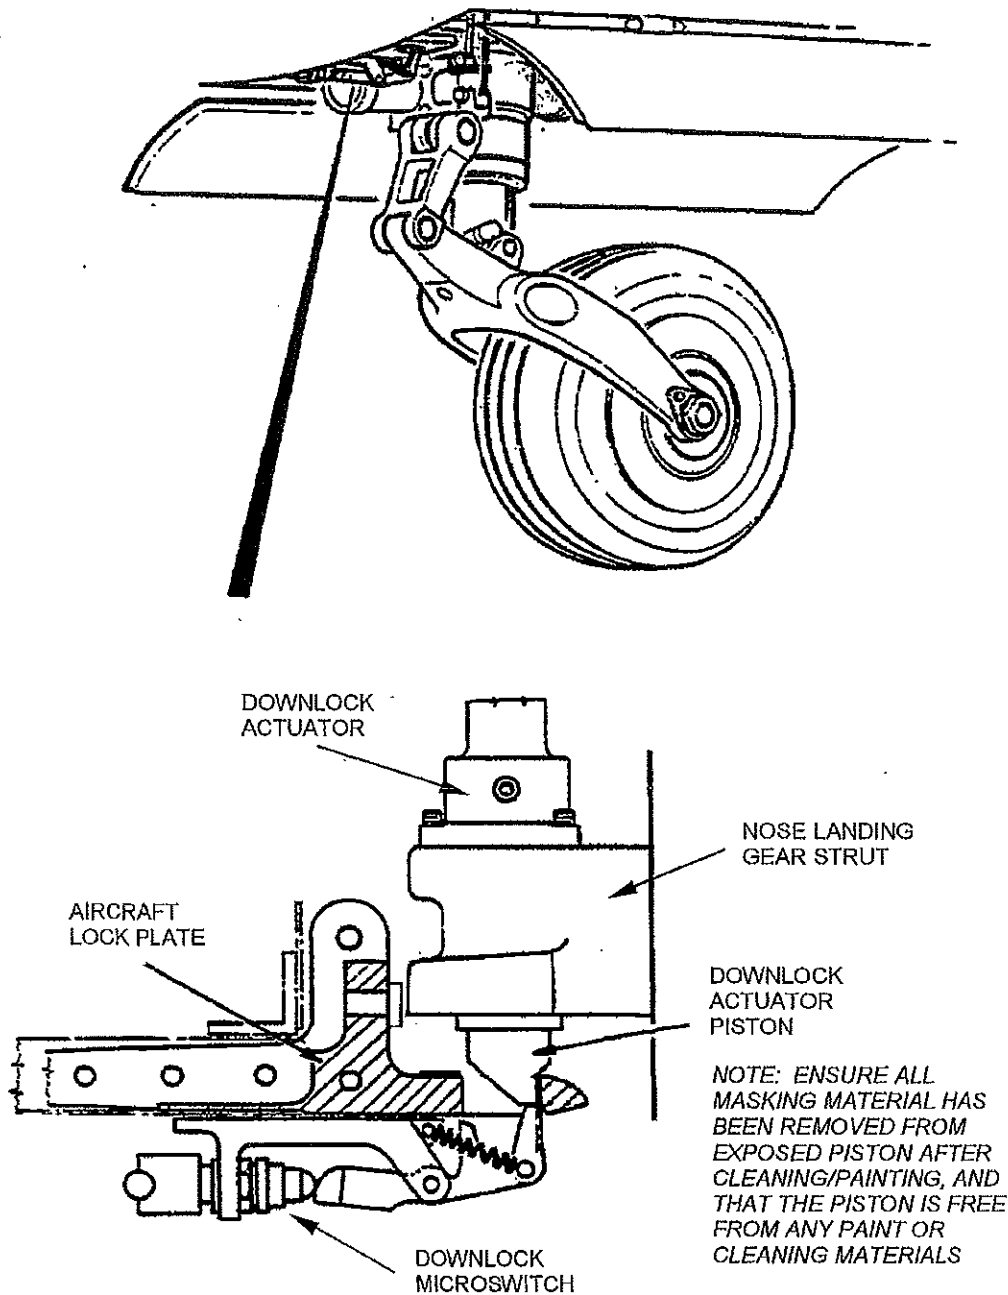
Figure 1

An incident occurred on a SD360 aircraft when the Nose Landing Gear (NLG) failed to lock in the down position - nose landing gear 'Unsafe' annunciated. On application of nosewheel steering to exit the runway after landing, the nose gear partially collapsed causing minor damage to the aircraft. The aircraft had just been re-painted and this was the first flight cycle out of the paint shop.

Subsequent investigation revealed undesirable paint spray on the exposed chromed piston of the NLG downlock actuator. This is believed to be the prime factor that prevented the downlock actuator piston engaging in the aircraft locking plate (Refer to Figure 1).

ENLARGED VIEW OF NOSE LANDING GEAR DOWNLOCK ACTUATOR

Before cleaning/painting ensure that all areas that are not to be painted or cleaned are adequately protected and subsequently checked for removal of masking material or undesirable paint spray afterwards - see Structural Repair Manual 51-23-00 and Aircraft Maintenance Manual Chapter 12-21-01

Note: Aircraft Maintenance Manual Chapter 12-21-01 calls for the lubrication of the landing gear after cleaning/painting of the exterior of the aircraft.
