## Incident Pictures

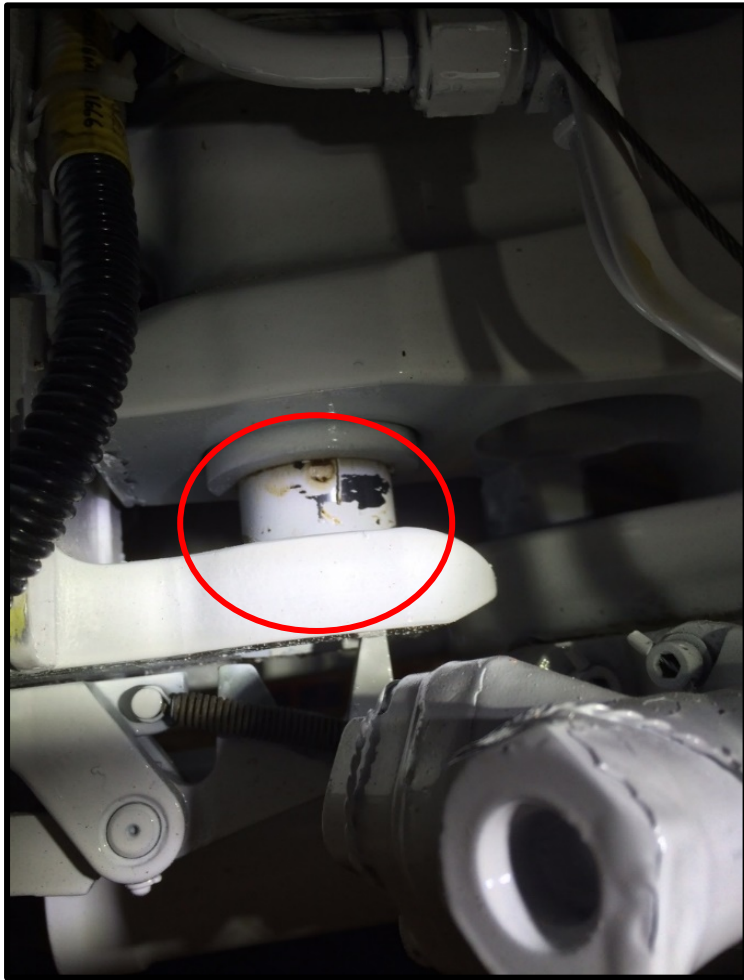
Figure 1: View of incident airplane's nose gear down-lock actuator piston (note white paint) as provided by the operator.

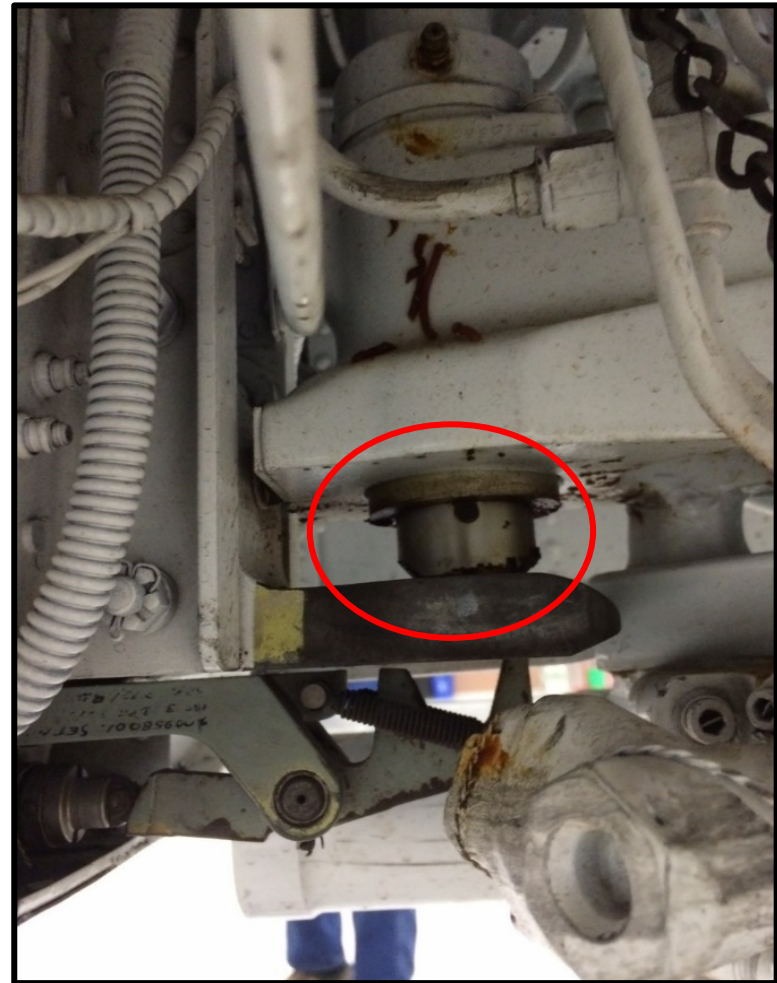
Figure 2: View of an exemplar airplane's nose gear down-lock actuator piston (note chrome color) as provided by the operator.
