# Continental Motors

## ENGINE FIELD INSPECTION REPORT

| ENGINE MODEL | TSIO550C (9B) |
| FILE NUMBER | 17-083 |

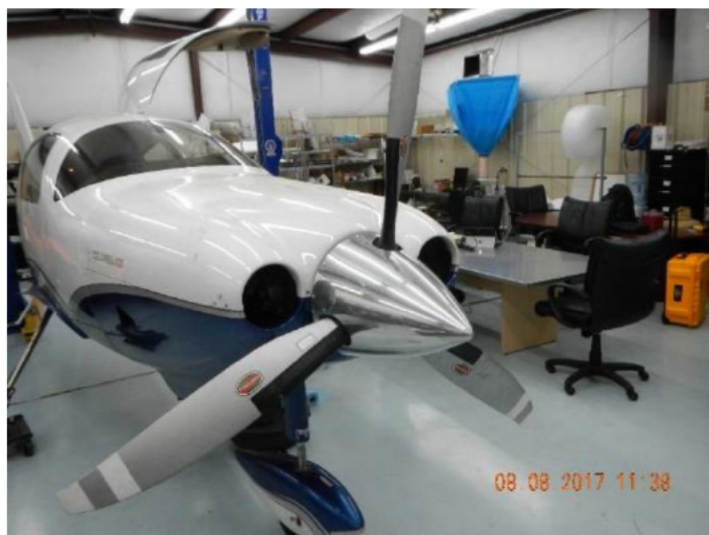
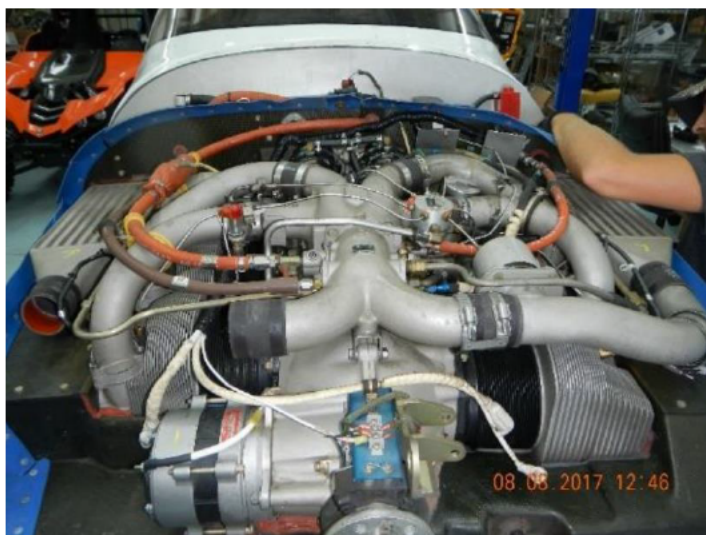
Two holes were discovered in the top of the engine crankcase assembly; one slightly forward and inboard of cylinder number-one attachment base and the other directly above cylinder number-two attachment base. Oil was observed on the right turbocharger and tailpipe. All flexible hoses connecting both turbochargers to the oil pump and the oil return hoses attaching both turbocharger oil reservoirs to the scavenge pump were intact. Torque putty was visible on the b-nuts and fittings. All T-fittings were intact and flexible hose b-nuts were tight.

The fuel injectors installed in cylinders one and two were loose in their respective cylinder heads. All other fuel injectors were correctly installed. The right and left Slick brand magnetos remained in place but the left magneto attachment ring was damaged at the magneto hold down washer. The left magneto condenser received impact damage.

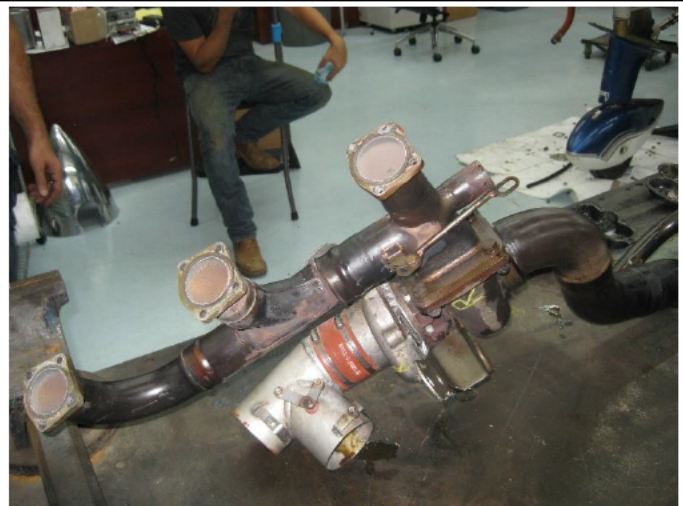
#### EXHAUST SYSTEM

Condition: The exhaust components did not exhibit impact damage. The right exhaust pipe exiting the right turbocharger exhibited a small amount of oil inside. The rear mounted exhaust cross-over exhibited burned on oil deposits.

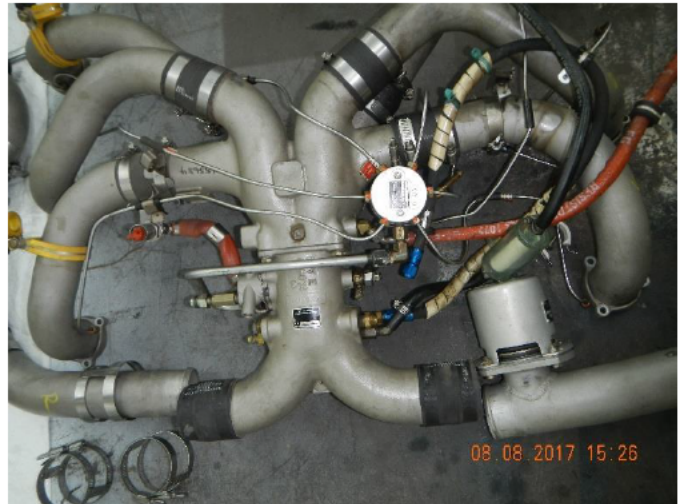
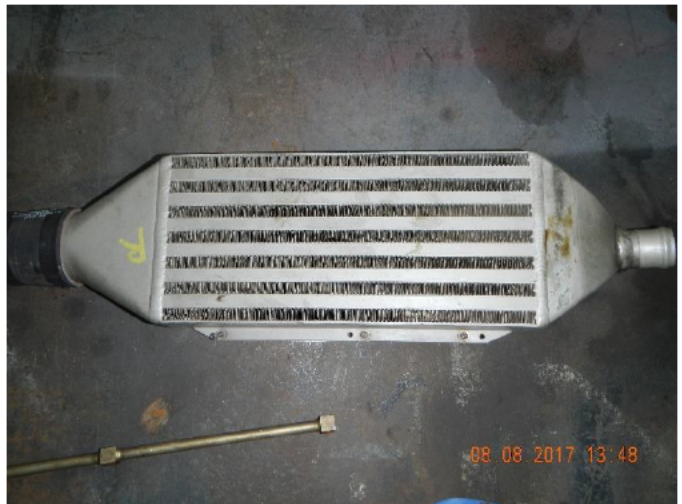
## INDUCTION SYSTEM

The induction system did not exhibit damage

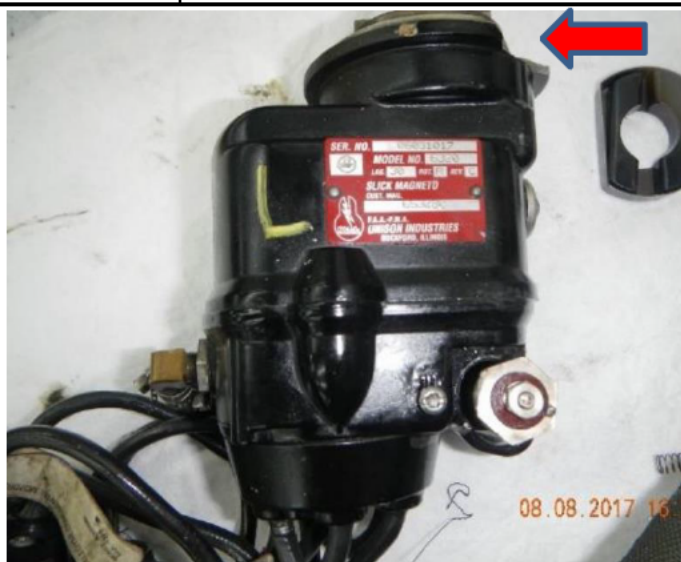
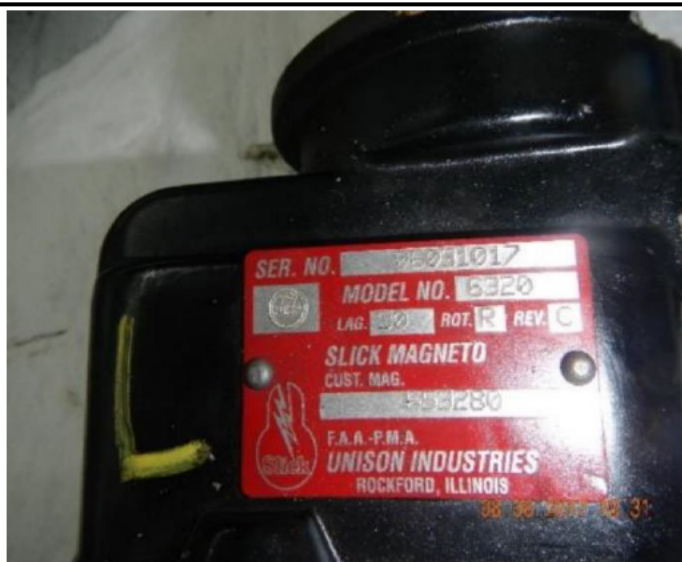
### LEFT MAGNETO

The mounting ring was damaged at the mounting washer. The condenser was impact damaged. When the magneto was rotated manually, the impulse coupler released normally and spark was produced.

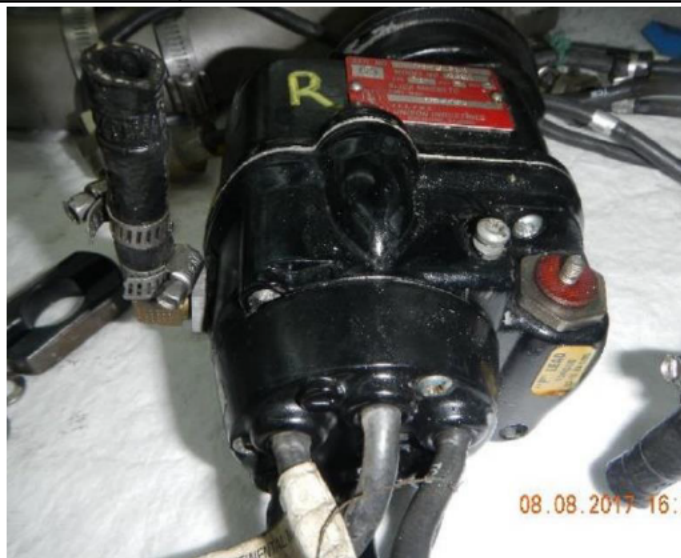
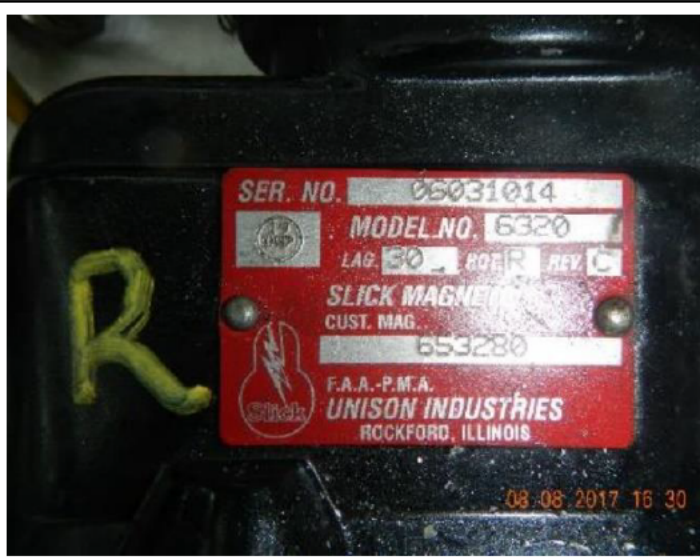
### RIGHT MAGNETO

No damage was noted. When the magneto was rotated manually, the impulse coupler released normally and spark was produced.

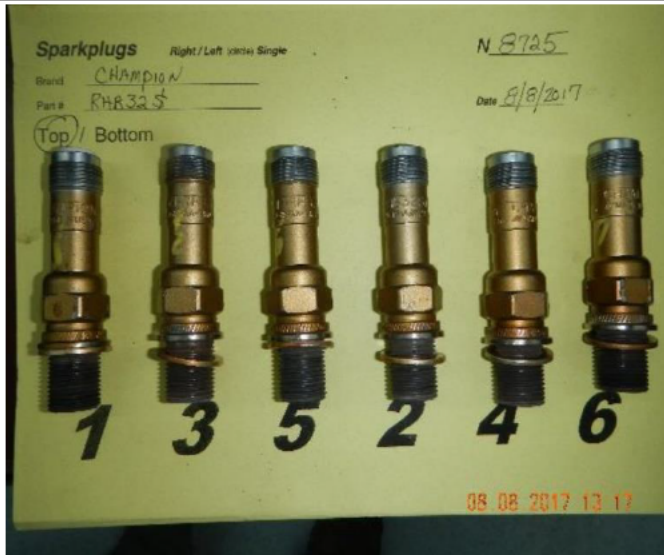
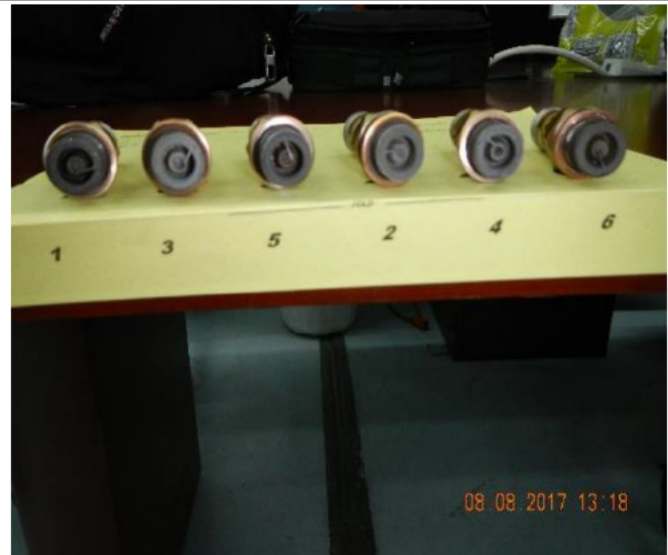
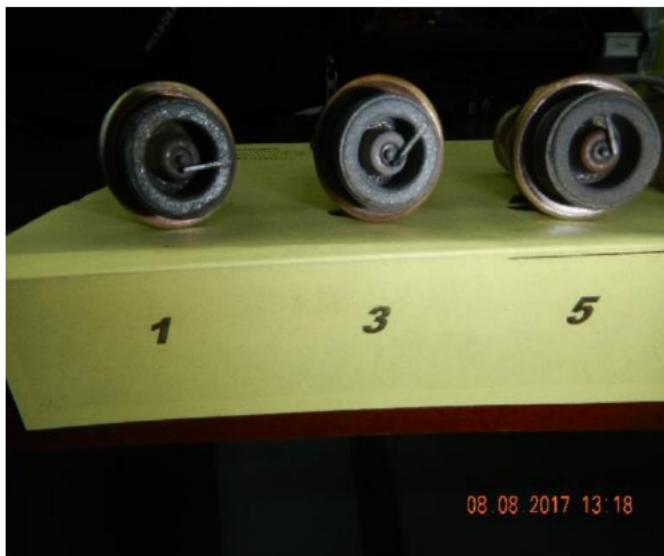
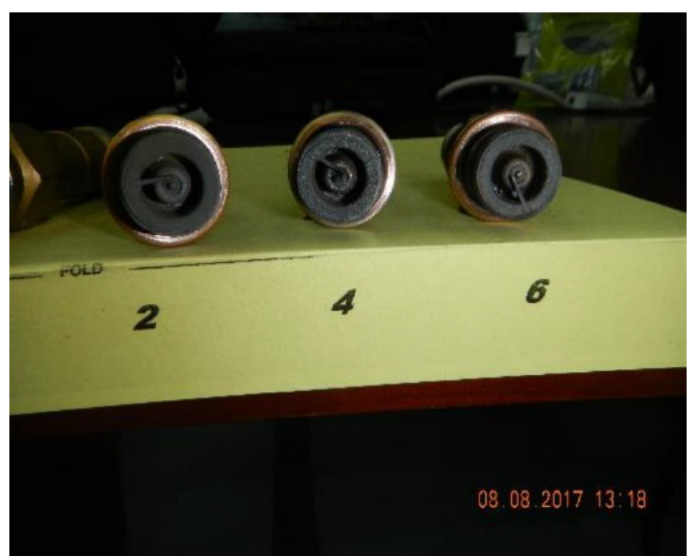
## TOP SPARK PLUGS

Condition: When compared to a Champion Check-A- Plug chart, the sparkplugs appear to be normal in wear and slightly dark in color

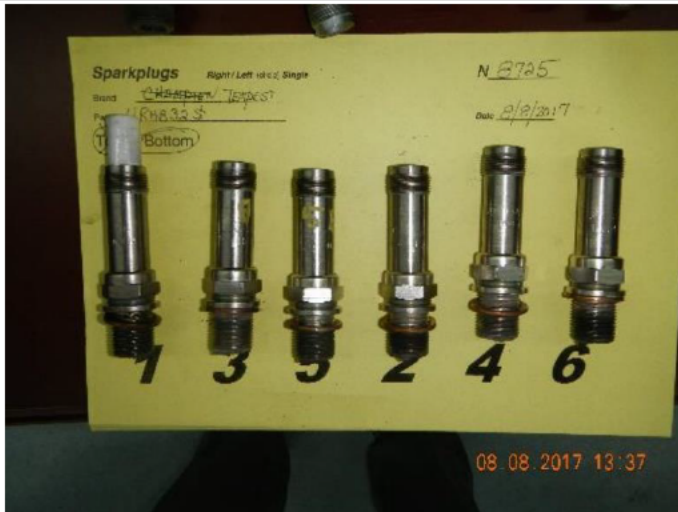
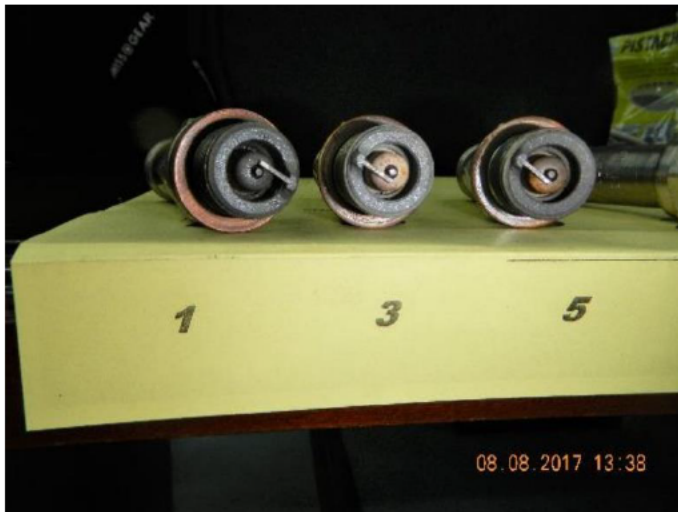
## BOTTOM SPARK PLUGS

Condition: When compared to a Champion Check-A- Plug chart, the sparkplugs appear to be normal in wear. Number 1 sparkplug internal insulator was damaged. Sparkplugs one and two are slightly dark in color.

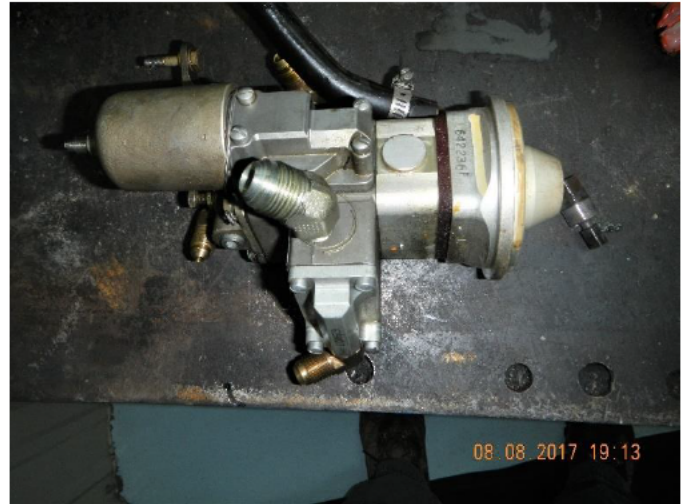
#### FUEL PUMP

Condition: The engine driven fuel pump was intact and undamaged. The drive coupling was intact and the fuel discharged a small amount of fuel when the drive coupling was manually rotated.

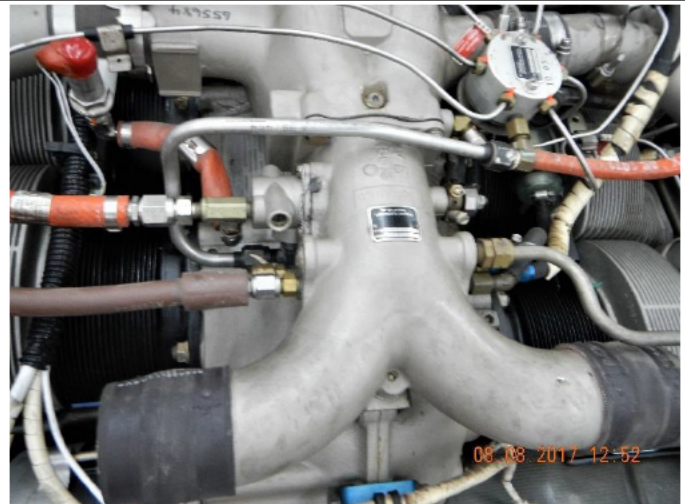
#### THROTTLE BODY METERING UNIT

Condition: No damage was exhibited. The throttle arm was properly secured

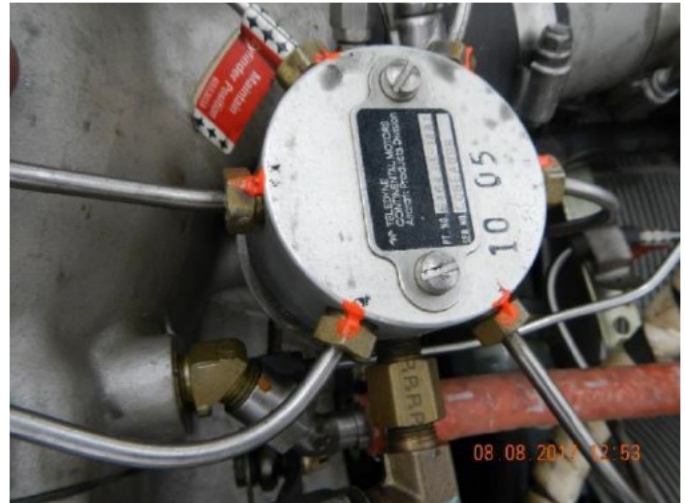
## FUEL MANIFOLD VALVE

Condition: There was not visible damage to the fuel manifold

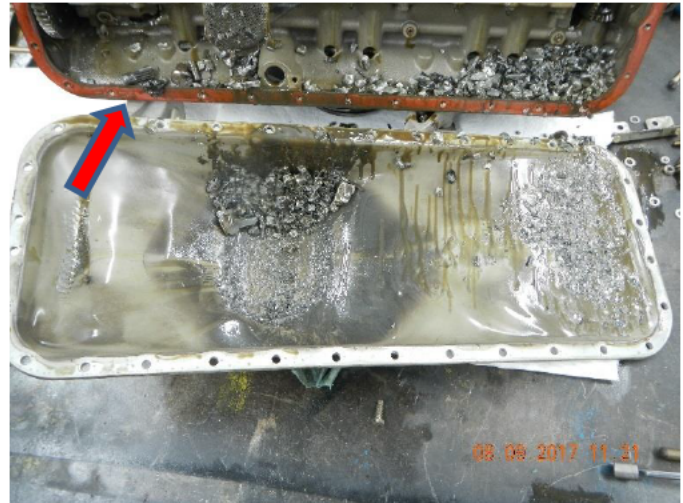
#### OIL SUMP

**Condition:** The oil sump received impact damage internally. The impression of gear teeth was visible on the lower rear. When the oil sump was removed, the camshaft gear was found adjacent to where the damage was exhibited. The oil sump contained damaged bearing material, broken rod bolts and nuts and other metal debris including the separated oil pump input shaft.

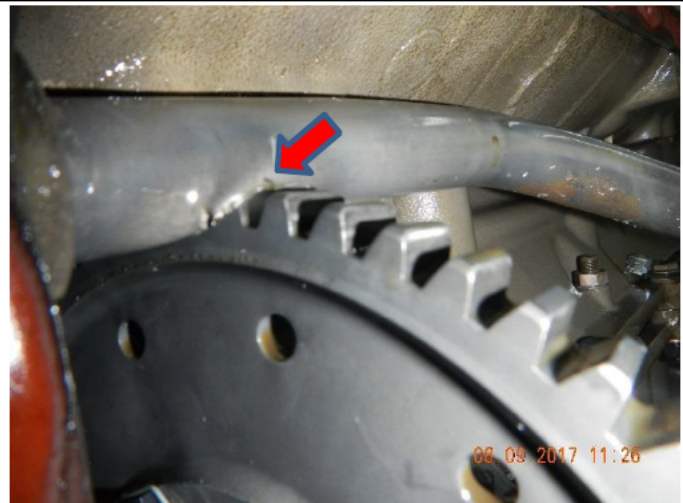
#### OIL PICK-UP TUBE & SCREEN

**Condition:** The oil pick-up tube was damaged where the camshaft gear became lodged after the camshaft separated. The screen exhibited metal material and contaminated oil.

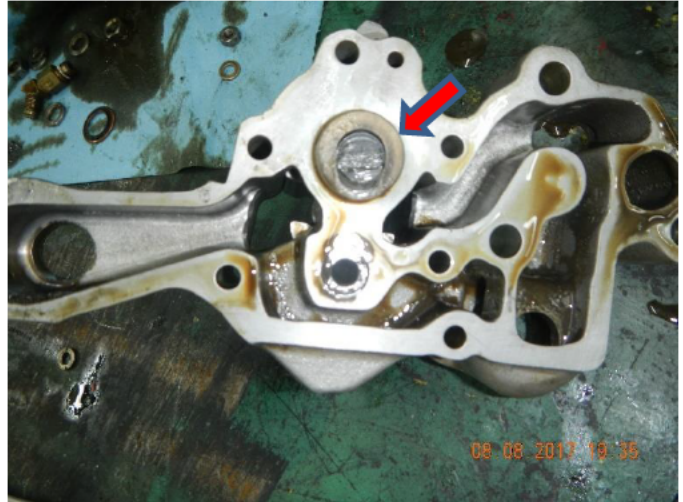
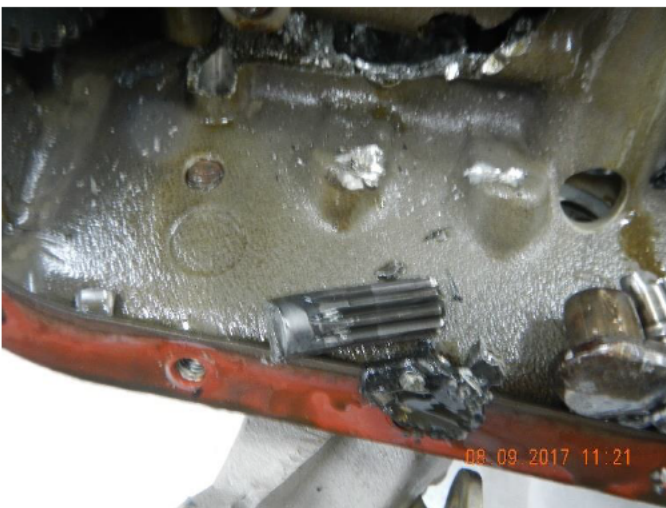
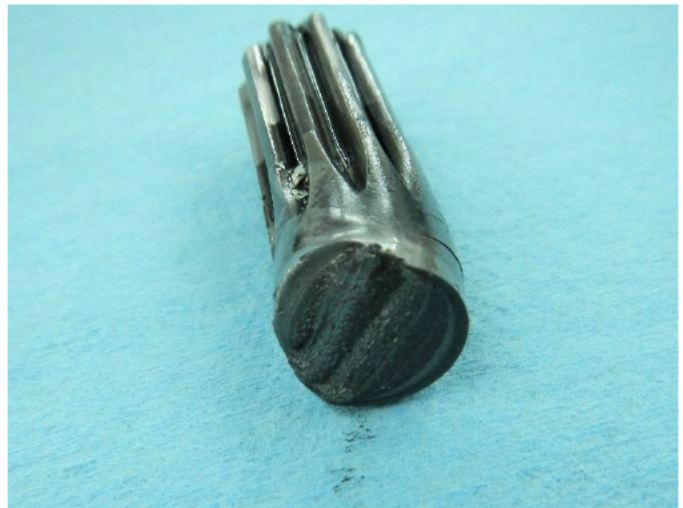
### OIL PUMP

The oil pump input shaft separated but was recovered from the oil sump. The oil pump gears could not be removed from the oil pump cavity due to the burr on the spline shaft. The oil pump and gears will be sent to CMI for an analytical and metallurgical examination at the request of the NTSB IIC.

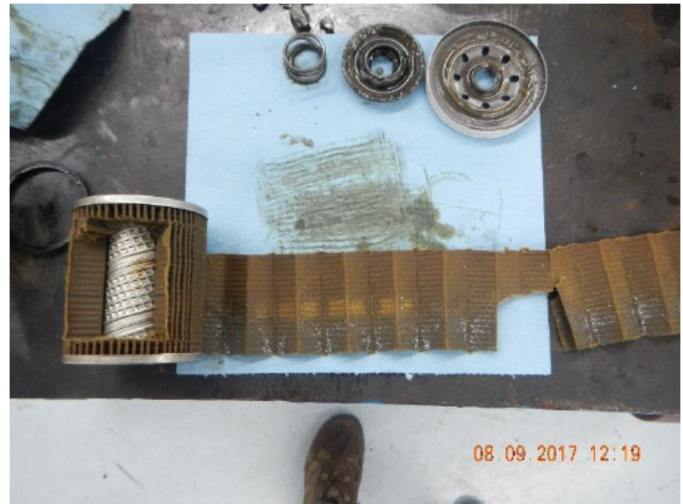
## OIL FILTER

The oil filter was opened and examined. The filter paper media pleats contained metal particles.

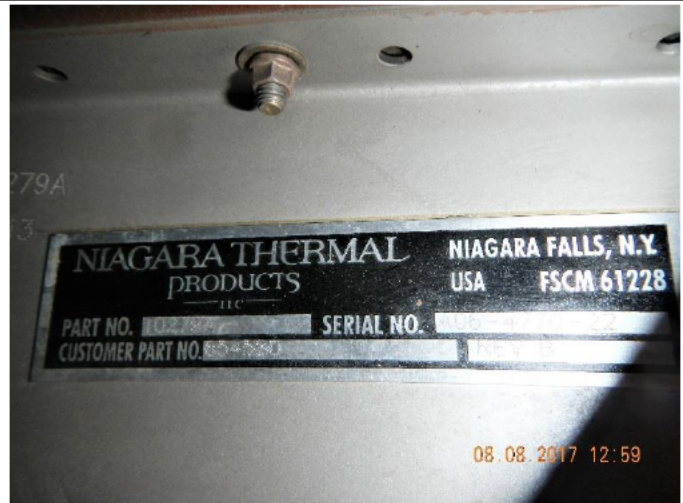
## OIL COOLER

The oil cooler was not externally damaged

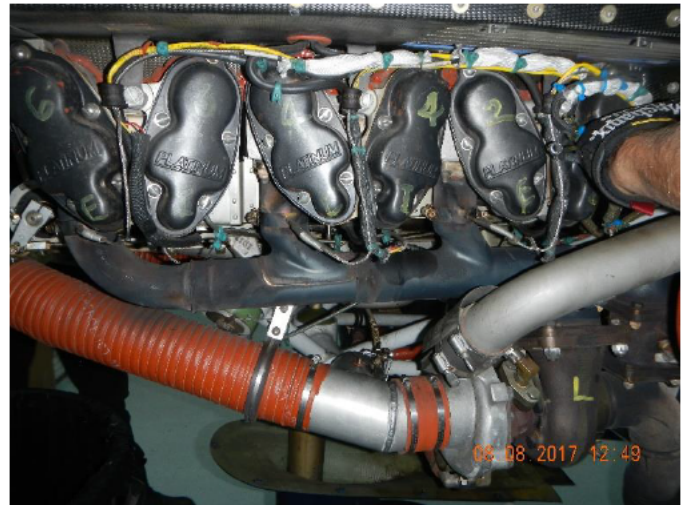
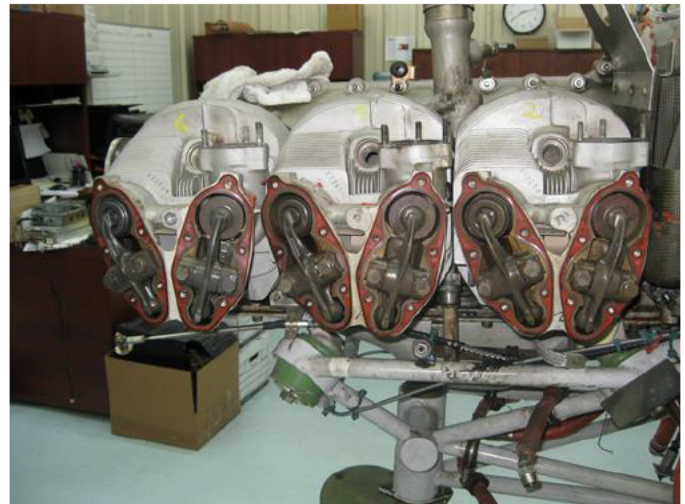
## CYLINDERS

| Condition: | Externally, all cylinders appear to be normal | | |

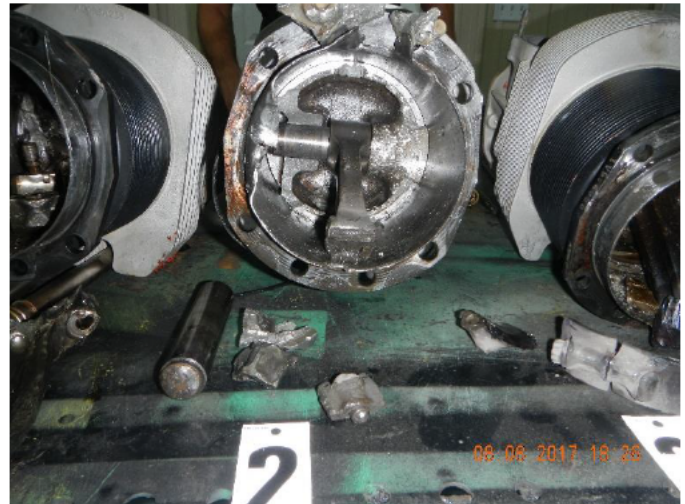
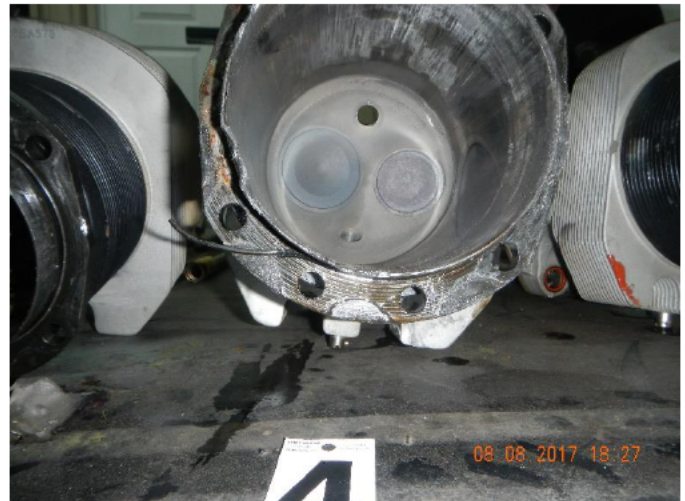
## VALVES

An electronic lighted borescope examination was performed. All intake and exhaust valves were intact and exhibited normal combustion signatures. When cylinders were removed, pistons for cylinders 1, 2, & 3 were stuck inside their respective cylinders and could not be removed. Cylinders 4, 5 & 6 were normal.

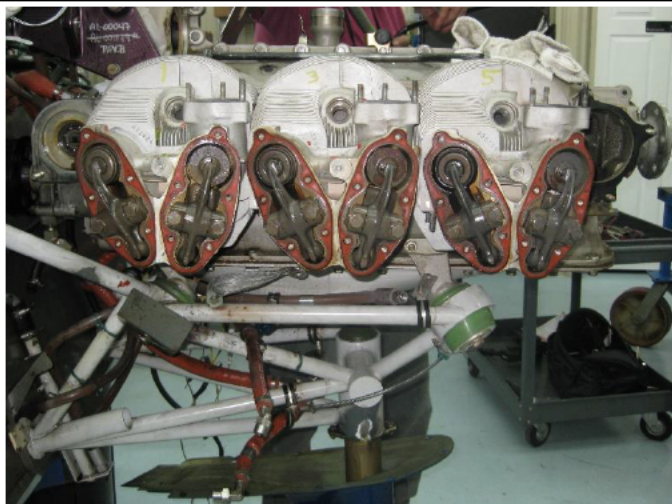
### ROCKER ARMS AND SHAFTS

All rocker arms and shafts were intact.

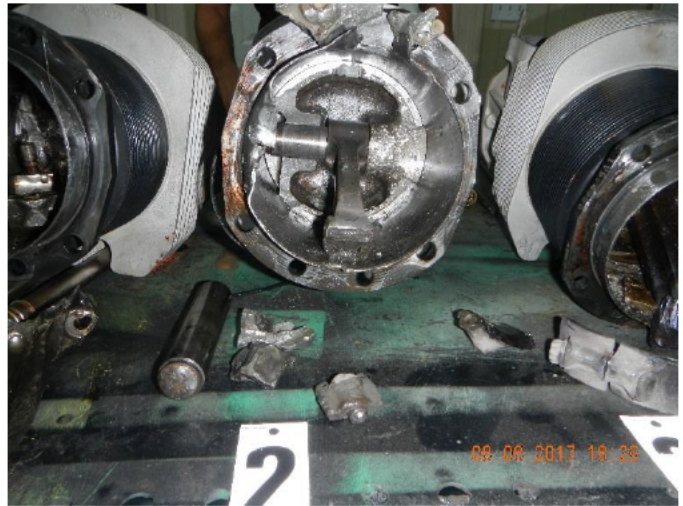
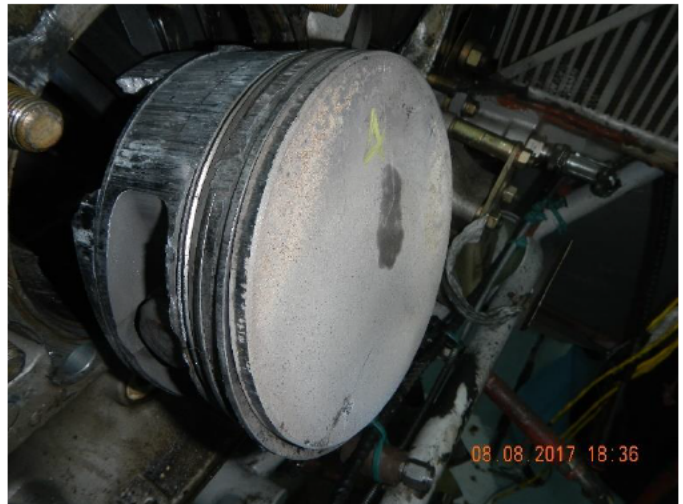
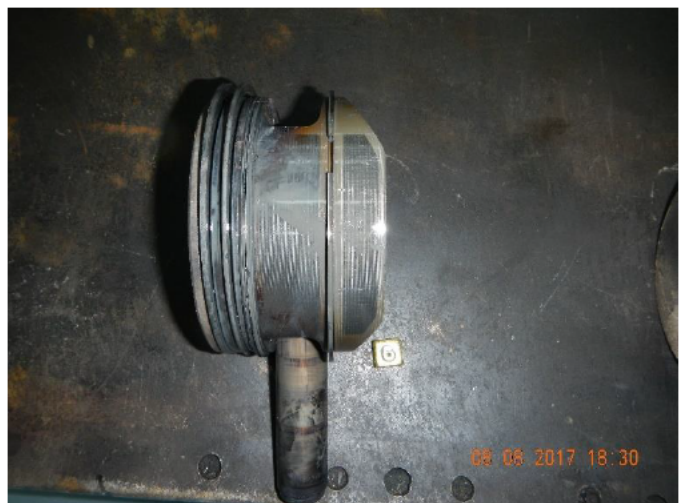
## PISTONS, RINGS AND PINS

Pistons for cylinders 1, 2, & 3 were stuck inside their respective cylinders and could not be removed.

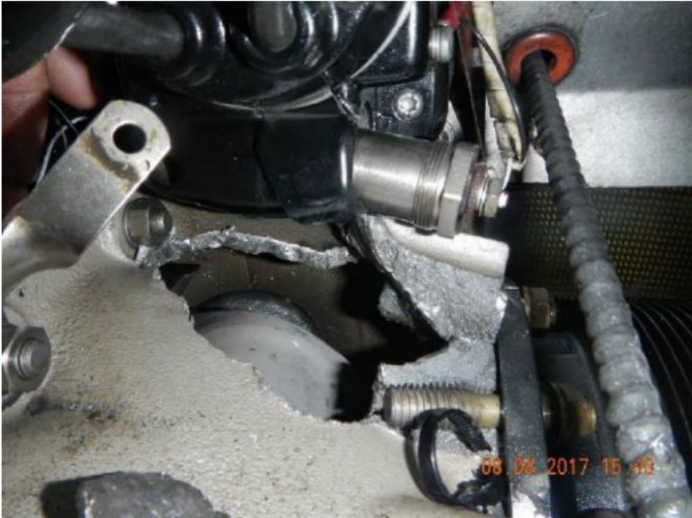
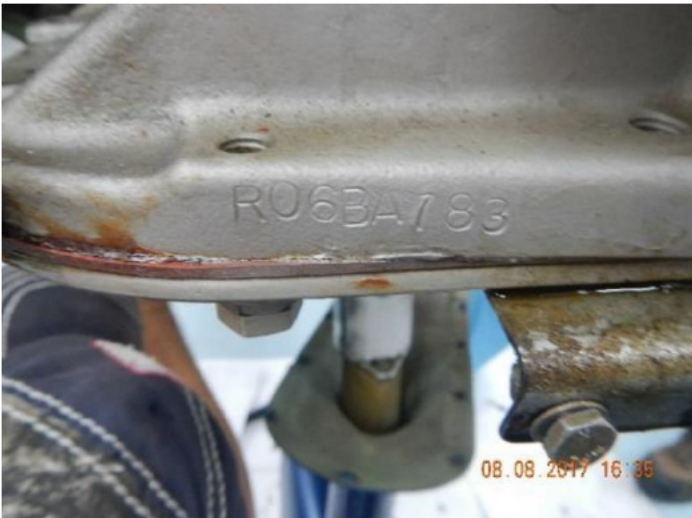
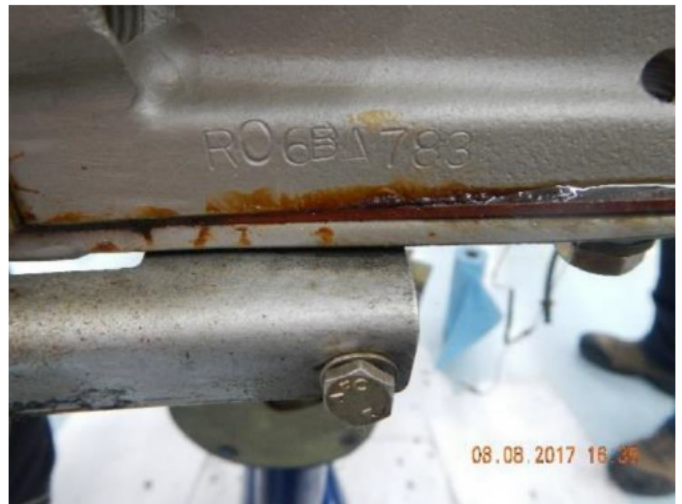
### CRANKCASE

The left upper crankcase half was damaged above the cylinder # 2 mount.

The right upper crankcase half was damaged above the cylinder # 1 mount

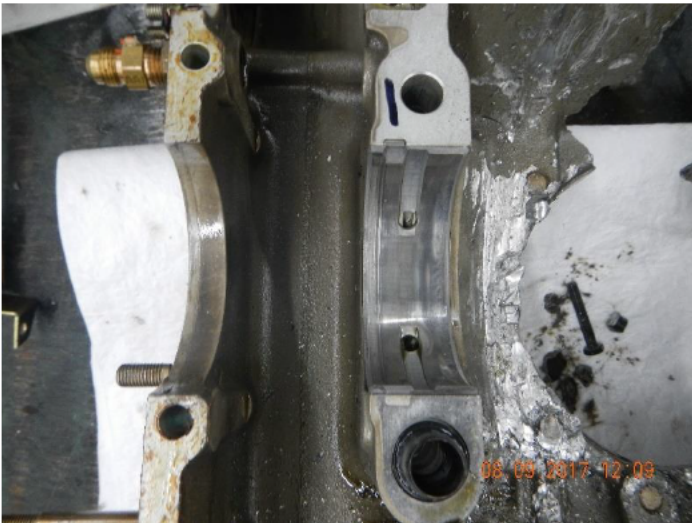
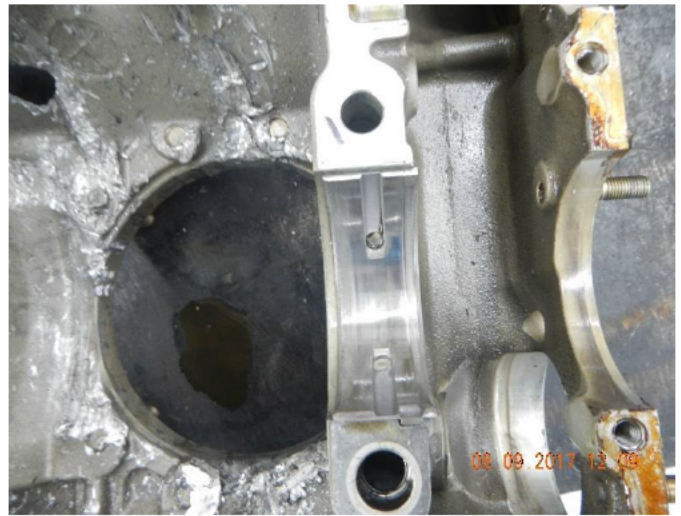
## #1 MAIN BEARINGS

Normal wear conditions were exhibited

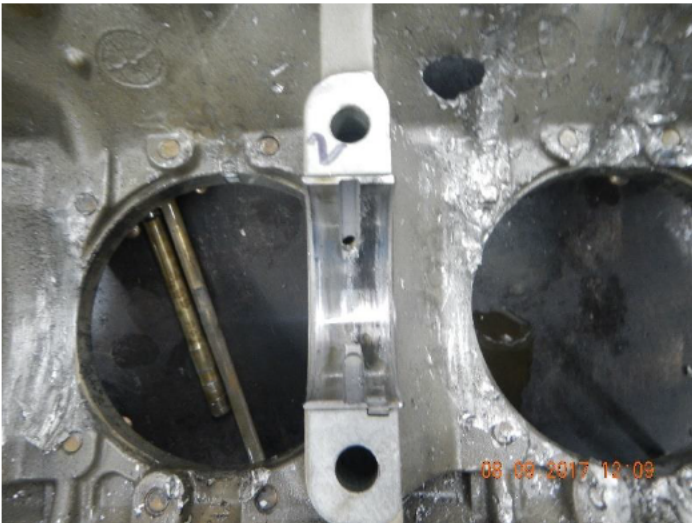
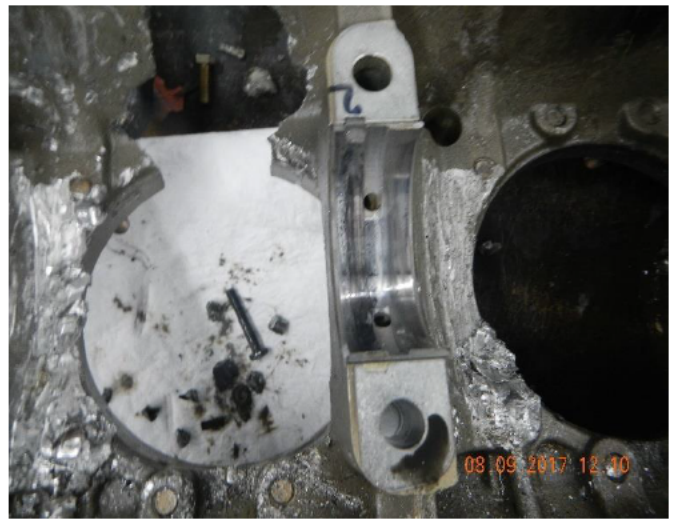
## #2 MAIN BEARINGS

Normal wear conditions were exhibited

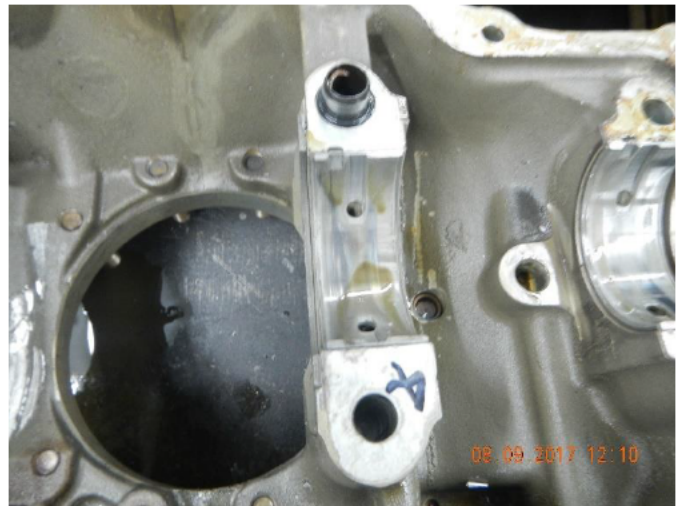
| #4 MAIN BEARINGS | P/N: 653547 | Date Code: 10-2005 |

| Condition: | Normal wear conditions were exhibited | |

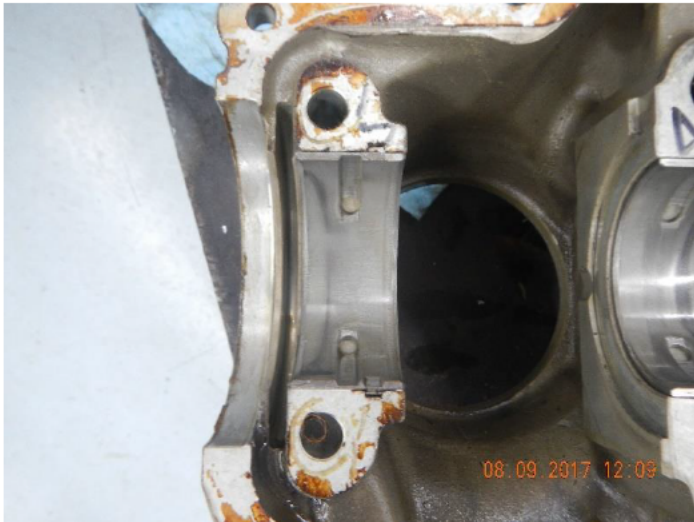
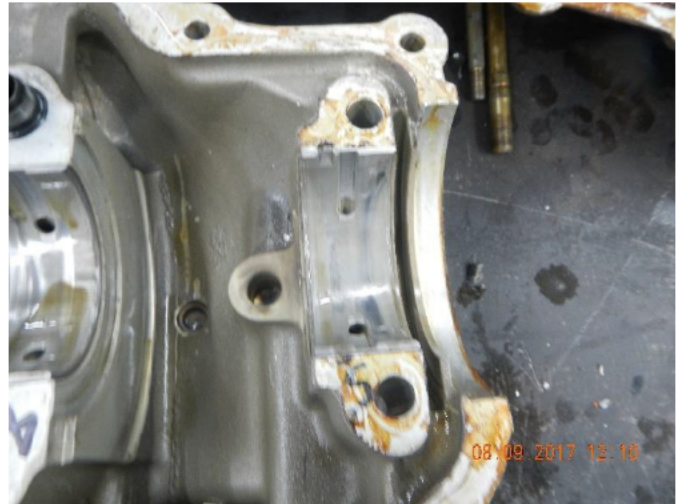
## #5 MAIN BEARINGS

Normal wear conditions were exhibited

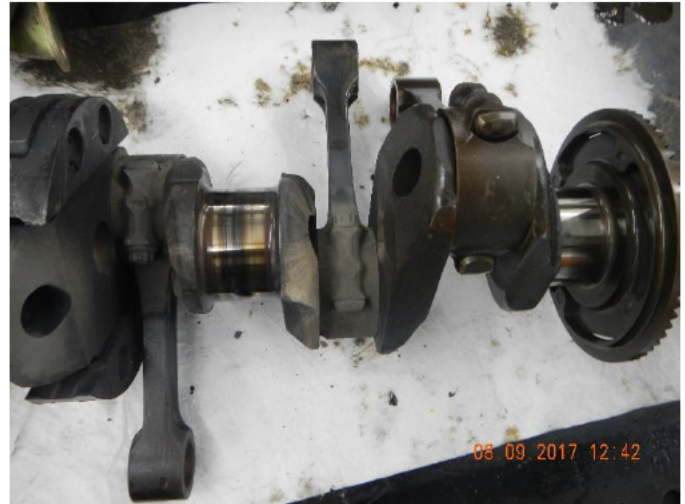
#### CRANKSHAFT

The # 3 main journal exhibited heat signatures. The corresponding main bearing did not.

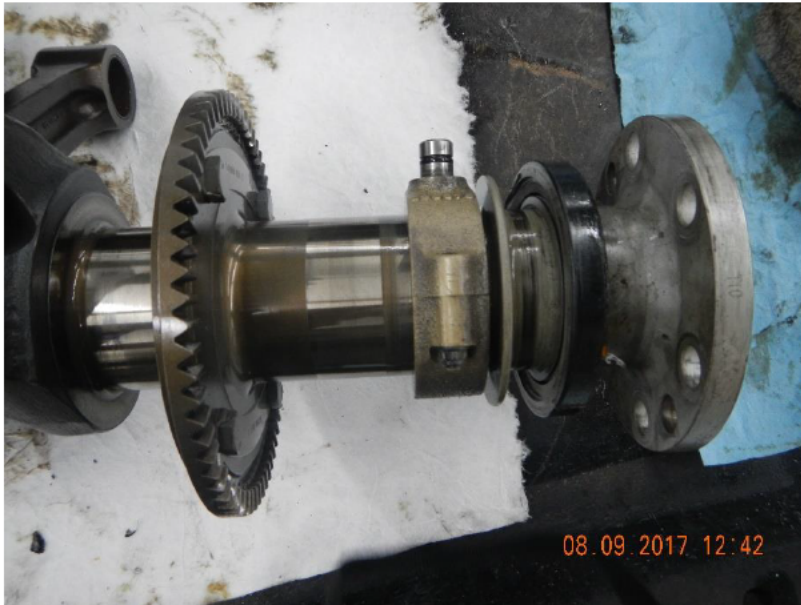
#### TRANSFER COLLAR

The transfer collar was not damaged.

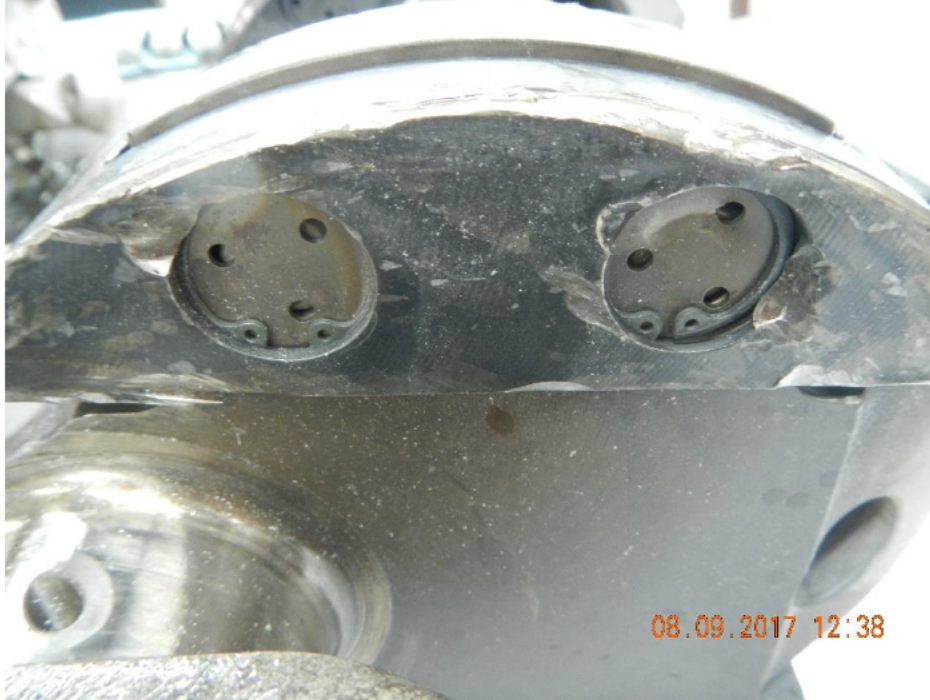
The counter weights remained intact but received mechanical damage from other components. All plates, pins and clips remained intact and in place.

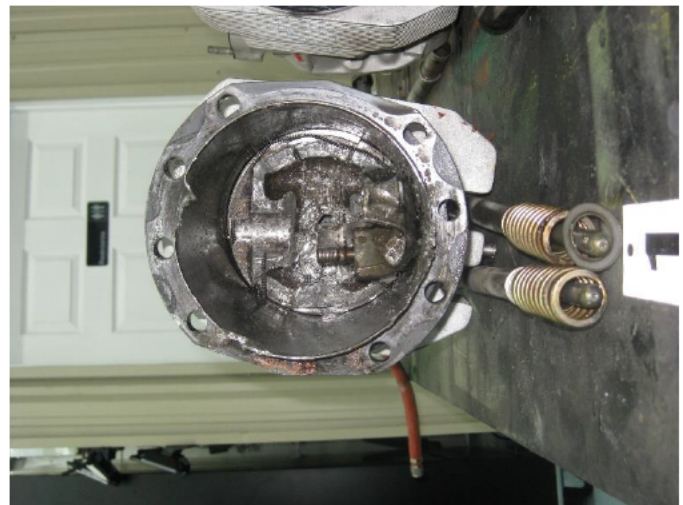
## #1 CONNECTING ROD

Condition: The rod separated at the connecting rod cap/bolts and piston pin boss

Condition: The rod bearing separated. Rod bearing material was located in the oil sump

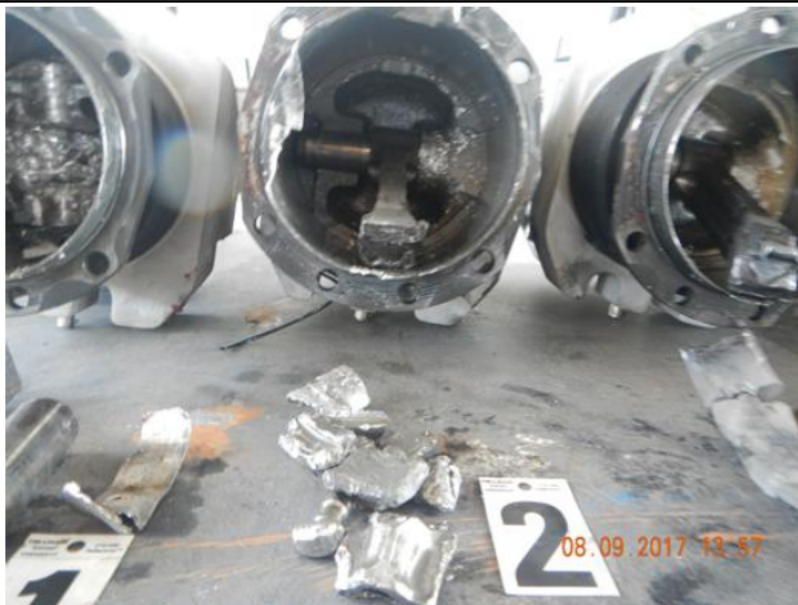
## #2 CONNECTING ROD

Condition: The rod separated above the connecting rod cap.

Condition: Destroyed

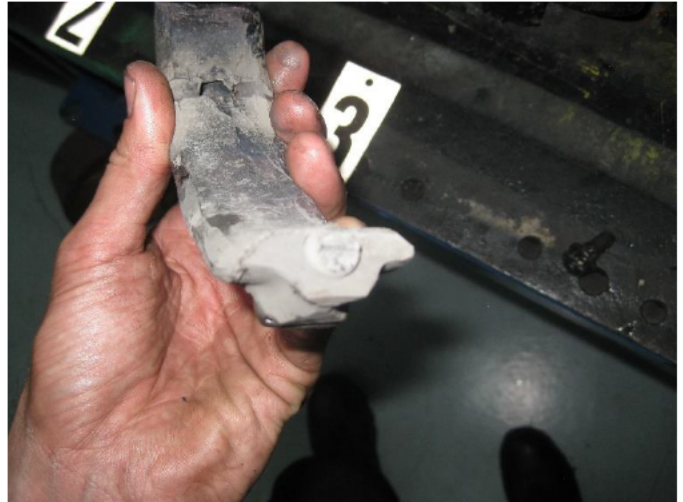
## #3 CONNECTING ROD

Condition: The rod separated above the connecting rod cap

Condition: Destroyed

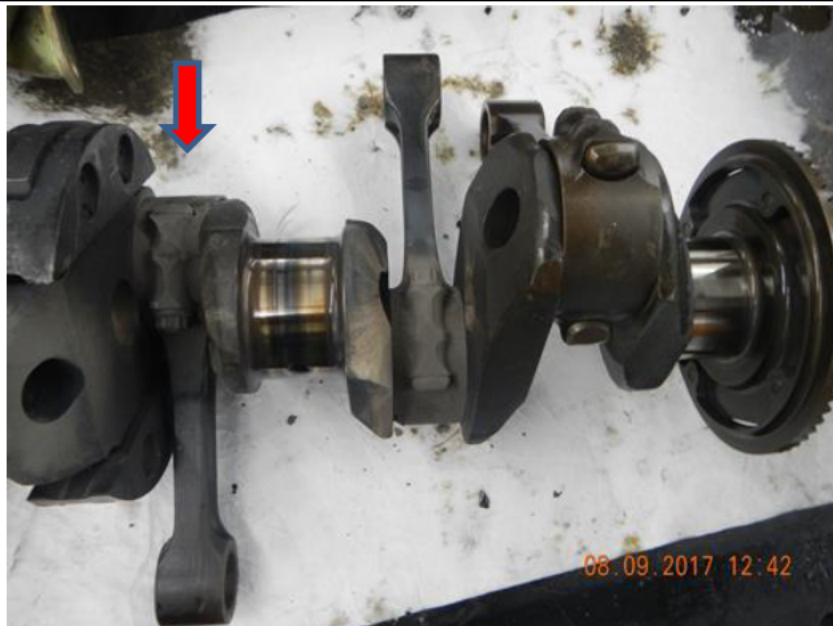
## #4 CONNECTING ROD

Condition: The rod exhibited thermal distress

Condition: Destroyed

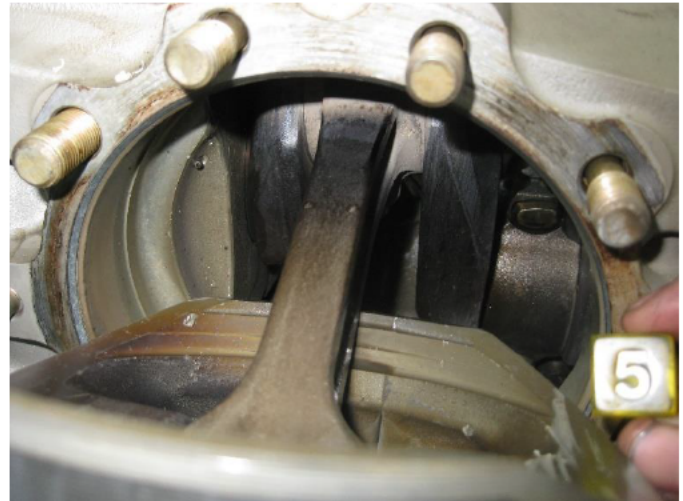
## #5 CONNECTING ROD

Condition: The rod exhibited thermal distress

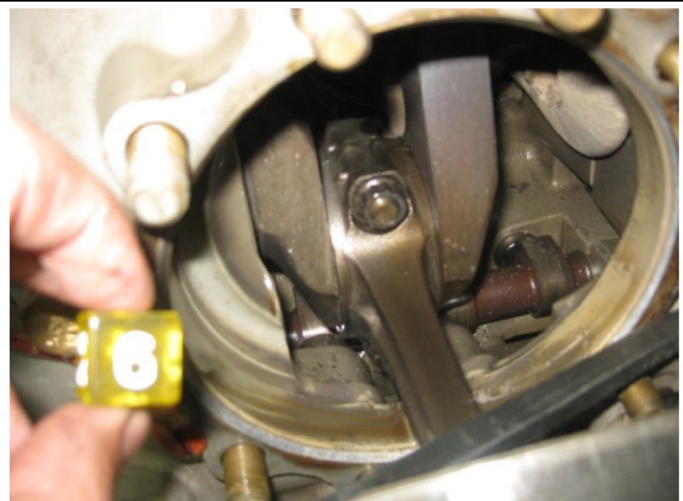
## #6 CONNECTING ROD

Condition: The rod exhibited thermal distress

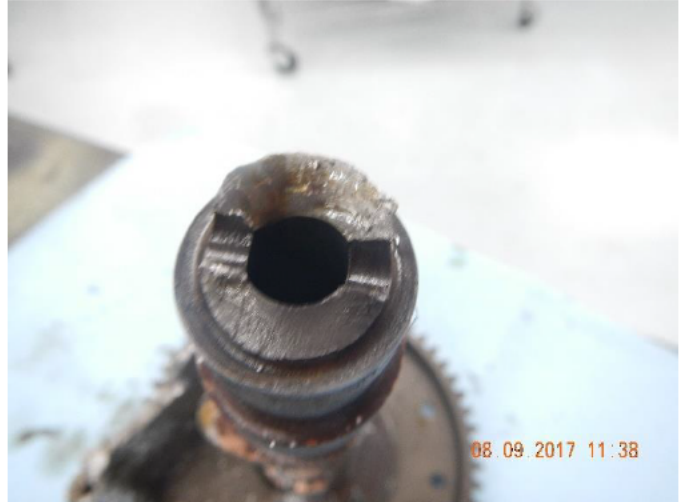
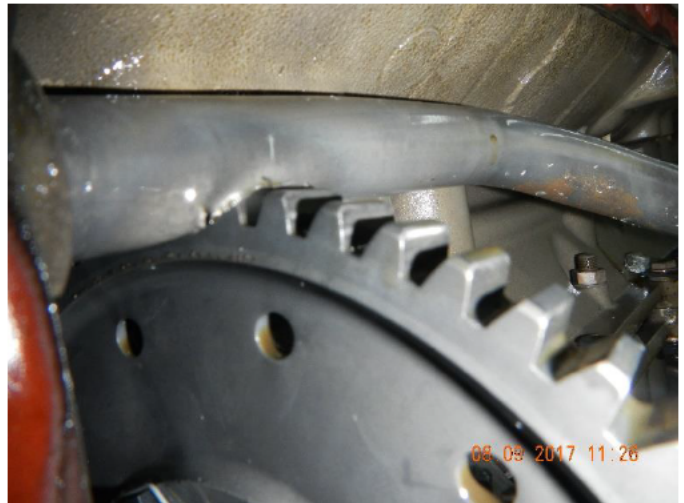
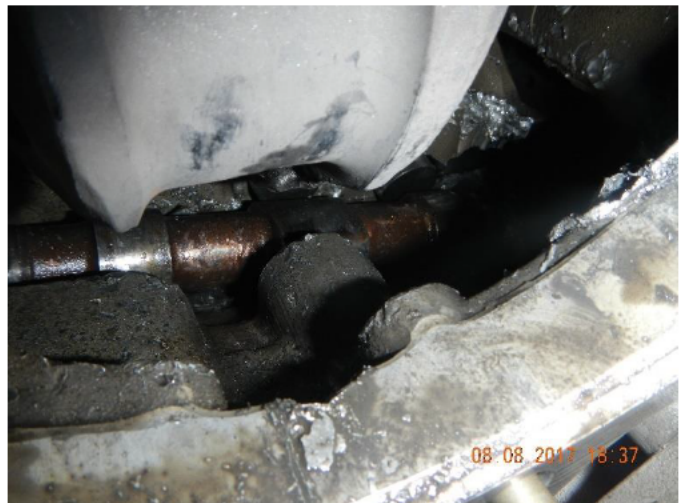
## CAMSHAFT

The camshaft was broken and the camshaft gear (PN# 656818A) exhibited several damaged teeth.

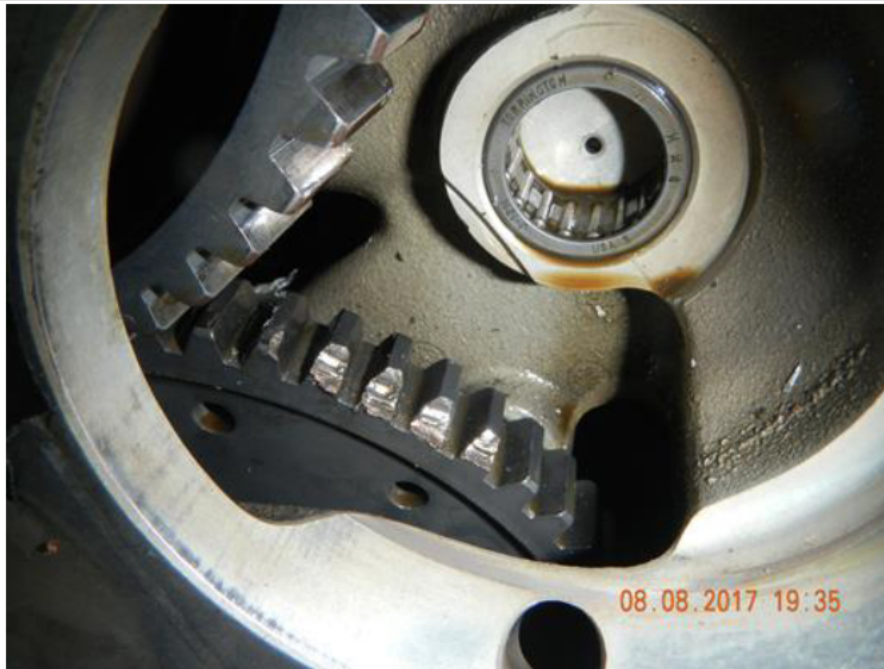
## ACCESSORY GEARS

The crankshaft and idler gears were intact. The cam gear exhibited damaged teeth. The cam gear contacted the oil pick up tube when the camshaft was damaged. See above.

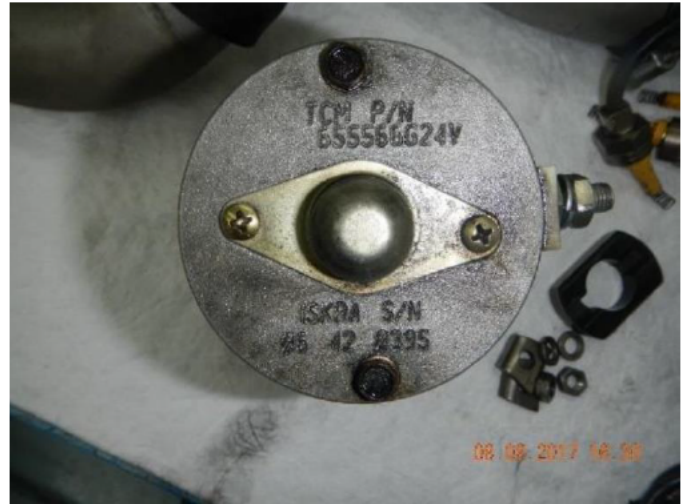
### STARTER

The starter was undamaged

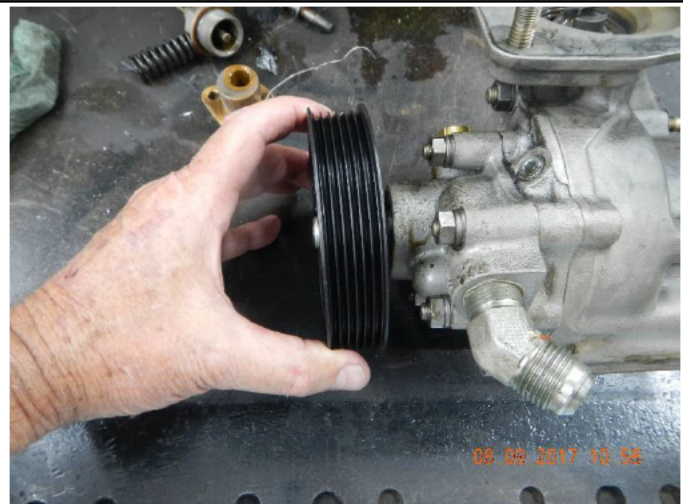
### STARTER ADAPTER

The starter adapter appeared undamaged with the possible exception of the PTO shaft. The pulley wobbled on the shaft. The starter adapter and pulley were sent to CMI Analytical for further examination.
