# Continental Motors

## ENGINE FIELD INSPECTION REPORT

| ENGINE MODEL | TSIO550C (9B) |
| FILE NUMBER | 17-083 |

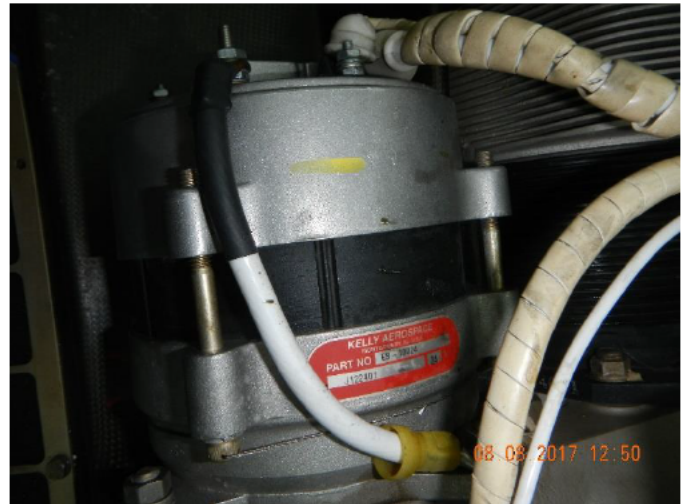
| Condition: | The alternator appeared to be undamaged | | |

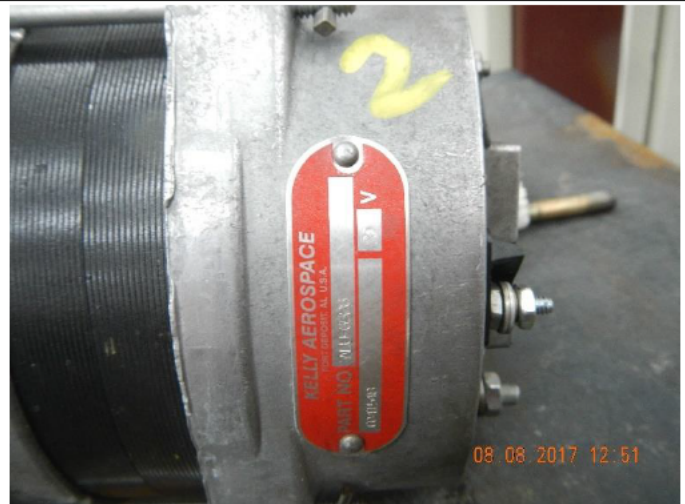
| Condition: | The alternator appeared to be undamaged | | |

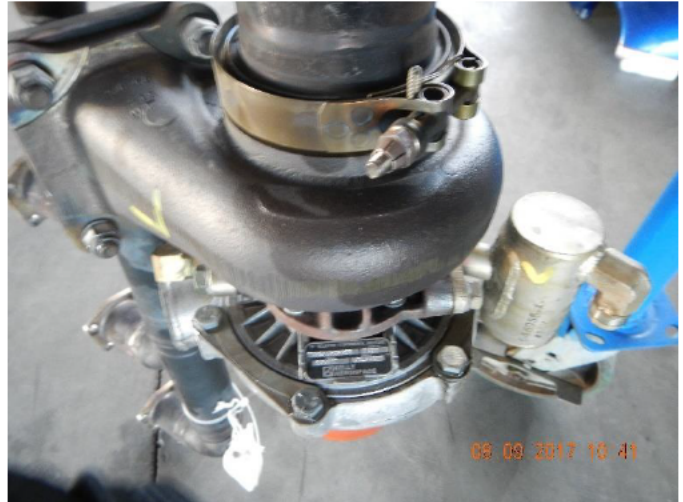
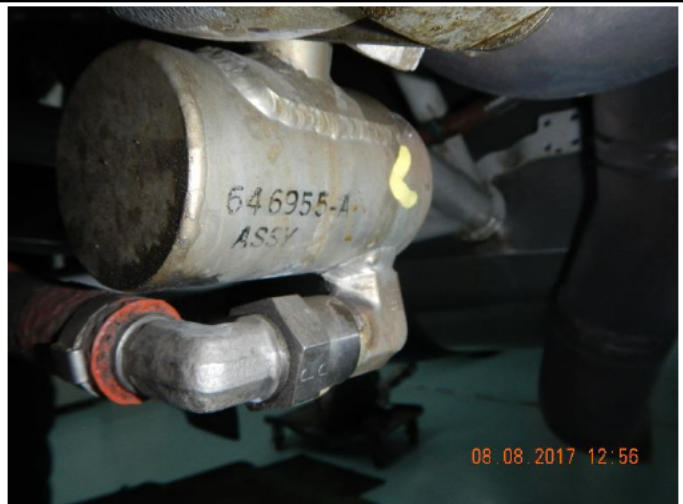
## LEFT TURBO

Condition: The left turbo exterior had a small amount of oil contamination and the exhaust pipe contained a small amount of oil. The compressor blades were undamaged and exhibit neither oil or oil stains. The turbo was retained by the NTSB to be shipped to CMI for an analytical examination by the Hartzell ASI.

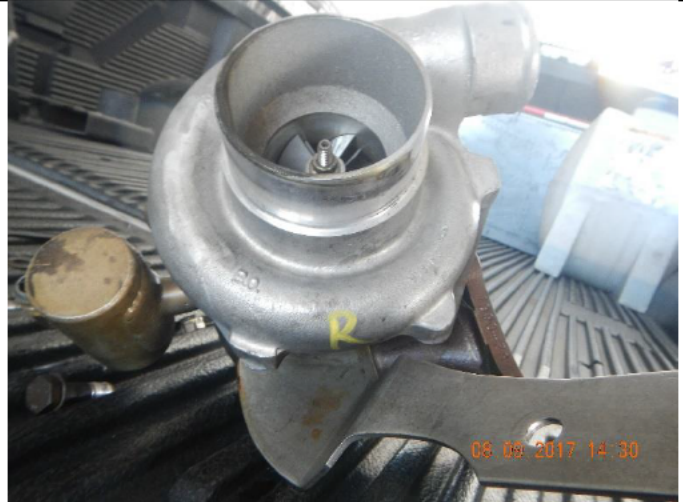
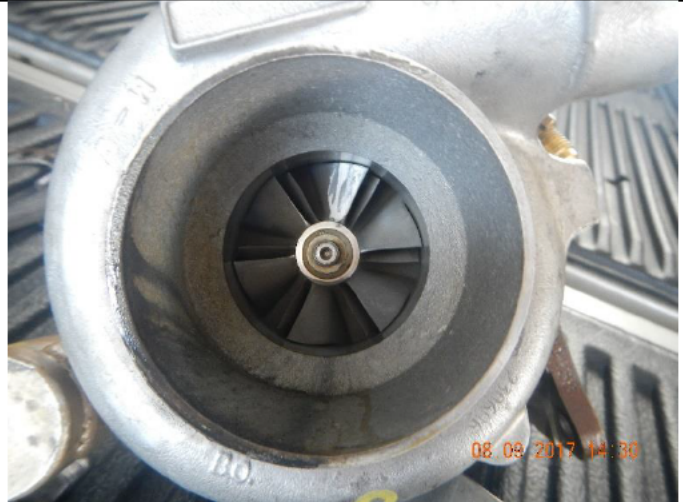
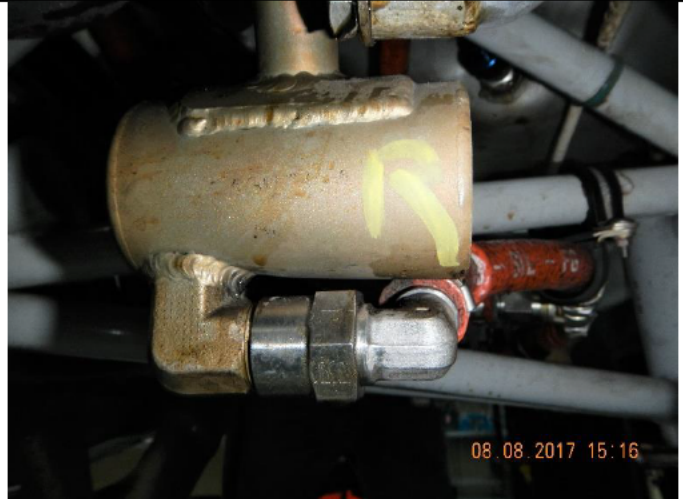
## RIGHT TURBO

No impact damage or oil contamination was exhibited by the right turbo. The turbo was retained by the NTSB to be shipped to CMI for an analytical examination by the Hartzell ASI. Connecting flexible hoses and fittings used to provide and return oil to/from the turbochargers were tight and contained torque (witness) putty.

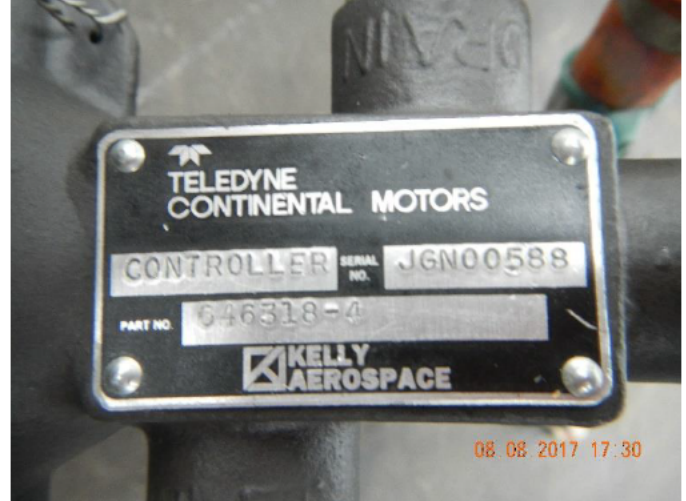
| Condition: | The turbo controller was undamaged. | | |

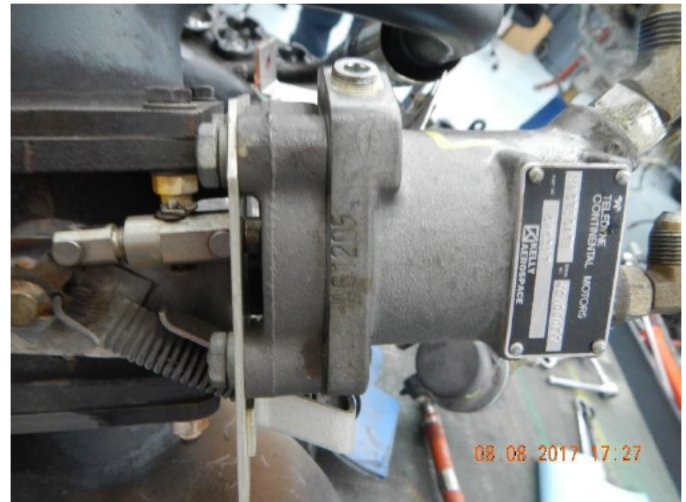
| Condition: | The wastegate did not exhibit any impact damage. | | |

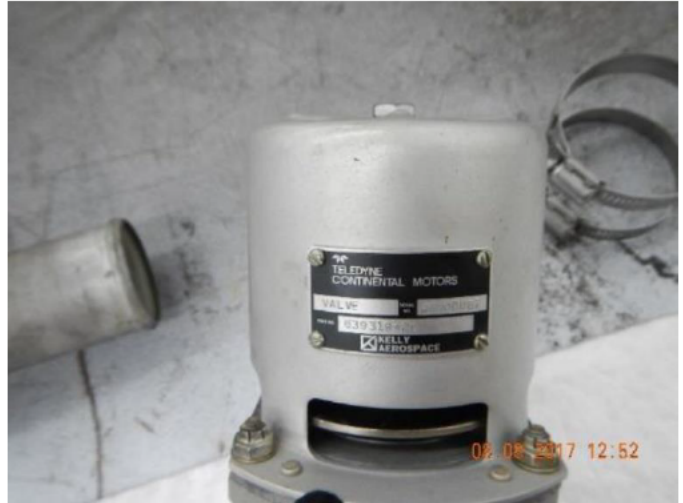
## OVERBOOST VALVE

Condition: The overboost valve was intact. When manually forced open, the spring-loaded valve closed normally.

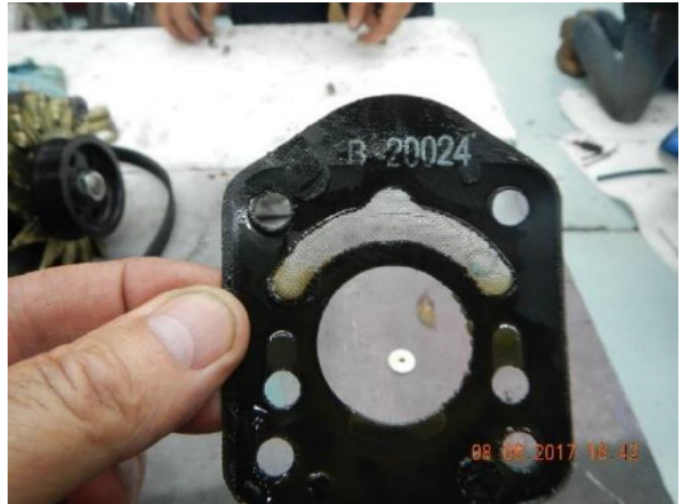
| PROPELLER GOVERNOR | Manufacturer: McCauley | M/N:C230D3R/T43 | S/N: 050335 |
|---|---|---|---|
| Condition: | No damage was noted. The throttle control arm was properly attached. The gasket/screen was clean | | |

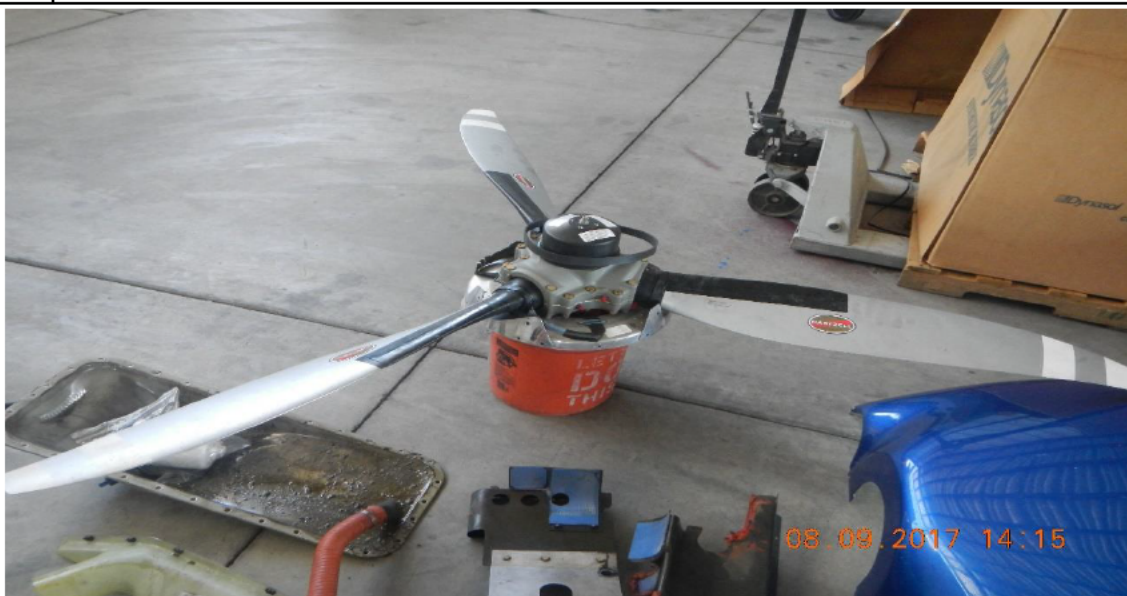
| PROPELLER | Manufacturer: Hartzell | M/N: HC-H3YF-1RF | S/N: LXZ69B |
|---|---|---|---|
| Condition: | The propeller hub and/or propeller blades did not exhibit any damage. | | |
