# Continental Motors

## Component Examination Report

| Engine Model: | TSIO550C (9B) | | Engine S/N: | 914445 | |
| Component P/N: | 642087- Starter Adapter Assembly | | Component P/N: | AL-00028-Pulley- Kelly Aerospace (part of Kelly Aerospace STC) | |

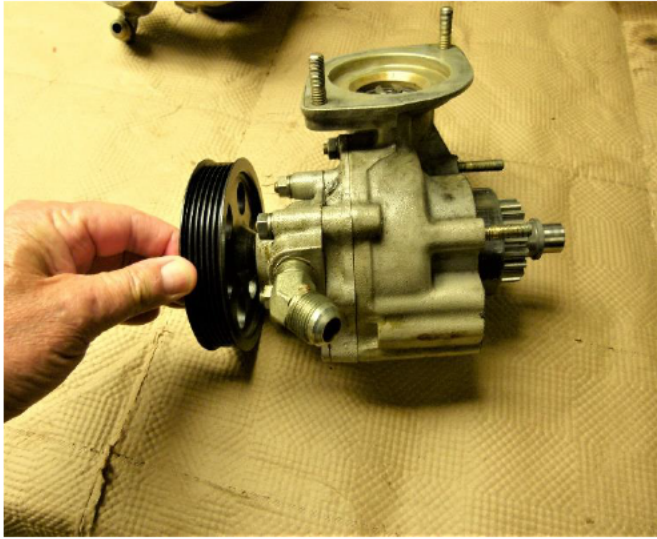
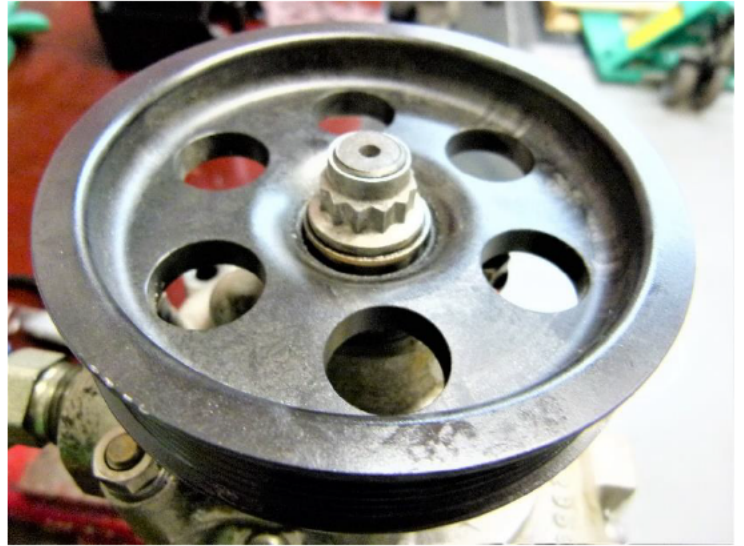
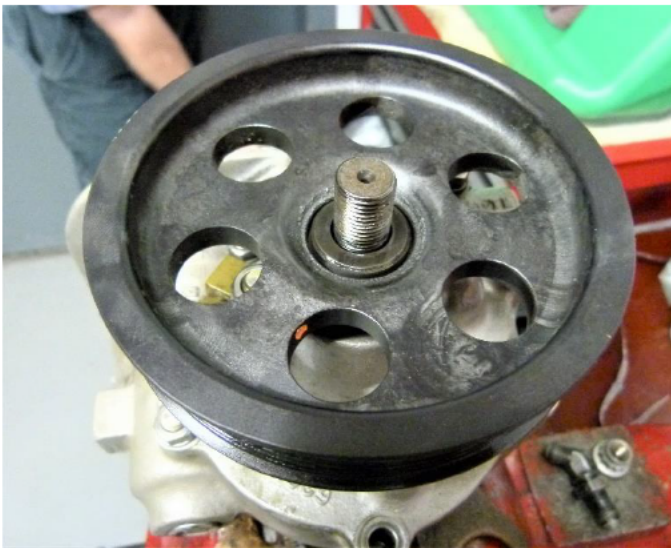
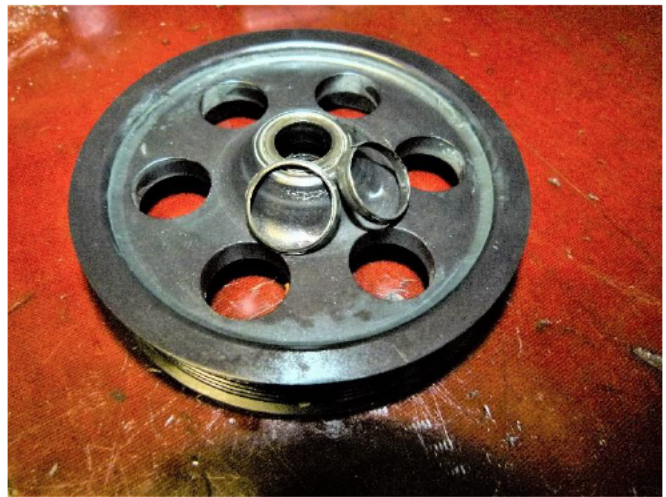
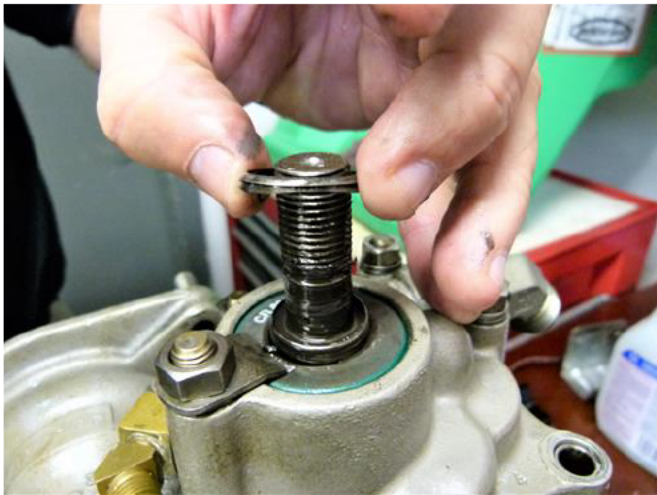
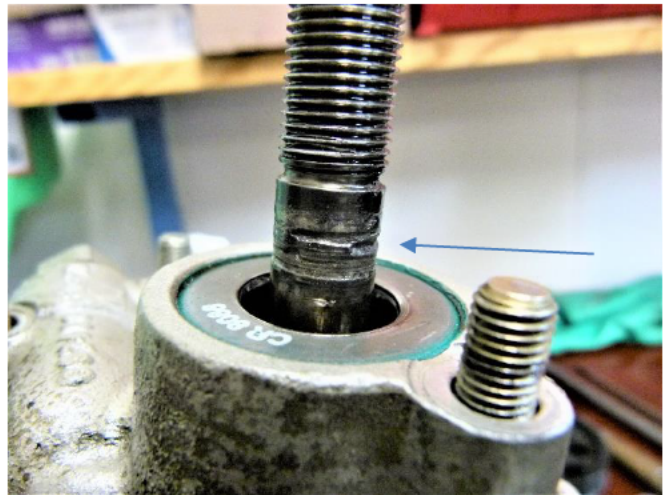
| Comments: | <p>The airplane was equipped with an optional third alternator. A pulley was installed on the starter adapter shaft to provide a power source for a third airframe alternator. The pulley assembly hardware (nut and washer) were tight but the pulley was found to be loose on the starter shaft allowing the pulley to wobble. The pulley was removed and found to be damaged. The ball bearing, shaft seal, spacer and shaft were also damaged. The condition of the pulley is consistent with damage caused by over-tensioning the accessory belt causing excessive side-load on the bearing, seal and shaft. The starter adapter assembly, including aftermarket pulley and belt as installed were located directly above the rear exhaust cross-over pipe which exhibited baked on engine oil.</p> | | | | |

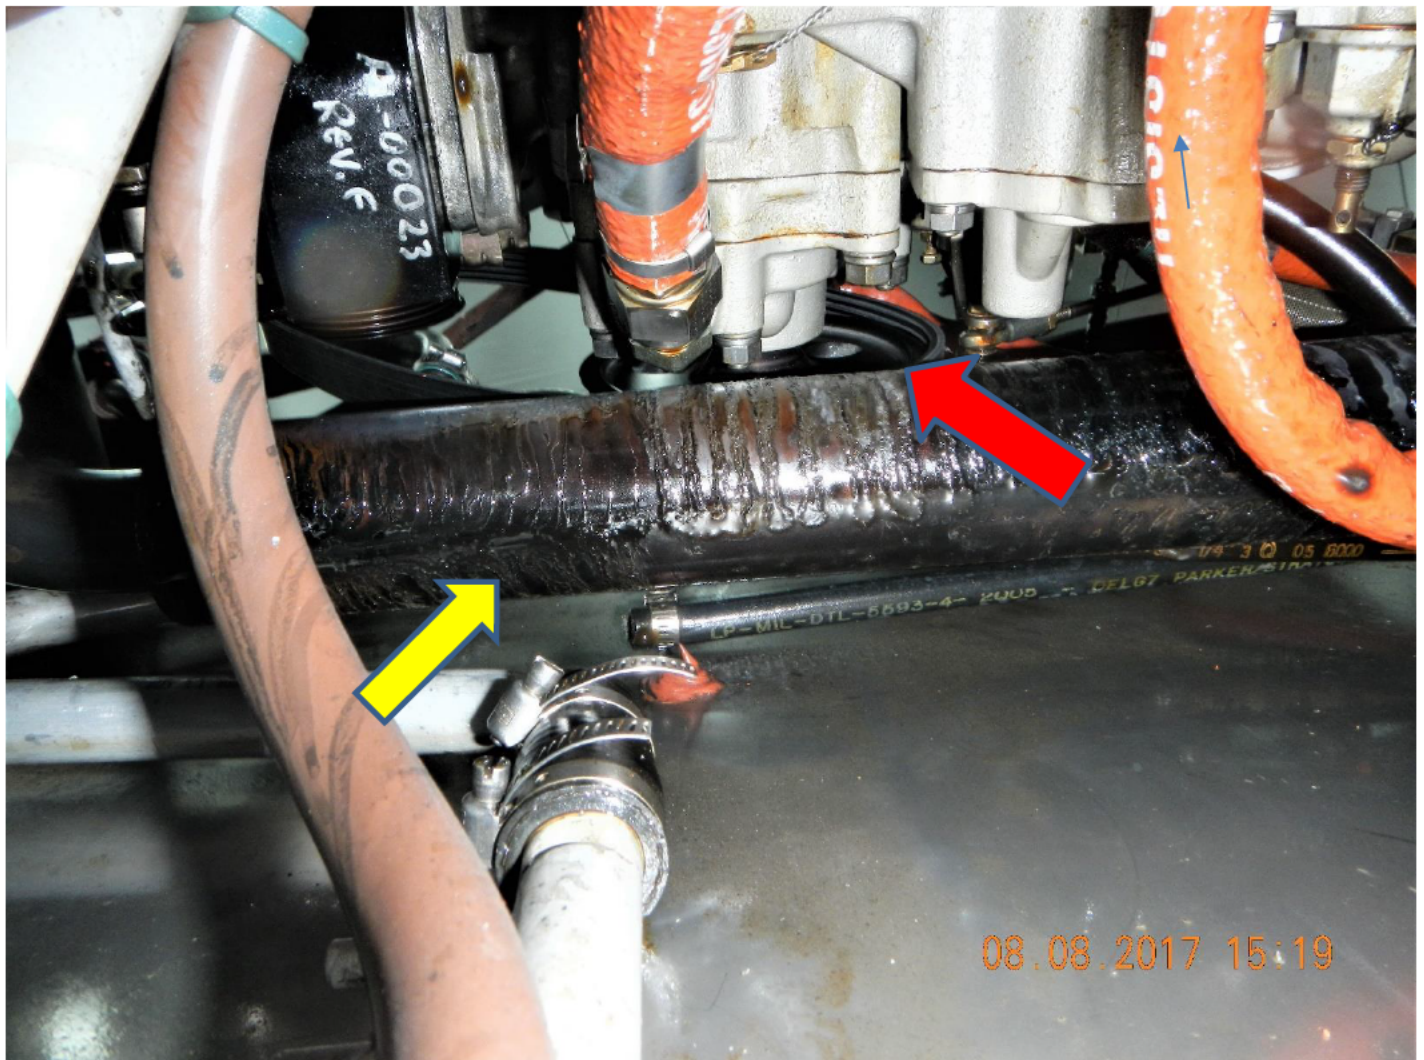
View looking up from beneath the engine near the firewall. The red arrow points to the starter adapter and aftermarket pulley used to power the optional third alternator. NOTE the baked-on oil on the outer surface of the exhaust cross-over tube located directly under the starter adapter pulley (yellow arrow).
