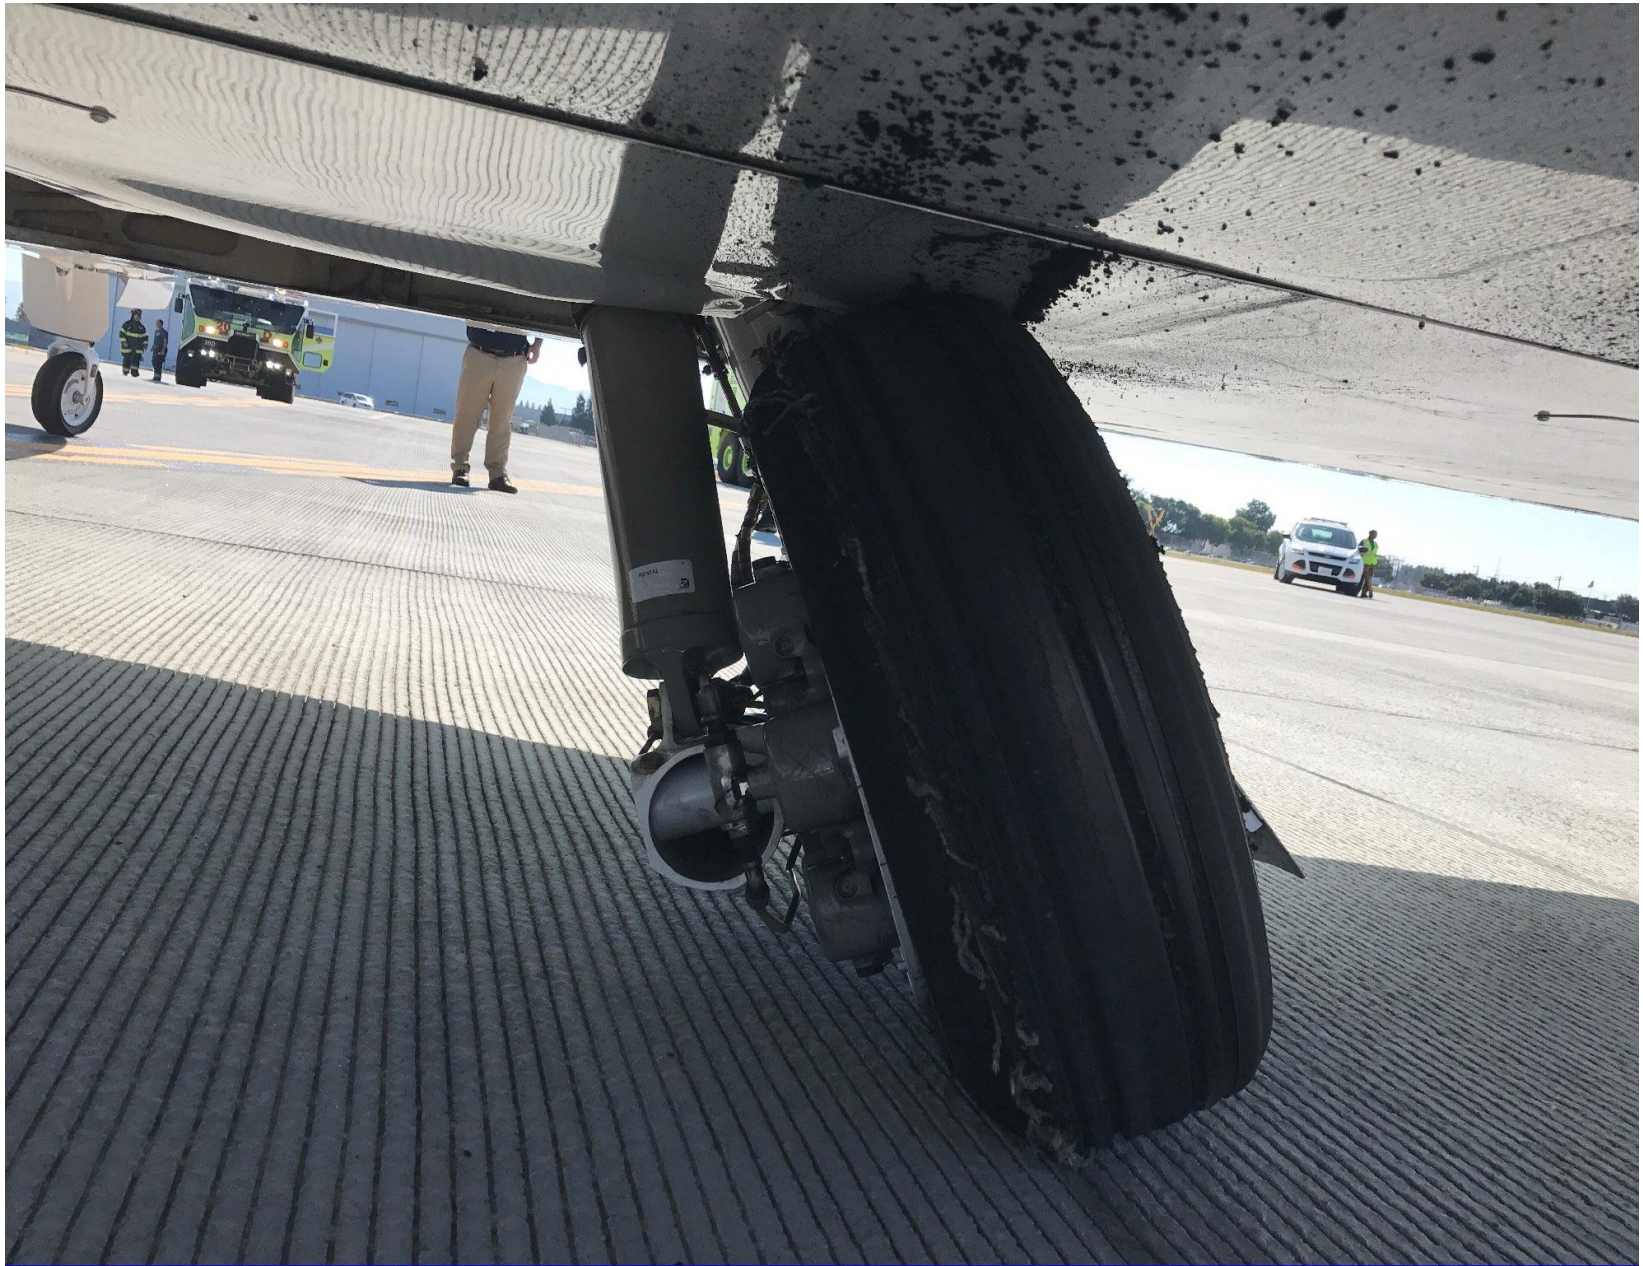
**Photo 1 – Accident site, view of the right main landing gear from the rear.**

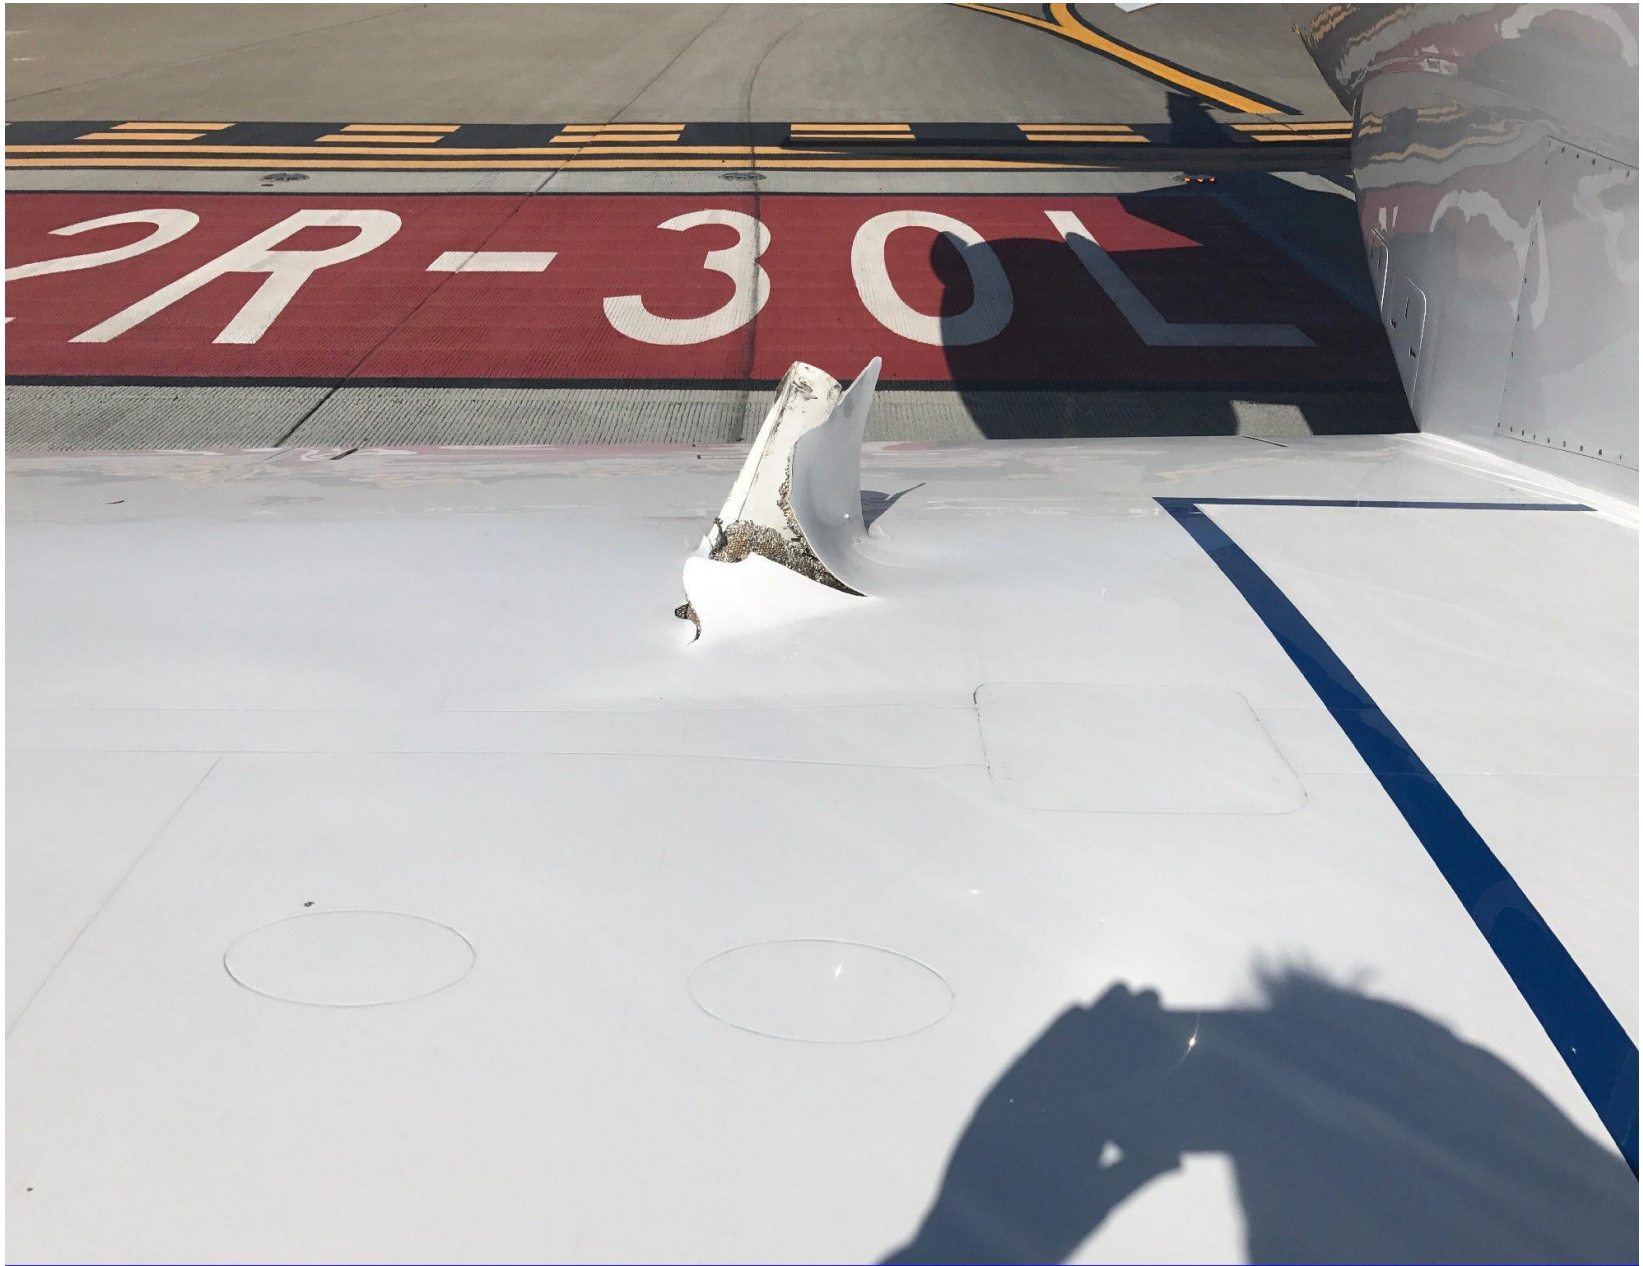
**Photo 2 – Accident site, top surface of right wing and right landing gear trunnion.**

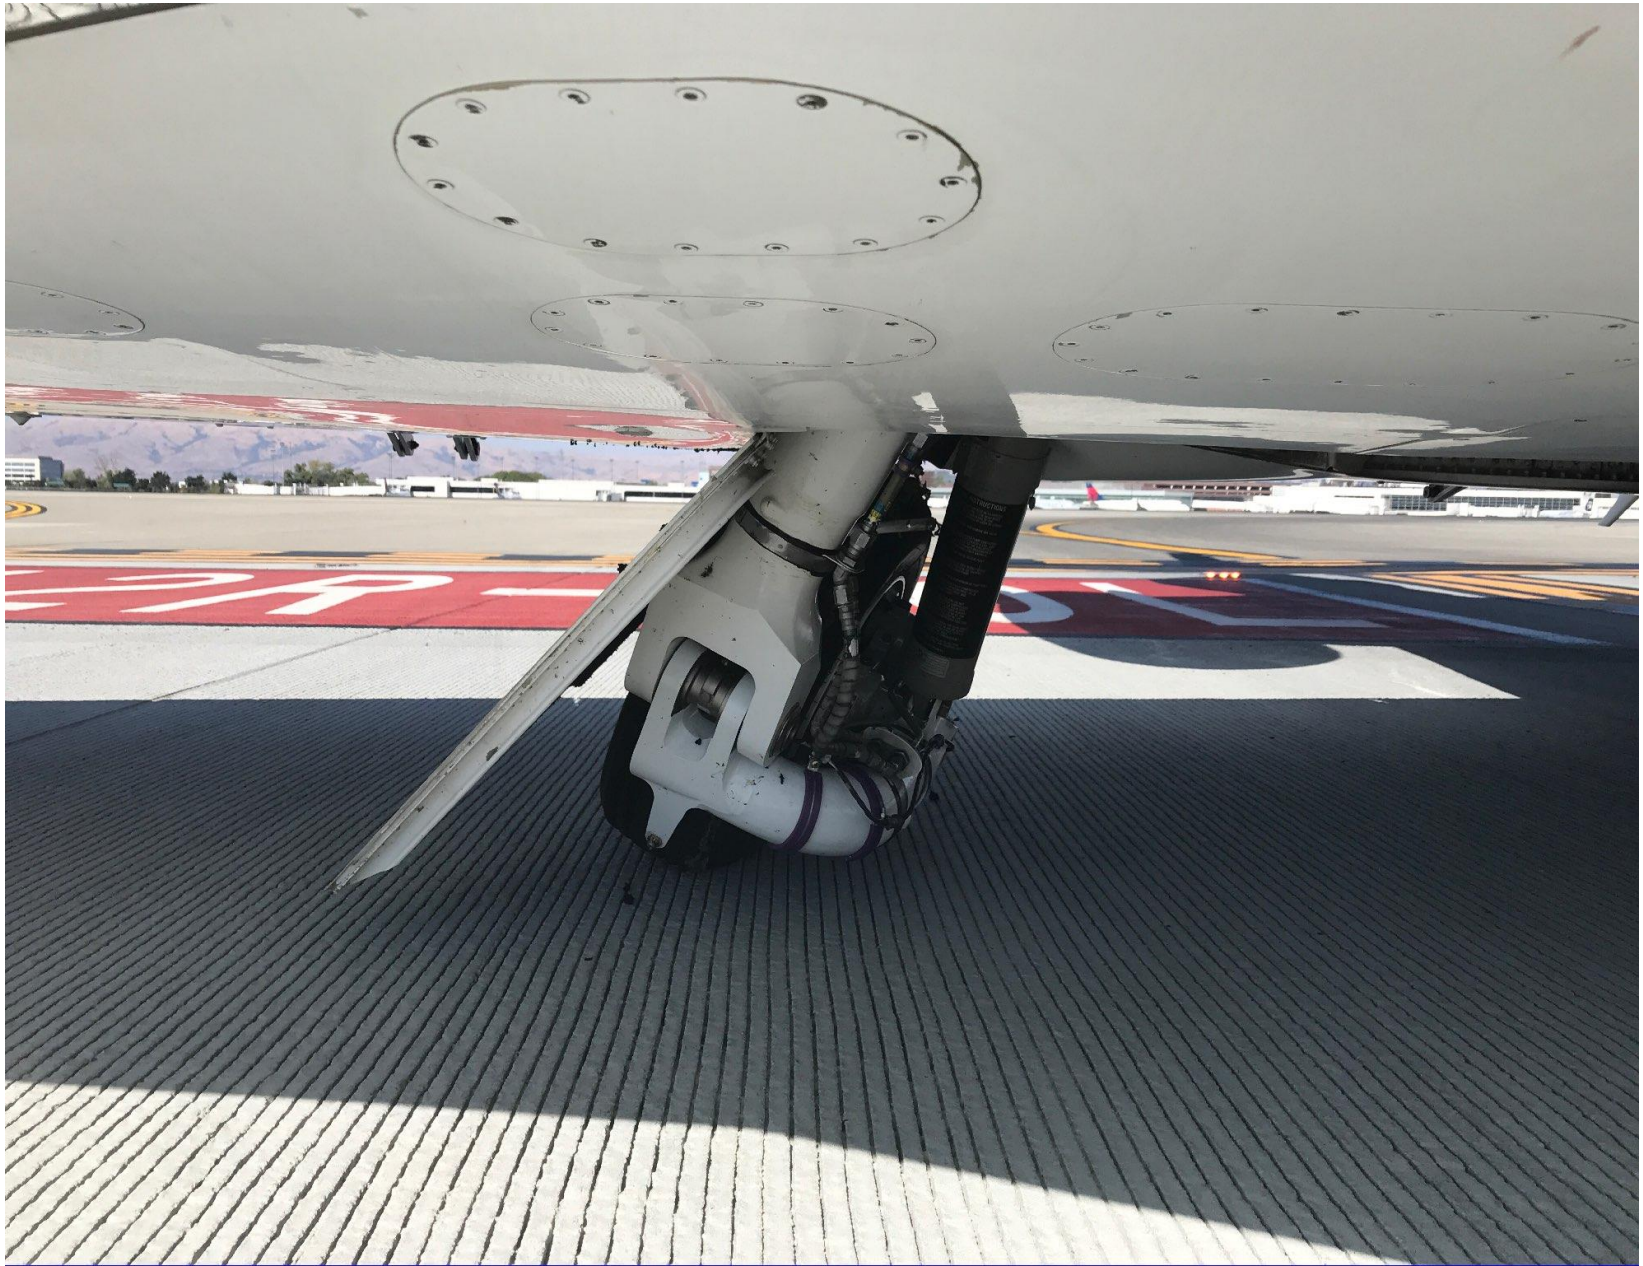
**Photo 3 – Accident site, view of right main landing gear from the front.**

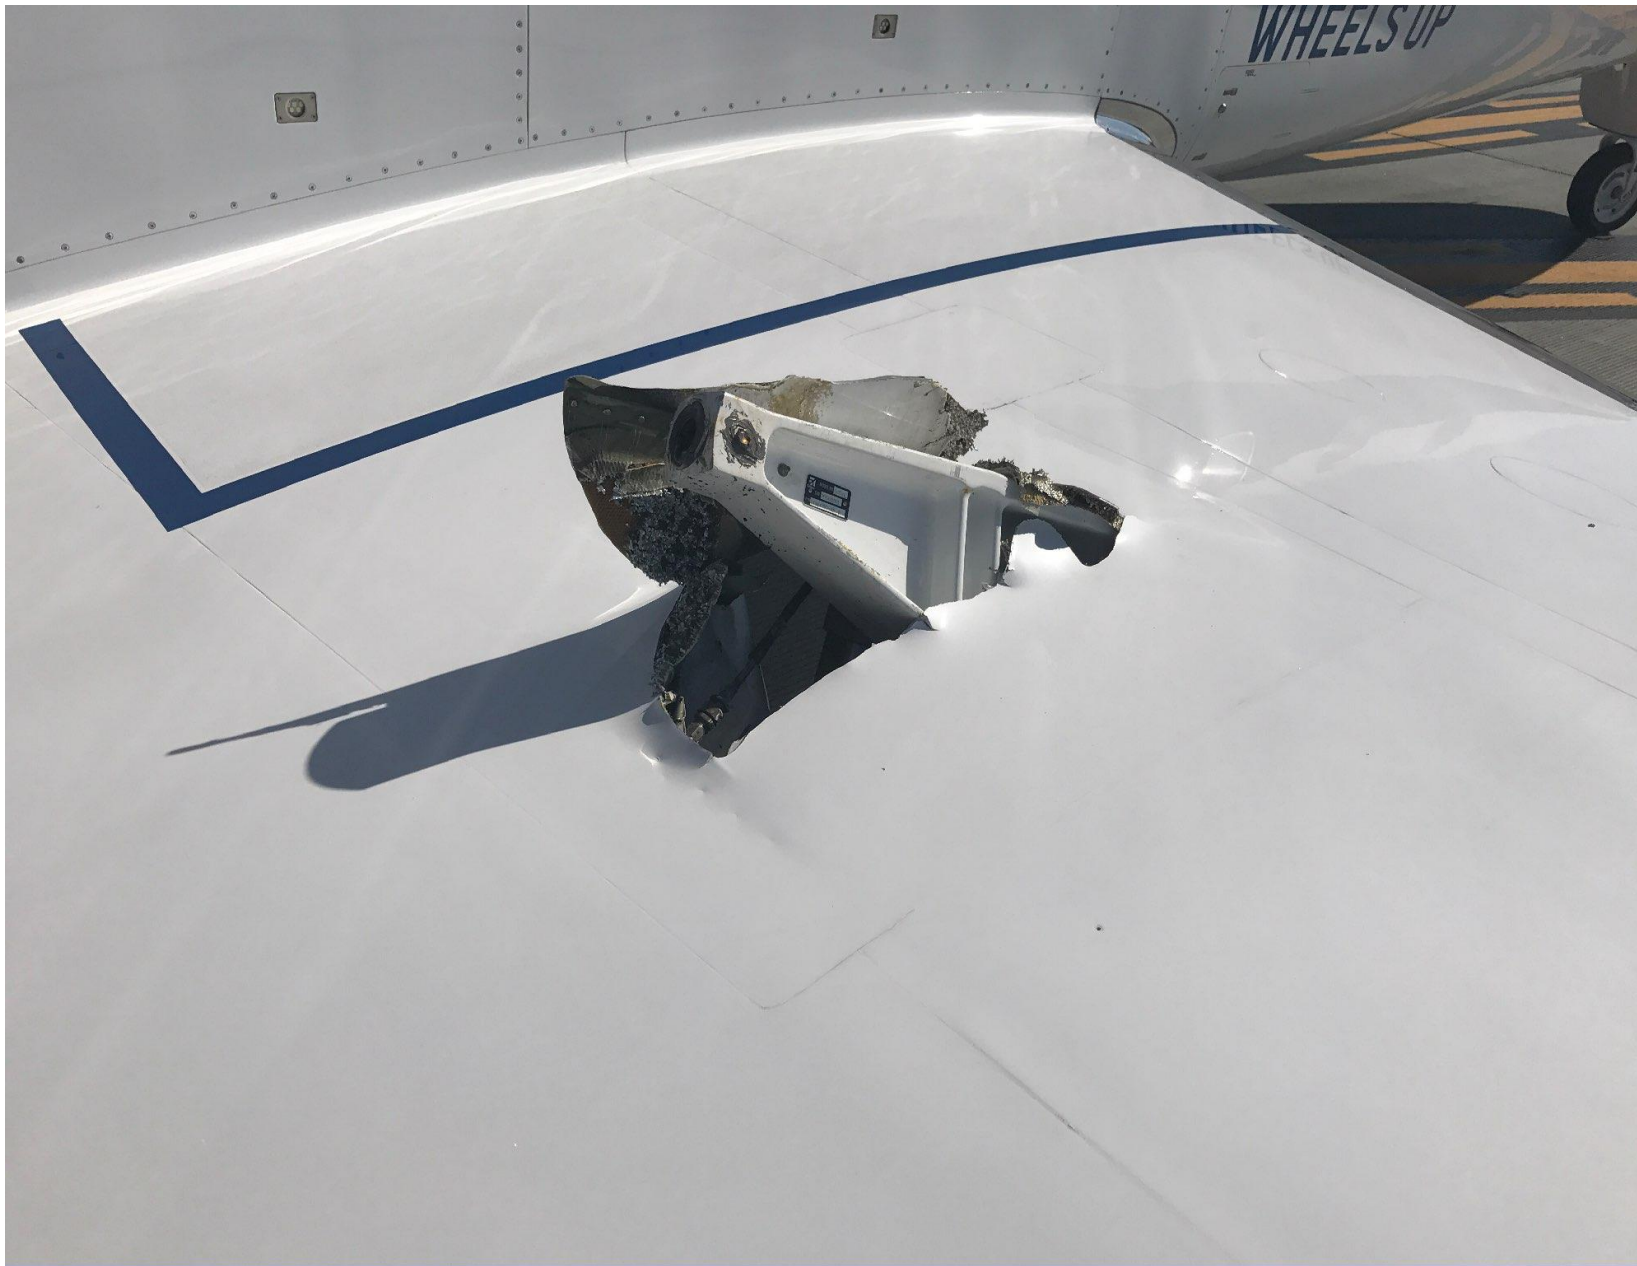
**Photo 4 - Accident site, top surface of right wing and right landing gear trunnion.**

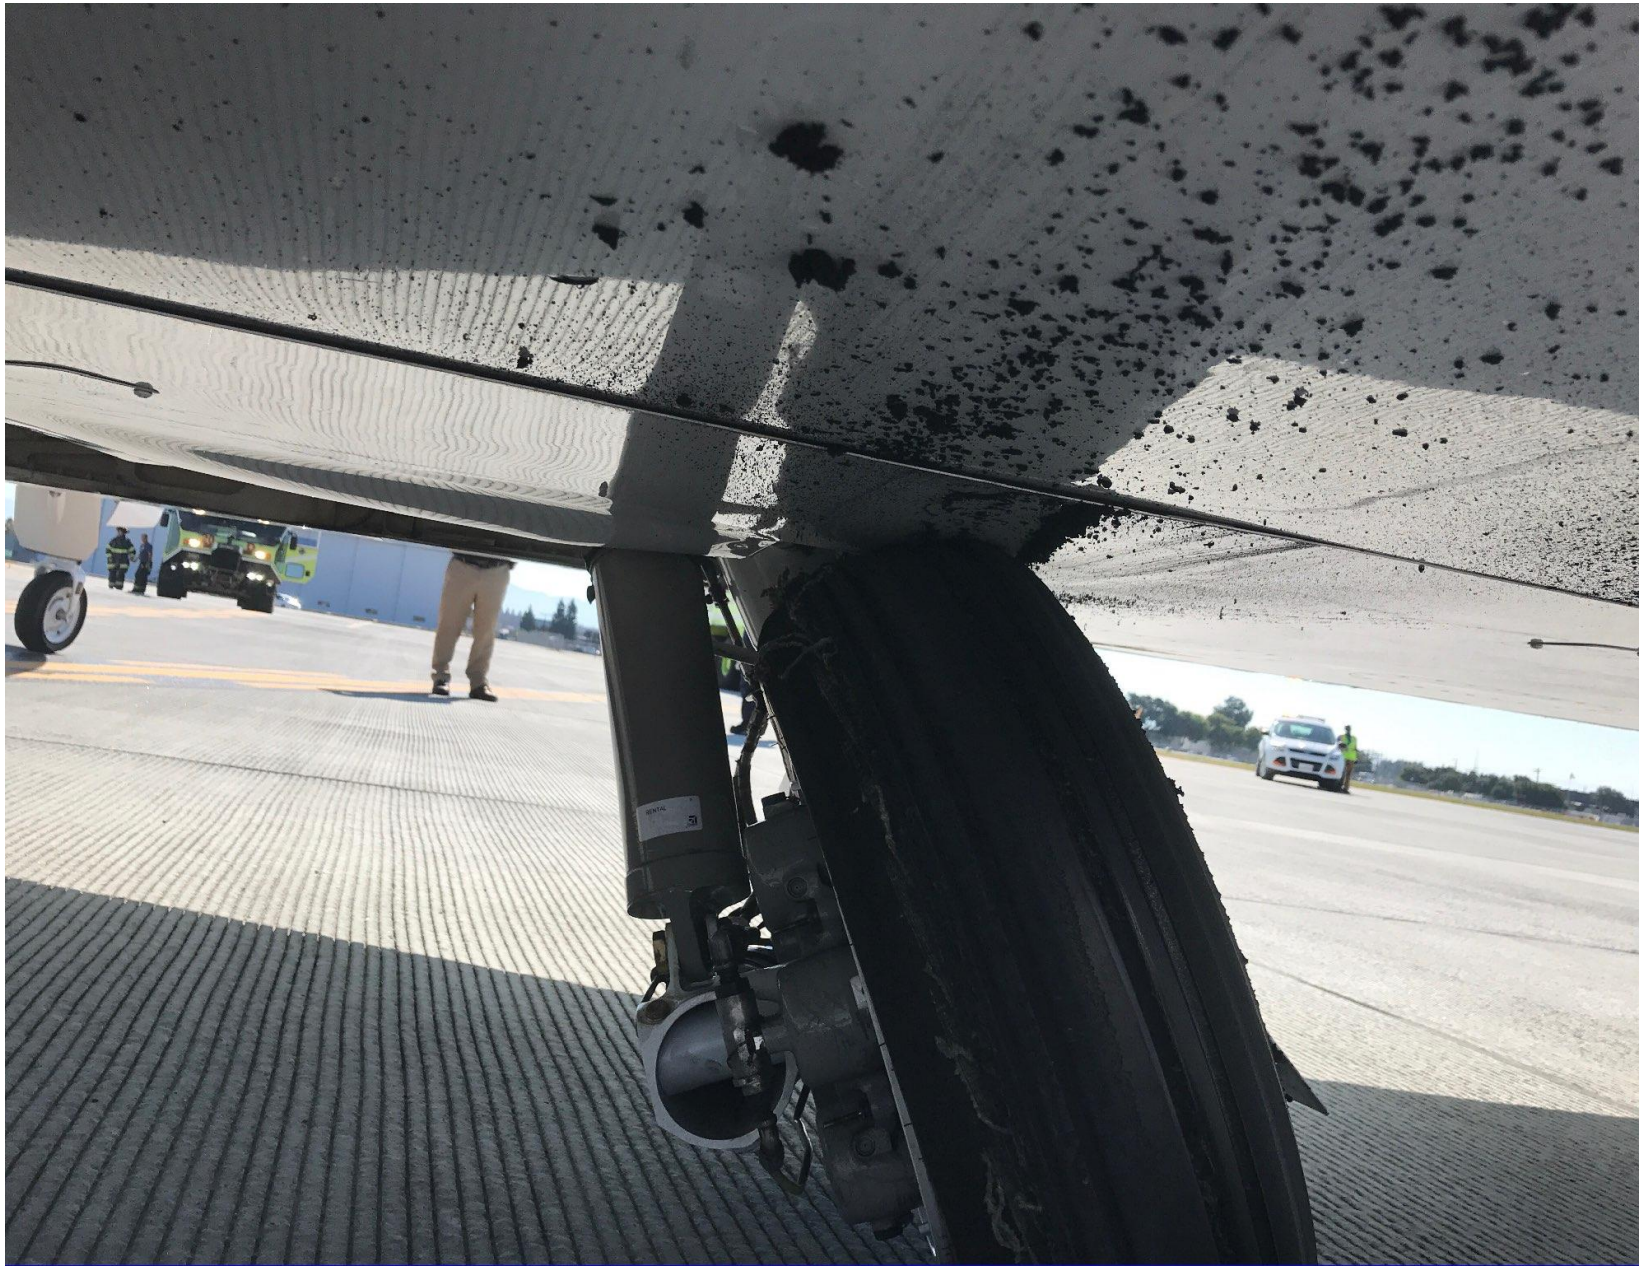
**Photo 5 - Accident site, view of the right main landing gear from the rear.**
