# NATIONAL TRANSPORTATION SAFETY BOARD

## MATERIALS LABORATORY FACTUAL REPORT

Report No. 17-074

Place : Glendale, Arizona  
Date : August 22, 2017  
Vehicle : Enstrom F-28F, N52PD  
NTSB No. : WPR17IA198  
Investigator : Albert Nixon

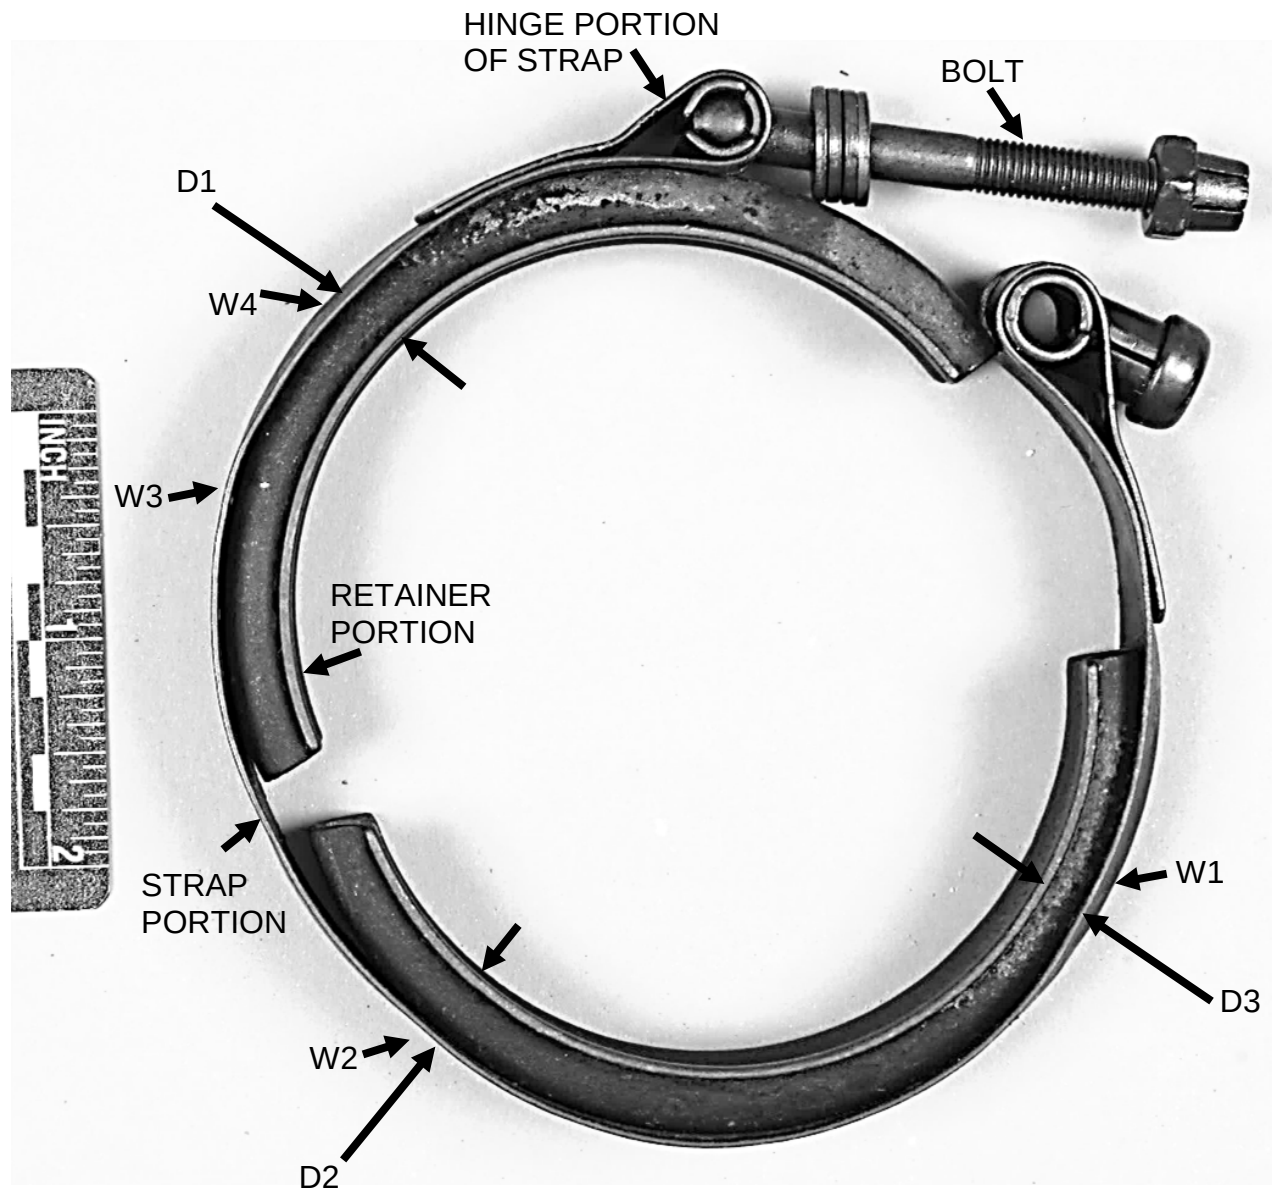
Figures 1 and 2 show photographs of the as-received V-clamp assembly, also referred in industry as a V-band clamp assembly. The assembly contained no evidence of an identification mark such as a part number or manufacturer name. The cross section of the retainer portion resembled the shape of a "V" character. The V-clamp assembly contained an outer strap portion and two V-shaped retainers. The two V-shaped retainers are located on the inner side of the strap portion. The bottom end of each V-shaped retainer was joined by two spot welds to the inner side of the strap portion. Examination of the clamp assembly revealed the two V-shaped retainer portions were attached to the clamp. Bench binocular microscope examination of the outer face of the strap portion revealed that three of the four spot welds contained a crack at the outer edge of the spot weld (nugget portion), see figure 3. The length of the longest spot weld crack ("W2") on the outer face measured approximately 0.17 inch. The edge of the strap portion in areas next to latch mechanism and diametrically opposite of the latch mechanism showed evidence of bending deformation that was toward the edge of the V-shaped retainer, see areas between arrows "D1" through "D3" in figure 1. In the deformed areas, the distance between the edge of the retainer and the edge of the strap were smaller compared to other non-deformed areas. This bending deformation damage was apparent on both sides (edges) of the assembly. The width of the retainers at the ends (see "Y1" in figure 2) was slightly wider compared to areas located midway between the ends of the retainers (see "Y2" in figure 2). The difference in width is also shown in figure 4. The strap was attracted to a magnet indicating it was a ferrous metal.

Figure 1. Photograph of the as-received turbo V-clamp assembly. The spot welds for the retainer are located approximately in the areas indicated by arrows "W1" through "W4". The distance between the inner surface of the clamp and the outer surface of the retainer was less in the areas between arrows "D1", "D2", and "D3", compared to other areas of the assembly. The distance between the inner surface of the clamp and the outer surface of the retainer in the deformed area between arrows "D3" measured approximately 0.16 inch. The distance between the inner surface of the clamp and the outer surface of the retainer in a non-deformed area measured approximately 0.24 inch, when measured with a caliper.

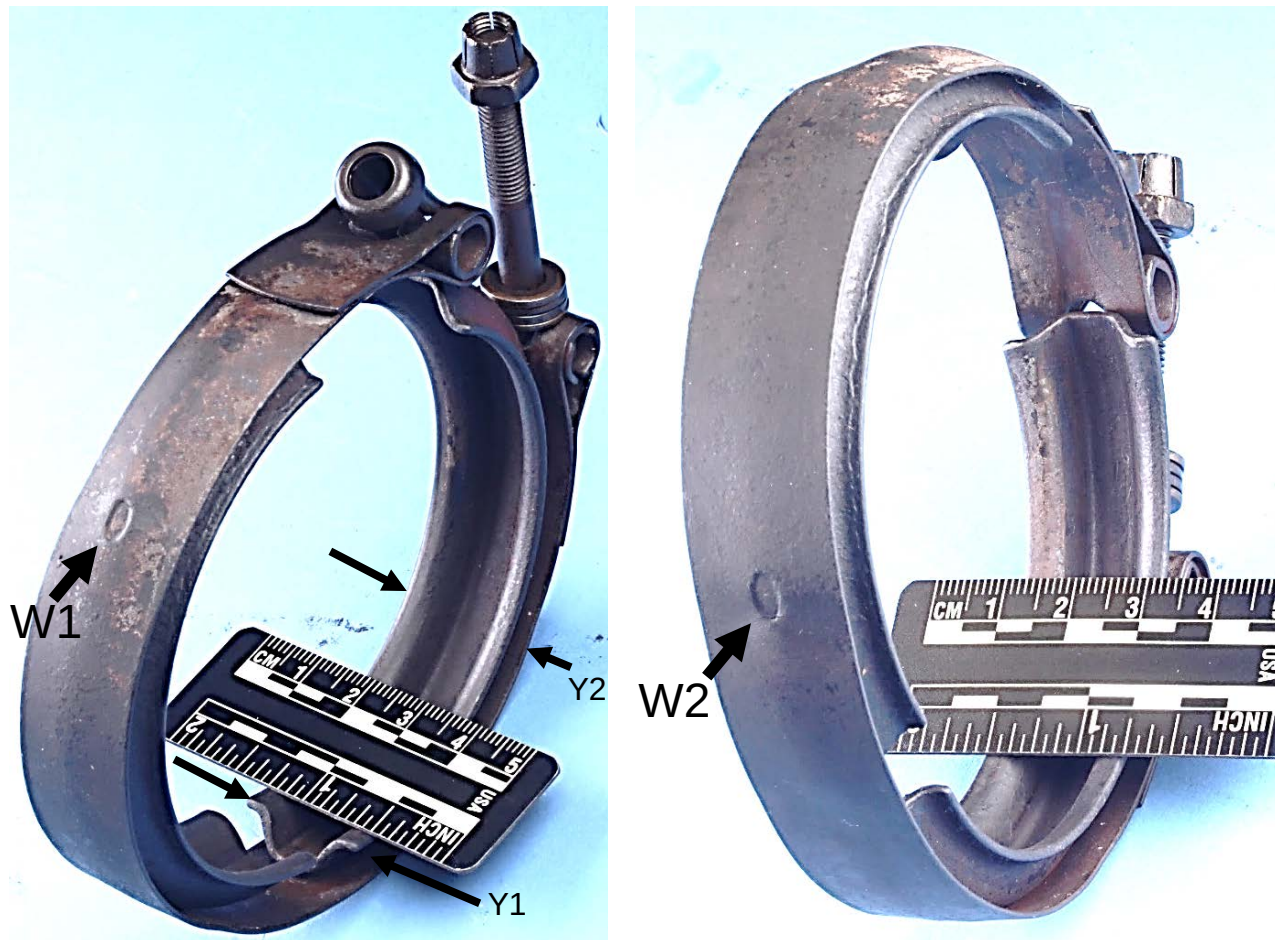
Figure 2. Photographs of the V-clamp assembly showing spot welds "W1" and "W2". The width of the retainer at one end in the area between arrows "Y1" measured approximately 0.82 inch. The width of the retainer in an area located midway between the ends ("Y2") measured approximately 0.76 inch.

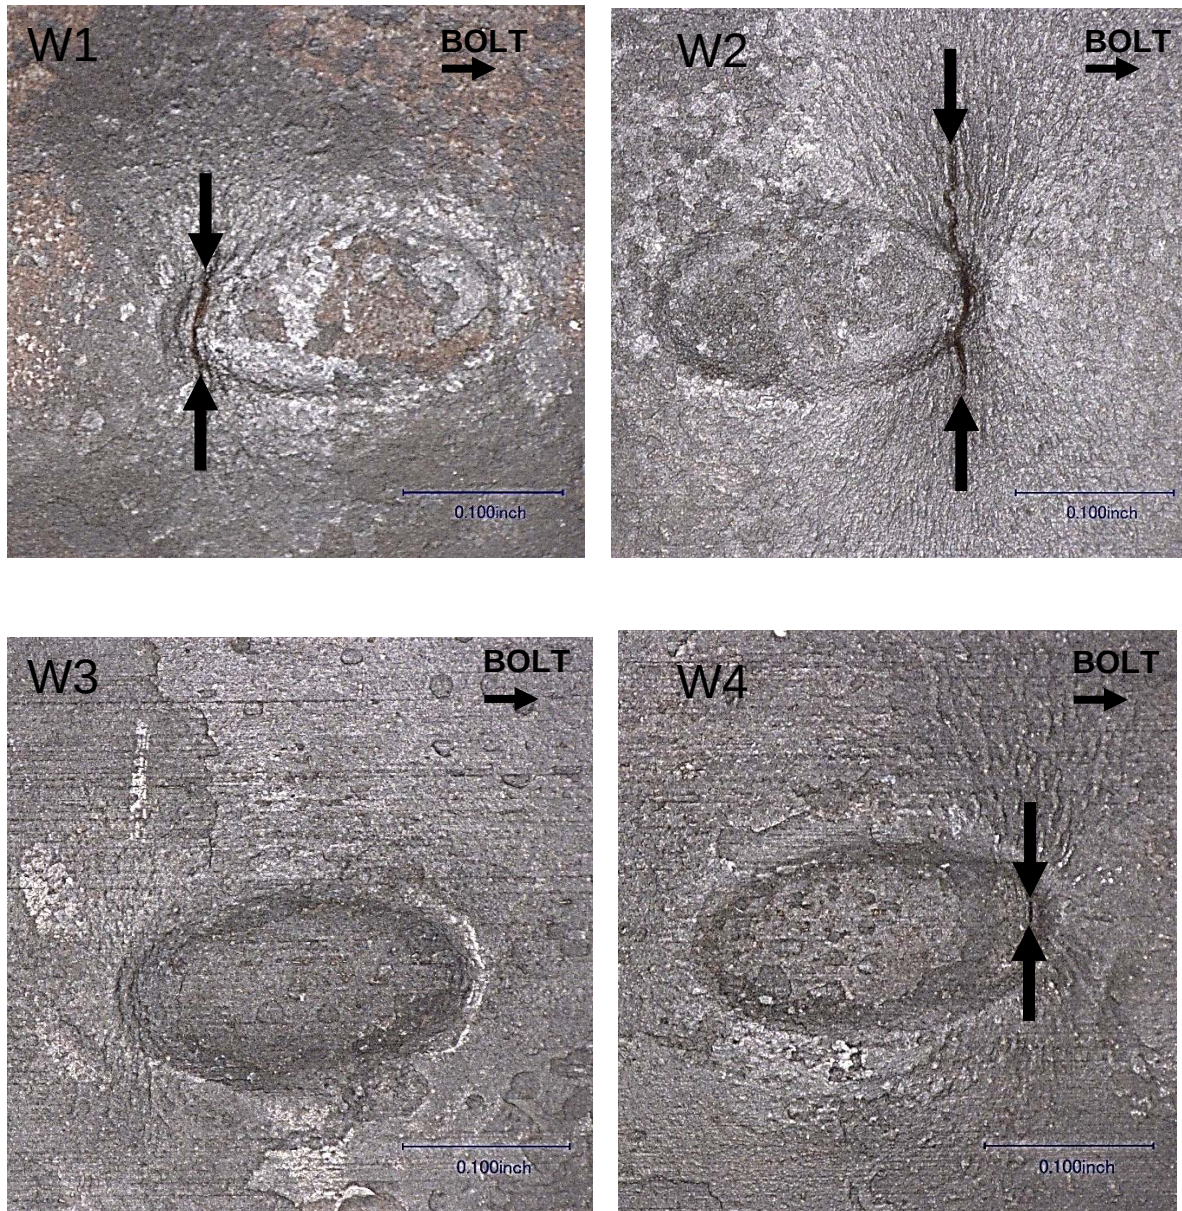
Figure 3. Photographs of outer face of the strap portion showing spot welds “W1” through “W4”. The spot welds appear oval. Spot welds “W1”, “W2”, and “W4” contained a crack at the outer edges in the area between arrows. Spot weld “W3” contained no evidence of a crack. The hinge portion of the strap that was attached to the bolt (for the latch mechanism) was located in the direction indicated by the arrow labelled “bolt”.

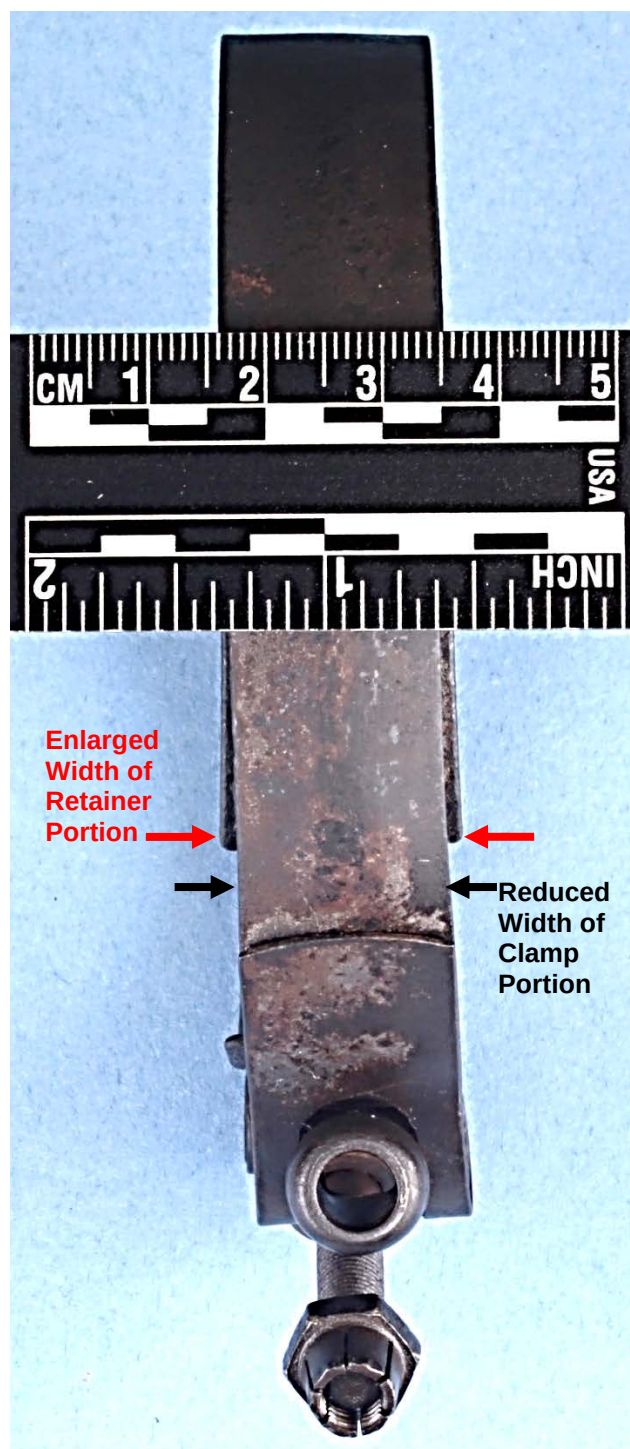
Figure 4. V-clamp assembly showing the reduced width of the clamp portion in the foreground and the enlarged width portion of the retainer in the background. The width of the clamp in the non-deformed area measured approximately 0.76 inch and in the reduced width area measured approximately 0.82 inch.

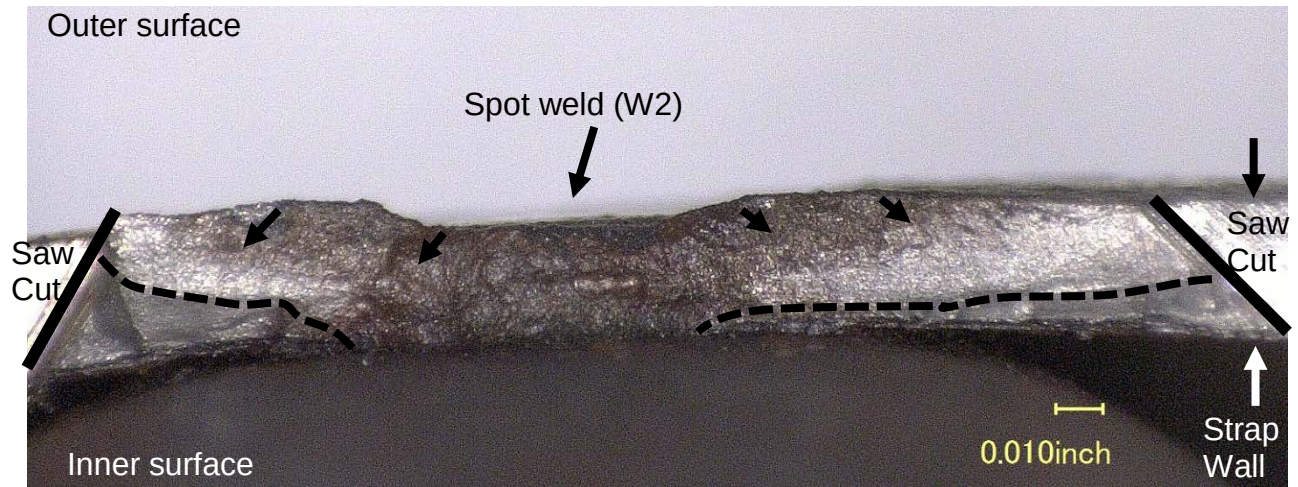
A saw cut was made through the strap portion that intersected the ends of the longest crack, indicated by arrow "W2" in figure 3. Figure 5 shows a photograph of the exposed face of the fracture. The fracture surface in the general area of the spot weld "W2" exhibited a brown tint consistent with an oxidized ferrous surface. The severely oxidized area extended between the outer and inner surface. Scanning electron microscope examination of the mating fracture face revealed a fatigue crack emanated from the outer surface of the strap. Fatigue crack propagation was in the general direction indicated by unmarked arrows in figure 5 and was through the thickness of the strap. The fatigue crack terminated in the areas indicated by a dashed line. The areas outside of the fatigue crack were on a slant plane and contained micro-void coalescence features typical of overstress separation. The length of the fatigue crack portion that intersected the inner surface measured approximately 0.07 inch.

Figure 5. Photograph of a portion of the strap showing a fatigue crack that emanated from the outer surface of spot weld "W2". Fatigue crack propagation was in the general direction indicated by unmarked arrows and terminated in the general area indicated by a dashed line.
