# NATIONAL TRANSPORTATION SAFETY BOARD

## MATERIALS LABORATORY FACTUAL REPORT

Report No. 17-072

Place : Gila Bend, Arizona  
Date : October 5, 2016  
Vehicle : Bell UH-1H, N175SF  
NTSB No. : WPR17LA002  
Investigator : Elliott Simpson, AS-WPR

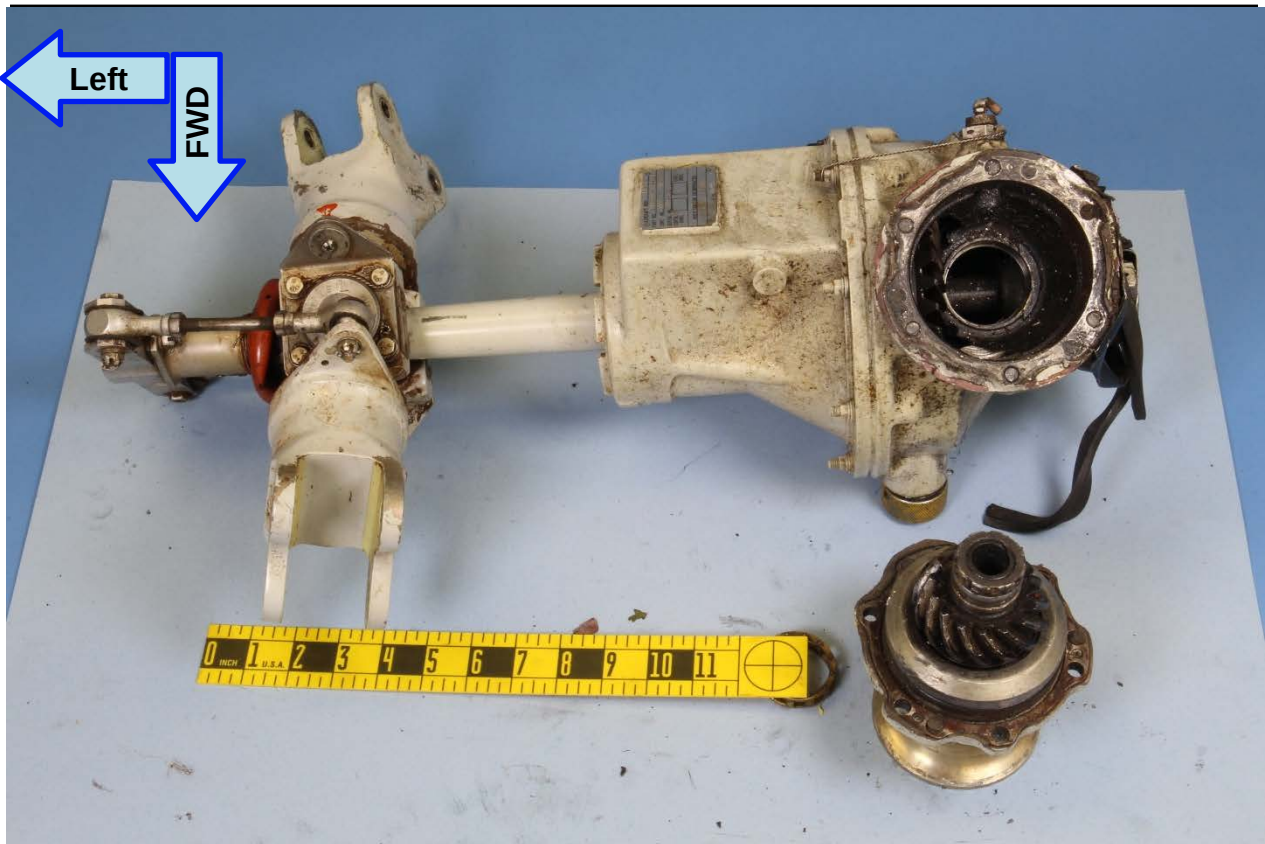
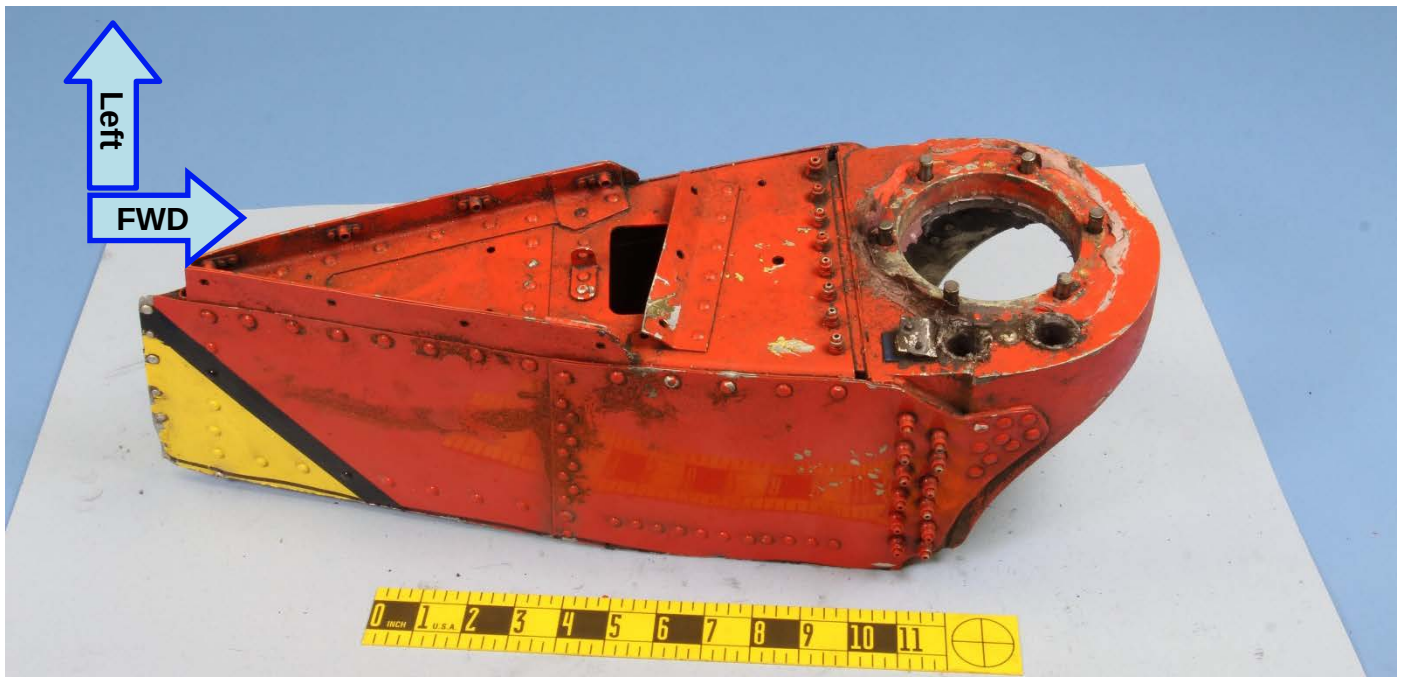
The as-received gearbox and tail rotor components and top of the vertical fin are displayed in figure 1. The input quill was separated from the gearbox at the assembly joint. As viewed in the upper view of figure 1, the input quill would rotate clockwise. The six studs that attach the input quill to the gearbox housing and the vertical fin were fractured at the input quill to gearbox housing joint line. The lower portions of 5 of the 6 studs were retained in their respective mounting holes in the fin. The sixth stud was found loose in the box that it was received in.

Figure 1. Overall views of the as-received components. Tail rotor gearbox with separated input quill at top and the upper portion of the vertical fin with gearbox mounting studs below.

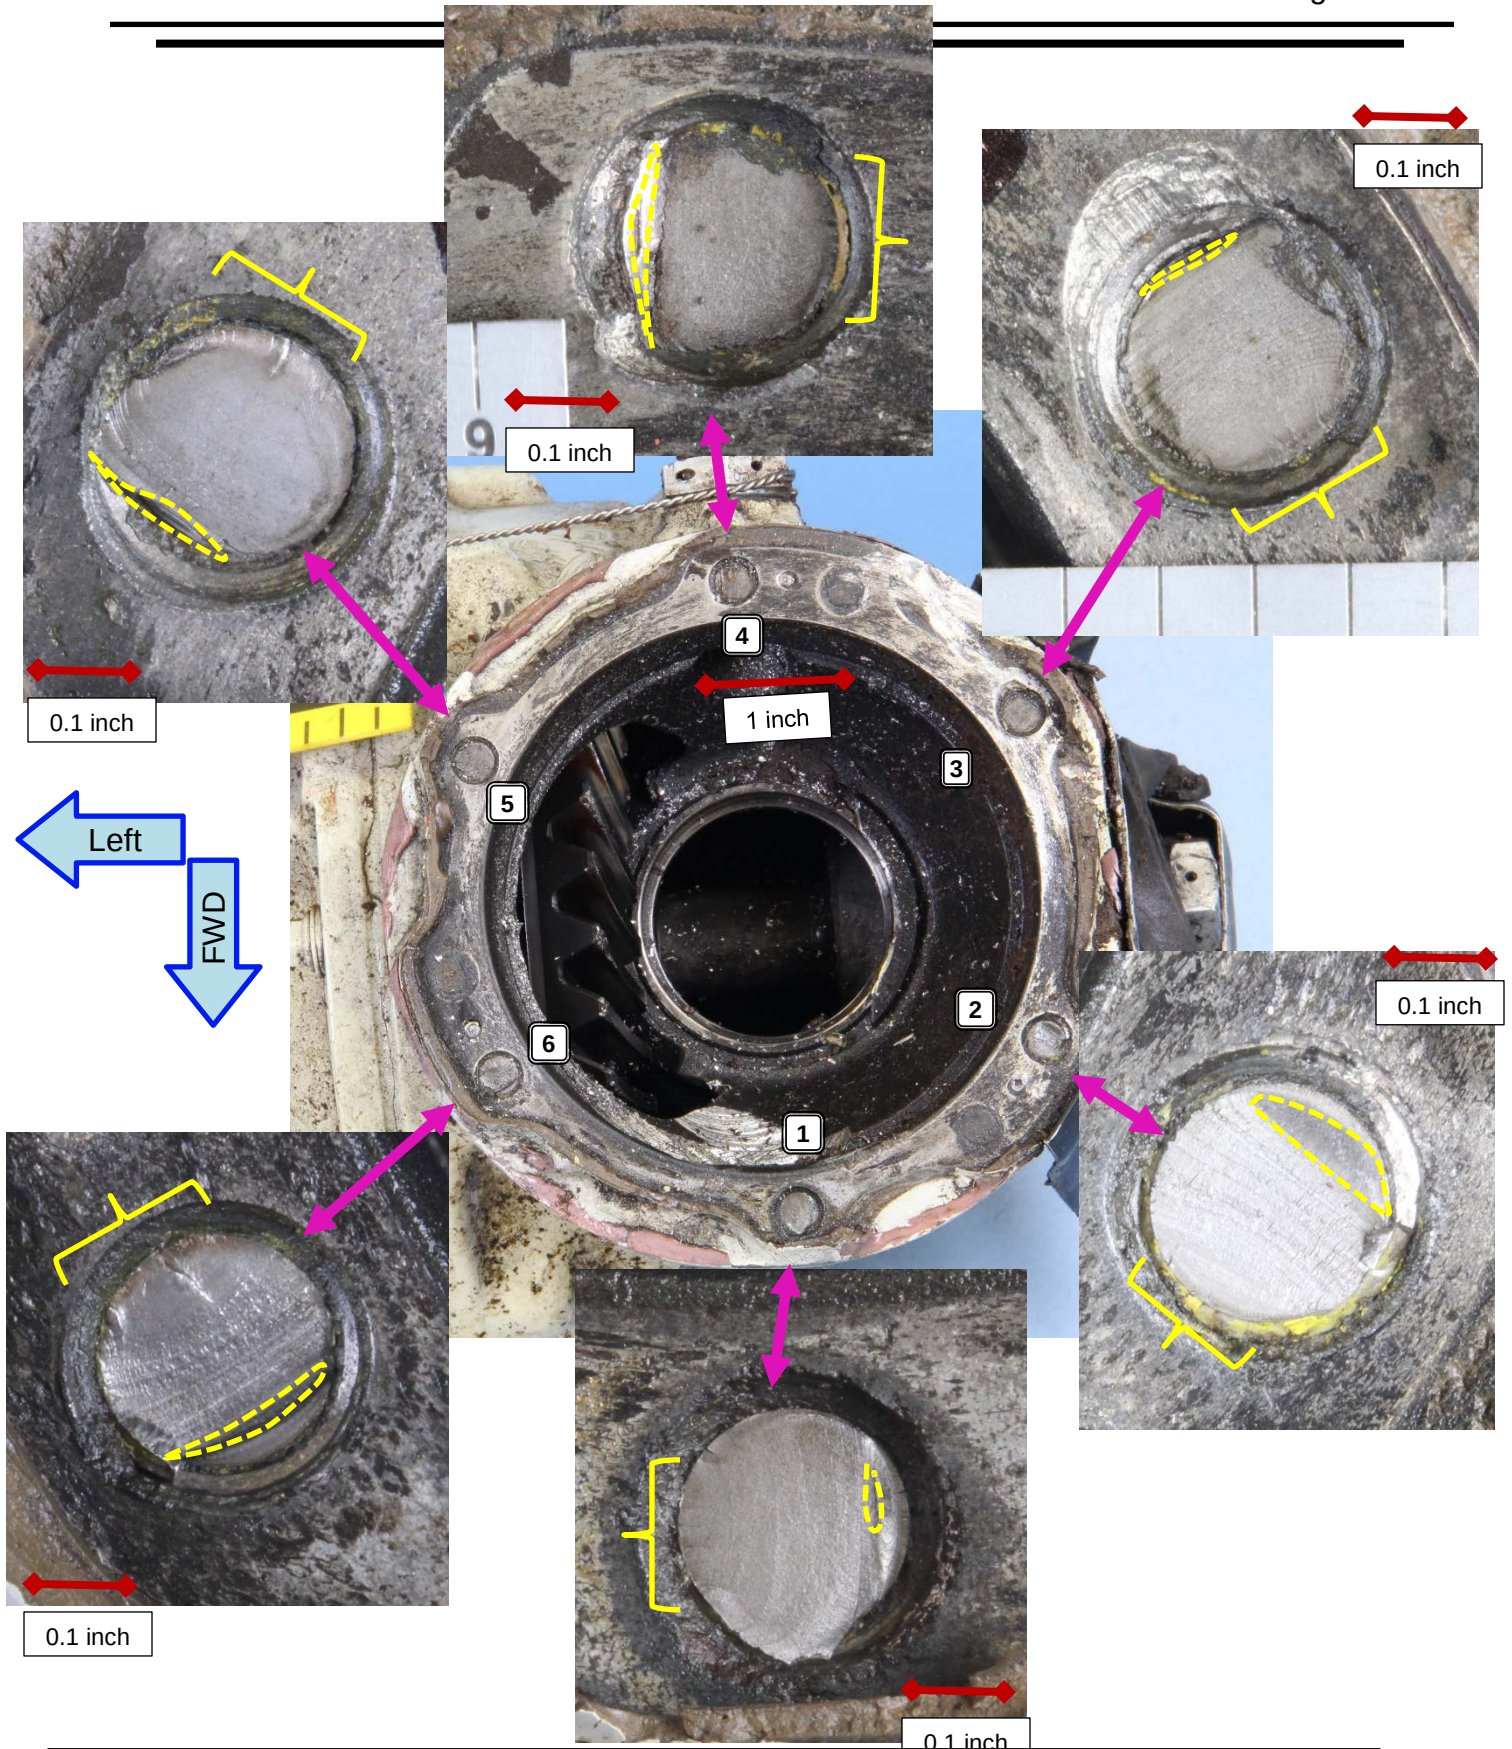
The upper, coarse threaded, portions of the fractured studs were retained in the gearbox case assembly as shown in center view of figure 2. The studs were arbitrarily numbered #1 through #6 in a clockwise direction with #1 at the forward side of the gearbox. With the studs cleaned, all six fractures displayed surface topographies and arrest lines indicating bending fatigue cracking. In each case, the fatigue initiated at multiple origins in the thread root radii on the clockwise side of each stud. Initiations areas are indicated by yellow bracket on each stud in figure 2. The fatigue cracks propagated diametrically across each stud terminating in small overstress regions outlined in yellow. A small area of secondary reversed bending fatigue cracking was also noted at the opposite side of each stud. The fatigue cracks penetrated between 89% and 98% of each stud cross section.

Magnified examinations of the studs and fracture areas found that the fatigue cracks had initiated at multiple locations the either the first, second or third full threads from the grip portion of the stud. The thread roots were smooth and typical of rolled thread roots. Yellow paste material consistent with zinc chromate paste was present in all thread roots.

Figure 2. Central image shows the placement of the fractured studs in the gearbox housing. Enlarged images of the stud fracture faces shown surrounding. Brackets indicate main fatigue origin areas and dashed lines outline the final overstress regions on each stud.

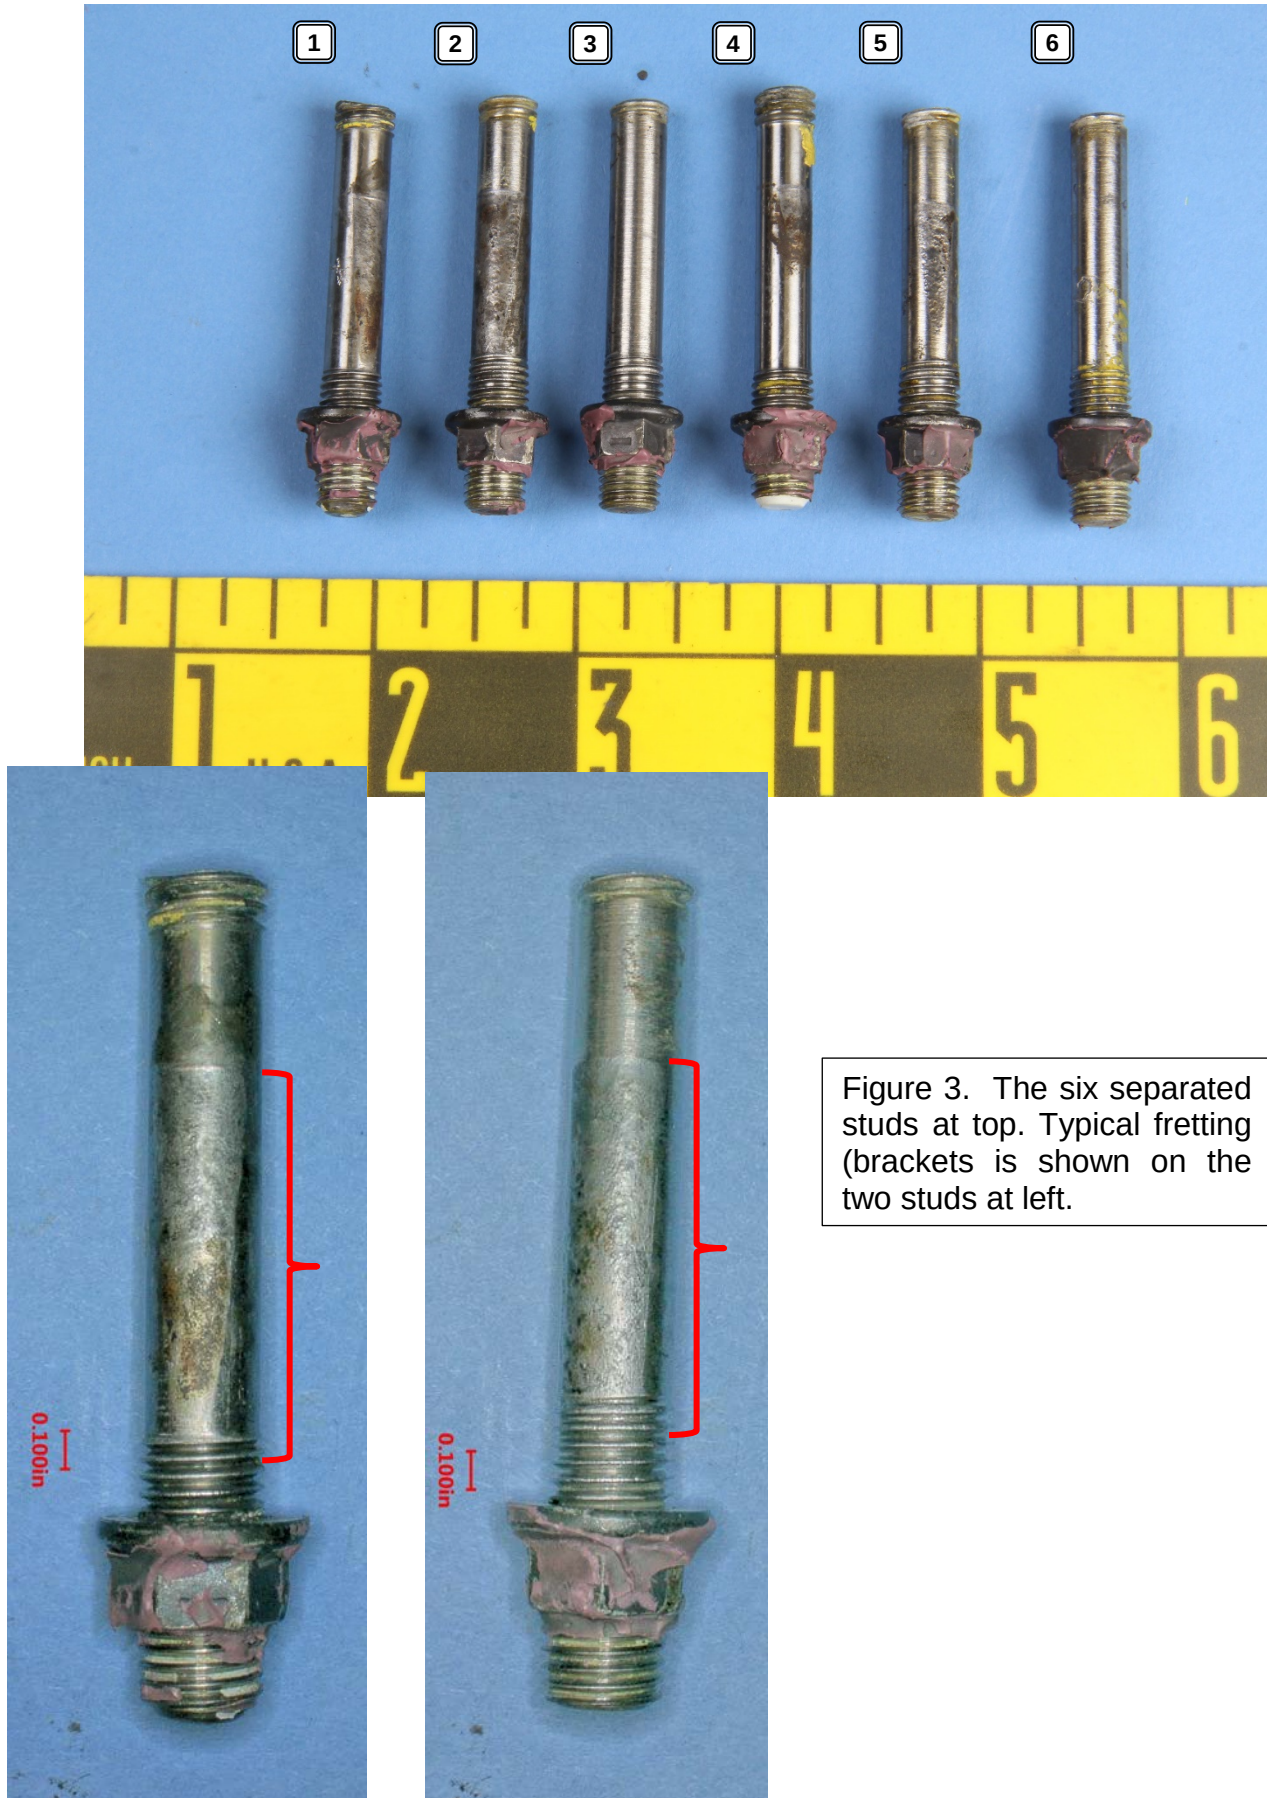
The recovered lower portions of the studs containing the fine threaded ends and nuts, are displayed in the upper view of figure 3, after cleaning in acetone with ultrasonic agitation. Studs #1, 2, 3 4 and 6 had been retained in their original locations in the vertical fin by assembly sealant applied to the nuts. When removed, each stud had two washers between the nuts and the fin structure. Stud #5 was found loose in the receiving box with no washers.

The unthreaded grip sections of all studs were marked by fretting wear on one side and typified by the lower images in figure 3. The fretting was on the grip side opposite the main fatigue crack origin areas. In most cases the wear scars corresponded to the length of the stud that passed through the vertical fin structure and in some instances, was present on the adjacent thread crests. Shorter fretting wear patterns were present on two studs. The fretting was not present on the stud lengths that passed through the input quill support housing.

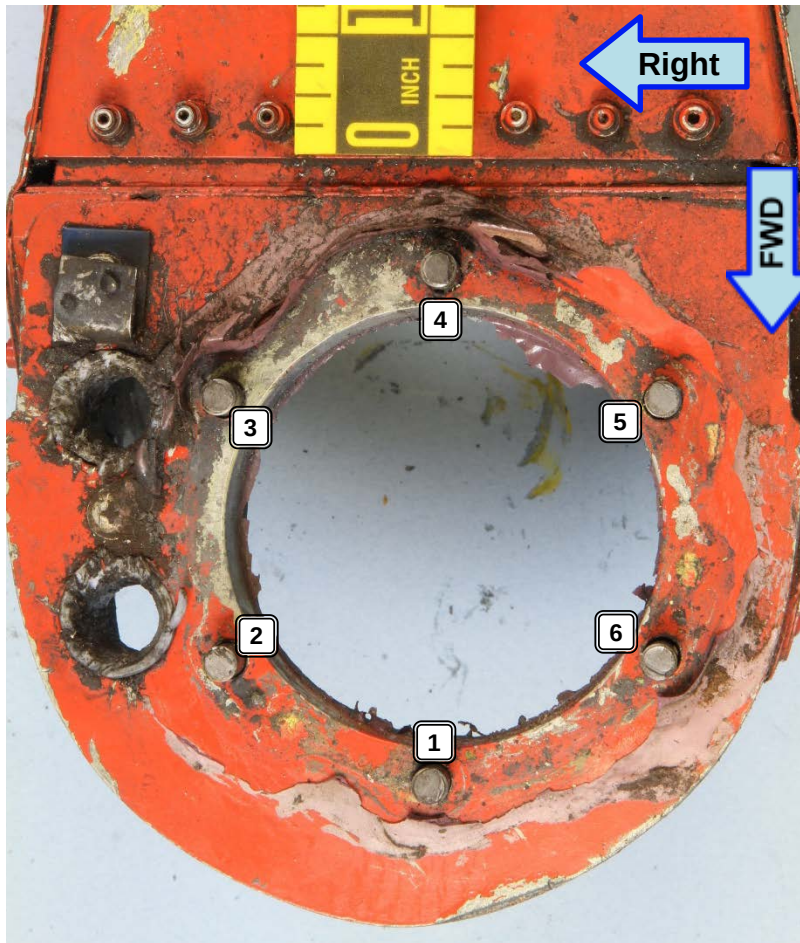
The corresponding locations on the fin structure were worn and slightly out-of-round, as shown in figure 4. Examining the interior of the fin holes also showed wear and damage corresponding to the fretting on the studs, as shown in figure 5.

Figure 4. Top down views of the gearbox mounting area on the top of the vertical fin with studs numbered at left. Lower two views show the wear (between yellow arrows) to the #1 stud hole.
