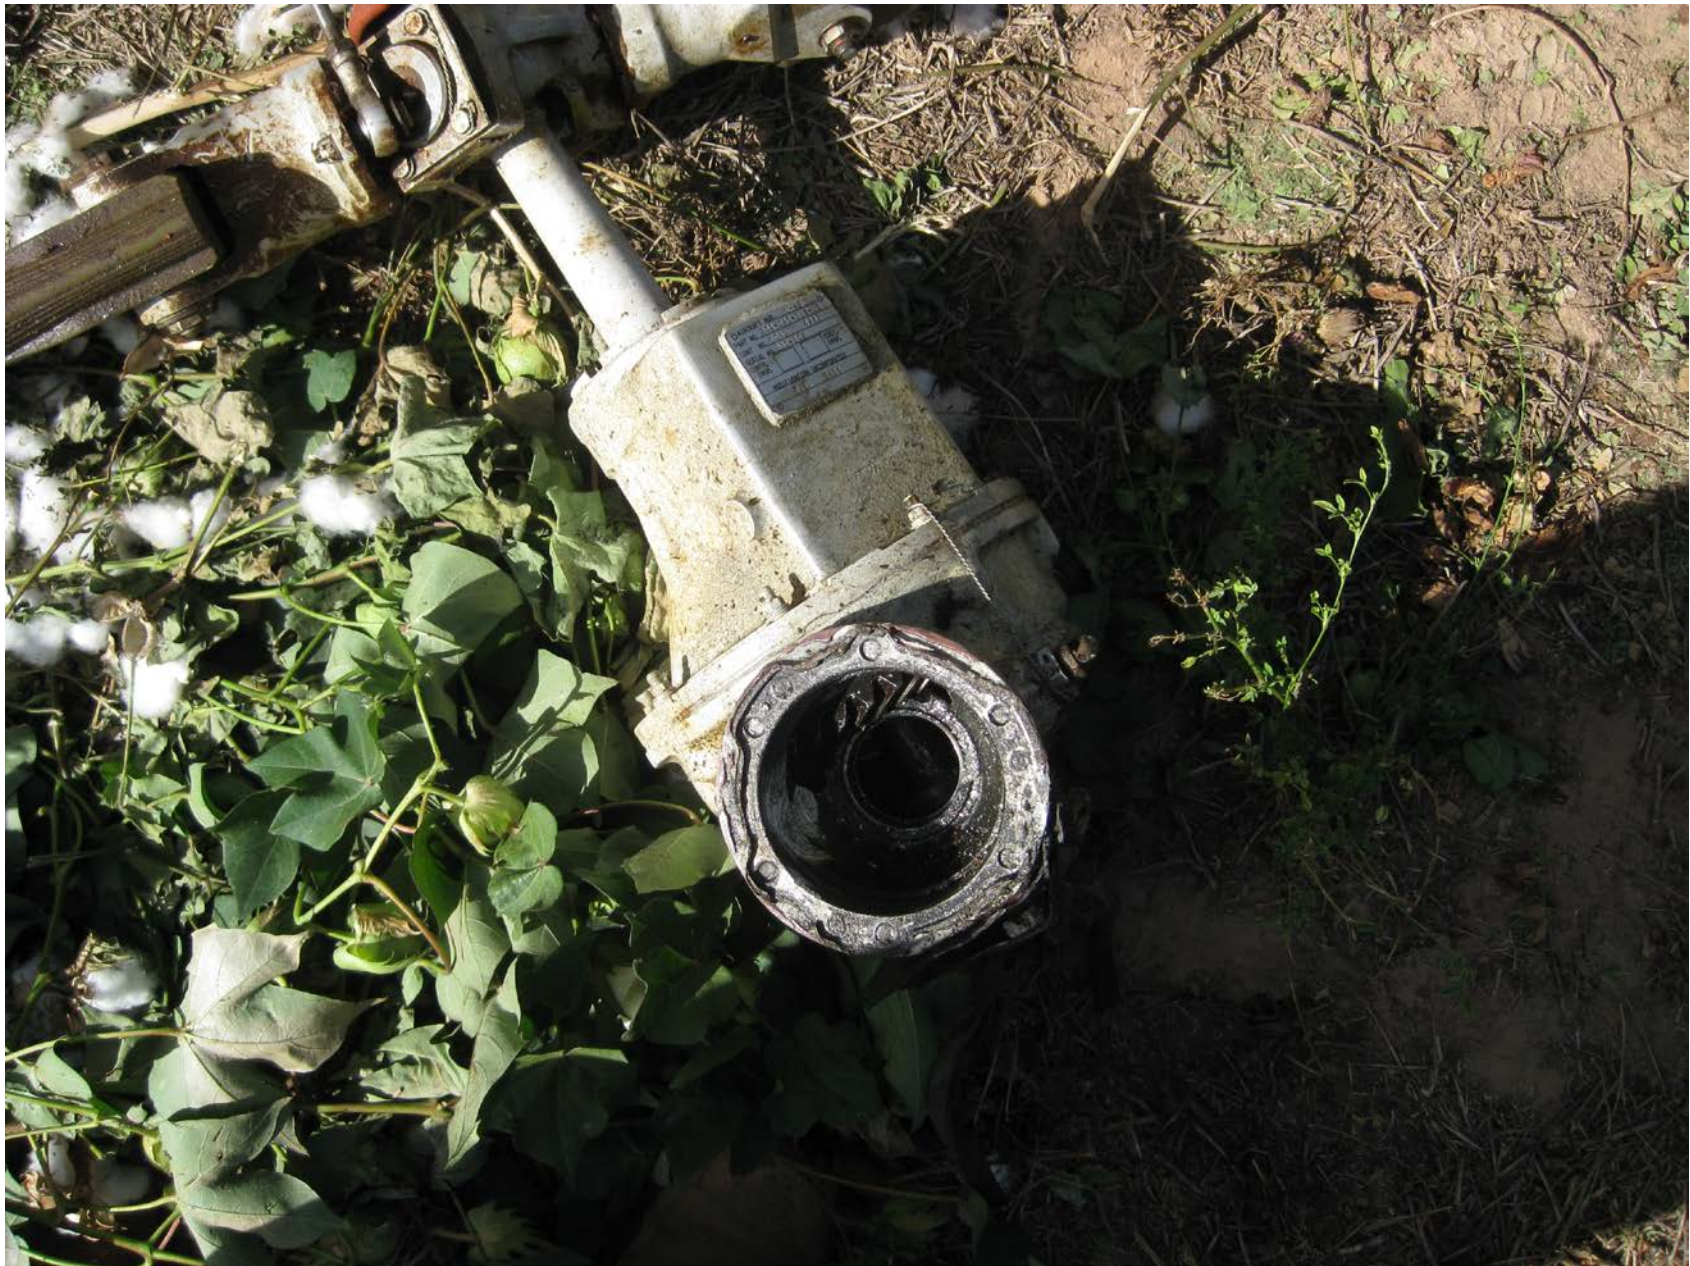
**Photo 1 – Tail Rotor Gearbox at Accident Site**

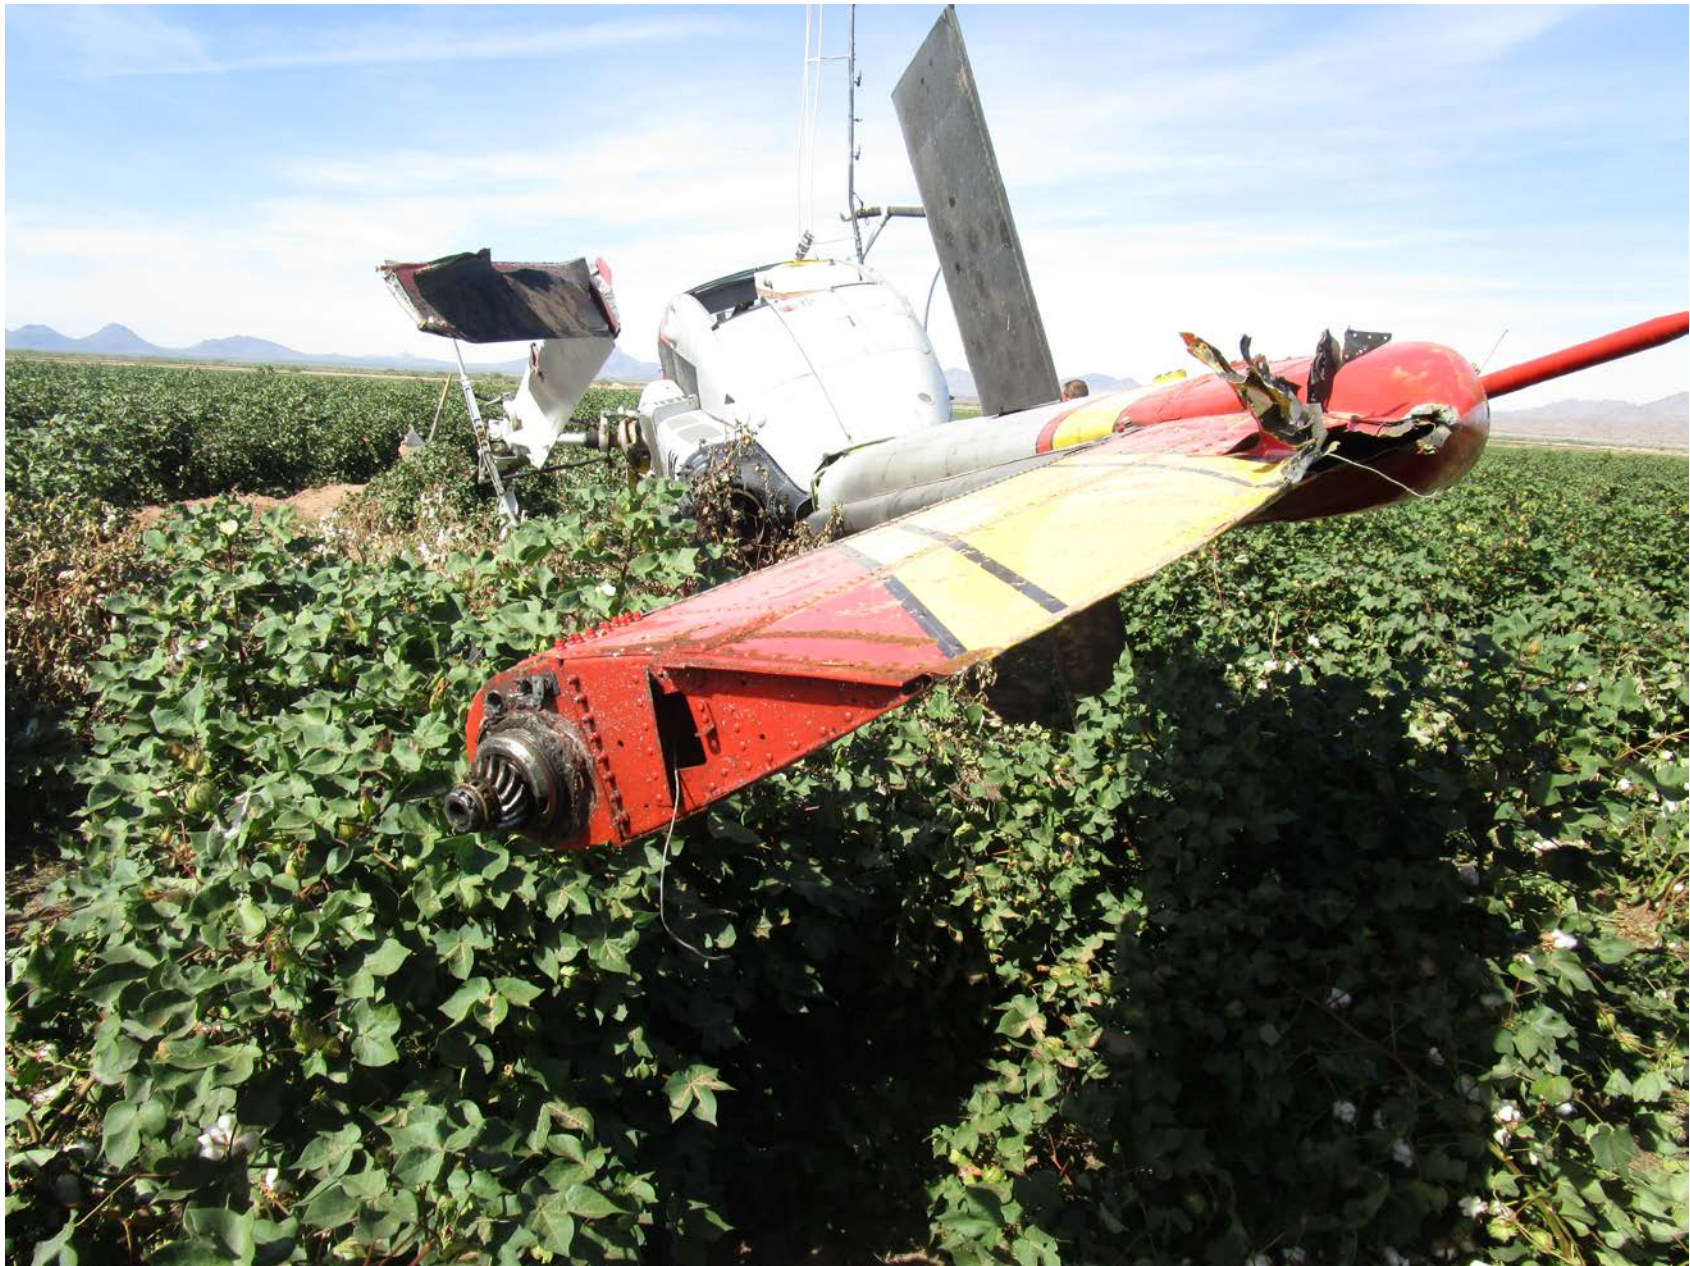
**Photo 2 – Vertical Fin at Accident Site**
