## **AIRPLANE EXAMINATION**

**WPR17LA003**

**Roberts, Idaho**

**Kolb Sport 600; N914NK**

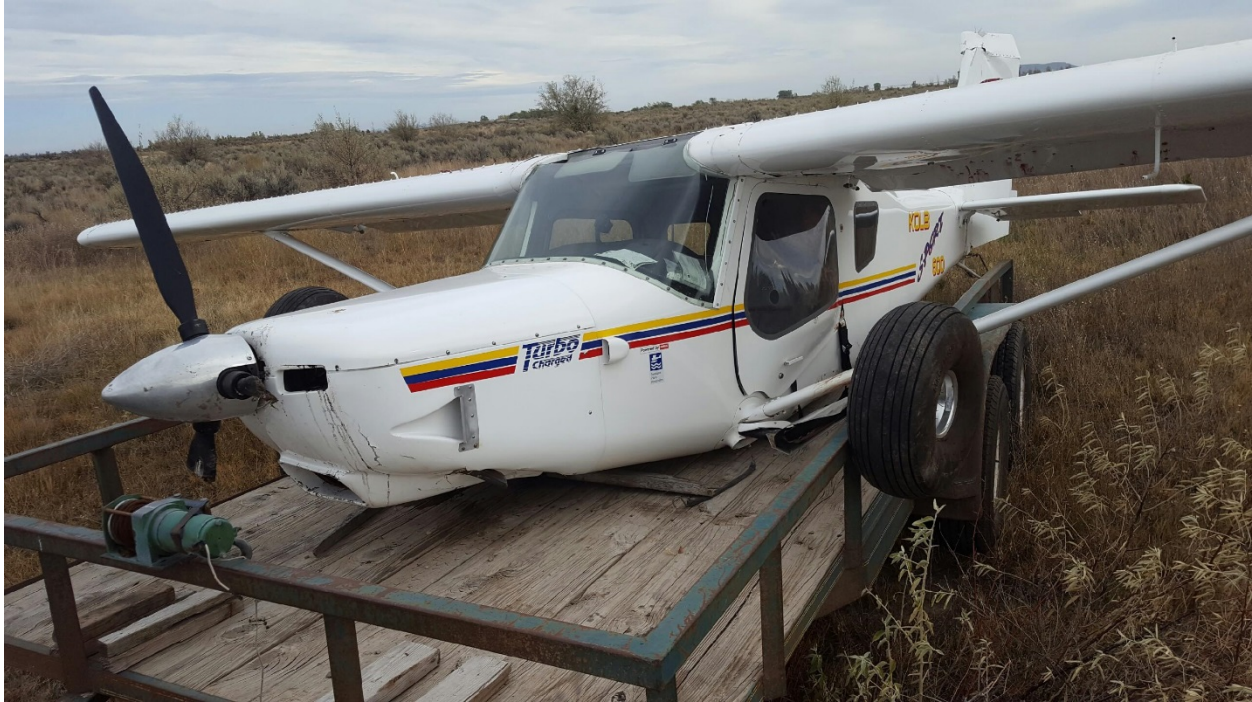
According to the pilot, he departed runway 24 after a successful pre-flight inspection and engine run-up. As the airplane reached approximately 100 feet above ground level, the pilot “felt” the airplane lose power. He then lowered the nose and initiated a left turn teardrop maneuver to land on runway 06. The pilot engaged the airplane’s auxiliary fuel pump to maintain engine power, but the propeller stopped rotating a few seconds later. Towards the end of the turn, the pilot determined that the airplane would not reach the dirt landing strip and leveled out early to land parallel to the runway. The airplane touched down about 200 feet south of the runway in sage brush and subsequently impacted debris before it nosed over inverted and came to rest.

Postaccident examination by a Federal Aviation Administration inspector revealed substantial damage to the rudder. The inspector reported that the right wing fuel tank was approximately half full.

Photo 1: Airplane at Rest

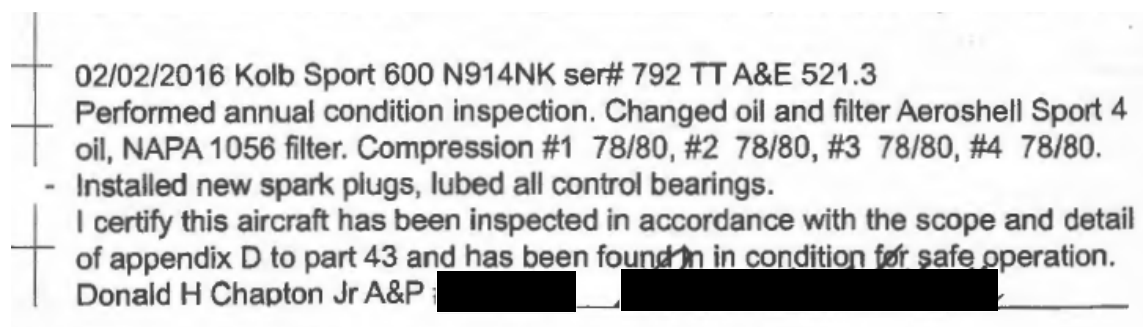
Engine Manufacturer: Rotax Engines  
 Engine Model Number: Rotax 914UL  
 Engine Serial Number: 4418601  
 Recent Inspection: Annual – 521.3 hours  
 Recent Recorded TSMOH: 577 hours  
 Time Since Inspection: 55.7 hours

According to the Rotax maintenance manual, the Rotax 914UL must be overhauled at 1,000 total flight hours or 10 years, whichever is first. At the time of the accident, the engine was 12 years old.

Photo 2: Recent Condition Inspection

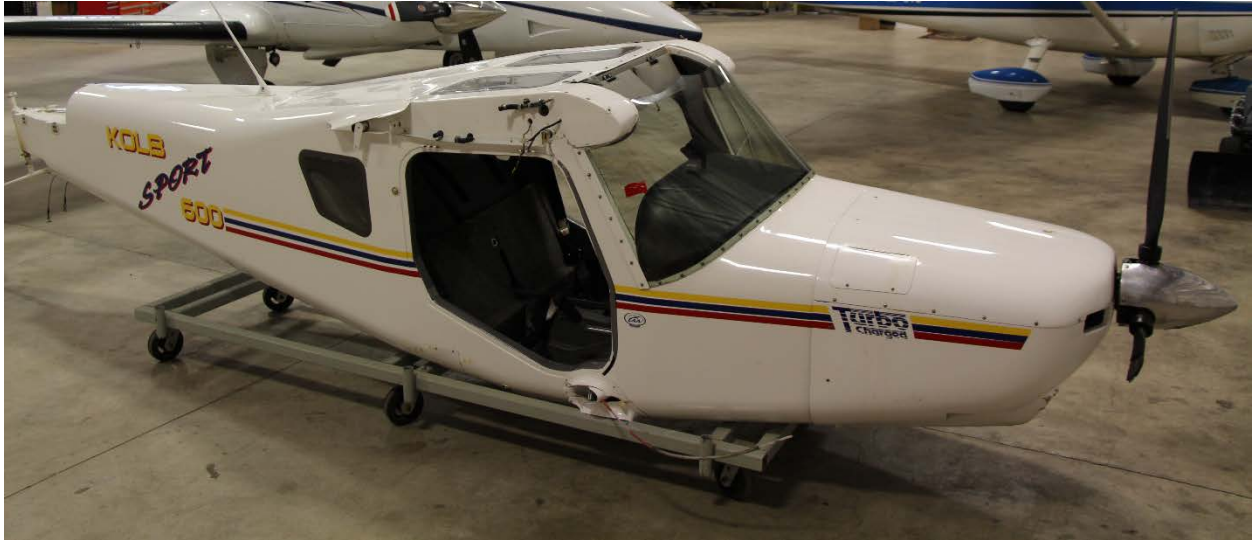
Photo 3: Airplane After Recovery

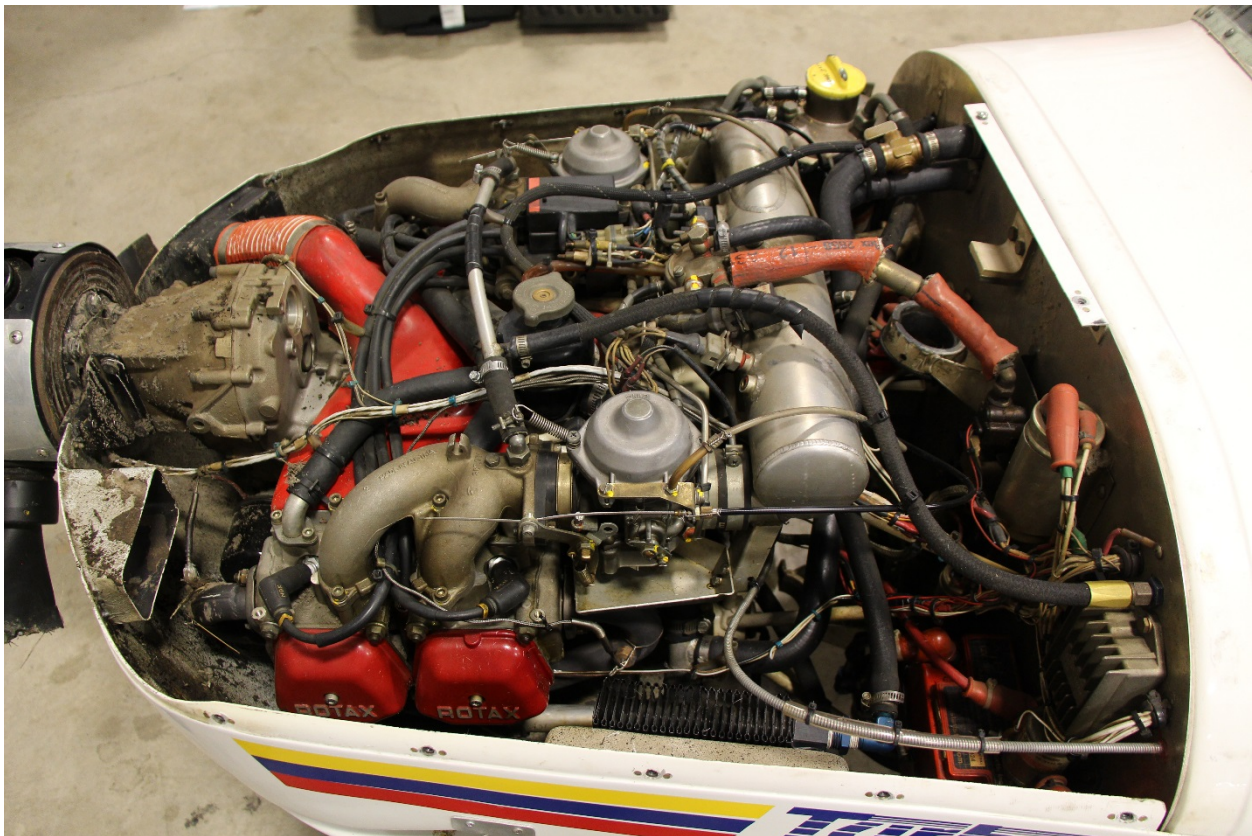
Photo 2: Engine as Received

The engine sustained minimal damage with the exception of the radiator, which was crushed aft and displayed a leak. Two propeller blades were separated at the propeller collar and the third blade remained intact.

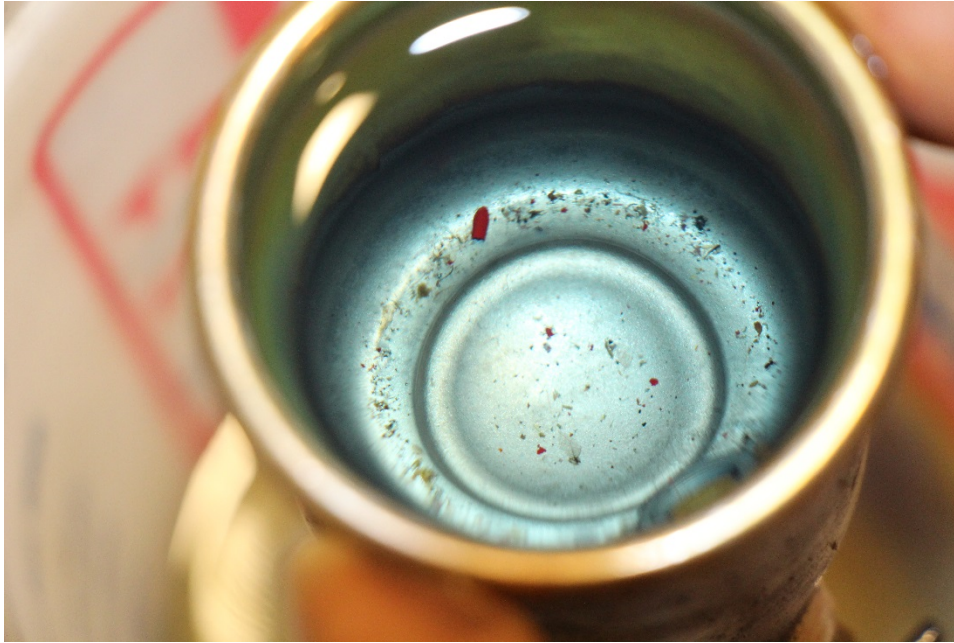
The gascolator was disassembled and several ounces of fuel were drained into a plastic container. The fuel bowl contained dirt. The fuel filter screen displayed dirt and debris approximately 1 inch in length by 0.5 inches wide.

Photo 5: Gascolator Bowl

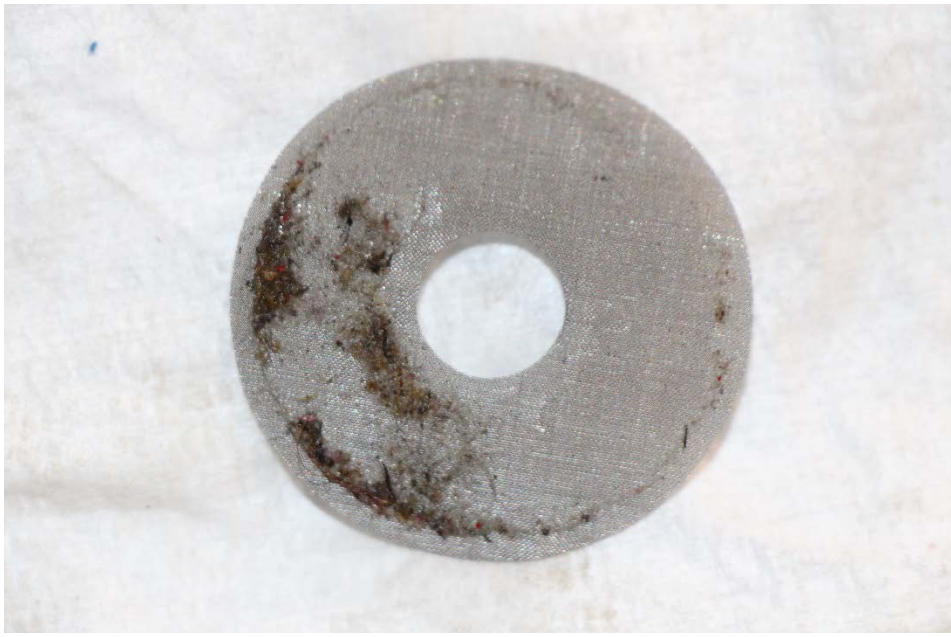
Photo 6: Gascolator Fuel Filter Screen

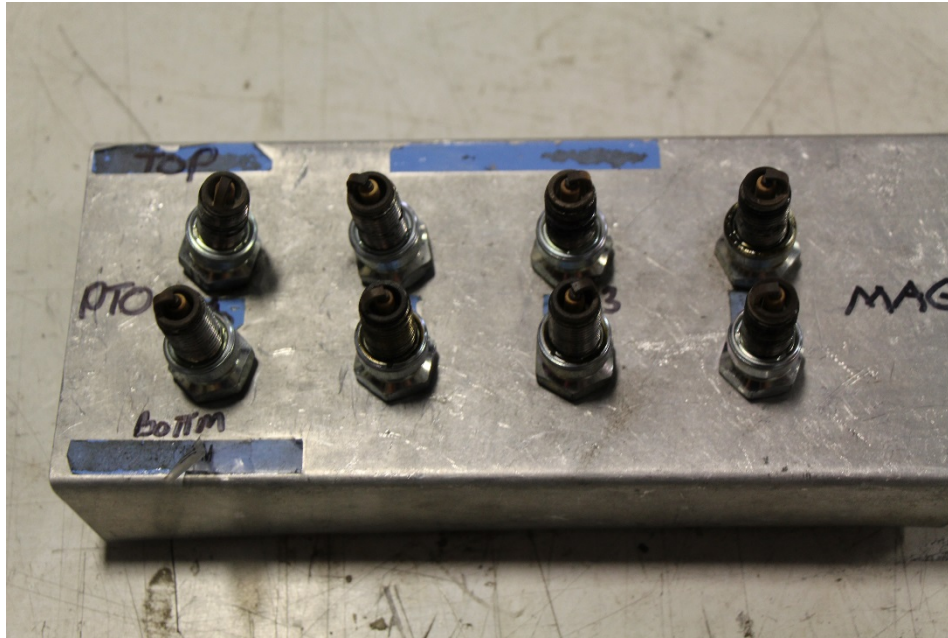
The spark plugs were manufactured by NGK (part no. DPR8EA9), and were removed and examined. The top plugs displayed normal wear. The no. 1 – 3 top spark plug ground electrodes gaps measured 0.035, no. 4 measured 0.032. The bottom plugs all exhibited normal wear. The bottom spark plug gaps were as follows: no. 1 – 0.035; no. 2 – 0.032; no. 3 – 0.034; no. 4 – 0.034.

Photo 7: Sparkplugs
