# **ENGINE EXAMINATION REPORT**

**WPR17LA012**

Location: Lovelock, NV  
Date: 10/20/16  
Aircraft: Lancair 4P, N4YB  
NTSB IIC: Shaver

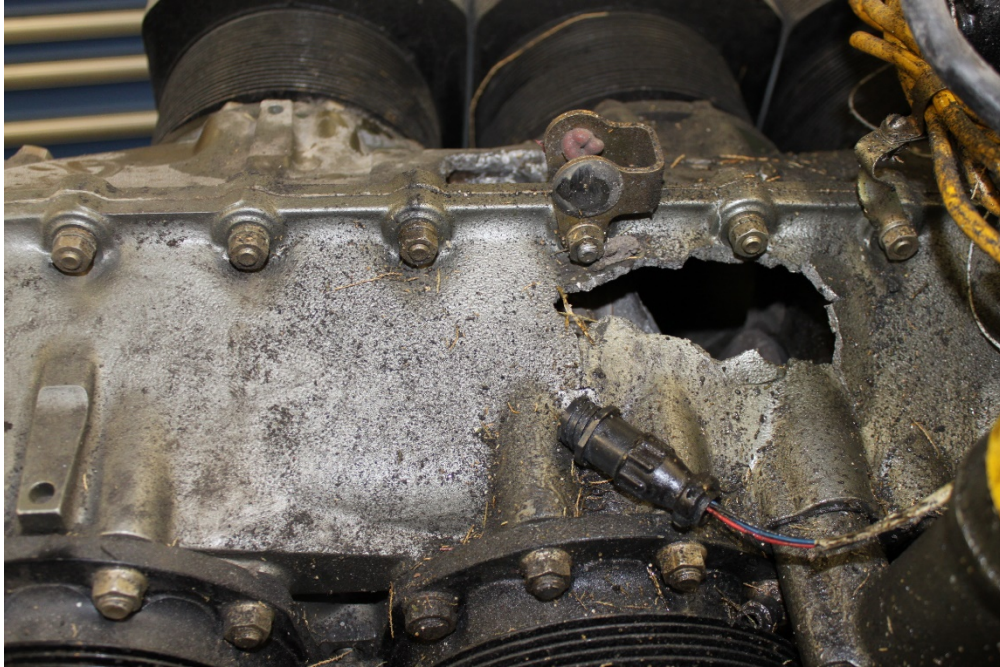
The engine had a hole upper portion of the crank case, above the #3 and #4 connecting rods. A portion of the cam shaft was protruding from the oil sump pan.

Figure 3 - Hole in case

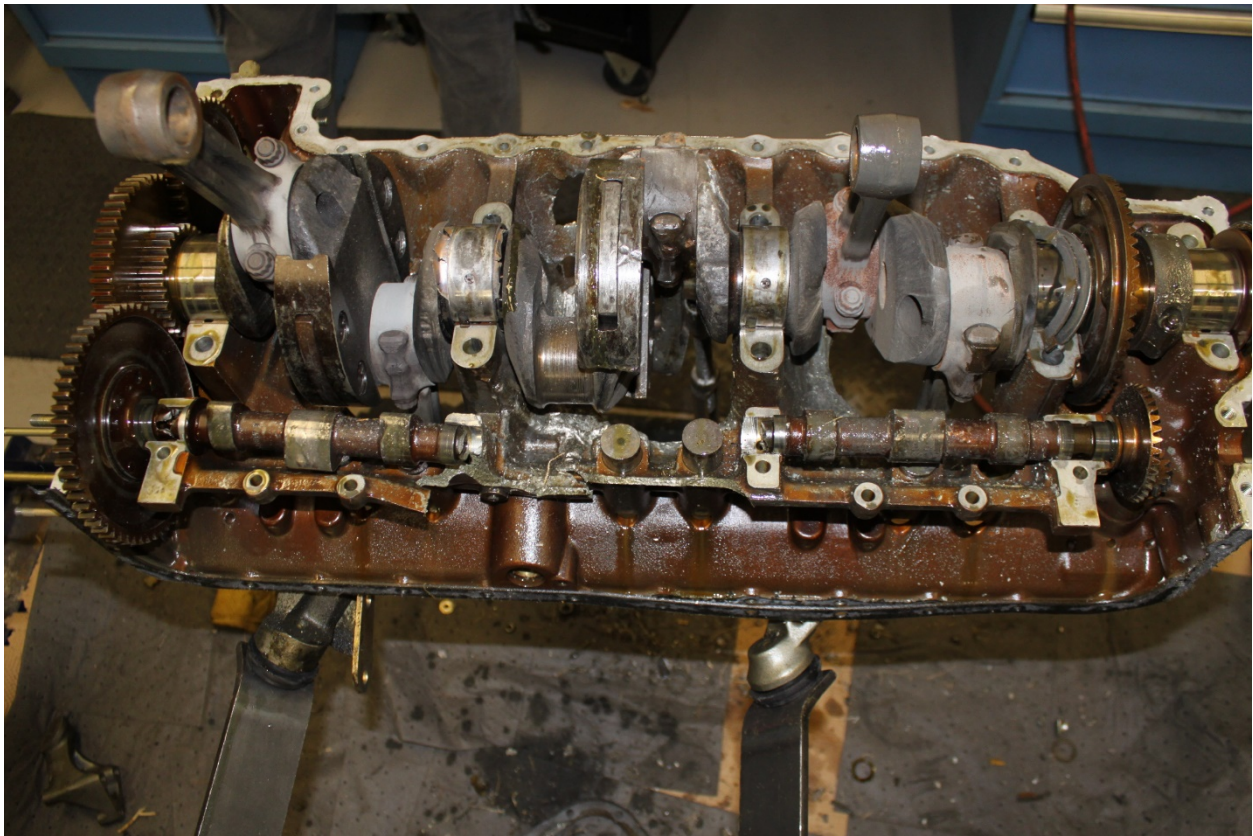
- The cam shaft was fractured into 4 pieces, most likely from impact of a connecting rod during the failure sequence.
- #3 and #4 pistons were completely disintegrated.

Figure 4 - Inside of case

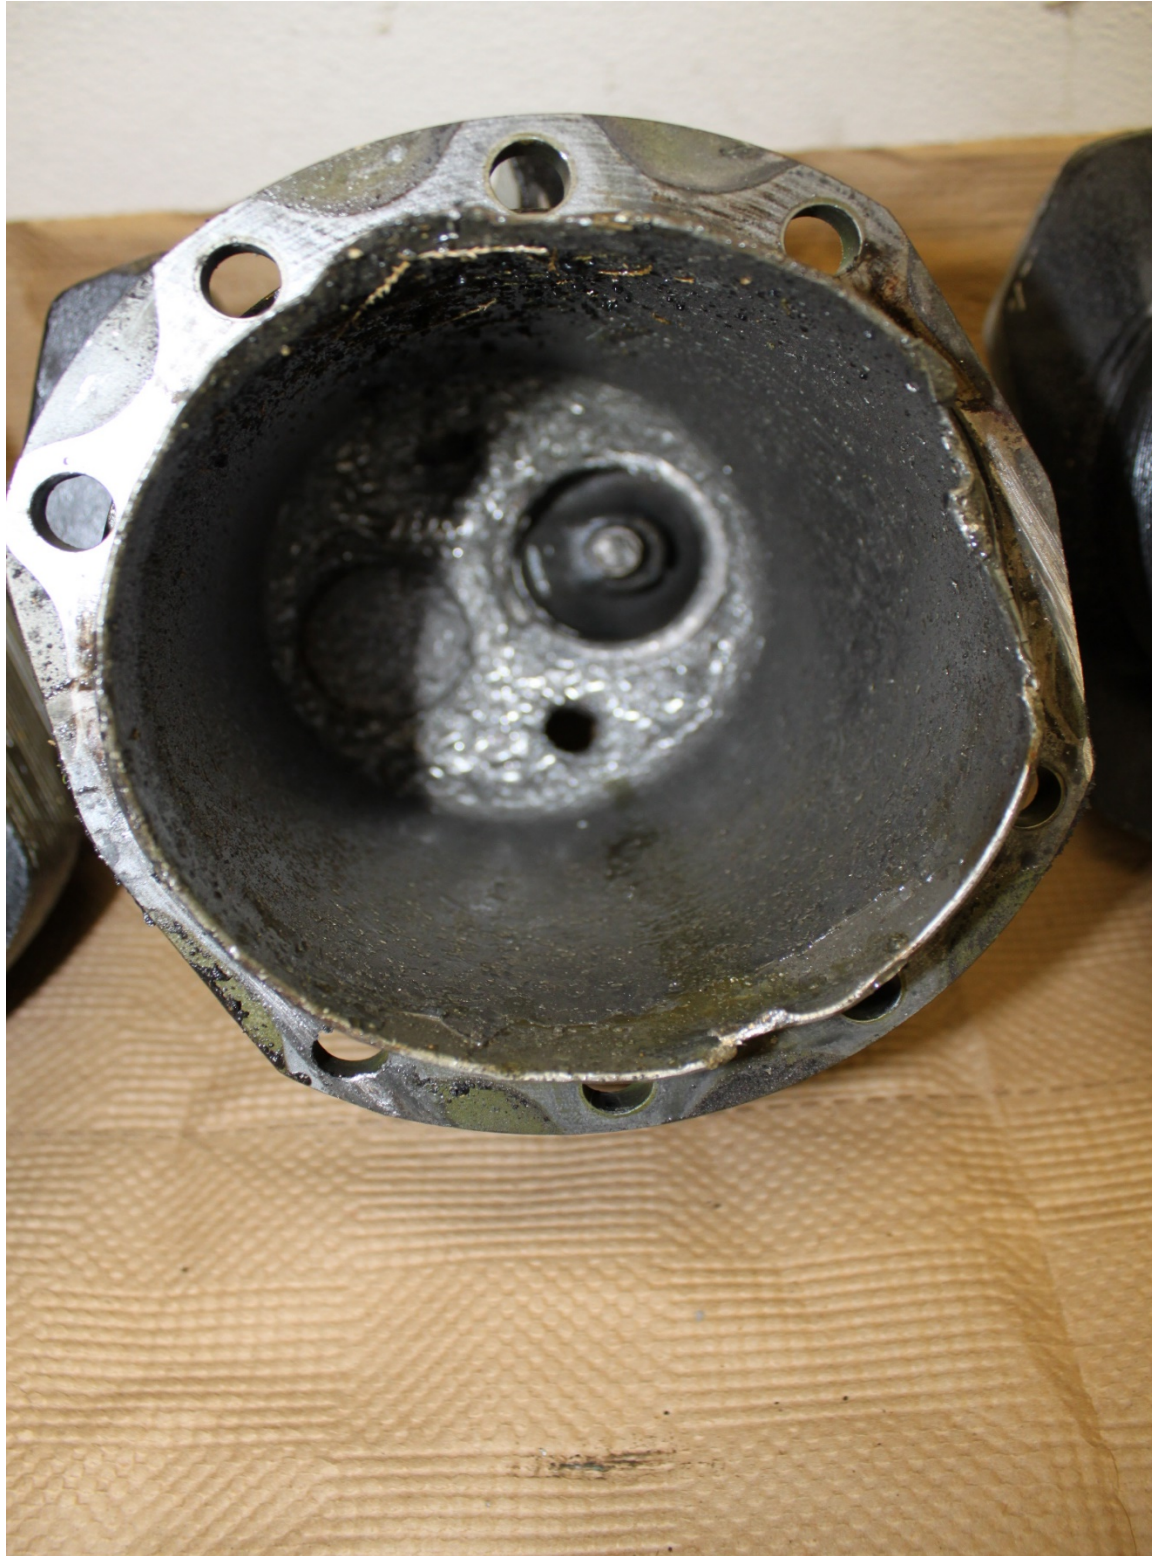
Figure 5 - #3 cylinder

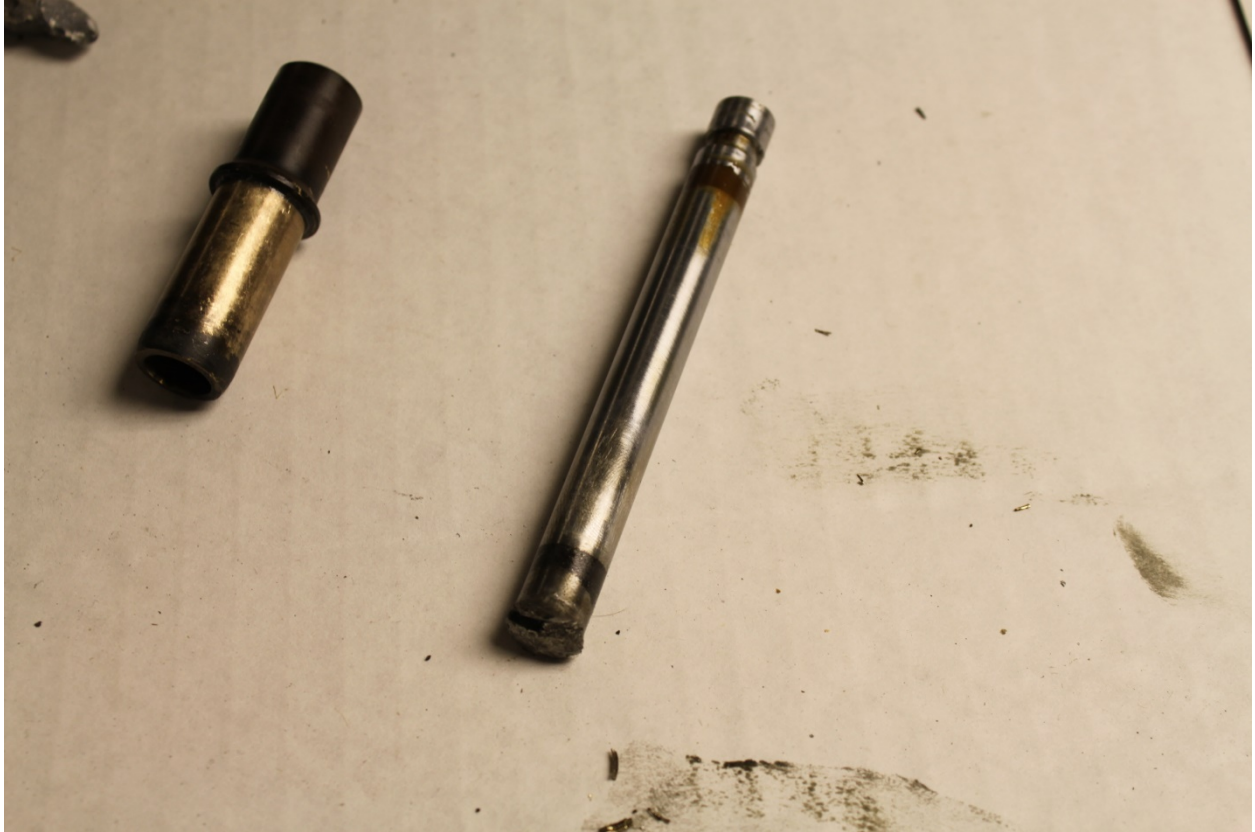
- #3 intake valve was broken just below the guide sleeve. The fracture surface was damaged from impact forces created by the piston and components during the engine failure. Fracture initiation could not be determined. The separated valve head could not be located in the engine. The valve stem was tested for metal hardness via Rockwell Hardness Test. Minimum hardness for the part is 32 HRC and the part tested at 36.5 HRC.

- The valve guide was not a Continental part. Until the rest of the logbooks are received, we don't know what had been done to the engine recently.
- Don't believe that the initiating event was oil starvation. Believe that the intake valve may have fractured, but without finding the valve head we can't prove.

Figure 6 - Valve Stem and Guide

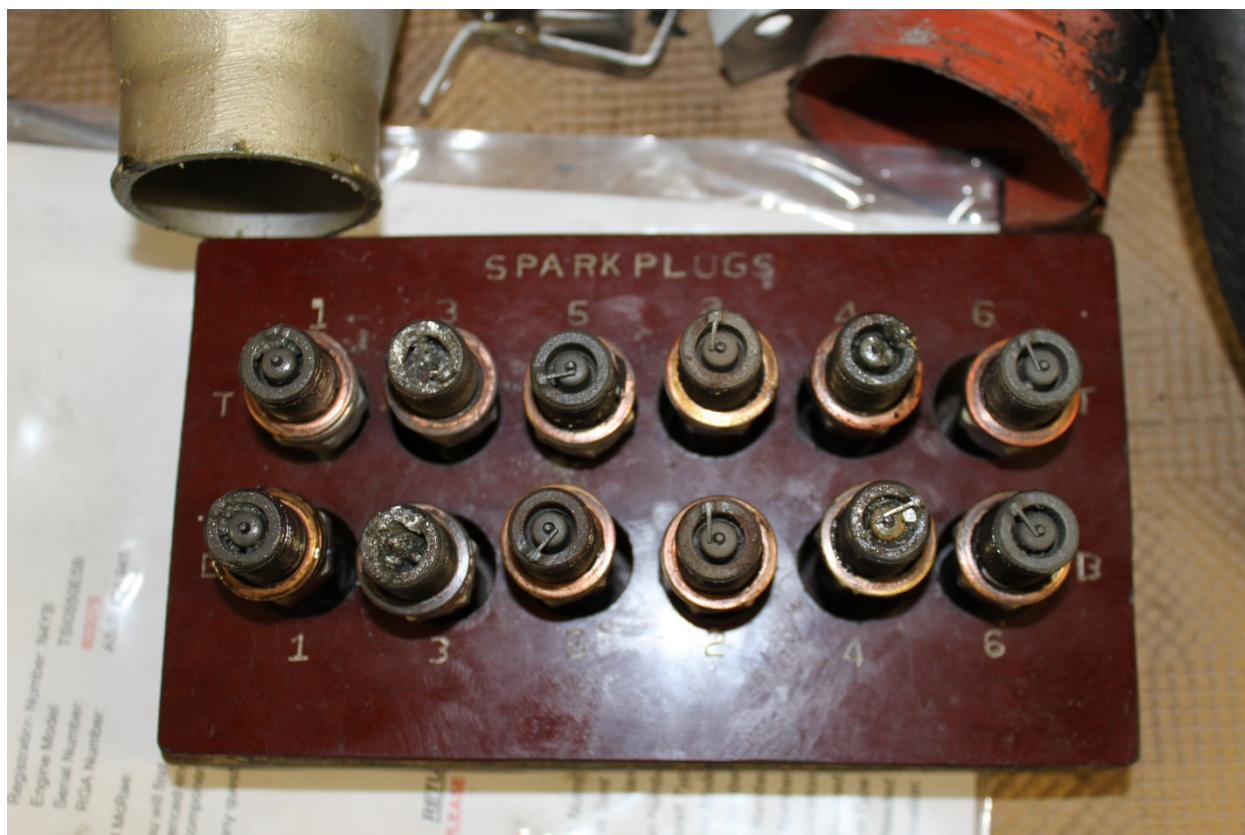
- Both turbocharger compressors rotated freely.
- The starter had some type of silicon sealant around the flange.
- Spark Plugs – Tempest Fine wire - All top and bottom plugs had metal particulate imbedded in the electrodes. #3 top and bottom plugs were severely damaged from both heat and impact. #4 plugs were also damaged.

Figure 7 - Spark plugs
