# Continental Motors

## ENGINE EXAMINATION REPORT

| ENGINE MODEL | TSIO-550-E5B |
| FILE NUMBER | 16-244 |

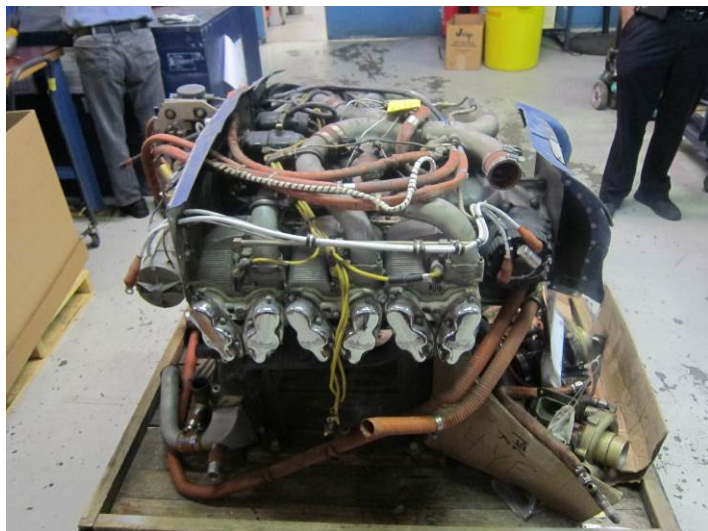
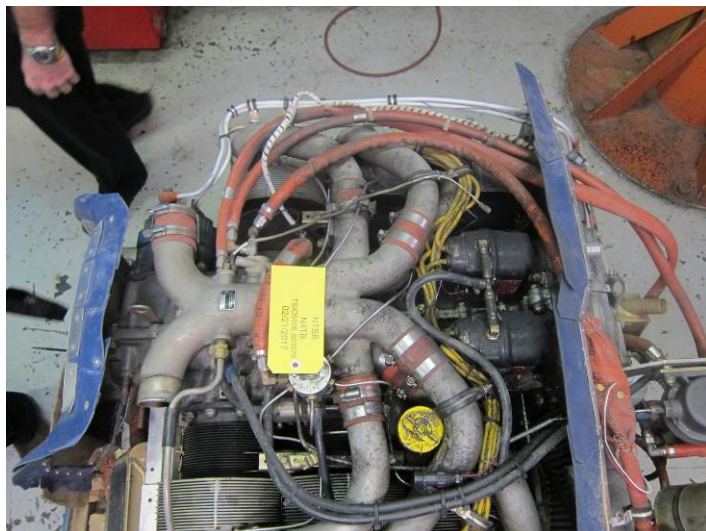
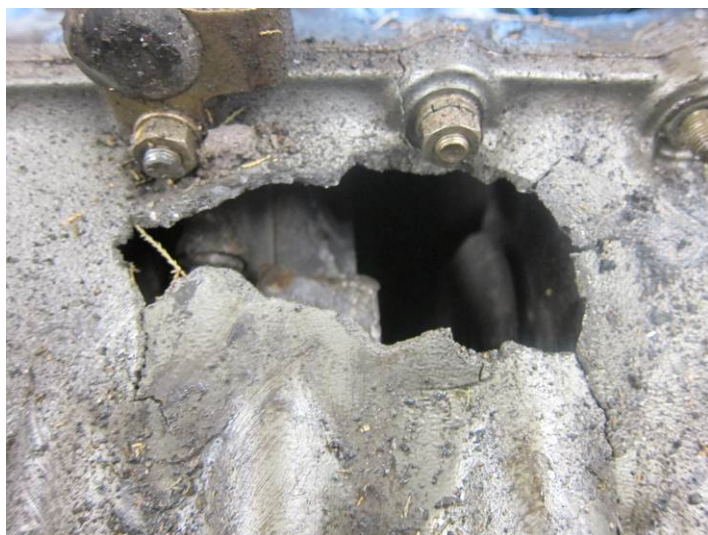
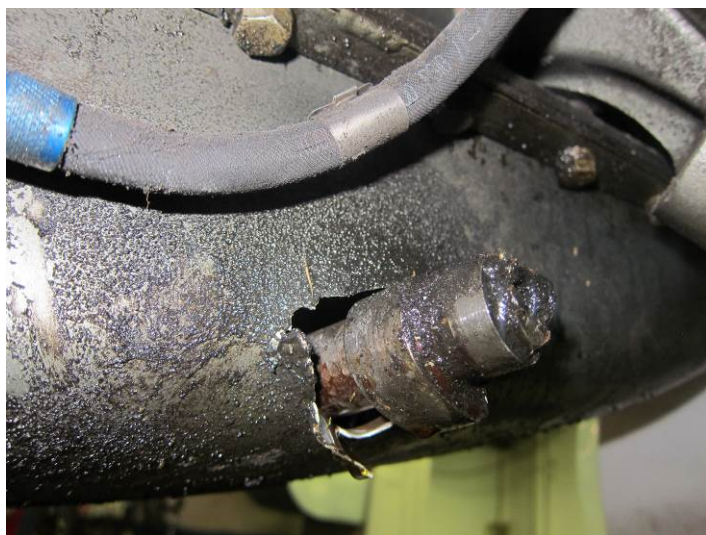
The exhaust system had been removed from the engine to facilitate shipment of the engine, but the components were returned within the engine crate. The engine exhibited holes in the top of the crankcase above the number three and four connecting rod journals. A section of the camshaft was noted sticking out of the right side of the oil sump.

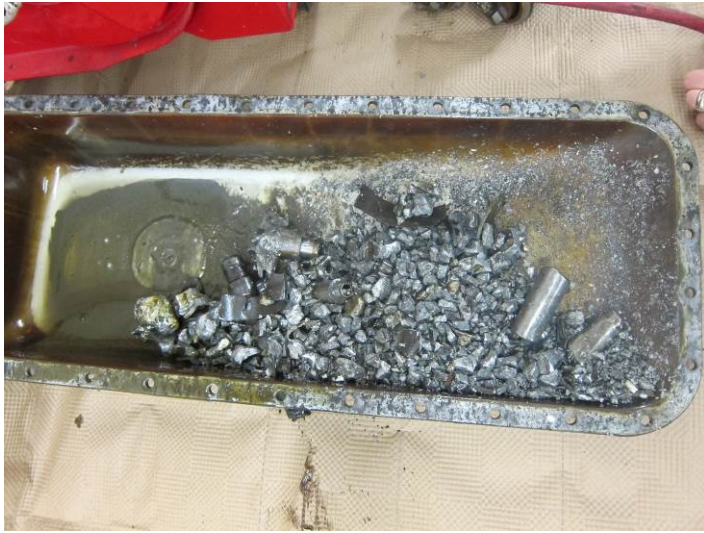
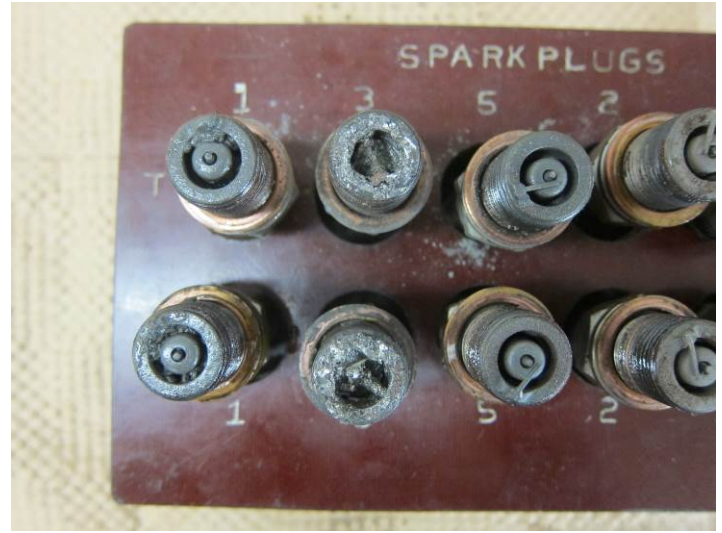
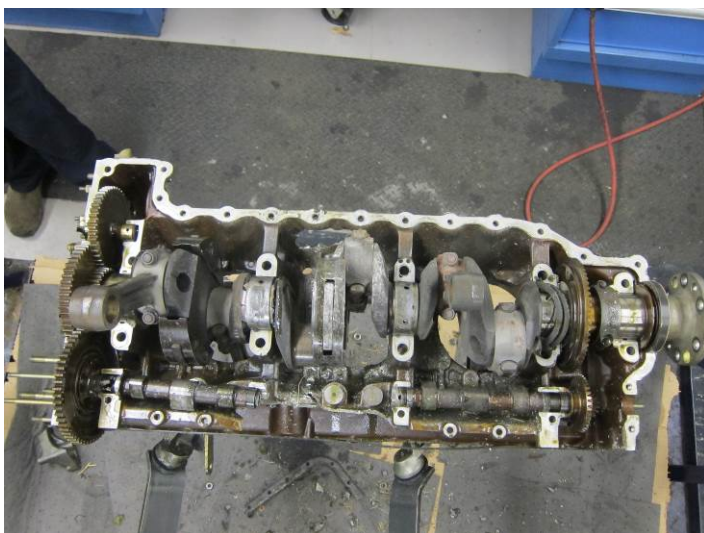
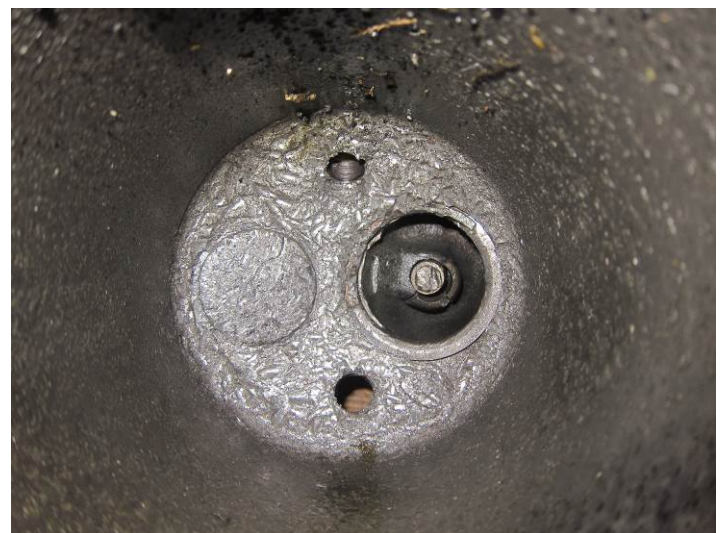
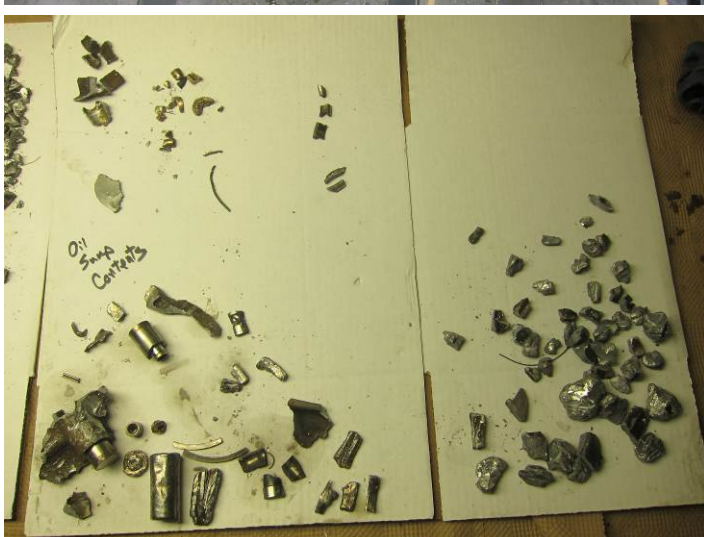
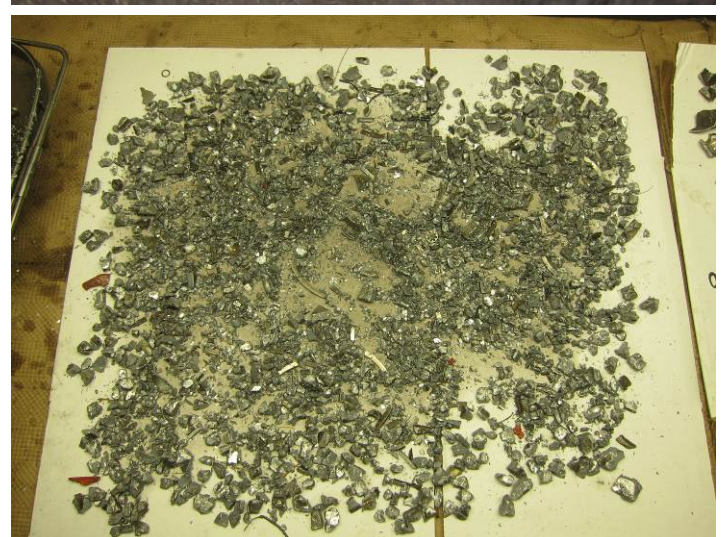
The engine was disassembled and a large amount of metal was located in the oil sump and throughout the engine. The number three and four pistons were fractured into several pieces that were located within the engine. The number three connecting rod had separated from the crankshaft. The connecting rods and crankshaft journals exhibited signs of thermal distress. The camshaft was fractured into four pieces. The top and bottom spark plugs from cylinder three exhibited debris damage and the electrodes were missing. The combustion chamber of cylinder number three exhibited impact marks from debris. The intake valve in cylinder three was broken at the bottom of the valve guide. The broken intake valve head was not located within the engine and the fracture surface of the valve stem was severely damage from debris. The number three intake valve guide was noted as being a Superior Airparts guide, PN: SA631496. A CMI metallurgist visually examined

the parts and determined that further examination would prove to be inconclusive due to the mechanical damage the parts sustained.

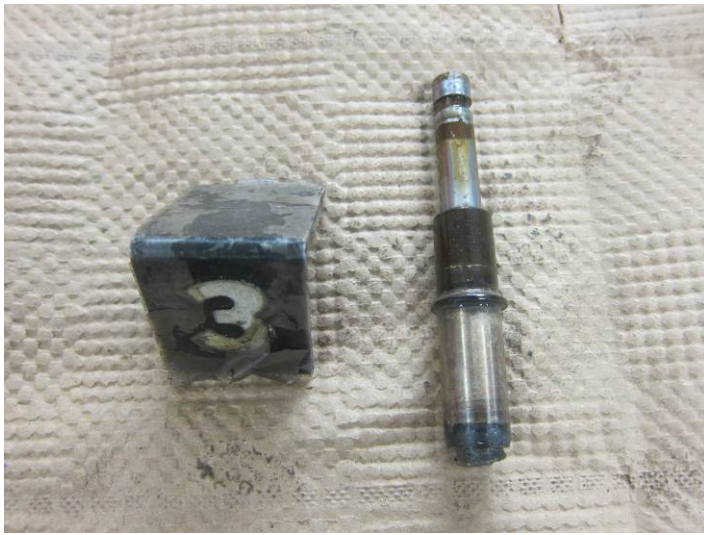
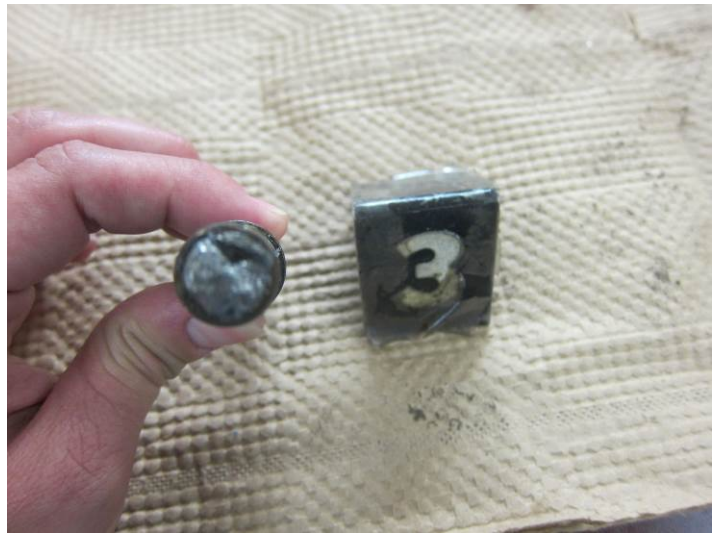
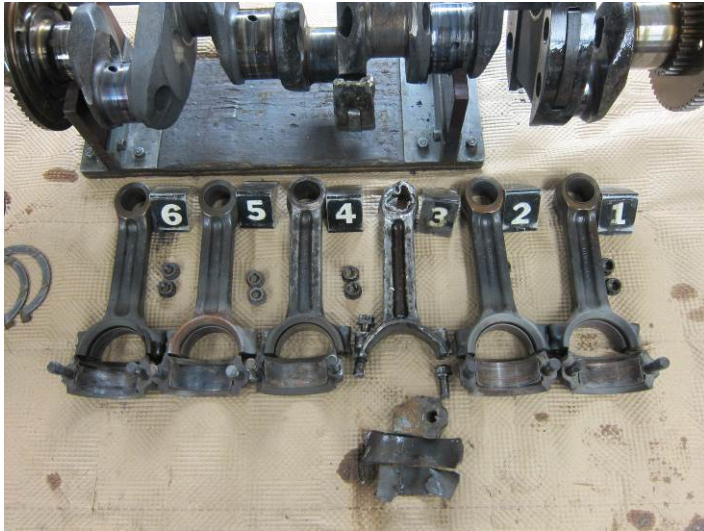
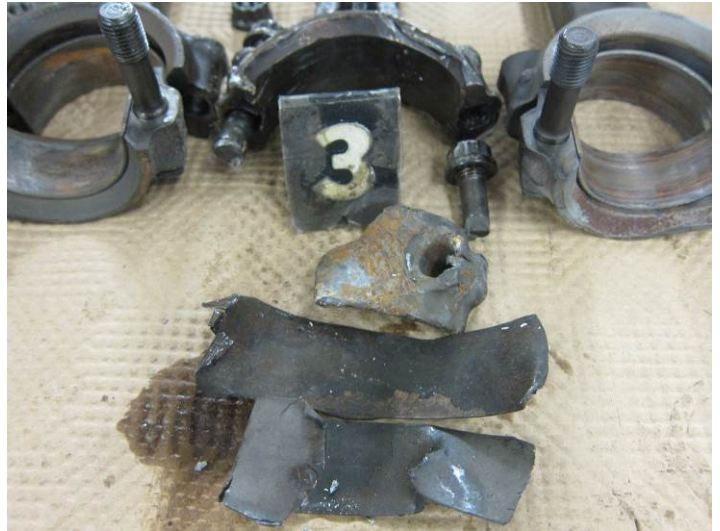
The number three intake valve head was broken from the valve stem and not located with the engine. The number three piston was broken up and the number three connecting rod separated. All of the connecting rods exhibited signs of thermal distress.
